# Clandon Farm, Martinstown, Dorset

## Archaeological Field Evaluation of Site of New Slurry Lagoon

Report No. 53444/2/1

October 2015

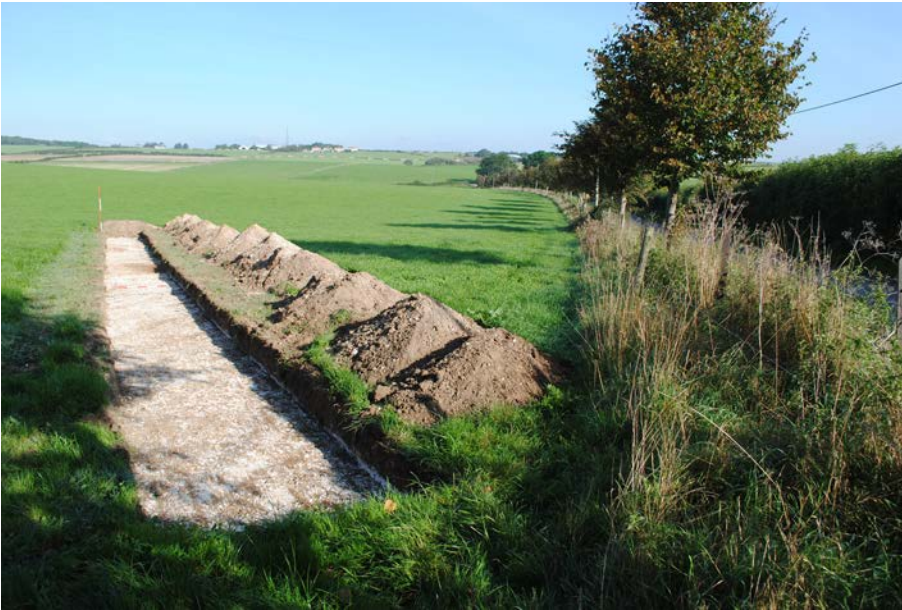
The natural chalk bedrock (101) was exposed at a depth of 0.2 m across the whole of the trench.

Overlying the natural chalk was a 0.2 m thick deposit of ploughsoil and pasture turf (100) forming the current field surface.

*Plate 1: Trench 1 viewed from south east. 1 m and 2m scales.*

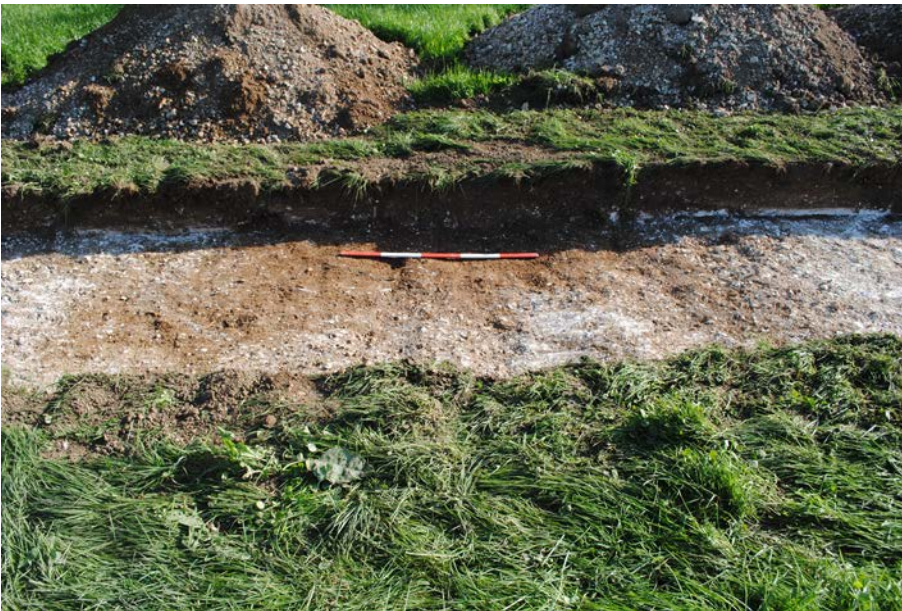
A single feature (102) was partially exposed within the trench. Its form, with disturbed chalk and a crescent-shaped deposit of soil along one side, is typical of a tree-throw, formed when a tree is blown over and uprooted. A small quantity of worked flint was recovered from the small sondage dug into this feature.

*Plate 2: Tree Throw 102 prior to investigation. Viewed from south west. 1m scale.*

Trench 1 revealed a single feature, a tree throw (Feature 102). Although this feature may be natural in origin, there is an increasing body of evidence to suggest that tree throws form a focus of prehistoric activity in the Mesolithic and Early Neolithic periods (Evans *et al.* 1999; Bellamy 2009). This tree throw may be an isolated feature, or may be one of a number of such features, which were formed before this part of the landscape was cleared in the Later Neolithic period (Woodward 1991). The site lies in an area where extensive prehistoric and Roman field systems and associated enclosures have been found and similar features could potentially exist on the site, beyond the limits of the evaluation trench.

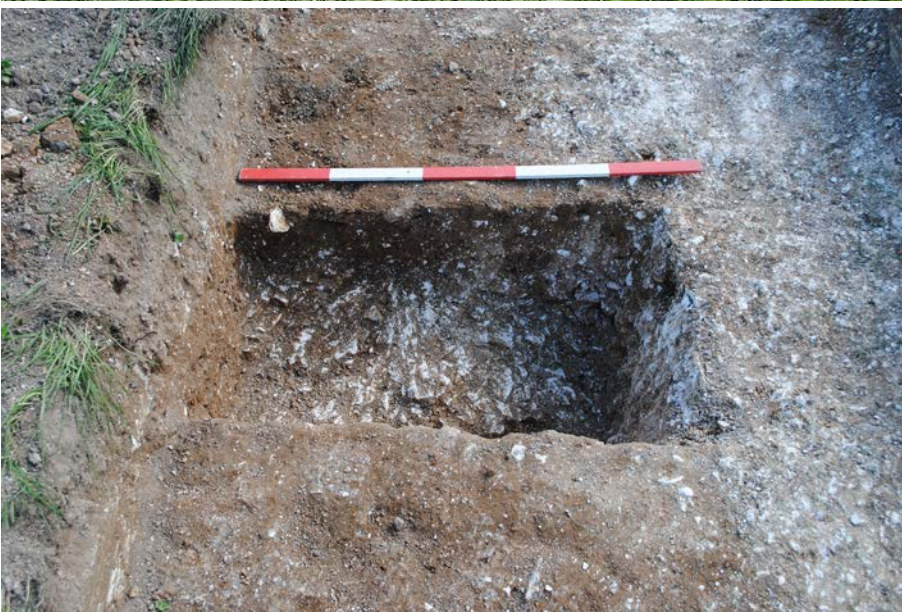
Five pieces of worked flint were recovered from the fill 103 of Tree Throw 102. These included both heavily and lightly patinated pieces. The assemblage consisted of one a core on a large thick squat flake, one other squat hard-hammer flake, a broken burin spall and two small broken thin flakes. The flint was generally undiagnostic, other than the burin spall, which may be of Upper Palaeolithic/Mesolithic date.

*Plate 3: Tree Throw 102 after excavation of sondage. Viewed from north west. 1m scale.*

The evaluation revealed a single natural feature of potentially Mesolithic date, and no other archaeological finds, features or deposits. The sample size of the area evaluated is sufficiently large to determine that it is not a deeply stratified site with a large number of cut features. The sample size was not sufficiently large to be certain whether the recorded tree throw is an isolated feature or not. As the proposed new lagoon is likely to cause substantial direct harm to any features or deposits, it is suggested that the creation of the new slurry lagoon be subject to an archaeological programme of works consisting of a Strip, Map, Excavate and Record exercise to discover and investigate any archaeological features on the site.
