Mapperton House, Mapperton, Beaminster, Dorset

Archaeological Recording of Contractor's Test Pits

Report No. 53460/3/1

November 2016

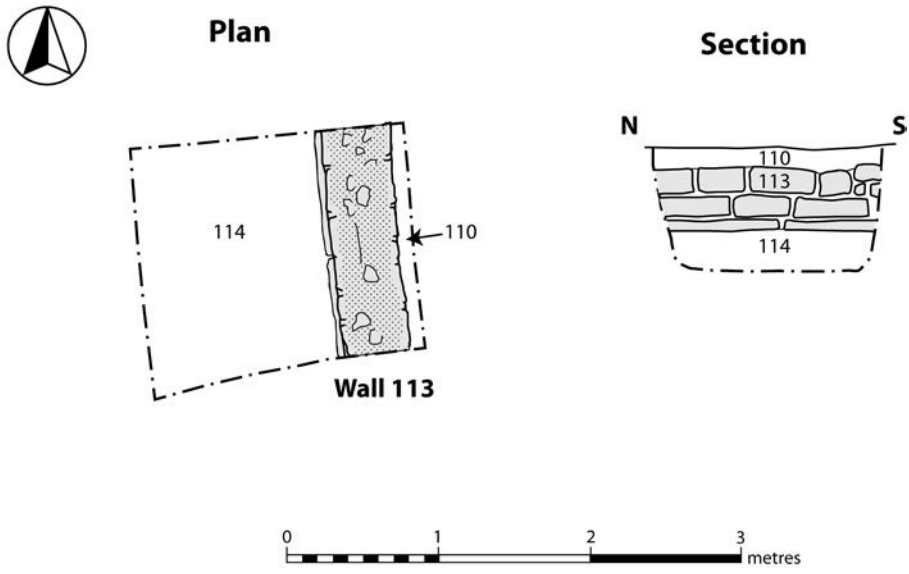
Figure 3: Plan and Section of Test Pit 2

Test Pit 2 was dug along a linear ridge running roughly north-south to the south of the church (Figure 2). The remains of a mortared stone wall (113), 0.46 m wide and surviving about 0.45 m high, was discovered running along this ridge (Figures 2–3; Plates **). It was faced with squared rubble stone on a basal spreader course of more tabular stone. The east face of the wall was not exposed. The buried garden soil layers 111 and 112 butted against this wall, which was covered by the present garden soil 110. The wall was founded directly upon a natural layer of clay and stone (114).

The overburden in all test pits was a layer of soil and turf. This was a roughly 0.25 m thick layer of brown/ reddish-brown silty clay (100, 110, 120, 130, 140). In Test Pit 2 this topsoil layer sealed the remains of Wall 113 and a thin layer of charcoal and clinker (111), which sealed a lower buried garden soil layer (112).

The test pits revealed very little new archaeological information and relatively few finds were noted. The only feature exposed was Wall 113 in Test Pit 2. This wall appears to be similar in build to a wall running south from the east end of the South Stables. Its course can be traced by the existence of a linear ridge in the ground, which runs from a stone outbuilding to the north down to the entrance drive into Garden Cottage. The west face of Wall 113 lines up with the west face of the outbuilding and with what appears to be a gate stop in the churchyard wall. It is likely that this wall is a former garden wall, delimiting a small close between the church and Garden Cottage. It is shown on the 1841 Tithe Map and on the 1889 and 1903 25-inch Ordnance Survey maps. In 1903, there is a small garden building constructed on its east side. The date of demolition of this wall is uncertain. There is no scar of this wall in the present outbuilding, which is first shown on the 1963 1:2500 Ordnance Survey map, so may have been demolished prior to this date.

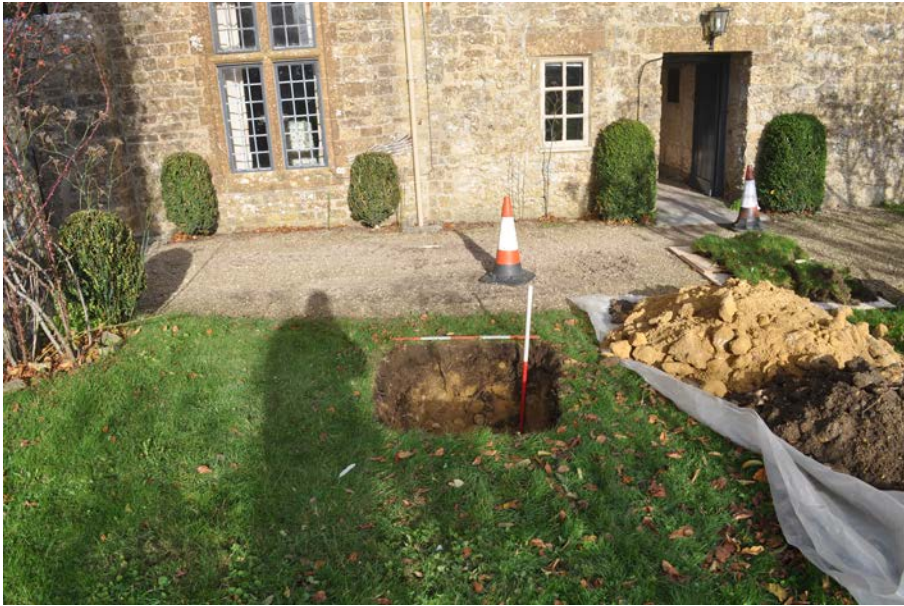
Plate 1: Test Pit 1 viewed from south. 1m scales.

Context	Description and Interpretation	Depth (m) below ground level
100	Topsoil: Dark brown silty clay with occasional small stone.	0.00 – 0.26m
101	Natural Sand and Stone: Compact dark yellow slightly clayey sand with frequent stone rubble 100–300mm across.	0.26– 0.85m
102	Bedrock: Irregularly flat limestone bedrock	0.85m +

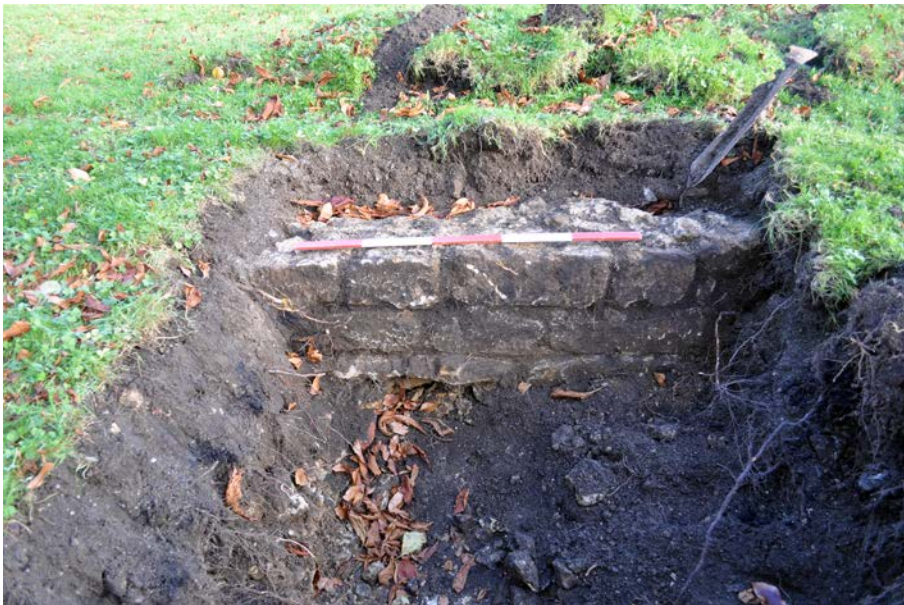
Plate 2: West elevation of Wall 113 in Test Pit 2. 1m scale.

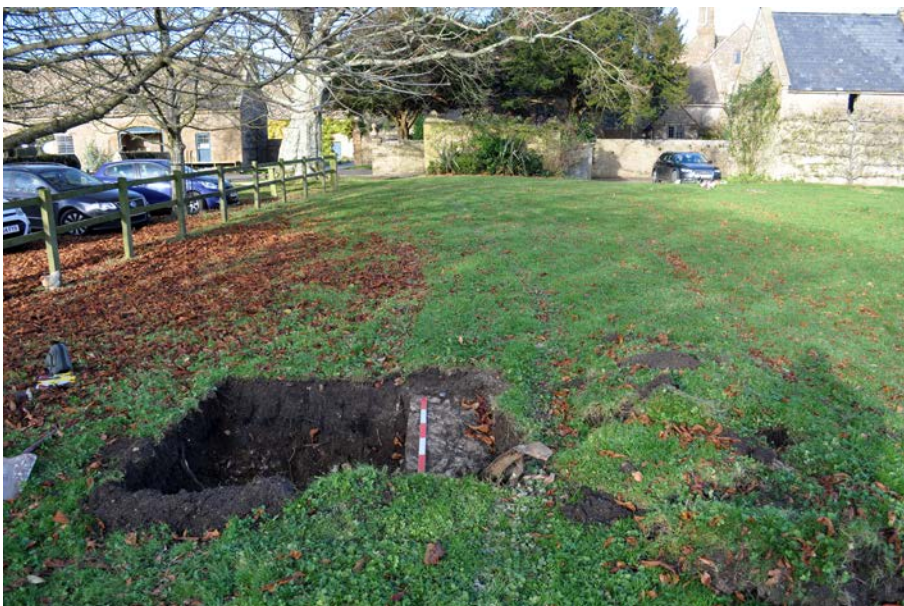
Plate 3: Test Pit 2 viewed from south showing alignment of Wall 113. 1m scale.

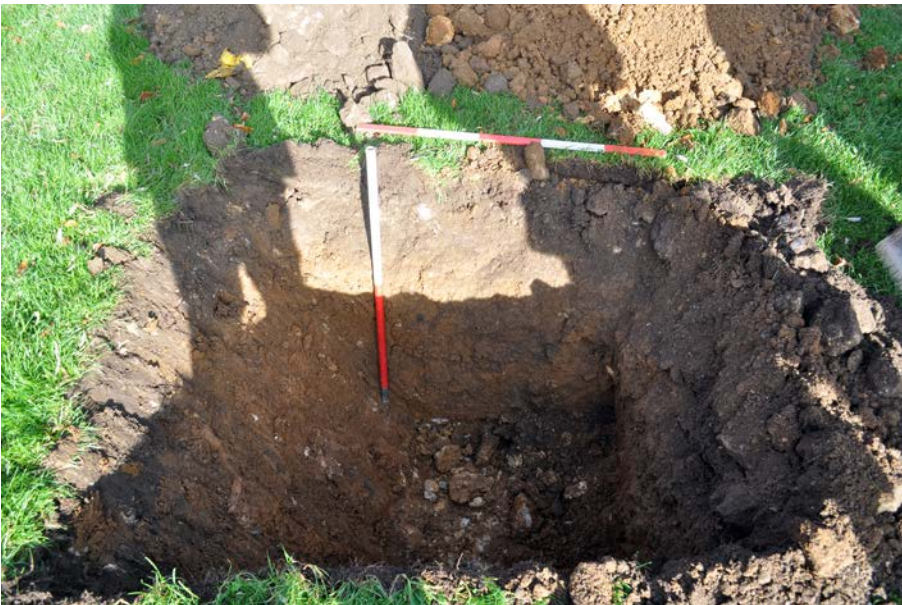
Both Test Pits 3 and 4 revealed deposits of mid reddish-brown silty clay (121, 131) between about 0.75–1.0 m thick, immediately below the topsoil, which has been interpreted as an alluvial deposit. A single animal bone and sparse charcoal flecks were noted within this deposit in Test Pit 3.

Plate 5: Test Pit 3 after excavation, viewed from south. 1m scales.

Context	Description and Interpretation	Depth (m) below ground level
120	Topsoil: Dark reddish-brown silty loam with frequent stone rubble up to 250mm across, moderate charcoal flecks.	0.00 – 0.25m
121	Alluvium?: Mid reddish-brown silty clay with occasional small stone 50–100mm across and sparse charcoal flecks. A single cattle bone also recovered.	0.25– 1.02m
122	Natural: Reddish-brown clay with frequent stone up to 250mm.	1.02– 1.22m
123	Bedrock: Irregularly flat limestone bedrock	1.22m +

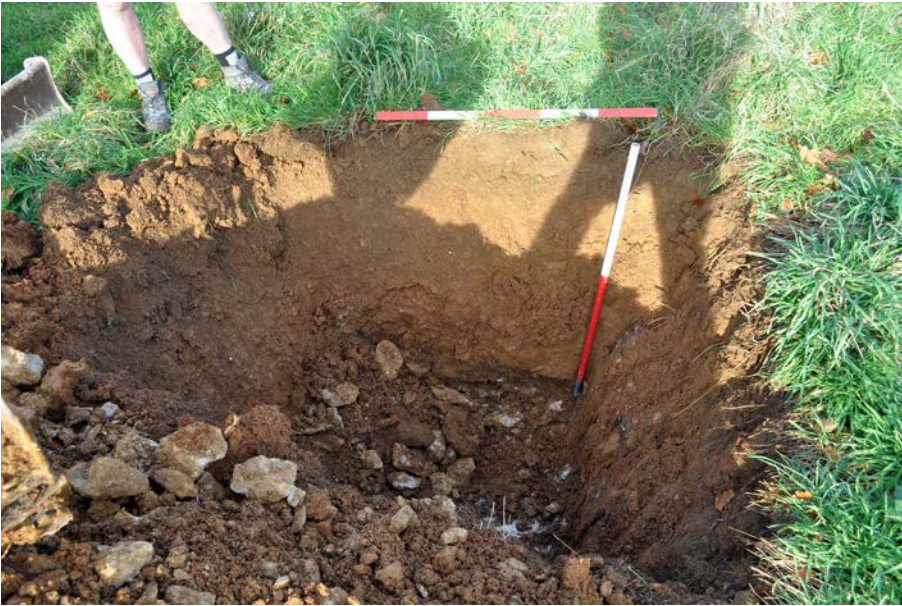
Plate 7: Test Pit 5 after excavation, viewed from south. 1m scales.

Context	Description and Interpretation	Depth (m) below ground level
140	Topsoil: Mid-dark reddish-brown silty clay.	0.00 – 0.25m
142	Natural Clay: Mottled grey and brown stiff clay with thin layer of broken flint/chert fragments in upper part.	0.25m +

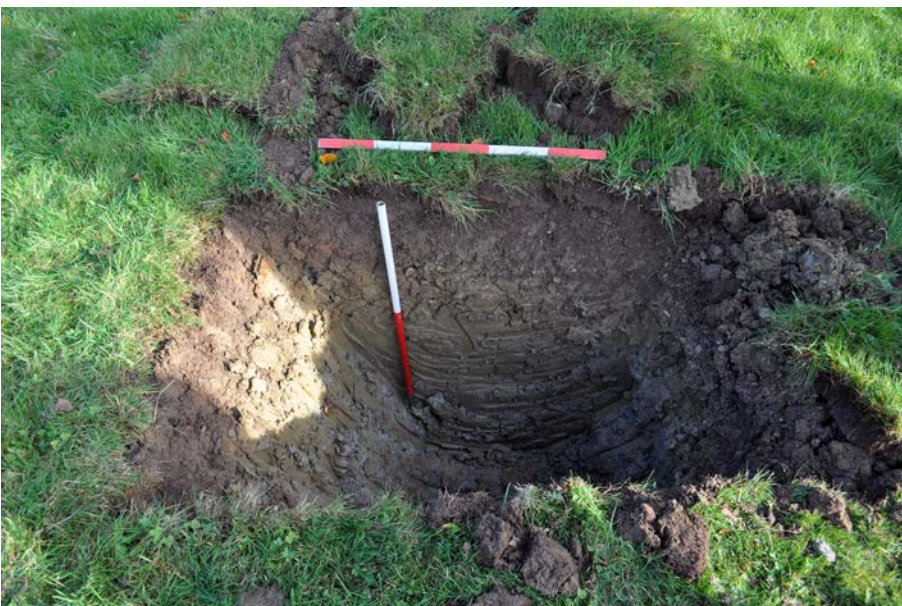
Plate 9: Test Pit 6 after excavation, viewed from west. 1m scales.
