# All Saints Church, Tarrant Keyneston, Dorset

Archaeological Observations and Recording,  
January 2017

Report No. 53461/3/1

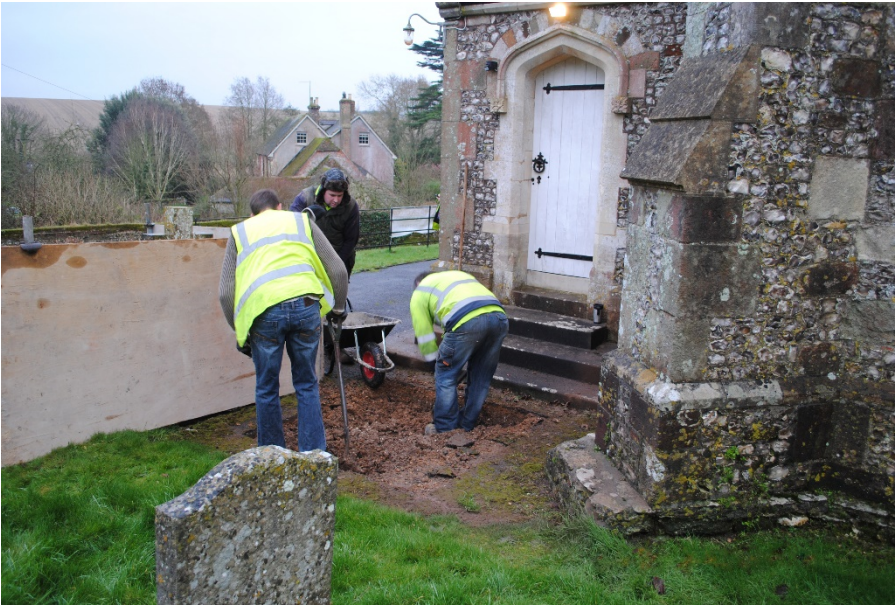
*Plate 1: Overview of works showing location of new soakaway pit outside vestry. View from north.*

The observed works comprised the excavation of a narrow drainage trench about 0.5 m deep running from the North Aisle into a new soakaway pit about 1.9 m square and over two metres deep.

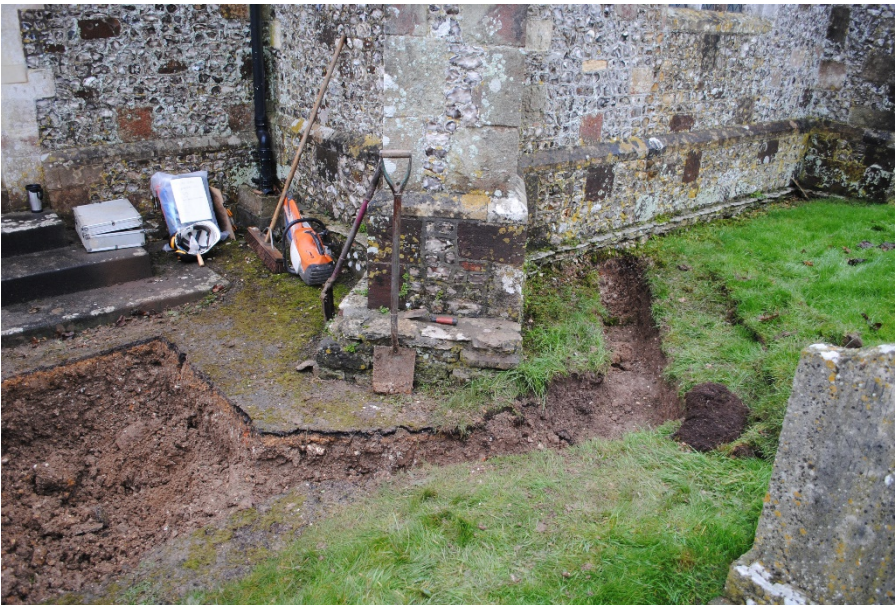
*Plate 2: Detail of new service trench linking North Aisle to new soakaway. View from east.*

A narrow service trench (Figure 2) to accommodate new drainage was manually excavated to a maximum depth of c. 0.5 m. The uppermost part of the adjacent soakaway pit was also hand-dug, pending arrival of tracked mini-digger with a toothed bucket, which was used to excavate the soakaway to full depth. Manual cleaning of key elements of the site was undertaken by the attending archaeologist where safe to do so, in order to establish or clarify aspects of the site's soil sequence and structural detail.

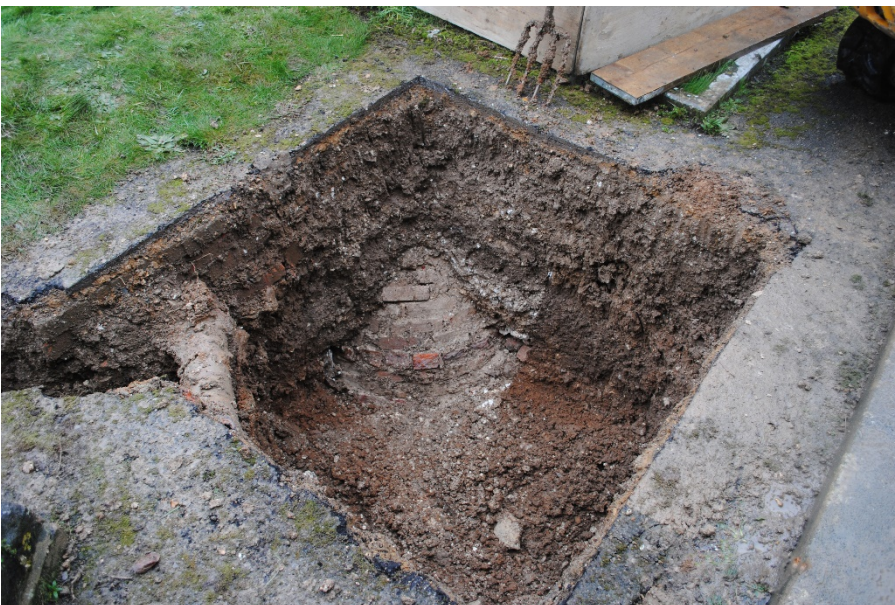
Part of a crudely corbelled lime-mortared red brick structure was encountered in the eastern corner of the new soakaway pit. The exposed structure appeared to be circular and is projected as having a maximum diameter of approximately 1.5 m. A possible base was noted at c. 1.7 m below ground level, giving the structure an overall height of about 1 m. The brickwork structure was set within a vertically-sided construction cut (104) which was also probably circular and c1.7 m deep, and below a backfill deposit (105), comprising loose, mixed mid grey-brown loamy silt, chalk flecks, occasional small flint and fragments of white/pale grey lime mortar. Cut 104 post-dated buried topsoil 103, and the feature as a whole was buried beneath dumped soil layer 102.

*Plate 3: Exposure of corbelled brick structure 106 in construction cut 104. View from west.*

The excavation trench was expanded slightly to the west to allow the structure to remain intact.

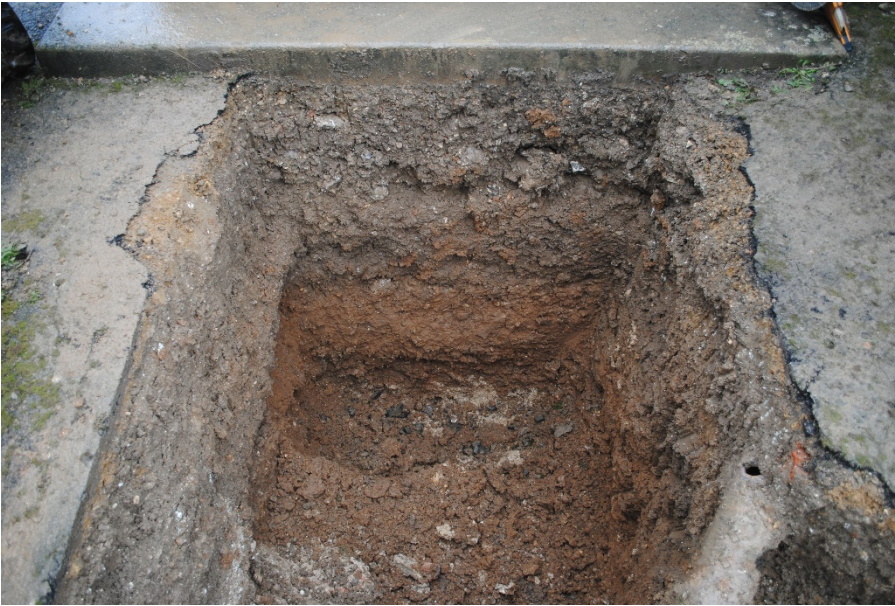
Immediately above 108, layer 109 comprised c 0.25 m thickness of mid-dark reddish brown loamy silt with moderate stones and occasional small nodular flint. The basal interface of the unit was 'wavy' and irregular, whilst the upper interface with overlying soil layer 107 was gradual and poorly defined. No finds were recovered. The deposit may represent initial post-glacial soil formation on the Coombe Rock, albeit perhaps subject to natural, and potentially anthropogenic, reworking.

Layer 107 comprised some 0.7 m thickness of developed colluvial or colluvially-derived soil, representing accumulation and re-working of hillwash, perhaps as the surrounding landscape was opened-up for agricultural use, and almost certainly predating the construction of the original church. This was a moderately firm mid orange-brown loamy silt with moderate amounts of small stone. No finds were recovered.

Layer 103 comprised some 0.2 m thickness of uncompacted, slightly humic, mid-dark grey-brown loamy silt, containing scarce small stones. The deposit is interpreted as a former topsoil. It was cut by feature 104 and subsequently buried beneath dumped soil layer 102 (see below). No finds were recovered.

Layer 102 comprised c. 0.6 m thickness of redeposited, mixed mid grey-brown loamy silt with common small stones, occasional larger stone and nodular flint, occasional chalk pieces, ceramic roof tile fragments and broken roof slate, East Dorset glazed earthenware and an adult or sub-adult lower sheep mandible. The deposit is interpreted as a relatively recent (probably 19th century) levelling-up dump.

*Plate 4: Soil sequence exposed in the south west face of the new soakaway pit. View from north east*
