# Church of St Michael and All Angels, Askerswell, Dorset

Archaeological Observations and Recording, July  
2017

Report No. 53472/3/1

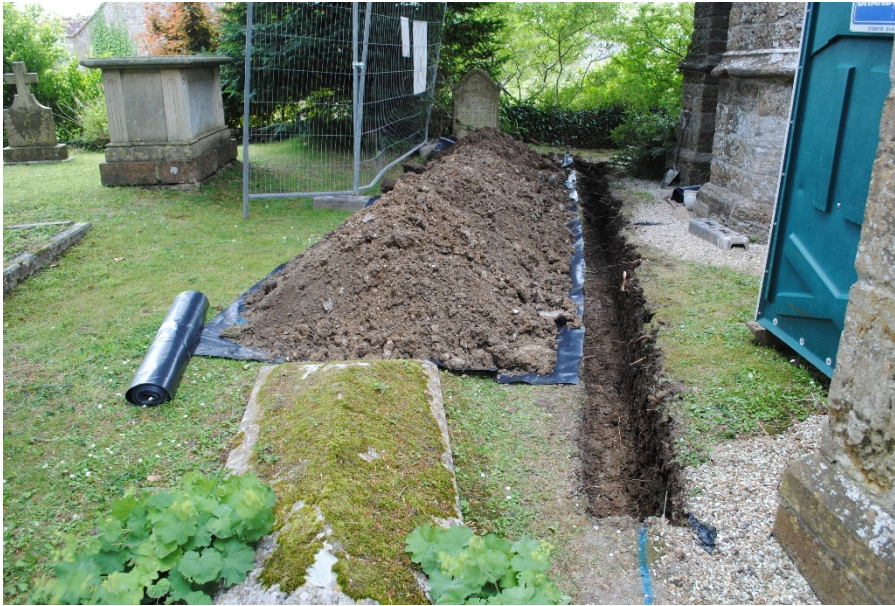
*Plate 1: Pipe trench south of Nave and West Tower. View from east.*

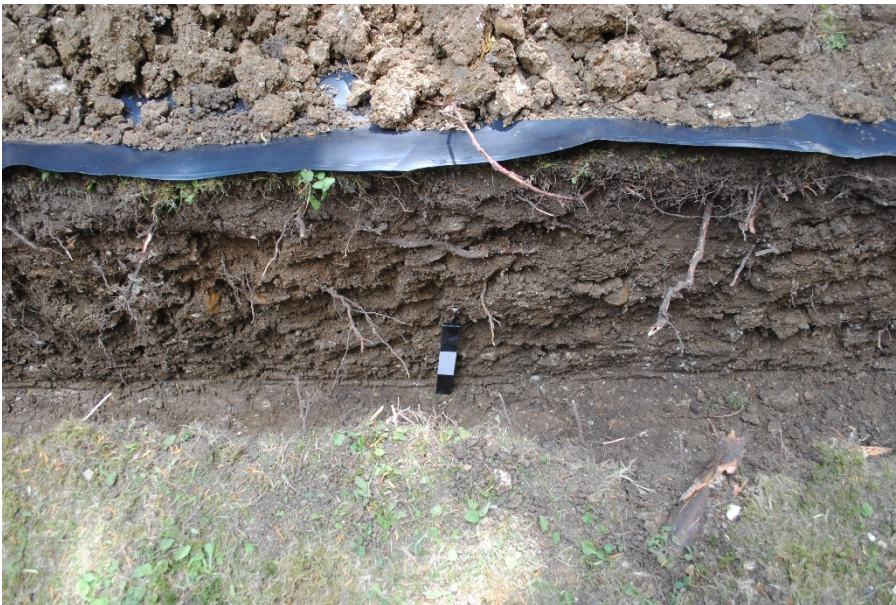
Trenching south and west of the West Tower revealed a similar soil sequence.

0.00 – 0.15 m BGL	<b>Topsoil</b>	Moderately firm mid-dark grey-brown slightly humic clayish loam, containing occasional stones >20mm and frequent small roots.
0.15 – 0.70 m BGL	<b>Churchyard Soil</b>	Moderately firm mid-yellow brown calcareous clay loam, containing occasional stones >40mm and scarce larger nodular flint, chert and greensand.
0.70 m + BGL	<b>Natural</b>	Firm mid-light yellow-brown clay loam containing common brecciated small- to medium stone, with occasional larger fragments up to c. 60mm.

*Plate 2: Detail of soil sequence south of West Tower. 0.3 m scale. View from north.*

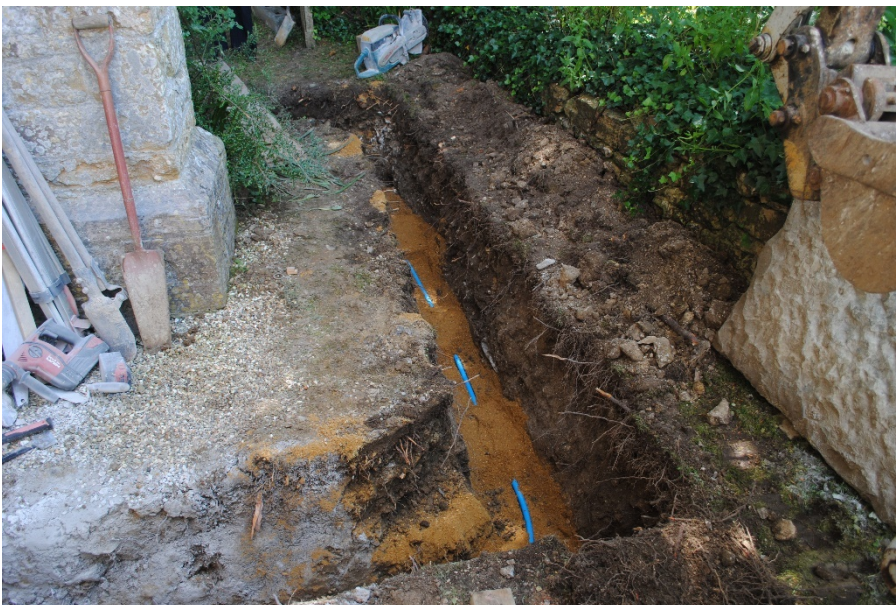
No footings from the church building were exposed. No indication of a crypt structure rumoured to lie beneath the West Door of the church was encountered.

*Plate 3: Pipe trench west of West Tower. View from north.*

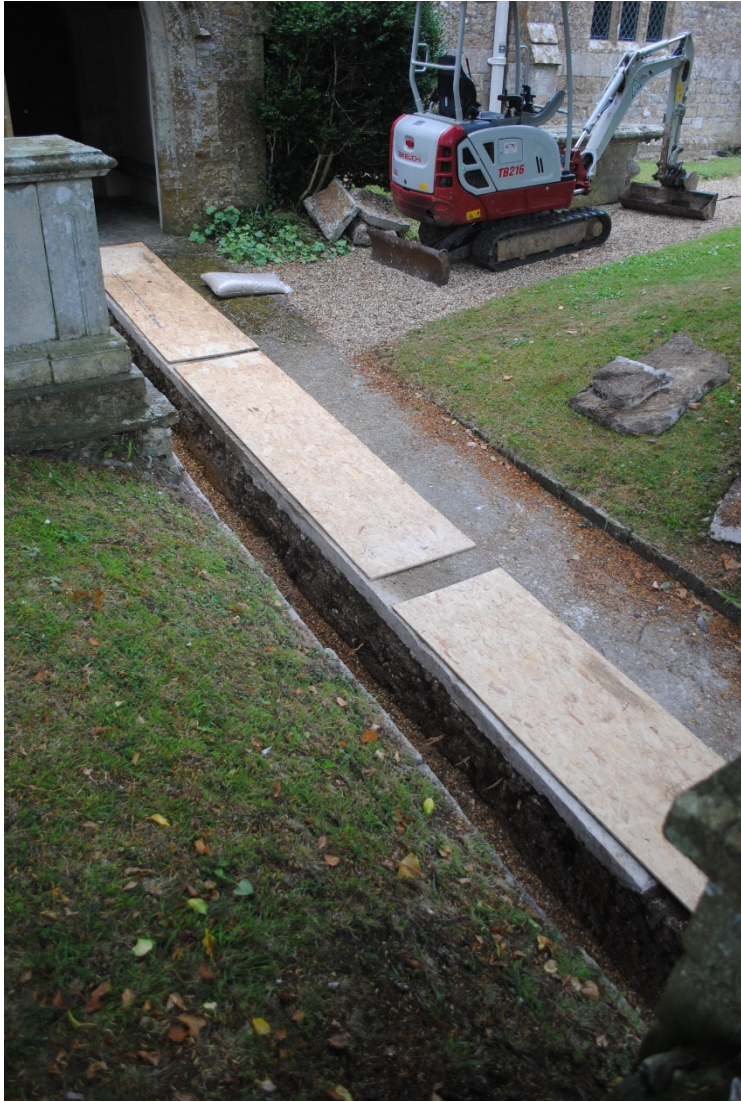
The upper two soil layers appear to have been scarped away by the creation of the ramped south path. Towards the southern end of the trench, beneath the south gate and Nallers Lane, the soils appeared mixed, largely homogenous and potentially reworked.

*Plate 4: Pipe trench along south path to Nallers Lane. View from south.*
