Upton Park Farm, Upton Road, Poole

Archaeological Observations and Recording during Change of Use
from Agricultural Land to a Suitable Alternative Natural Greenspace
(SANG) Phase 2, July–September 2016

Report No. 53415/3/2

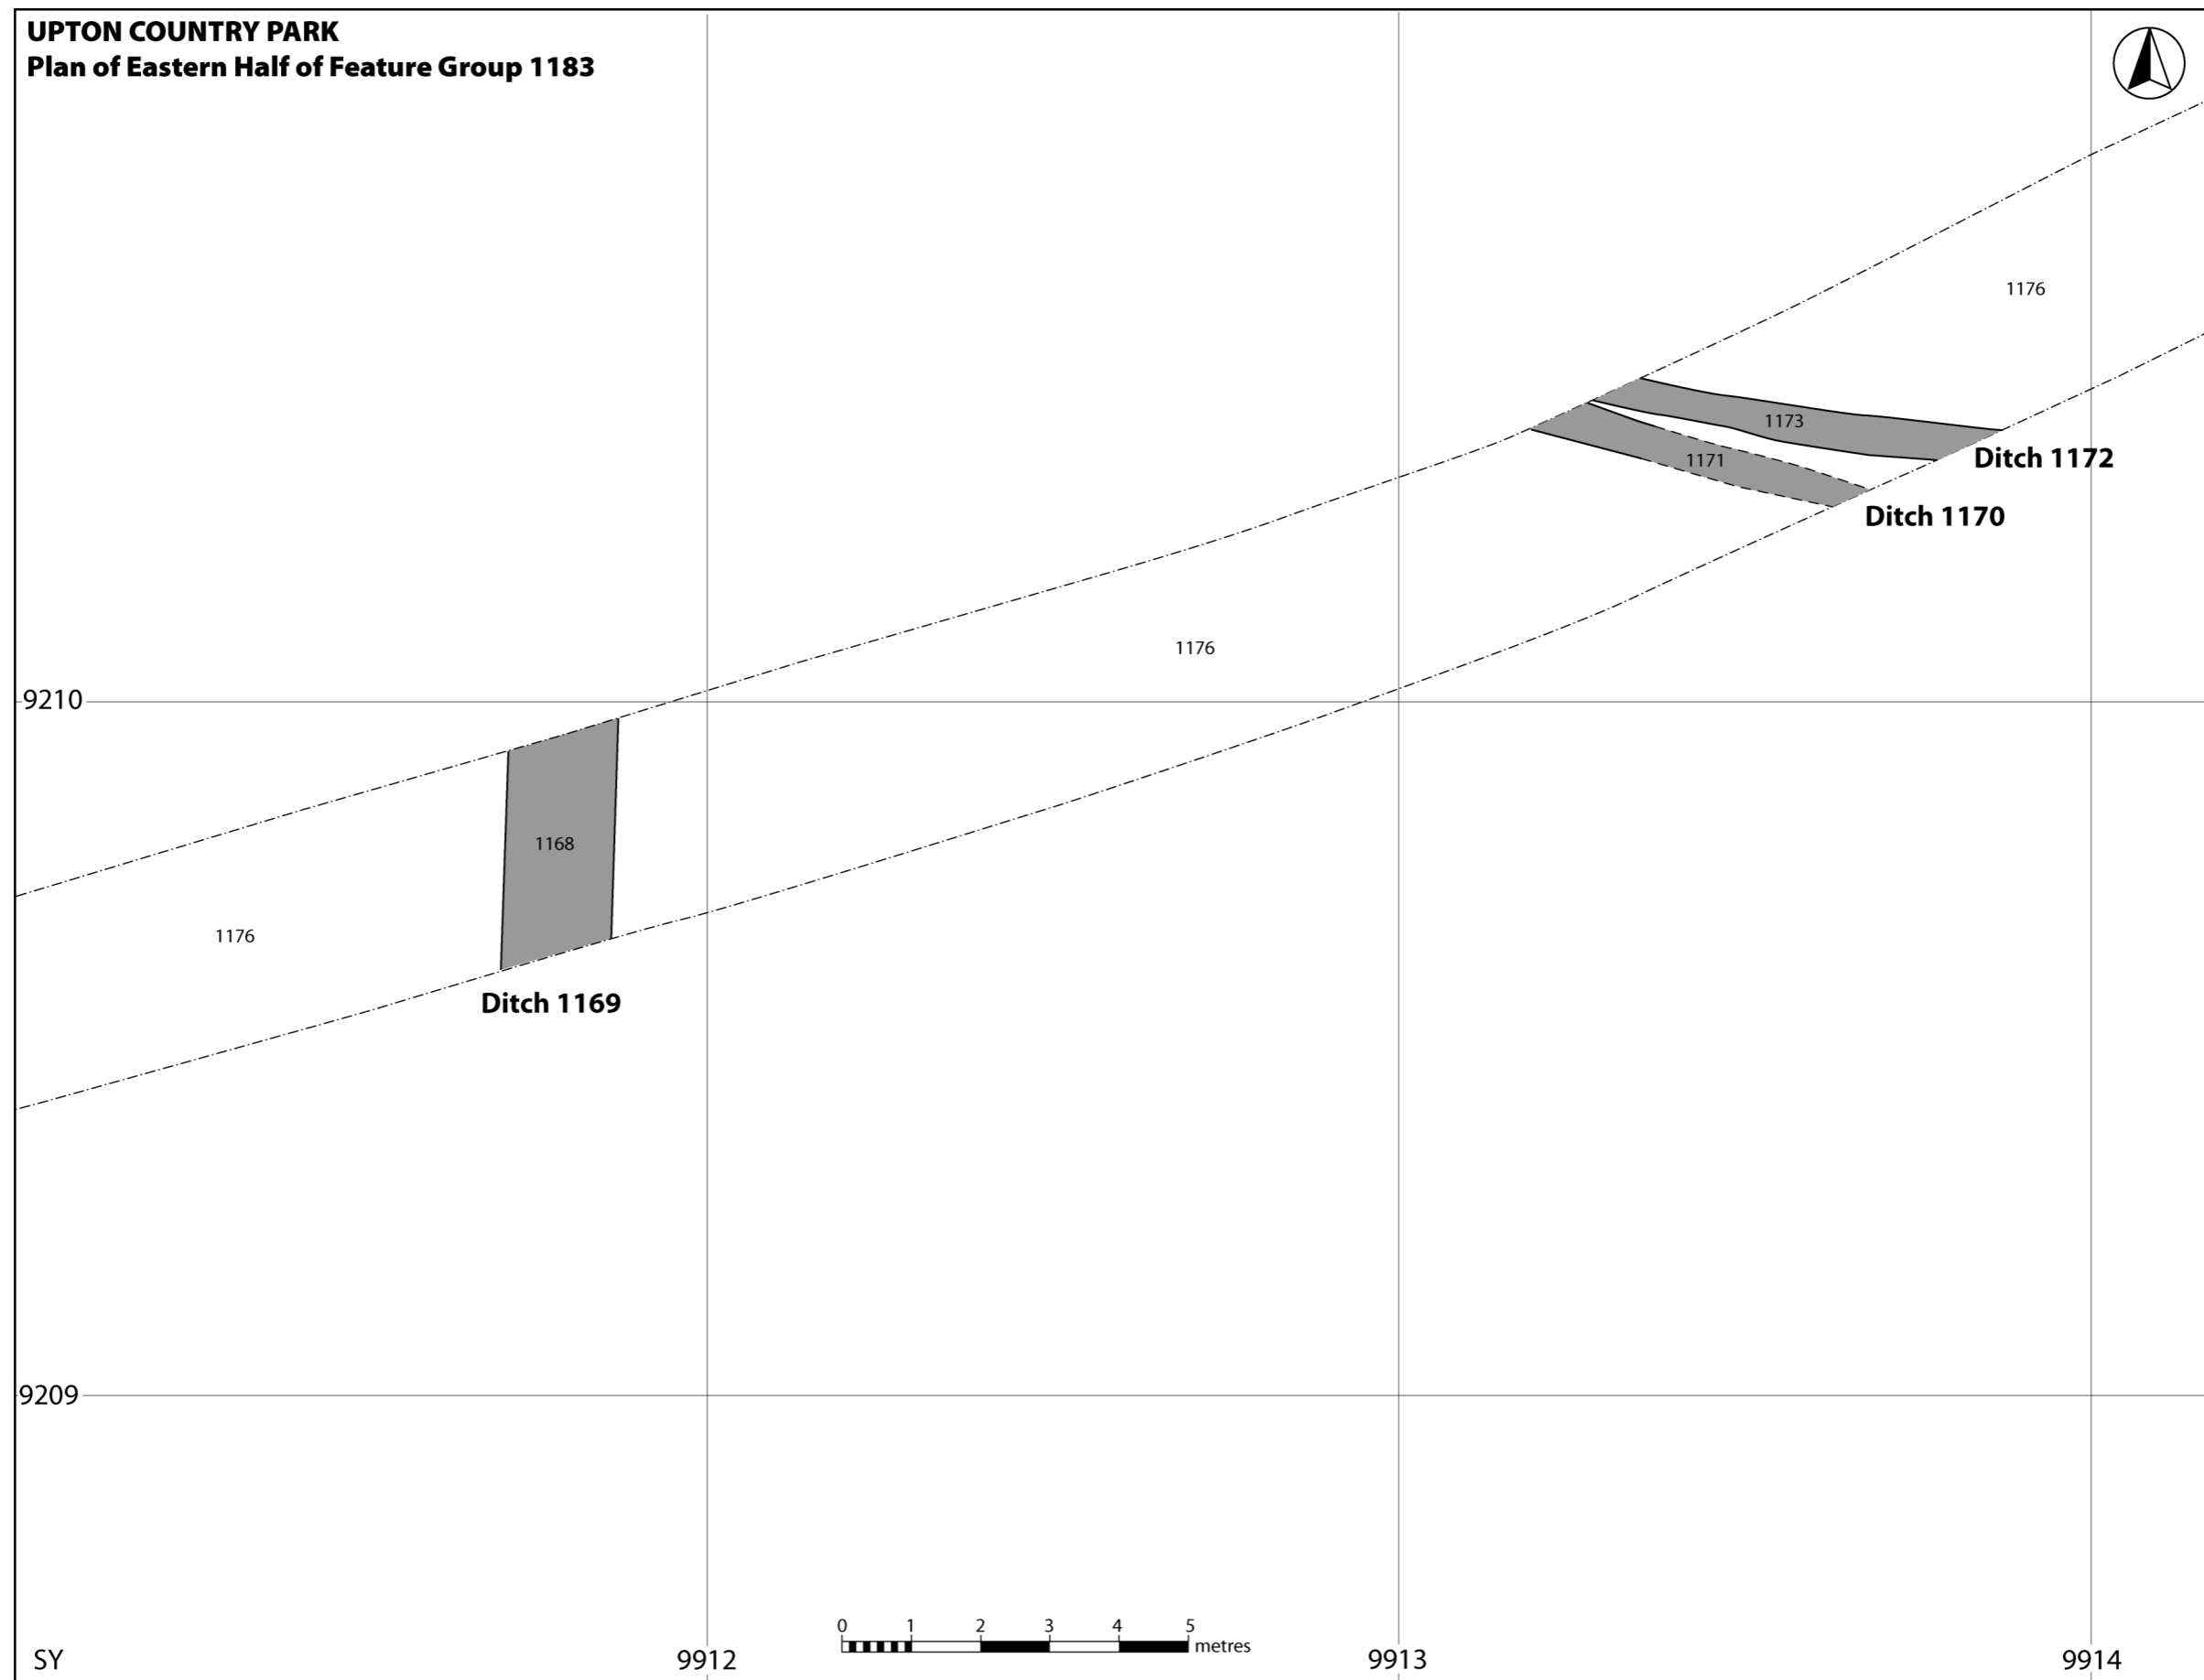
Figure 7: Plan of east half of Feature Group 1183.

Along the southern edge of the field were a series of features that have been recorded as Feature Group 1183 (Figures 2, 7 and 8). About 40 m west of Feature Group 1182, were a pair of shallow ditches 1170 and 1172 running in a roughly WNW-ESE direction (Figure 7). They were both about 0.5 m wide and 0.15 m deep with rounded sides and base and filled with dark grey clayey sand (1171, 1173). The close proximity and broadly similar orientation of these ditches suggests they may represent the redefining of a single boundary. Ditch 1172 contained a single sherd of medieval pottery. About 35 m further west was another WNW-ESE ditch (1166), which may be associated with 1170/1172 as part of a system of parallel boundaries. Ditch 1166 was about 0.7 m wide and very shallow, petering out to the east. It was filled with dark greyish-brown clayey sand (1165). No dating evidence was recovered.

Between ditches 1166 and 1170/1172 was a 1.6 m wide ditch (1169) running N-S (Figure 7; Plate 12-13). It was filled with dark grey sand (1168). No dating evidence was recovered.

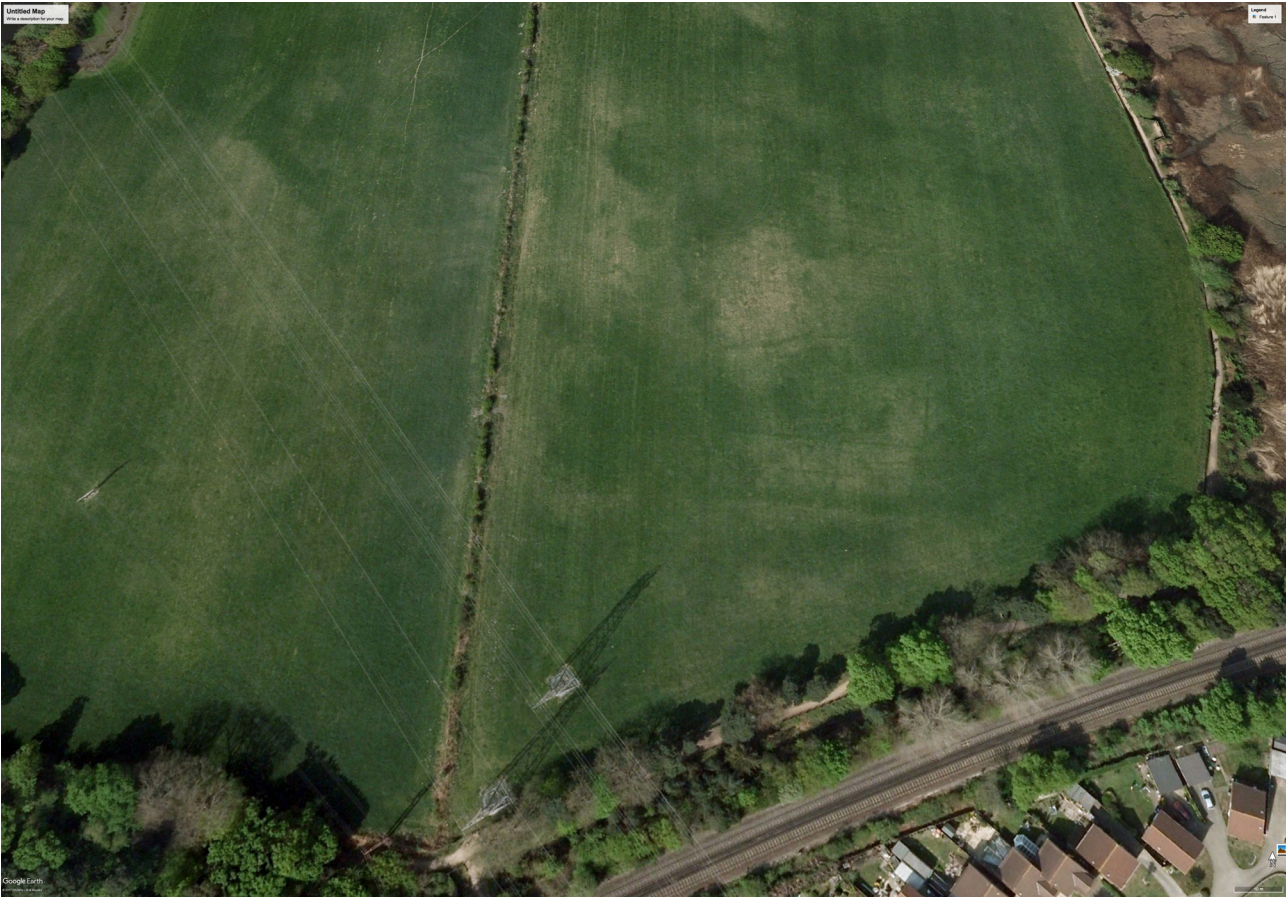
Towards the southern end of the field, about 125 m south of Feature Group 1180, was Feature Group 1181 (Figure 2). This consisted of three parallel ditches (1118, 1120, 1122) about 0.75 – 1.5 m apart running in a roughly E-W or ESE-WNW direction (Figure 5; Plate 8). The ditches were shallow U-shaped ditches between 0.85 – 1.45 m wide and 0.09 – 0.16 m deep, cut into the natural sand 1117. All three ditches were filled with similar dark greyish-brown clayey sand (1119, 1121, 1123). A single sherd of medieval pottery was recovered from the fill of Ditch 1122 and two fragments of burnt clay from the fill of Ditch 1118. The similarity of these ditches and their close proximity suggests they may represent different phases of redefining of a single boundary. The course of this boundary cannot be traced on the aerial photographs (Figure 9).

At the southern end of this feature group were three further ditches (1152, 1154, 1156). Ditch 1152 was oriented NNW-SSE, possibly curving round to the south just at the edge of the trench. Its relationship with Ditch 1154 was not determined as the two ditches crossed each other just outside the trench. Ditch 1152 was filled with mid to dark greyish brown clayey sand (1151) and did not contain any datable material. Ditches 1154 and 1156 ran in an E-W direction, roughly parallel to each other (Plate 11). They were filled with dark greyish-brown clayey sand (1153, 1155) and did not contain any datable material. These two ditches appear to have been part of a broad E-W cropmark visible on a 2007 aerial photograph (Figure 9).

Figure 9: Google Earth Aerial Photograph 2007 showing cropmarks in southern part of site (© 2017 Infoterra Ltd and Bluesky)

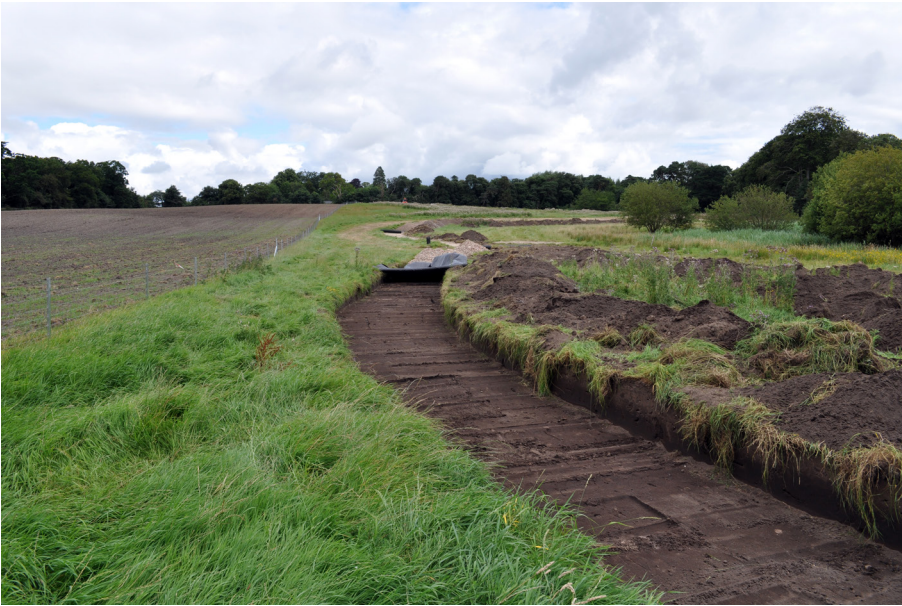
The course of the new road was divided into two parts for ease of recording and the Trench 10 was the part of the road that ran through the northern field. Almost the whole length of Trench 10 had been excavated and the roadway constructed before Terrain Archaeology was informed about the works. Only the southernmost 65 m of the route was observed archaeologically (Figure 2). In this area, the groundworks did not penetrate below the topsoil and colluvium, except in one small area where grey/yellowish-grey clayey sand natural (1001) was exposed at a depth of 0.55 m below present ground level. No archaeology was revealed.

Plate 1: Trench 10 looking north, showing first part of trench observed.

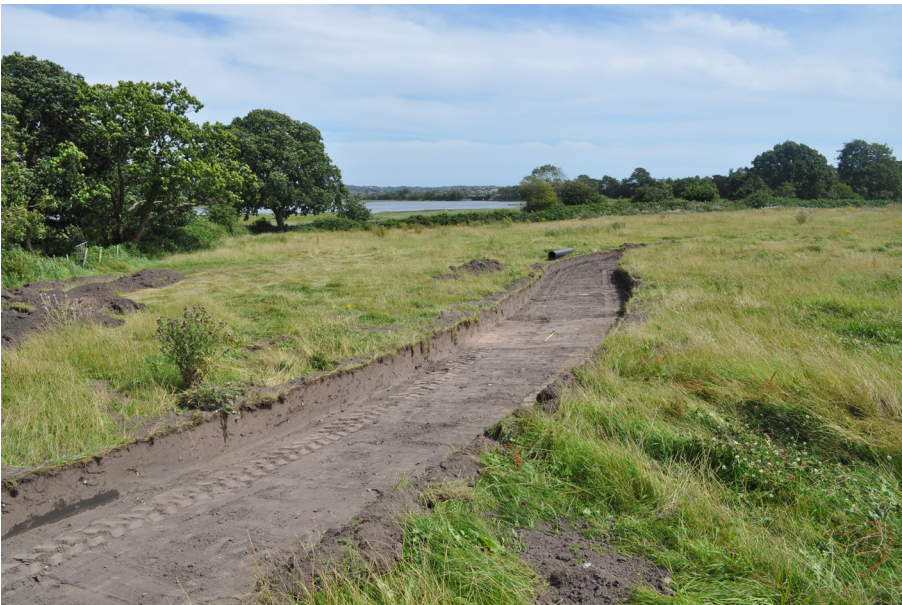
Plate 2: Trench 11, looking towards cleared area of Feature Group 1179. View from NW. 1m scale.

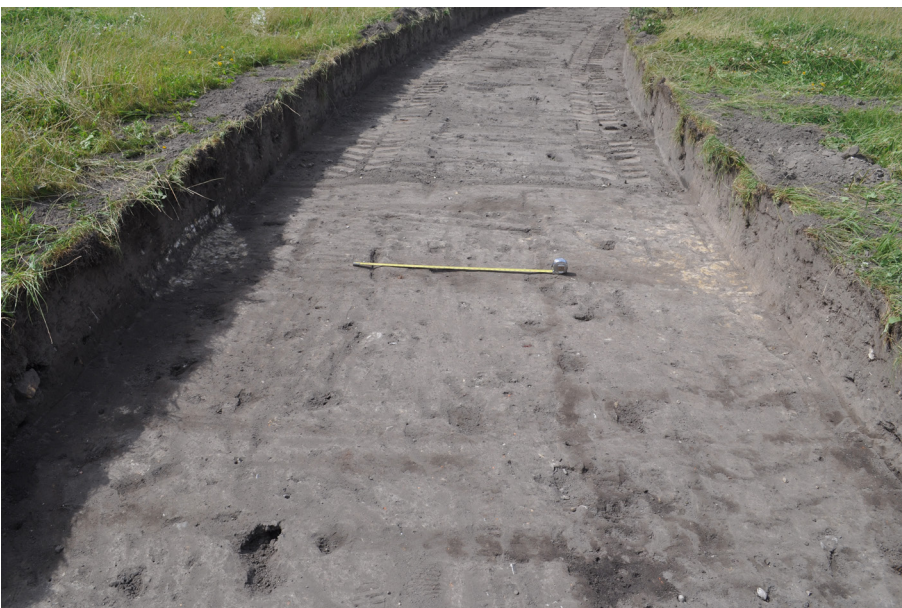
At the north end of the field on relatively level ground just below the slope of the ridge was a group of features consisting of two discrete small clay areas (1104, 1105) and two linear clay structures (1106, 1108) (Figure 3; Plate 2). These features were not investigated beyond recording the exposed parts in the base of the new roadway. To the north west, features 1104 and 1106 were spaced about two metres apart and both were only partially exposed in the edge of the trench (Plate 3). Feature 1104 consisted of a curving, perhaps circular or ovoid, clay structure over 1.15 m across. The lower exposed part of this feature was a hard pale grey, yellow and orange burnt clay deposit, over which was a thin layer of dark greyish-brown sand with frequent charcoal flecks and a layer of clay lumps in dark greyish-brown charcoaly sand (Plate 4). This feature lay immediately below the topsoil and may be the remains of a hearth or oven. Feature 1105 to the north consisted of a roughly triangular area of hard mottled pale grey, yellow and orange burnt clay, 1.2 m across. 1105 was less regular than 1104, but may also be the remains of an oven or hearth.

Plate 3: Features 1104 (left) and 1105 (right) in Feature Group 1179, viewed from SE. 1m scale.

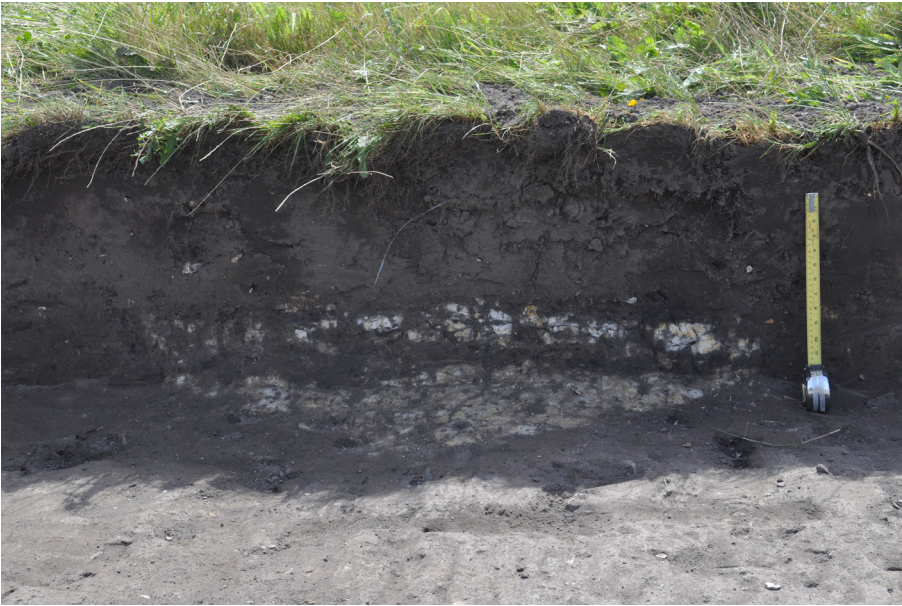
Plate 4: Detail of Feature 1104. 30cm scale.

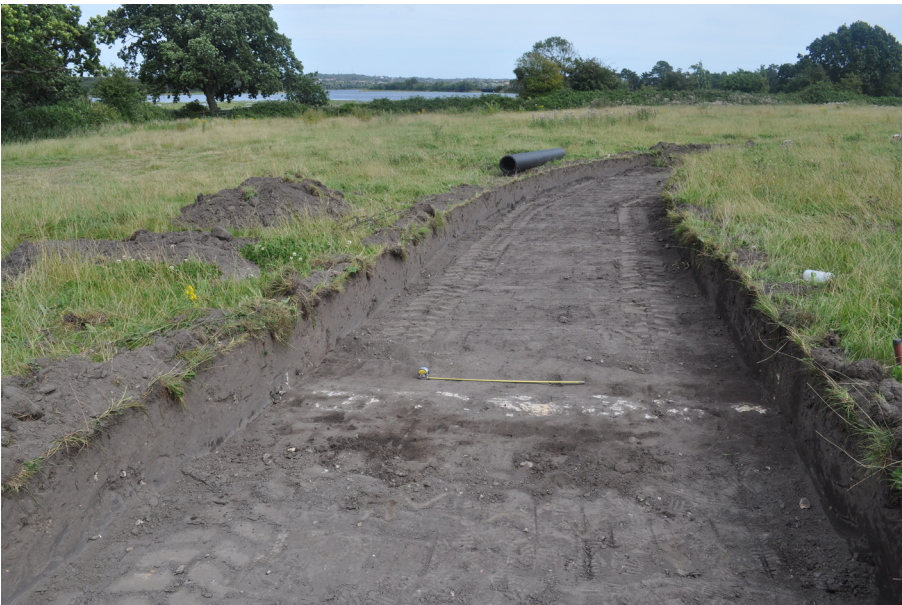
About 7.5 m to the SE lay Feature 1106. This was one of a pair or roughly parallel linear features with 1108, oriented roughly NNE-SSE and about 17.5 m apart (Figure 3; Plate 5). Feature 1106 was 0.3 m wide and comprised yellow/white/buff clay lumps, including some rectangular lumps measuring 5-8 by 25cm across, which looked like they may have been deliberately cut clay 'bricks'. Feature 1108 was also 0.3 m wide and consisted of white clay lumps, but no coherent structure could be seen in this clay. Both 1106 and 1108 may represent the remains of clay-built walls.

Plate 5: Feature 1106, looking ESE. 1m scale.

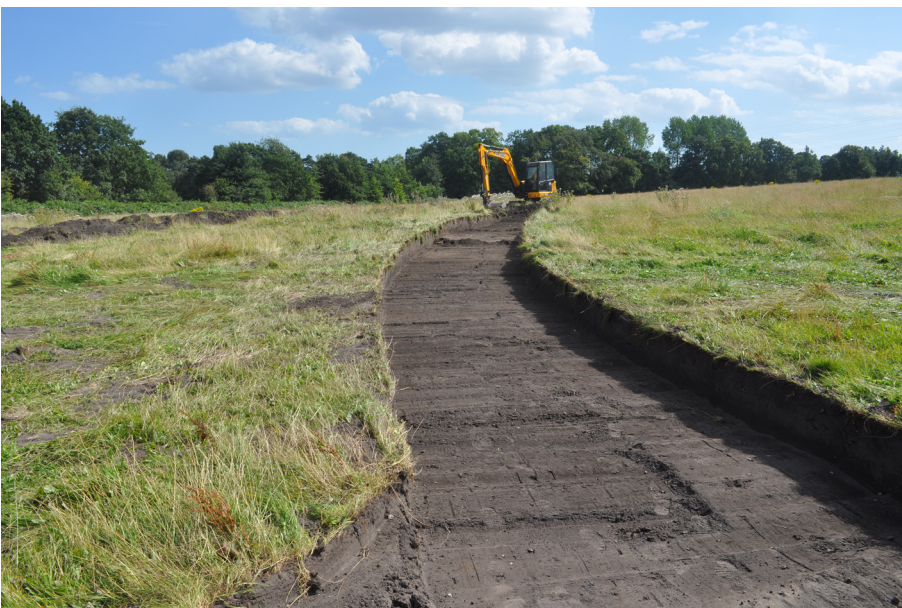
Plate 6: View towards Feature Group 1180, looking south.

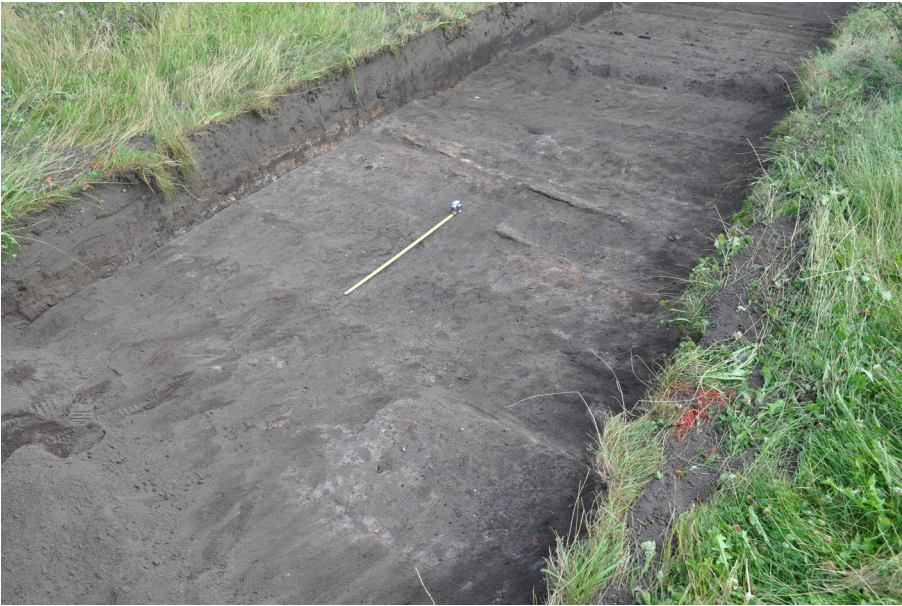
About 35 m to the SSE of Feature Group 1179 lay Feature Group 1180 (Figure 2). It consisted of a complex of features numbered 1112 centred on SY 99208 92324 (Figure 4; Plates 6-7). Feature 1112 consists of two 0.2 m wide strips of hard orange-brown clayey sand, aligned, roughly E-W and about 0.6 m apart. One strip ran across the whole width of the trench, but the other was only present in the western part. Around these strips were patches of hard reddish-brown burnt clayey sand with grey ash lenses and charcoal flecks, pale-mid grey sand with ash and charcoal flecks, mixed hard greyish-brown sand and clay patches with charcoal flecks and burnt flint, and soft dark greyish-brown sand with moderate charcoal flecks. No finds were recovered from this feature group and it is difficult to interpret the exposed remains. The occurrence of charcoal flecks and burnt flint might suggest the presence of a hearth or oven near by, but without further investigation, the interpretation and date must remain uncertain.

Plate 7: Feature Group 1180, looking SE. 1m scale.

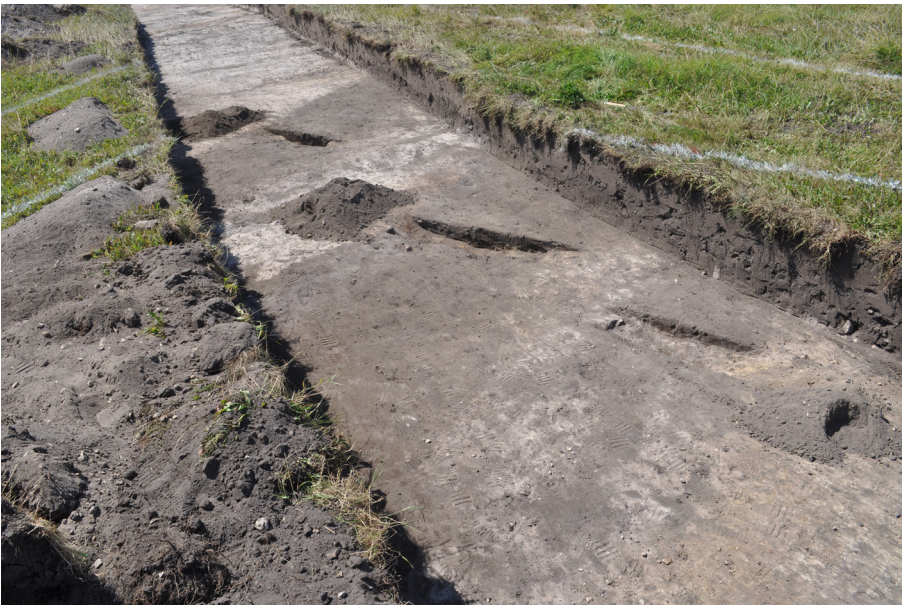
Plate 8: Ditches 1118, 1120 and 1122 of Feature Group 1181, looking east.

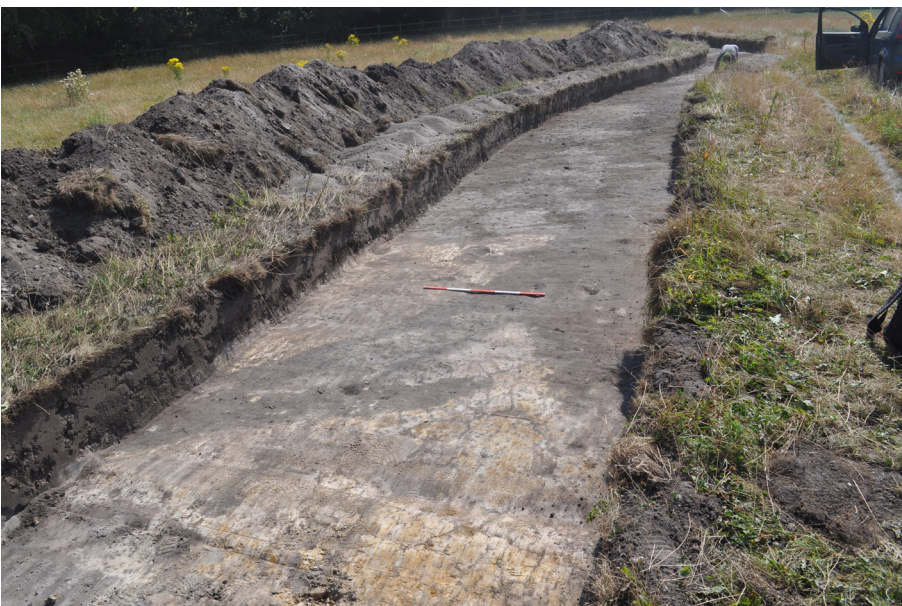
About 22 m SSW of Feature Group 1181 lay the greatest concentration of archaeological features exposed during the works (Figures 2 and 6; Plates 9-11). Feature Group 1182 comprised a number of linear and curvilinear ditches. The earliest feature was probably the curvilinear ditch 1128 near the north end of the complex. It was the only feature that has more than one fill. The lowest deposit (1131) was a thin charcoal-rich sand, over which was a dark greyish-brown clayey sand (1130) with a pale yellowish-grey sand (1129) above. This ditch was cut by two other ditches (1126, 1177). The north side was cut by a shallow E-W ditch 1126 filled with dark greyish brown clayey sand (1127), which contained a small amount of medieval pottery. The western/southwestern end of ditch 1128 was cut by a large curvilinear ditch 1177, which ran roughly SSW and curved round towards the south and east (Figure 6; Plate 10). It was about 1.2 m wide, with rounded sides and flattish base up to about 0.3 m deep. Filled with dark greyish-brown clayey sand (1178, 1133, 1143, 1147), containing some medieval pottery. Ditch 1177 was cut by two ditches (1146, 1150). Ditch 1146 was a shallow linear feature, 0.6 m wide, aligned E-W, filled with dark greyish-brown clayey sand (1145), but contained no datable material. This ditch appears to be part of a linear cropmark visible crossing the field in a 2007 aerial photograph (Figure 9). Ditch 1150 appears to have been two parallel intercutting linear features, oriented roughly WSW-ENE, which cut the southern end of 1177. They were filled with dark greyish-brown clayey sand (1149), containing some medieval pottery.

Plate 9: Feature Group 1182, looking SSW. 1m scale.

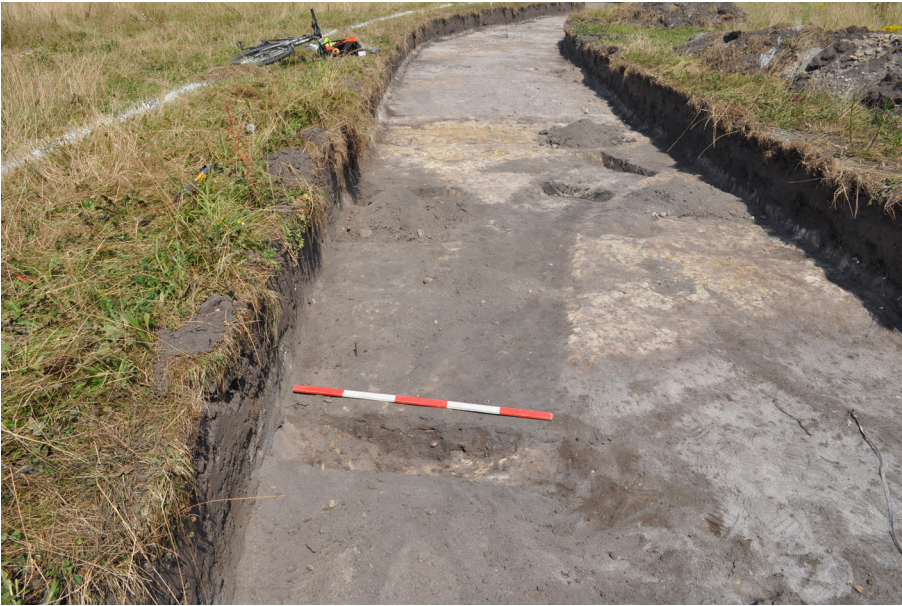
Plate 10: Section 1144 across Ditch 1177 in northern end of Feature Group 1182, looking NNE. 1m scale.

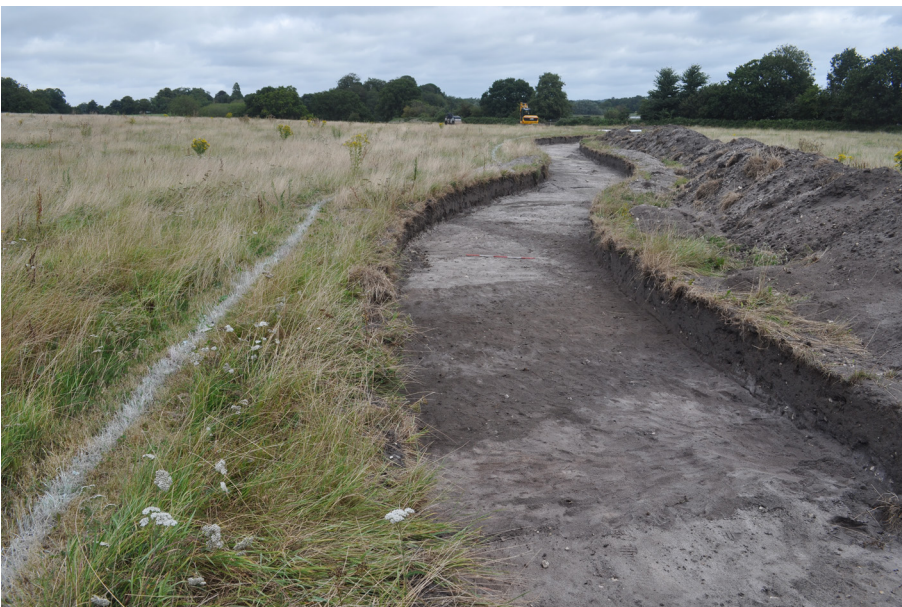
Plate 11: Southern end of Feature Group 1182, with Ditches 1154 and 1156 in foreground, looking NNE. 1m scale.

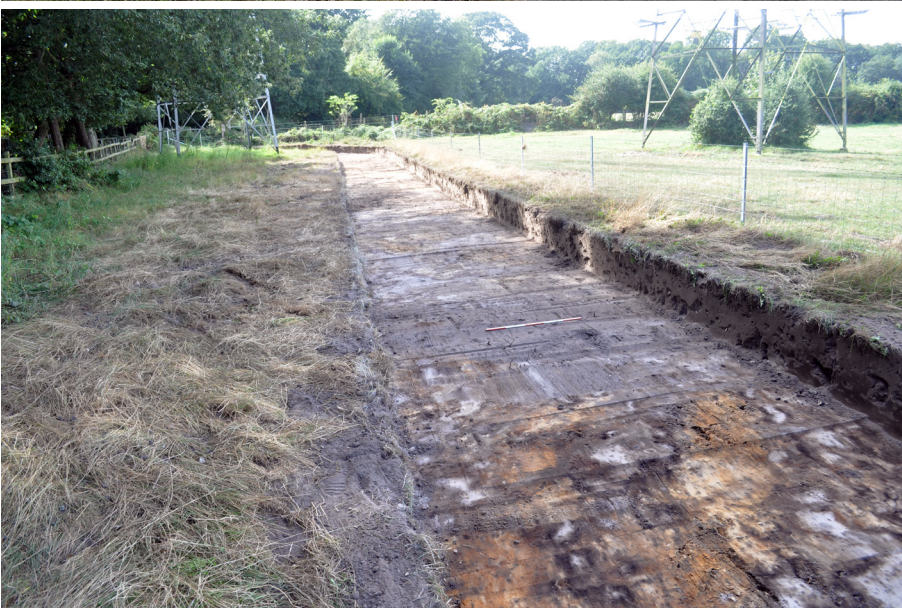
Plate 12: Southern end of Trench 11, looking W, with Ditch 1169 in foreground. 1m scale.

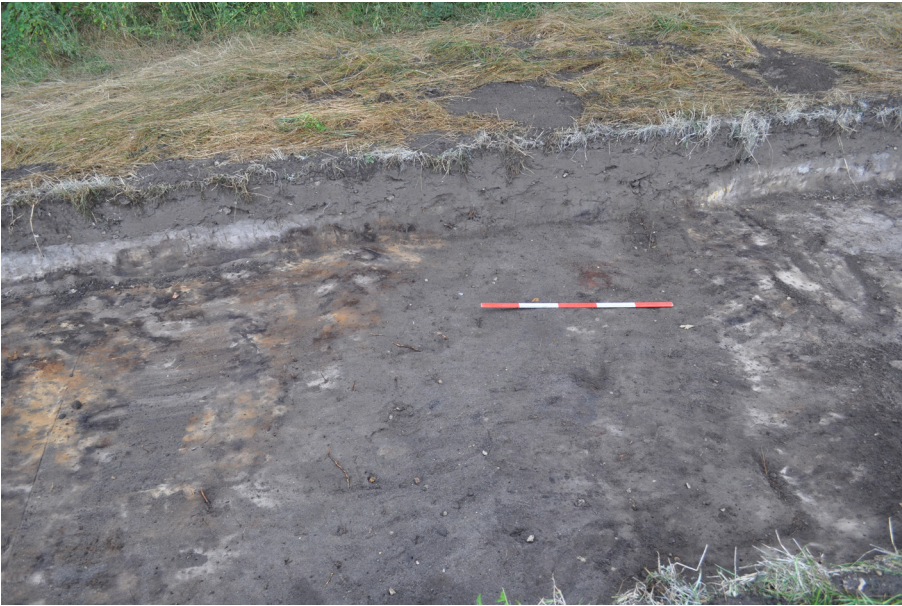
Plate 13: Ditch 1169, looking north. 1m scale.

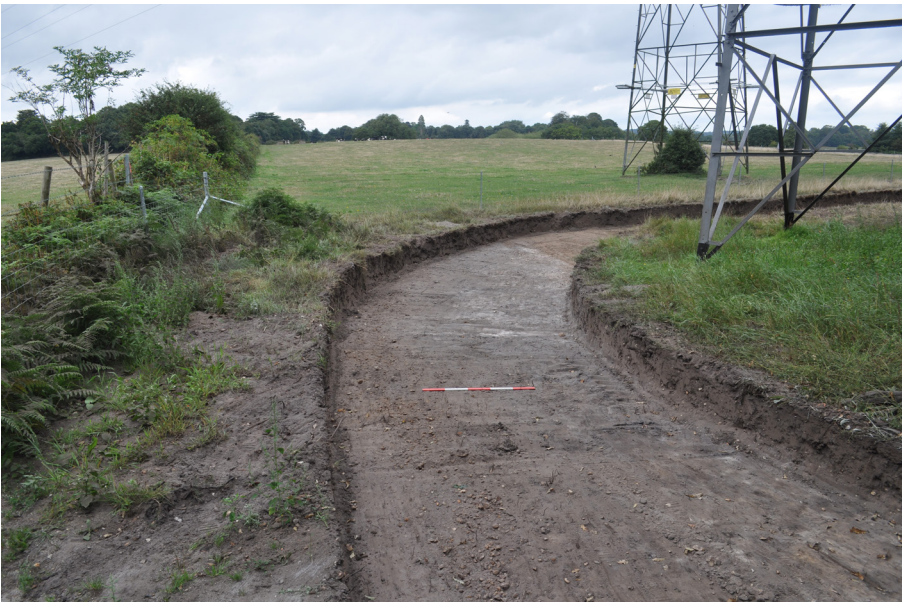
At the southwestern end of the trench, was a layer of poorly sorted flint gravel in a dark greyish-brown clayey sand matrix (1160) over two metres wide, with a roughly N-S edge to the east. It continued beyond the trench to the west (Figure 8). This appears to grade into the natural sand below and may be no more than an area of gravelly natural. Several metres to the east of this gravel was a broad shallow (0.15 m deep) flat-bottomed cut (1162), which had a

Plate 14: Southern end of Trench 11 with gravel layer 1160 to left and Feature 1162 in background. 1m scale.

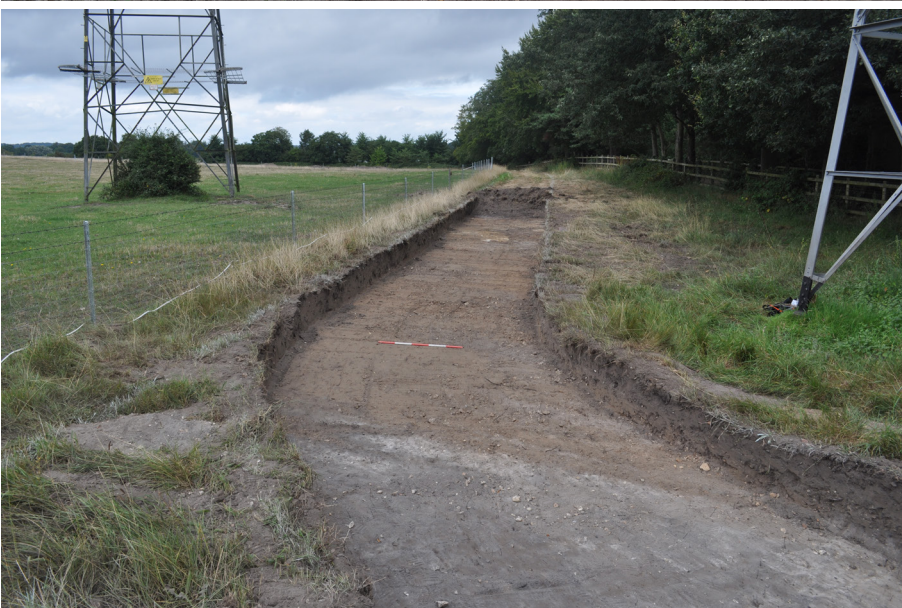
steep-sided western edge running N-S, but no clear eastern edge. It was filled with mid-dark reddish-brown gravelly clayey sand (1161), which could be traced for a width of about 13 m (Figure 8). No dating evidence was recovered from this feature, which remains difficult to interpret, but lies on the projected line of the Roman road.

Plate 15: Feature 1162 looking east. 1m scale.

Although the southern end of Trench 11 crossed the projected line of the Roman road, this feature was not positively identified during the observations. Feature 1162 lies on the line of the road, but could not be definitely identified as part of it. At about 13 m wide cut 1162 appears to be too wide to represent the actual width of the road and there was no trace of a basal turf layer or of any gravel metalling as recorded about 400 m further north in 1985 (Jarvis 1985a). If 1162 is part of the road, then it appears that the turf was removed and a shallow cut was made into the natural sand beneath and backfilled with firm gravelly sand before the structure of the road was built on top. This might be because the natural sand was quite soft in this area. No trace of any gravel metalling survived. The gravel deposit 1160 may have been part of the road, but it appears more like a gravelly part of the natural sand, rather than an archaeological feature.
