**GEOTECHNICAL BOREHOLES, PORTLAND HOUSE,
BELLE VUE ROAD, WEYMOUTH, DORSET
Archaeological Observations and Recording**

Report No. 53340/3/1

**GEOTECHNICAL BOREHOLES, PORTLAND HOUSE,
BELLE VUE ROAD, WEYMOUTH, DORSET
Archaeological Observations and Recording,
November 2010**

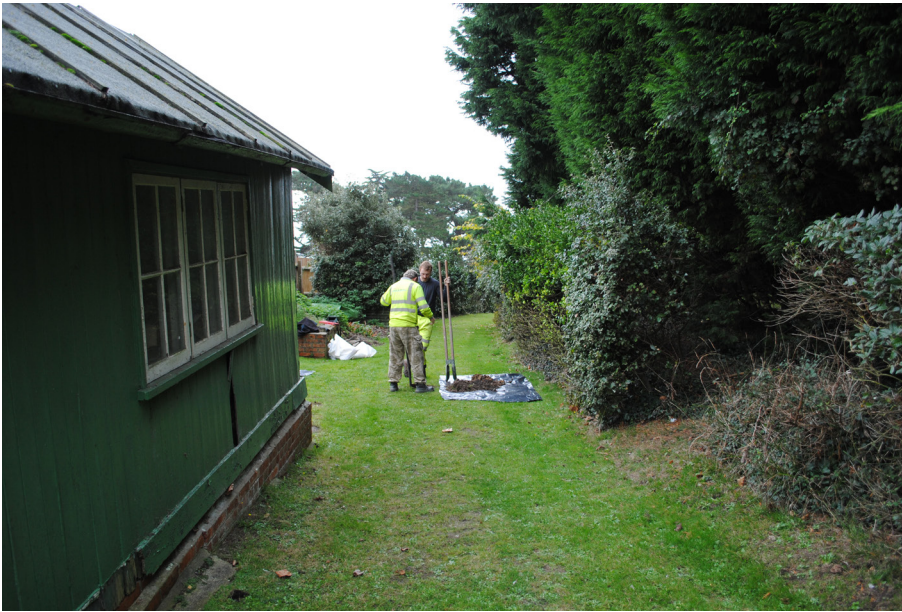
Plate 1: Borehole BH10 during digging of inspection pit, looking south.

Borehole BH10 was located in the northeast part of the grounds of Portland House at SY6802978026. It lay just to the south of a wooden garden shed in a garden path or track that lead down into the lower part of the garden (Plate 1). The inspection pit measured 0.3 m by 0.3 m across and 1.05 m deep. The upper 0.3 m comprised hard-packed small stone, gravel, brick fragments and clinker in a dark grey gritty clay loam matrix (1001), which formed the metalling of the track (Plate 2). This lay above yellowish-grey natural clay (1002).

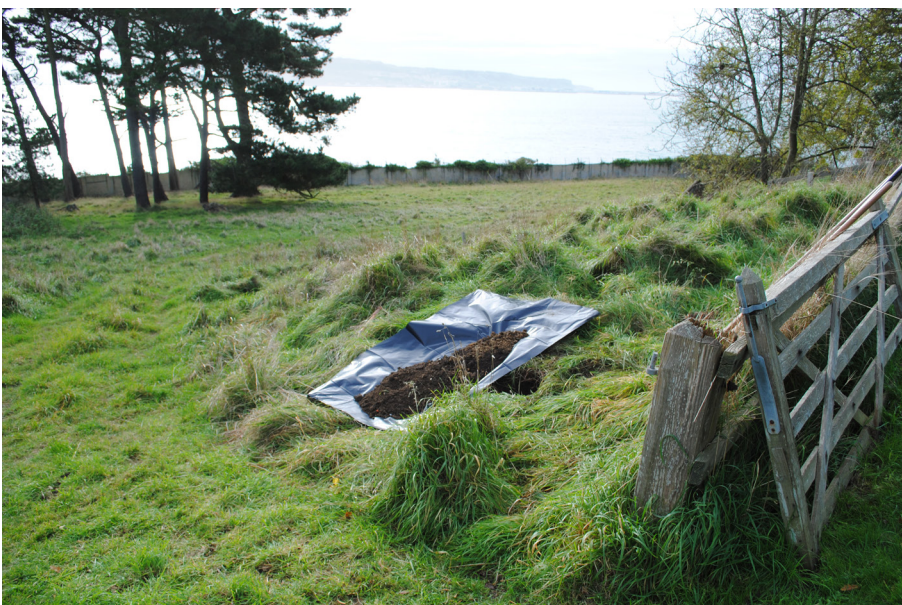
Plate 3: Location of Borehole BH11, looking south.

Borehole BH11 was located in the northeast of the paddock that forms the lower part of the grounds of Portland House (Plate 3) at SY6804677979. It lay just to the south of a wooden fence to the west of the track in an area of rather disturbed rough grass (Plate 3). The inspection pit measured 0.4 m by 0.4 m across and 1.2 m deep. The upper 0.3 m comprised mid brown clay topsoil with sparse coal fragments (1201). It lay on top of a mid brown clay subsoil, 0.6 m thick (1202), which overlay stiff yellowish-grey natural clay (1203).

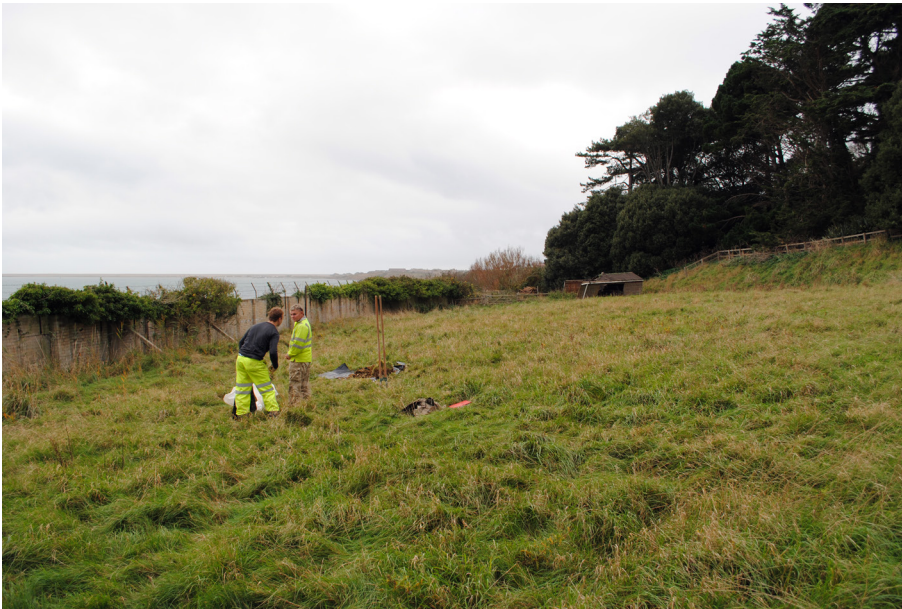
Plate 5: Location of Borehole BH12, looking west.

Borehole BH12 was located towards the southern edge of the grounds of Portland House in the lower paddock at SY 6805377916 (Plate 5). The inspection pit measured 0.3 m by 0.3 m across and 1.05 m deep. The upper 0.3 m comprised hard-packed small stone, gravel, brick fragments and clinker in a dark grey gritty clay loam matrix (1001), which formed the metalling of the track (Plate 2). This lay above yellowish-grey natural clay (1002).
