Mapperton House, Mapperton, Beaminster, Dorset

Archaeological Recording of Biomass Heating System Groundworks

Report No. 53460/3/2

December 2017

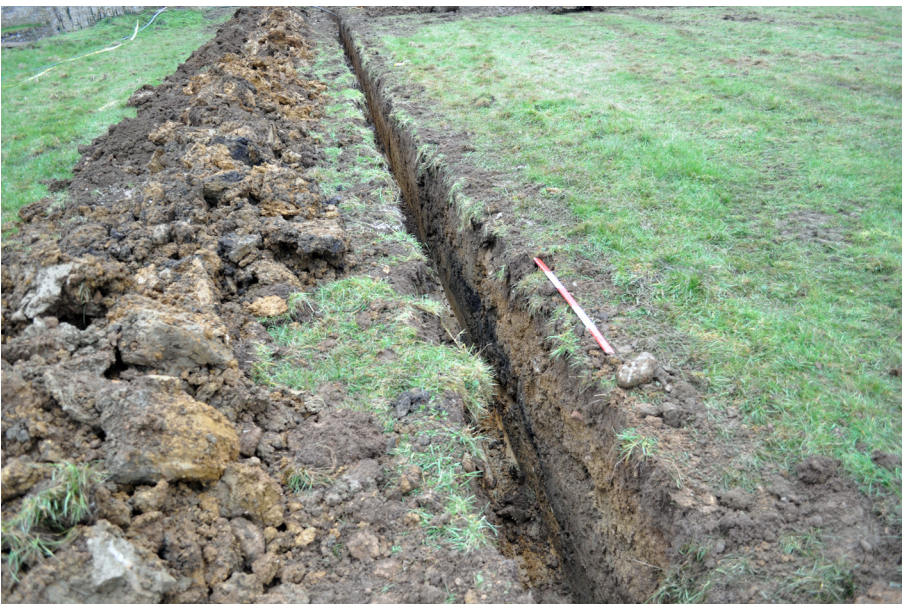
A large linear feature (256) was found running roughly E-W. Its projected line crosses the area between the North and South Stables and appears to be on a similar line to a possible hollow way visible as an earthwork in the meadow to the west of Trench 21 (Figure 2). It consisted of a broad shallow hollow about 11.7 m wide and 0.55 m deep, with a more steeply-sided deeper central part about 4.2 m wide and over 0.5 m deep (Figure 3, Plate 2). The base of this feature was not exposed. It was filled with a thin layer of dark greyish-brown silty clay with frequent charcoal (255) along the southern side, over which, in the deeper part of the feature was a deposit of mid brown silty clay (254). The shallower part of the feature was filled with a layer of reddish-brown clay with moderate to frequent small stone (253), which sealed both fills 254 and 255 (Figure 3).

Plate 2: Possible Hollow Way 256 in Trench 21, looking South. 1m scale.

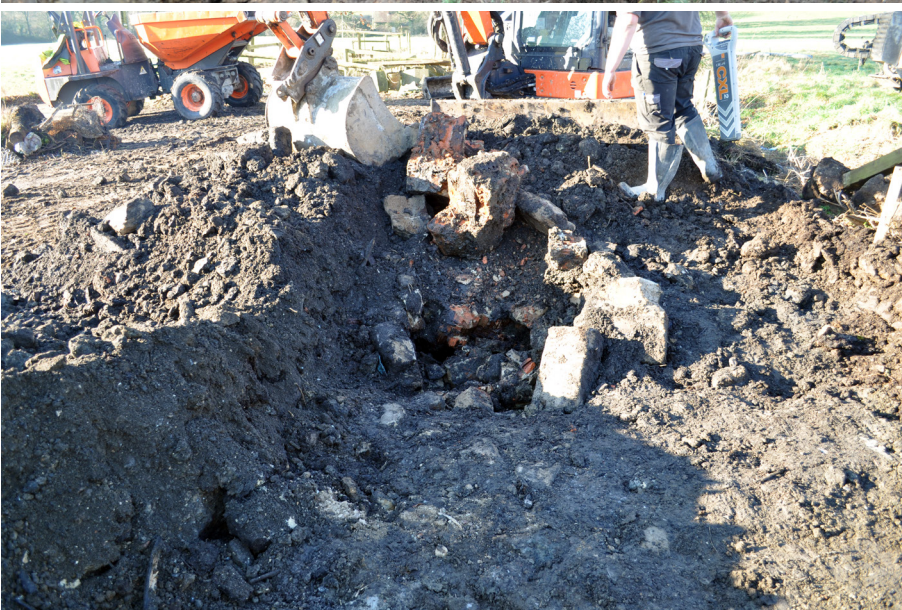
The site of the new boiler house was in the area of a former pond at the southern end of the meadow, as depicted on the 1841 Mapperton Tithe Map and on historic Ordnance Survey maps until 1970. The pond had been backfilled with a large quantity of stone and brick rubble (including large lumps of mortared masonry) and timber in a dark greyish-brown silty clay matrix (216), which was over 1.0 m thick (Plate 3).

Plate 3: Large rubble infill (216) of former pond on site of new Boiler House.

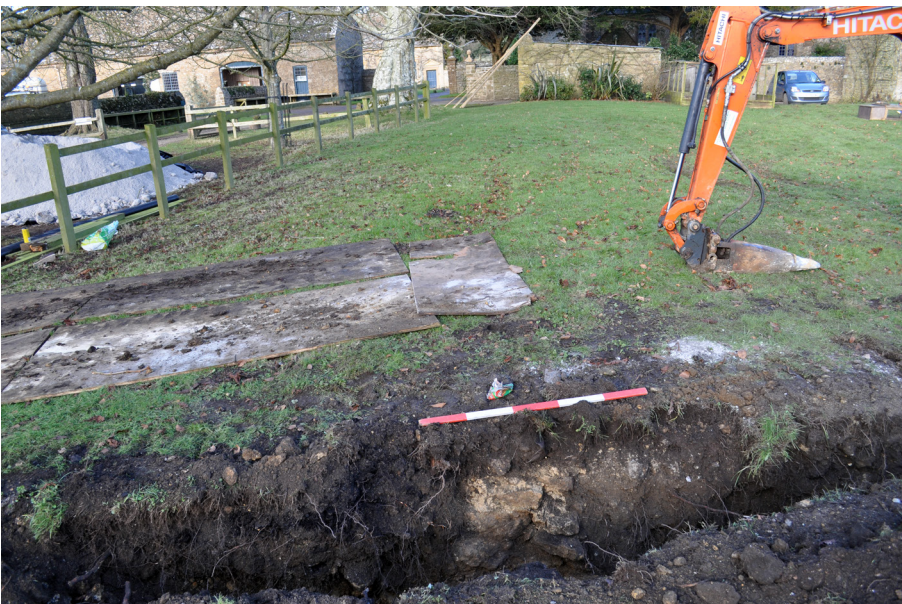
A mortared stone wall 113 running roughly N-S to the south of the Church was initially recorded in Test Pit 2 (Bellamy 2016). Pipe Trench 20 cut through this wall and the section recorded (Figure 5; Plate 5). The wall was 0.46 m wide and survived about 0.45 m high and constructed of mortared squared rubble stone on a basal spreader course of more tabular stone. It was founded directly upon the natural clay and stone (114).

Plate 5: Wall 113 cut by Trench 20, looking north along ridge marking former course of the wall. 1m scales.

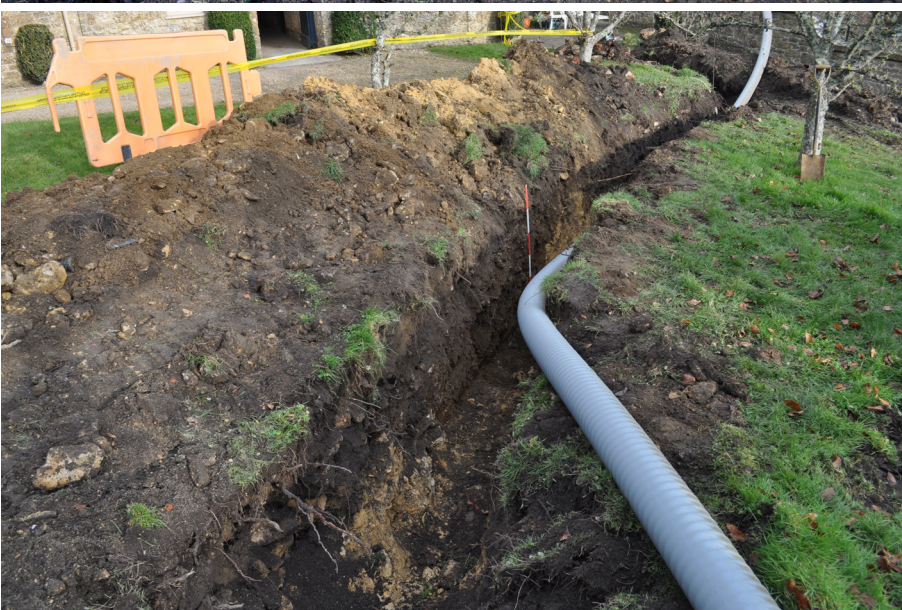
A large linear cut (157) oriented roughly N-S was exposed in Trench 20, about 4 m west of the garden wall marking the edge of the formal gardens in the valley (Figure 4; Plate 6). It had a sloping cut over 0.65 m deep into the natural

Immediately west of possible terrace 157 was a large pit or scoop (160) about 2.6 m across (Figure 4; Plate 6). It had concave sides but the plan shape and overall size of this feature was not determined and it was not exposed to its full depth. It was filled with mid reddish-brown soil and stone rubble (161) and contained some nineteenth century bottle glass.

Plate 6: Feature 160 in foreground and terrace 157 just beyond 1m scale, looking NE.

The possible terrace 157 running about four metres west of the current garden wall along the upper western edge of the stream valley east of the house, may be an earlier garden feature, but not one shown on any of the historic maps, or it may be simply be the remnants of the original upper slope of the valley side, buried by soil build-up against the existing garden wall. The adjacent feature 160 is of uncertain function, but may be the remains of a large tree-hole. It contained nineteenth century material.

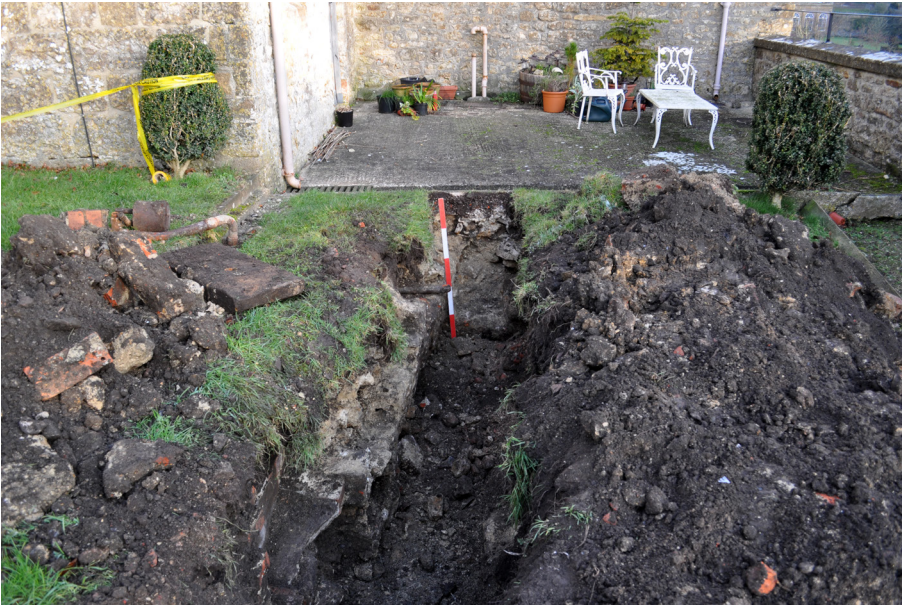
Immediately to the north of Wall 155 was another stone structure (152) 2.75 m wide, built from 0.6 m thick walls of mortared stone rubble (Figures 4–5; Plate 7). The base of the structure was not exposed, but it was over 0.8 m deep. It was filled with loose stone and mortar and it had been capped by a concrete slab. It is unclear what this structure is but it might be a large soakaway.

Plate 7: Structure 152, looking north. 1m scale.

In the area immediately to the south were the remains of a small stone-built structure or shaft (152). This may be the remains of a large soakaway or similar. A small building is shown in this position on the 1889 and 1903 25-inch Ordnance Survey maps, which may depict this structure, which argues that it was visible above ground and, therefore, is unlikely to simply be a soakaway. This structure is not shown on the 1841 Mapperton Tithe Map, so is

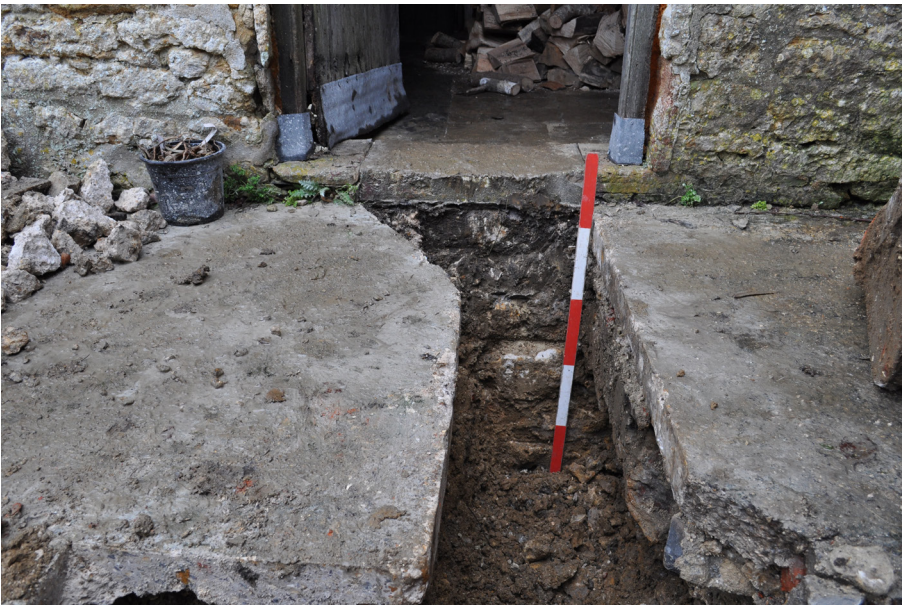
Plate 8: Wall Footings 167, viewed from east. 1m scale.

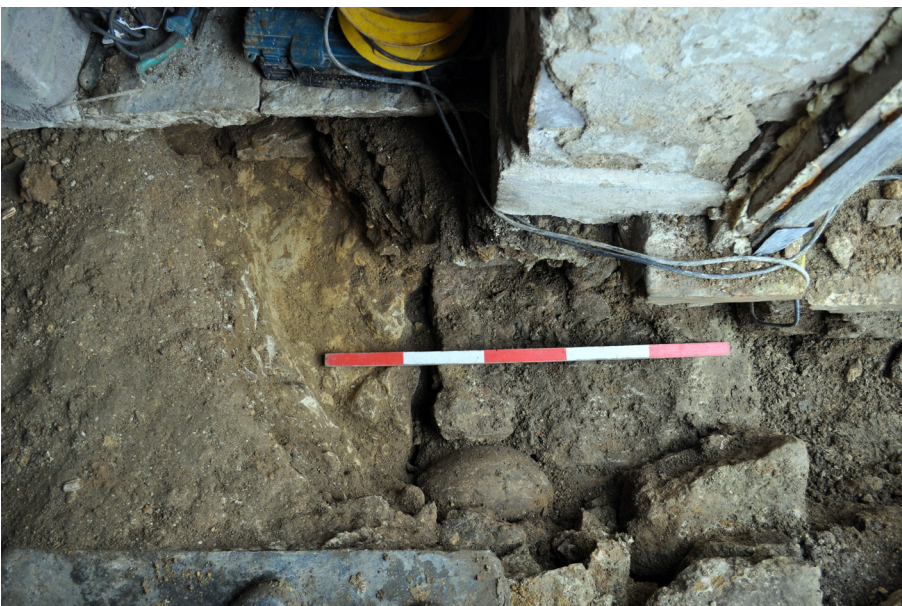
Plate 9: Wall Footing 167 with construction trench 168 to right. 1m scale.

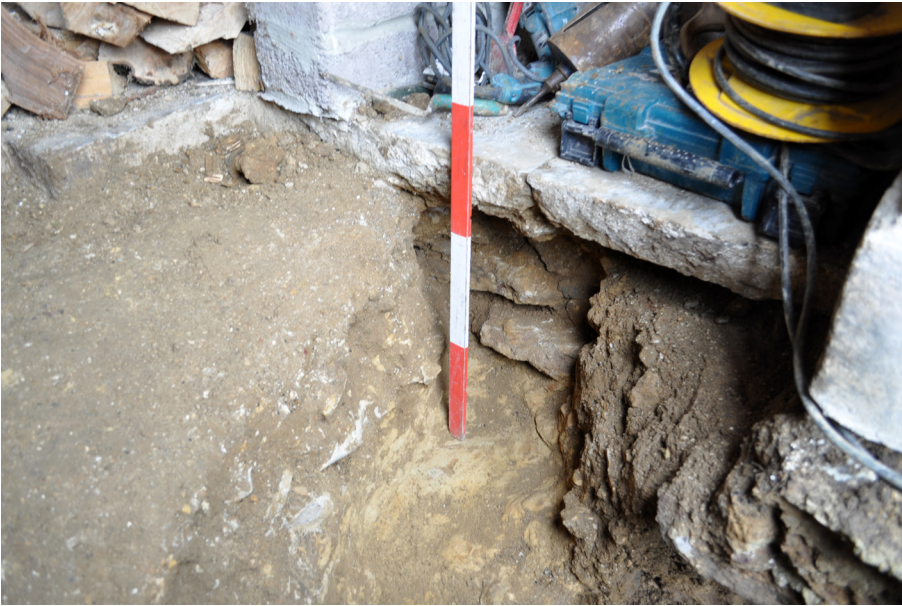
A small trace of the footings of the north wall of the room was exposed below the stone flags of the floor in the NE corner of the room (Figure 6; Plate 10). This footing consisted of stone rubble bonded with clay (173) in a construction trench (171).

The existing stone flag floor (175) was laid on a 60 mm thick loose small stone and clay bedding layer, which overlay a 0.35 m thick layer of firm reddish-brown silty clay (170) and tightly packed stone rubble, which formed a levelling layer over the natural cemented yellowish-brown sand and stone (174) (Plates 9–10).

Plate 10: Wall Footing 173 below stone flag floor 175. 1m scale.

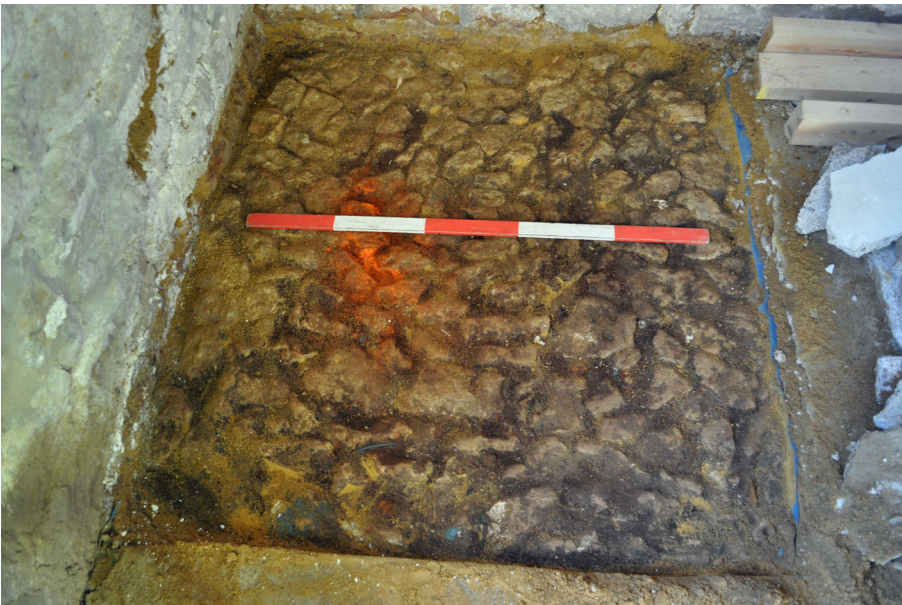
A test pit (Trench 17) was dug in the south west corner of the South Stables. This revealed an earlier rough cobbled floor (301) below the modern concrete surface (300) (Plate 11). The cobbles were set in a yellowish-brown clayey sand, which overlay a 0.2 m thick levelling layer of rubbly yellowish-brown silty clay (302) over the natural clay (303).

Plate 11: Cobbled Floor 301 in South Stables, looking west. 1m scale.

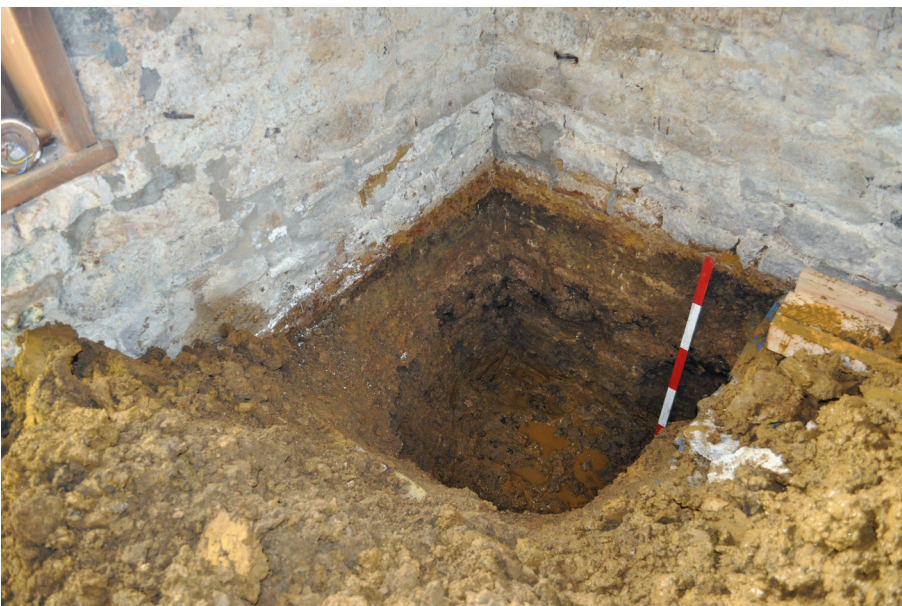
The footings of the stables were about 0.85 m deep and consisted of irregular rubble stone roughly brought to courses and bonded with lime mortar (306) (Plate 12). The footings were built in a construction trench (304) cut into the natural clay and backfilled with dark yellowish-brown clay (305).

Plate 12: Footings 306 of South Stables exposed in Trench 17, looking south west. 1m scale.

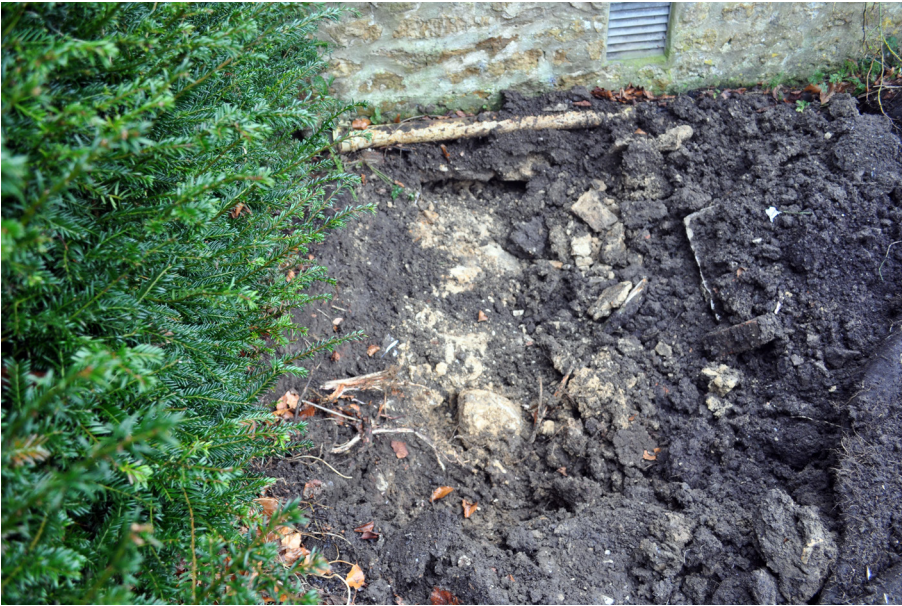
Trench 18 was dug in the walled garden of the Old Rectory against the north wall of the Conservatory Boiler Room. It revealed the buried remains of a mortared stone wall (328) 0.55 m wide capped with flat coping stones, running N-S (Plates 13–14). The wall was built in a construction trench 327 dug into the natural clay along the western side of the wall (Figure 7). No trace of a construction cut was noted to the east and this side of the wall was butted by loose garden soil (326), down to a depth of over one metre, suggesting this was a revetment wall to a garden terrace. This wall is shown on the 1841 Tithe Map.

Plate 13: Wall 328 disturbed by initial machining of Trench 18, looking south.

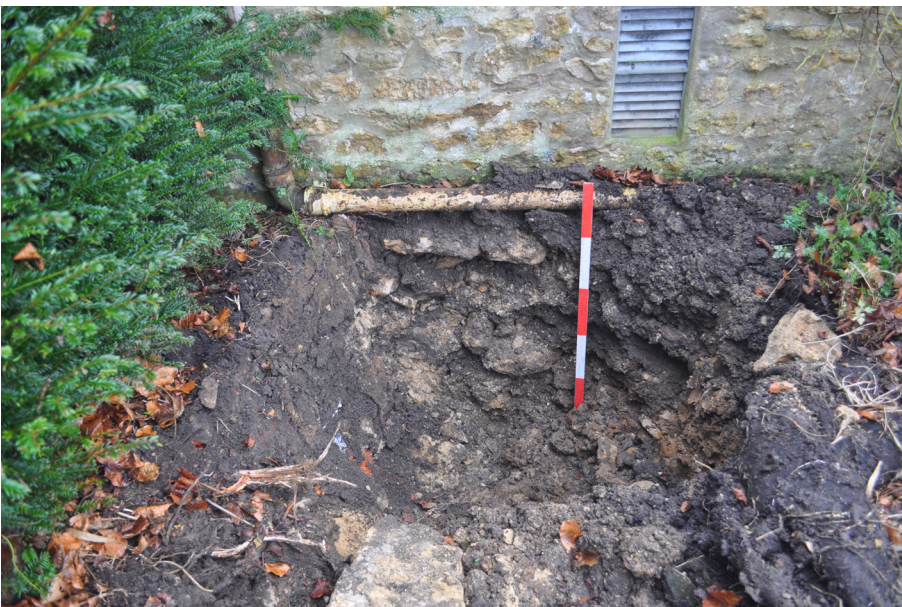
Plate 14: Wall 328 sectioned in Trench 18, looking south. 1m scale.

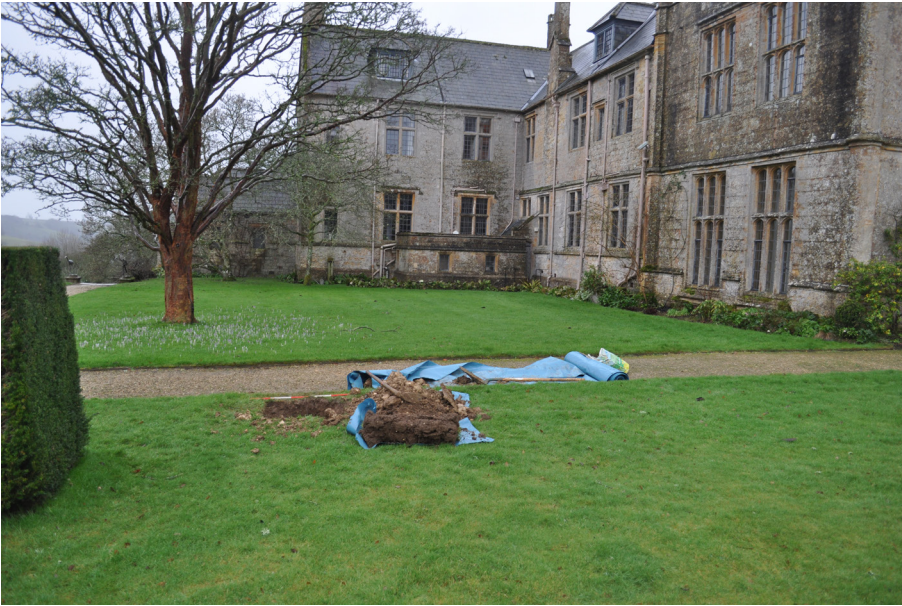
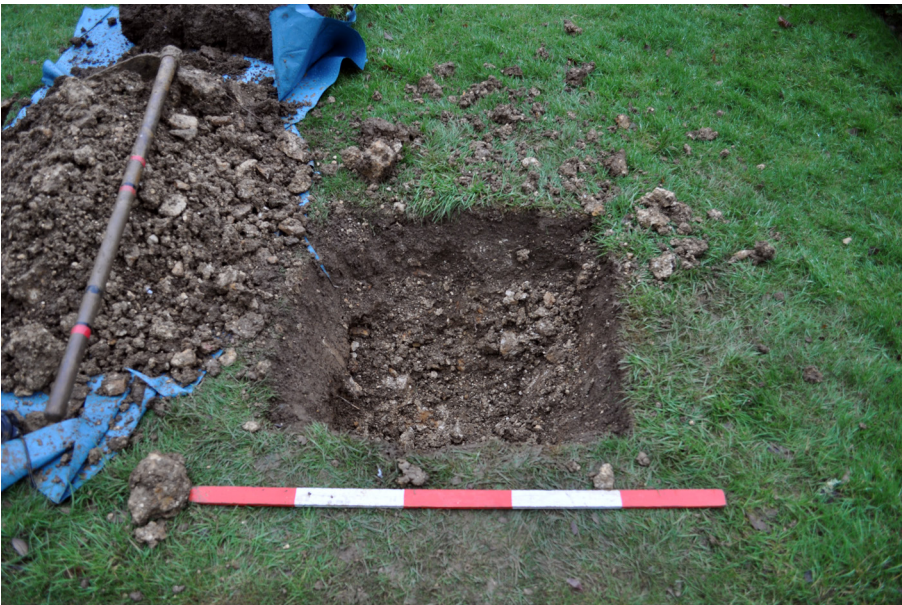
Trench 22 in the south east corner of the lawn north of Mapperton House revealed a 0.2 m thick layer of topsoil (350) over natural clay and stone (351) (Plates 16–17).

Plate 16: Trench 22 in garden north of Mapperton House, looking south.

Plate 17: Trench 22 in North Lawn, looking north. 1m scale.
