St Mary's Church, Chickkerell

Archaeological Observations and Recording during Excavation of Structural Engineer's Test Pits

Report No. 53486/3/1

May 2018

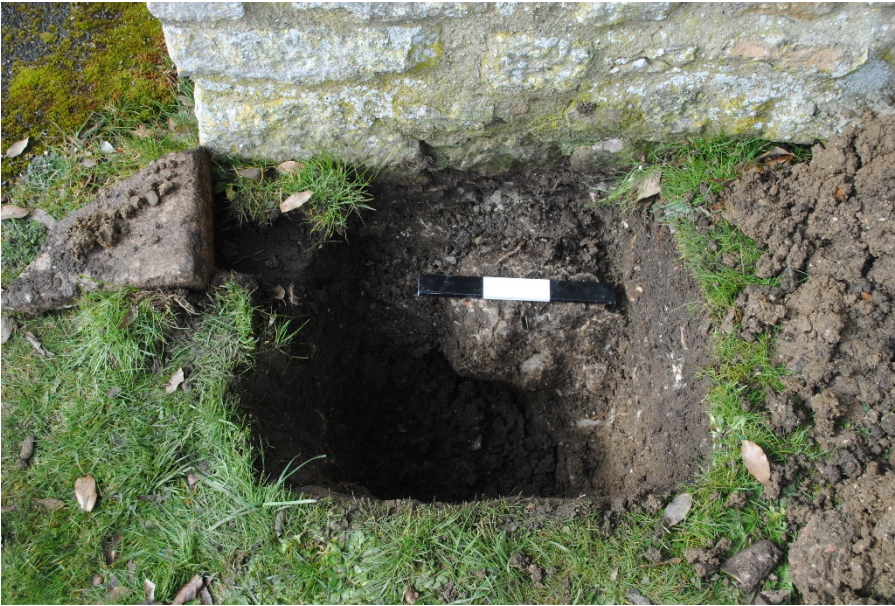
Test Pit 1 was dug adjacent to the south eastern corner of the South Porch (Figure 2, Plate 1). It measured 0.6 m by 0.5 m at ground level, and was 0.5 m deep. A limestone rubble footing was identified beneath the porch wall, of unknown depth and presumably originally contained within a simple linear cut into pre-existing graveyard soils. No detailed recording of the footing was possible.

Plate 1: Test Pit 1, showing the rubble footing of the South Porch. View from East. 0.3m scale.

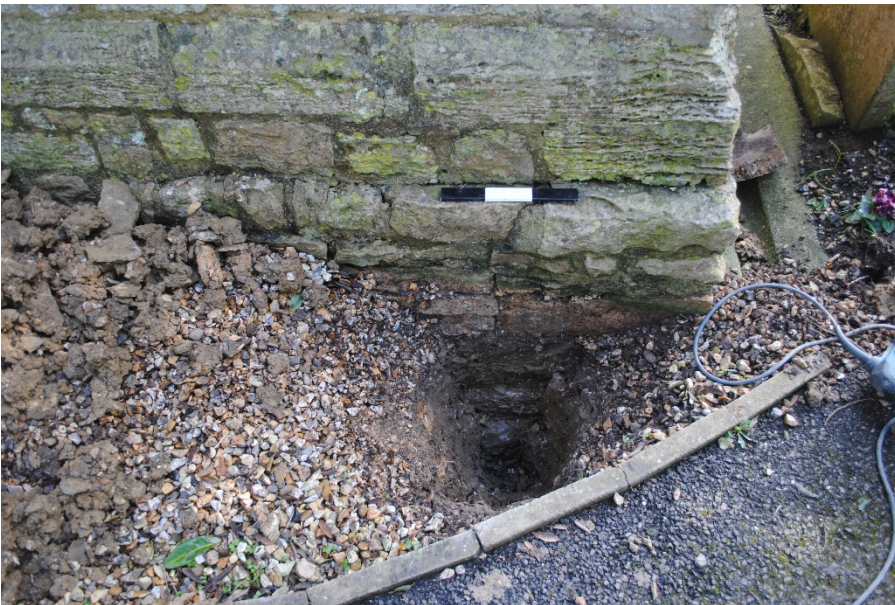
Test Pit 2 was sited at the south end of the west end of the Nave (Figure 2, Plate 2). It measured 0.5 m by 0.4 m at ground level and was about 0.9m deep. Several courses of undressed limestone footing were seen flush with the offset near the base of the Nave wall. This footing appeared to have a base at c. 0.8 m below modern ground level, although inward tapering of the pit makes this observation tentative. Soils outside the footing comprised homogenous graveyard soil below a recent thin capping of fine gravel.

Plate 2: Test Pit 2, showing foundation of the west Nave wall. View from west. 0.3m scale.

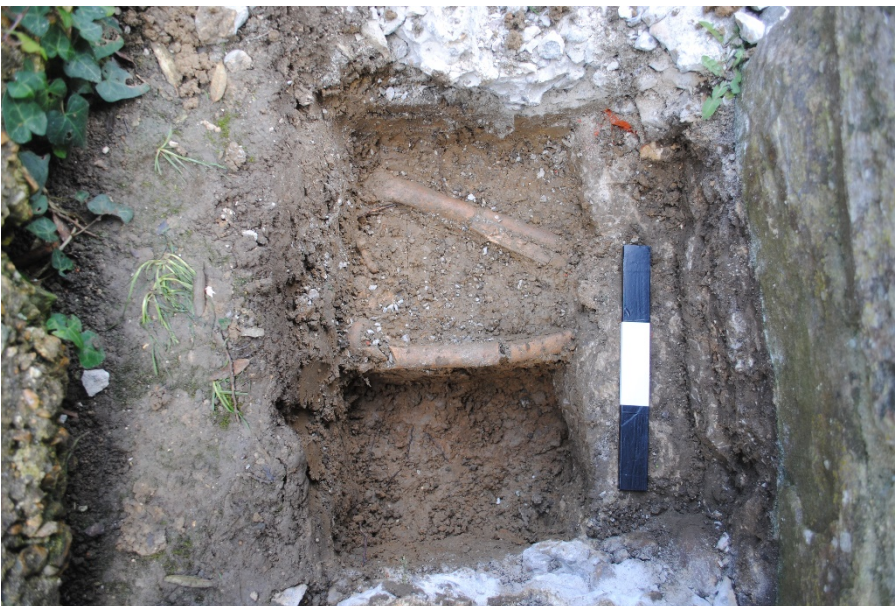
Test Pit 3 was sited at the north end of the western end of the North Aisle, (Figures 2 and 3, Plate 3) on the terrace created for the construction of the North Aisle. It measured 0.6 m by 0.5 m and was dug to a maximum depth of about 0.35 m below (reduced) ground level.

At about 0.25 m below ground level a pair of *in situ* human femurs was identified indicating a supine, uncoffined adult burial, interred with head to the west. The burial is not intrinsically dated, but its relatively shallow burial depth and the presence of small hand bones between the upper ends of the femurs suggests typical medieval or early post-medieval placement with hands crossed over the pelvis. The skeleton lay in mid yellow-brown silty clay. No grave cut could be discerned within the small area exposed. To the east, the lower legs were cut away above the knees by construction of the North Aisle.

The pit additionally exposed an external basal offset to the North Aisle wall of about 0.15 m. This appears to comprise only a single course of undressed (or very crudely dressed) sub-square limestone blocks and was not present internally (Terrain Archaeology 2011).

Plate 3: Test Pit 3, showing the upper legs of an articulated human burial cut by the foundation for the North Aisle. Vertical, north to top of frame. 0.3m scale.
