# Lytes Cary, Charlton Mackrell, Somerset

## Observations and Recording during Installation of New Fibre Optic Cable

Report No. 53494/3/1

June 2018

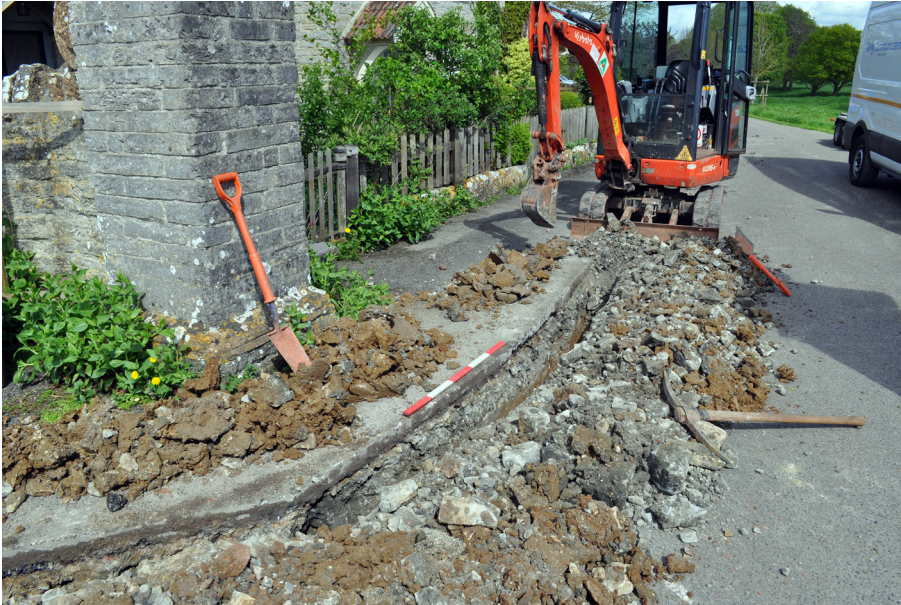
Elements of the structure of the drive to Lytes Cary Manor were exposed during the works. The surface consists of a layer of tarmac between 0.10 m and 0.13 m deep (100, 203). In the entrance and in the area of Lytes Cary Cottages the tarmac is laid on a very hard-packed stone rubble layer (101) (Plate 1). Along the north arm of the drive (Trench 1), the road is on a slight causeway raised up by up to a metre above the surrounding ground. This causeway appears to consist of hard-packed stone rubble in a brown clay loam matrix (105, 107) (Plates 2-3). In the parts of the north arm of the drive where the road is at ground level, there appears to be a mid brown stony clay subsoil layer (104, 106) beneath the road.

*Plate 1: Trench 1 in gateway into property showing road base 101 over natural clay. 1m scale.*

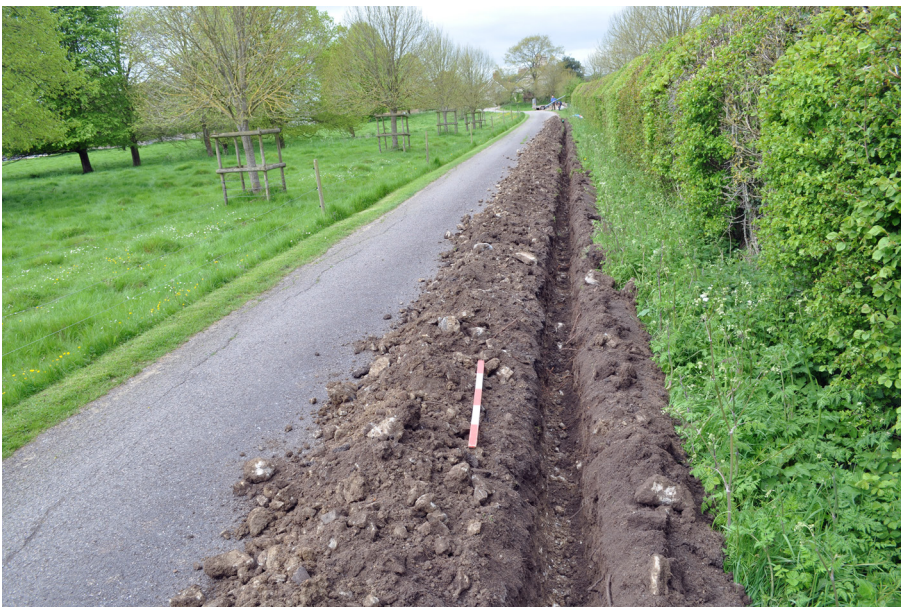
*Plate 2: Trench 1 looking west, dug through road causeway deposit 105. 1m scale.*

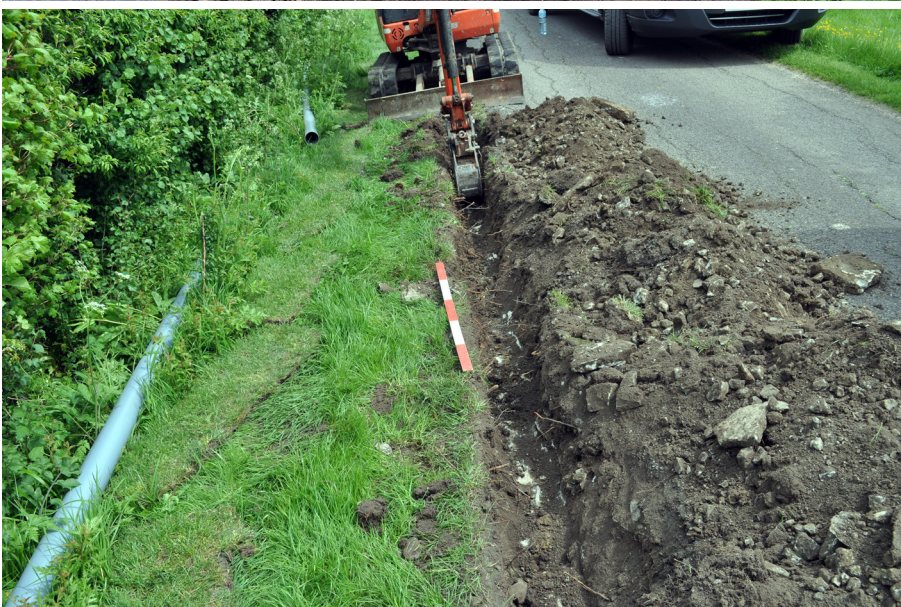
*Plate 3: Trench 1 looking east, cutting through road causeway deposit 106. 1m scale.*

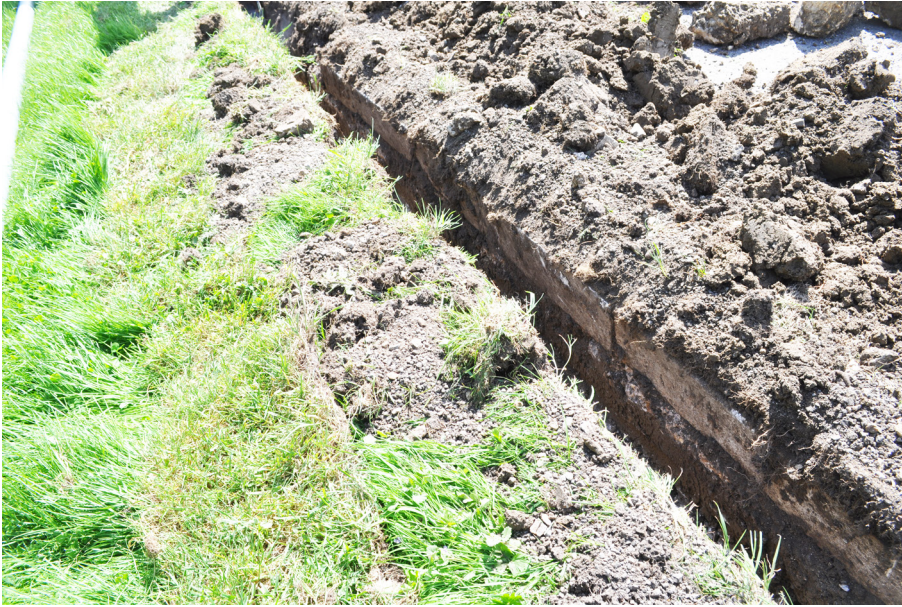
Along the eastern arm of the drive (Trench 2) the tarmac is laid on a 0.2 m thick layer of crushed stone (208). For about a 10 metre length on the east side of the drive (Figure 2), the road is edged by a line of precast concrete blocks set in concrete (204 (Plate 4). This perhaps represents a repair consolidating the edge of the road.

*Plate 4: Concrete block road edging 204.*

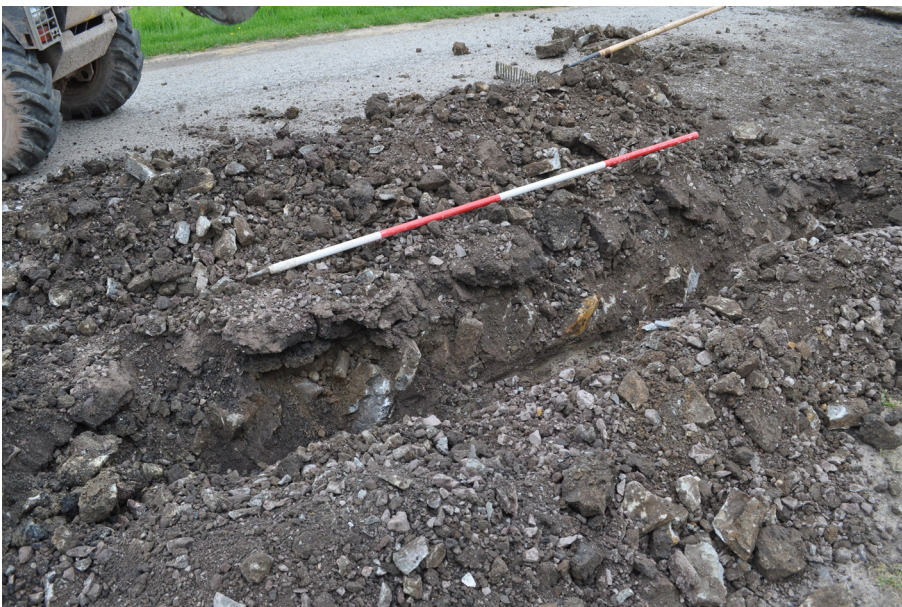
Three stone-filled field drains were recognised during the works. These all ran roughly N-S and consisted of one (205) running along the east side of the drive (Plate 5) and two others (207, 209) beneath the road. All three of these drains were previously recorded as part of the archaeological observations during the installation of a new water main (Bellamy 2004). None of these drains were dated, but are likely to be post-medieval.

*Plate 5: Pitched stone of Drain 205, near south end of Trench 2. 2m scale.*

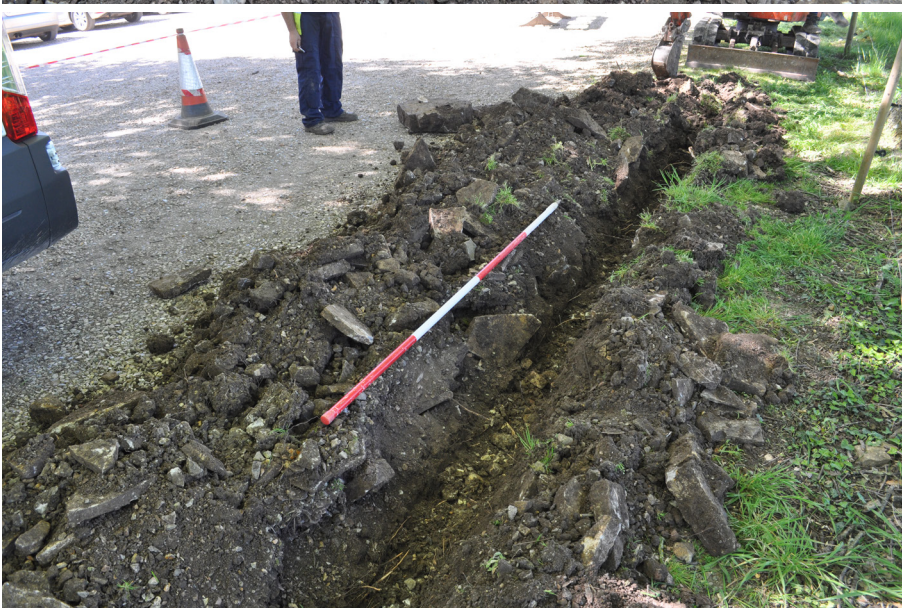
The car park make-up comprised the existing gravel surface and grass edging (300) over a 0.2 m thick layer of dark greyish-brown clay loam frequent large stone rubble up to 600mm across (301) (Plate 6). This stone layer continued up to the western end of the car park. This overlay a thin layer of dark brown clay loam (302) immediately over the natural clay 303 and may be the remains of the original topsoil before construction of the car park.

*Plate 6: Car park deposits 300 and 301 over natural clay 302 in Trench 3. 2m scale.*

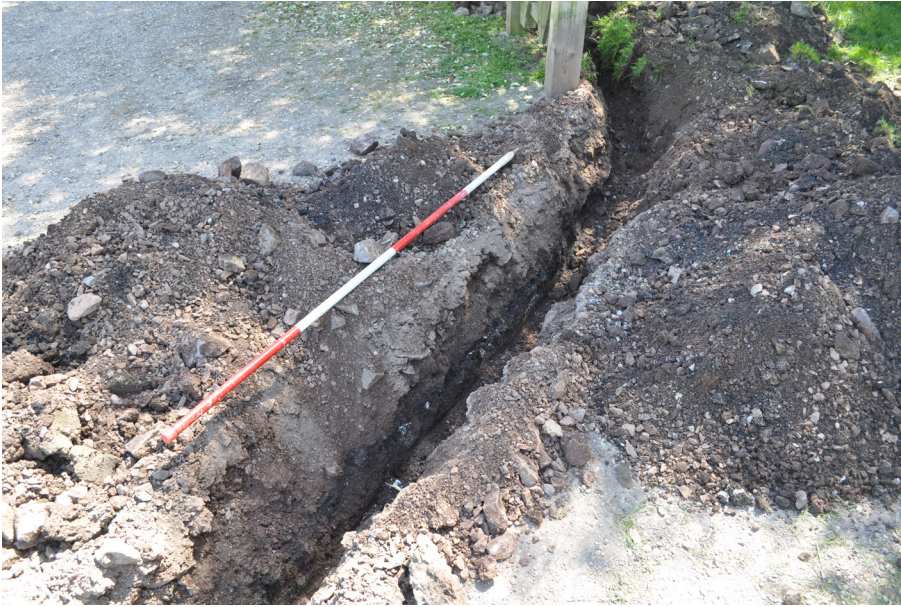
At the western end of the car park and into the farm track beyond, the trench crossed the line of the water main (304). In this area, beneath the farm track was a hard packed layer of dark clay with clinker and ash (306) which extended southwards to about five metres from the farm buildings (Figure 2; Plate 7). It was covered by the stone track surface (305) and the topsoil (307) to the south of the track. Further south towards the buildings were a series of dark and mid brown clay loam layers (308, 309, 310) below the topsoil.

*Plate 7: Ashy backfill deposit 306 beneath farm track at edge of car park. 2m scale.*

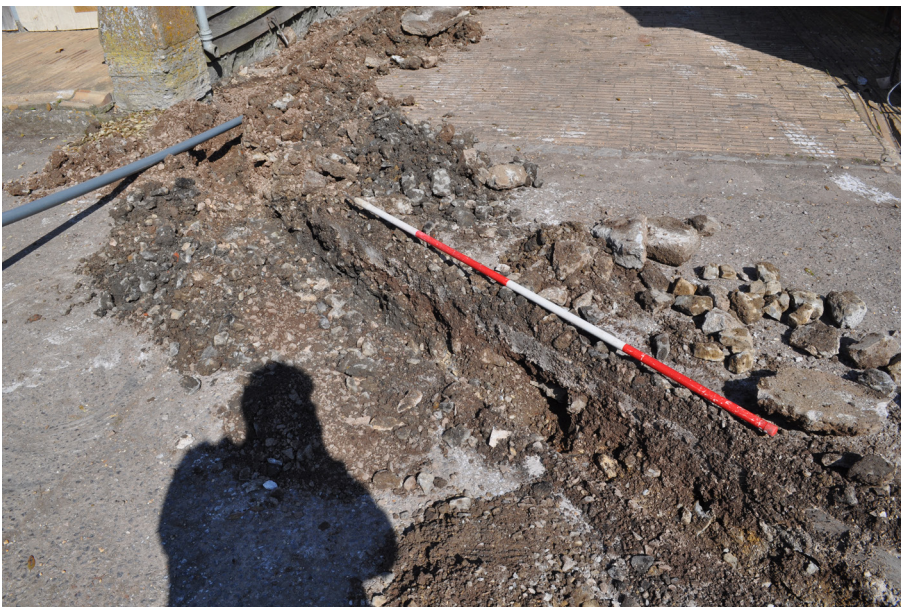
The concrete surface 400 was laid on top of a thin layer of dark greyish-brown clay loam and small stone (404), which may represent an earlier yard surface (Plate 8). This overlay a cast iron drain cover set in concrete (403) and a rubbly levelling layer (405) and an area of disturbance (402).

*Plate 8: Possible former yard surface 404 beneath concrete yard surface 400, overlying yard make up 405. Drain cover 403 in centre of photo. 2m scale.*

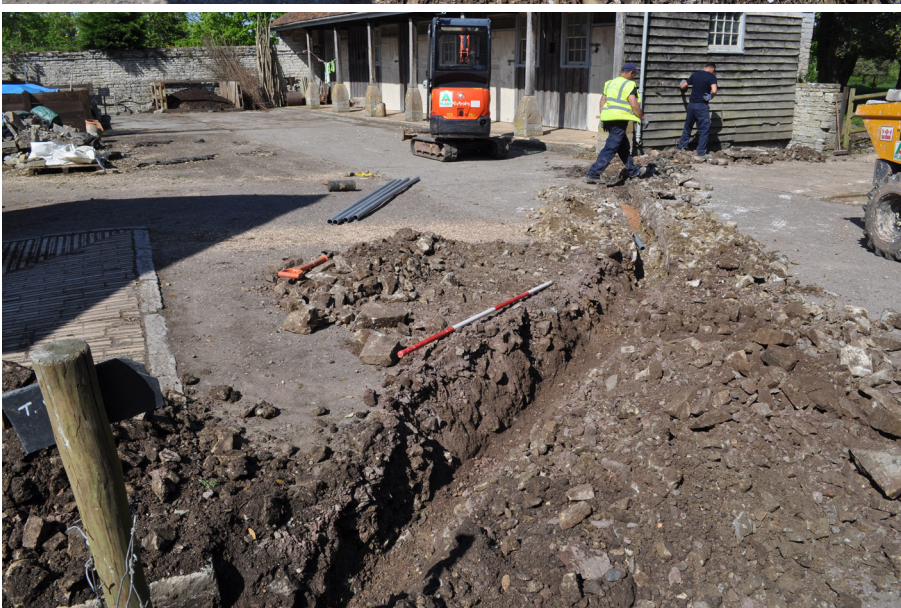
The gravel yard surface 406 was laid on a stone rubble sub-base (407 (Plate 9).

*Plate 9: View of Trench 4 cutting through yard surface 406 and sub base 407. 2m scale.*
