Normandy/Kohima, School Lane, Dorchester, Dorset Archaeological Field Evaluation

Report No. 53483/2/1

Archaeological Field Evaluation, April 2018

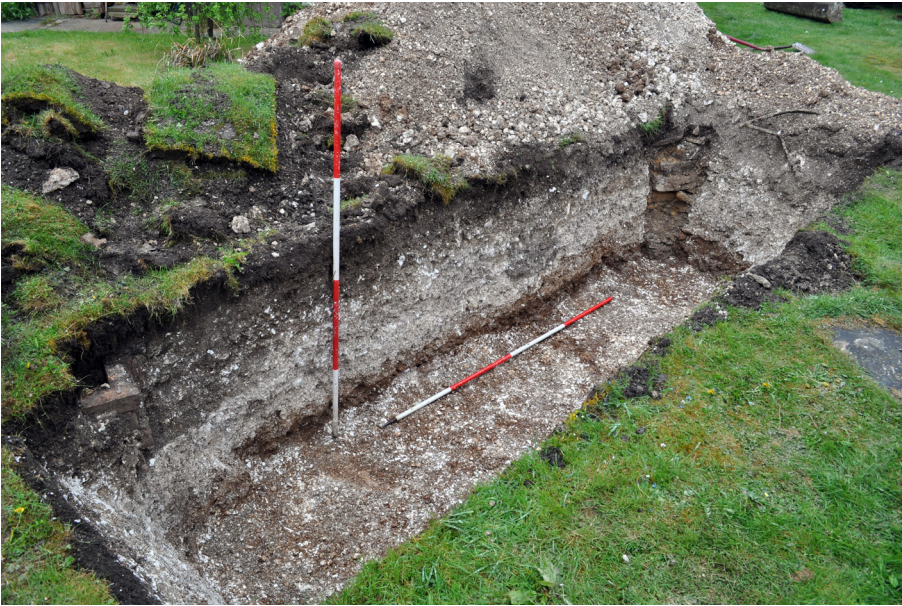
Plate 1: Trench 2 after excavation showing prehistoric soil 208 below chalk deposits of Counterscarp Bank. Viewed from SW. 2m

Overlying the natural chalk bedrock in Trench 2 was a 0.2 m thick layer of dark yellowish-brown calcareous silty clay (208) with frequent flint nodules, particularly at the base of the deposit and included worked flint waste of probable Late Neolithic/Early Bronze Age date. This layer was sealed by the Roman Counterscarp Bank material 207 (Figure 4; Plate 1). This layer is similar to a buried soil deposit found many places within the Roman town, sealed beneath Roman features. It is likely to be the remains of an agricultural soil of prehistoric origin and reworked in the Roman period and then sealed and protected by the Roman town defences, possibly some time in the late second or third century AD.

Substantial remains of a dumped chalk bank (207, 306) exposed in Trenches 2 and 3 (Figures 4–5; Plates 1–2). It comprised tips and dumps of chalk rubble interspersed with lenses and layers of grey chalky silt and yellowish brown chalky clay silt. This bank survived to a height of about 0.95 m in Trench 2 and was over 13.5 m wide. It was constructed directly on top of the old ground surface (208). The tip lines generally dipped towards the west suggesting it was built out from the eastern side. Although no material was recovered from this feature, its location, scale and stratigraphic position strongly suggest that it is the remains of the Counterscarp Bank of the Roman town defences.

In the north east corner of Trench 2 (Plate 1) was the corner of a mortared limestone rubble structure (202) set on a limestone chippings and mortar footing about 0.8 m thick (Plate 5). This was within a construction cut 201 dug into the remains of the Counterscarp Bank 207 (Figure 4). This structure was identical in construction to the remains of the south wall of the nave exposed in Trench 3. Structure 202 lies to the south of the line of this wall and may be the remains of a buttress. A photograph of the church dated c. 1870 shows a buttress in this position (<http://www.opcdorset.org/fordingtondorset/Files/WFordingtonHistoryChristchurch.html>). The 1888 1:500 Ordnance Survey town plan shows buttresses along the nave of the church.

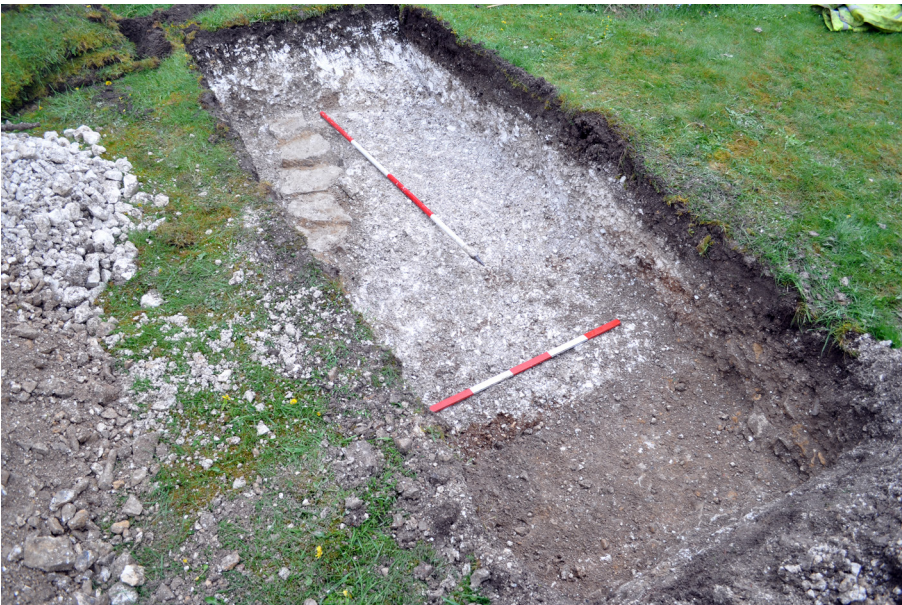
Plate 2: Trench 3 viewed from NNE showing chalk rubble 306 of Counterscarp Bank cut by foundation trench 307 of Christ Church nave wall and drain 305. 1m and 2m scales.

A brick culvert (305), with a tile base and a stone capping (304) was found in Trench 3 cut into the top of the Counterscarp Bank 306 (Plates 2 and 6). It lay to the south of wall 308. It was curvilinear in plan entering the trench

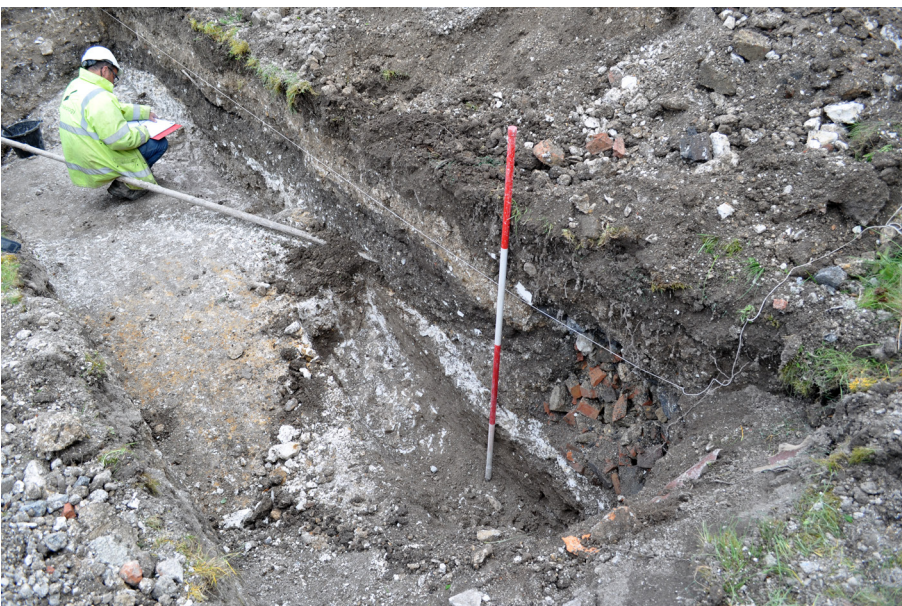
Plate 3: Edge of Outer Ditch 117 of the Roman Town defences in machine sondage at east end of Trench 1. Viewed from West. 2m

The eastern edge of the outer ditch of the Roman town defences was exposed in a small machine-dug sondage in the west end of Trench 1 (Figure 3; Plate 3). This consisted of a moderately sloping cut into the natural chalk, aligned roughly N-S. It was filled with a mid to light greyish-brown slightly calcareous clayey silt with sparse small chalk lumps (118), which contained a single fragment of Roman tile and a piece of unworked shale. No secure dating evidence was recovered, but the location, alignment and stratigraphic position of this ditch suggest that it is the outer ditch of the town defences (Figure 2).

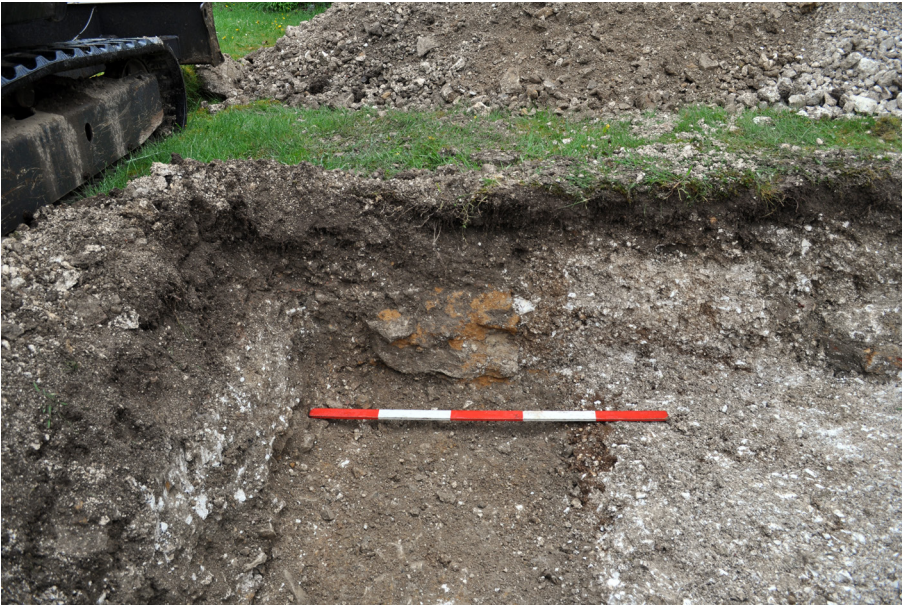
Plate 4: South Wall 308 of the Nave of Christ Church with mortared crushed stone footing 309 below. Viewed from West. 1m scale.

The robbed out remains of an E-W mortared limestone rubble wall 0.45 m thick (308) were exposed in the northern end of Trench 3 (Figure 5; Plate 4). This wall was built on top of a limestone chippings and mortar footing (309) and constructed within a construction trench cut into the top of the Counterscarp Bank 306. This wall remnant was on the line of the south wall of the nave of Christ Church, as shown on the historic Ordnance Survey maps.

Christ Church was constructed in 1846 to serve the community of West Fordington. Only one fragment of the south wall of the nave (308) was exposed. This wall was of mortared limestone rubble and was founded on deep, mortared, limestone chipping footings (309) cut into the top of the Roman Counterscarp Bank. The partial remains of a buttress on the south wall of the nave (202) were also revealed and had a very similar construction to the nave wall. It is likely that the brick drain 305 is also part of the church. To the east of the church, were features cut into the natural chalk (107, 114), which may be associated with the construction phase of the church. The rammed chalk and mortar surface (111, 106) is probably the part of an attempt to consolidate the soft ground of the Outer Roman Ditch to aid the construction of the new church.

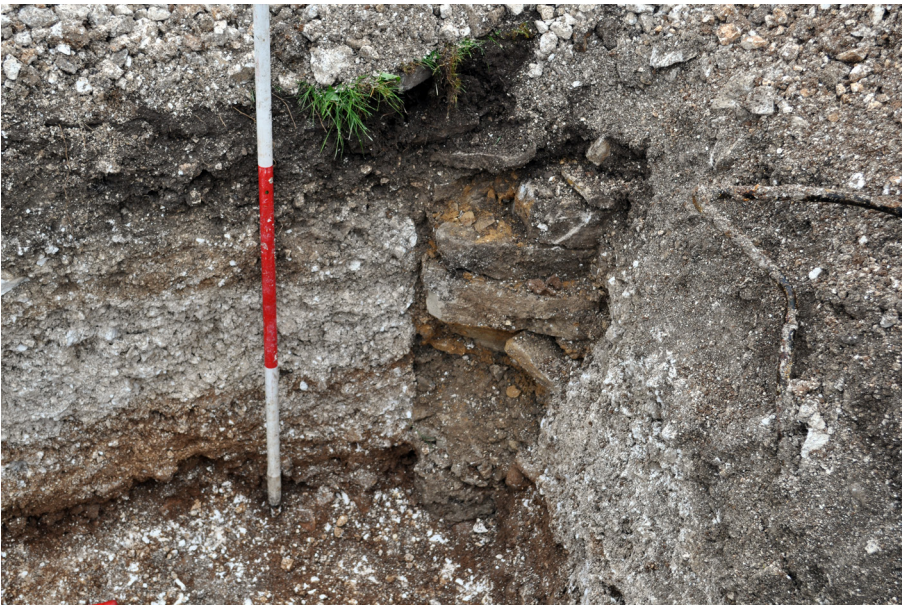
Plate 5: Buttress 202 in north east corner of Trench 2. Viewed from South. 2m scale.

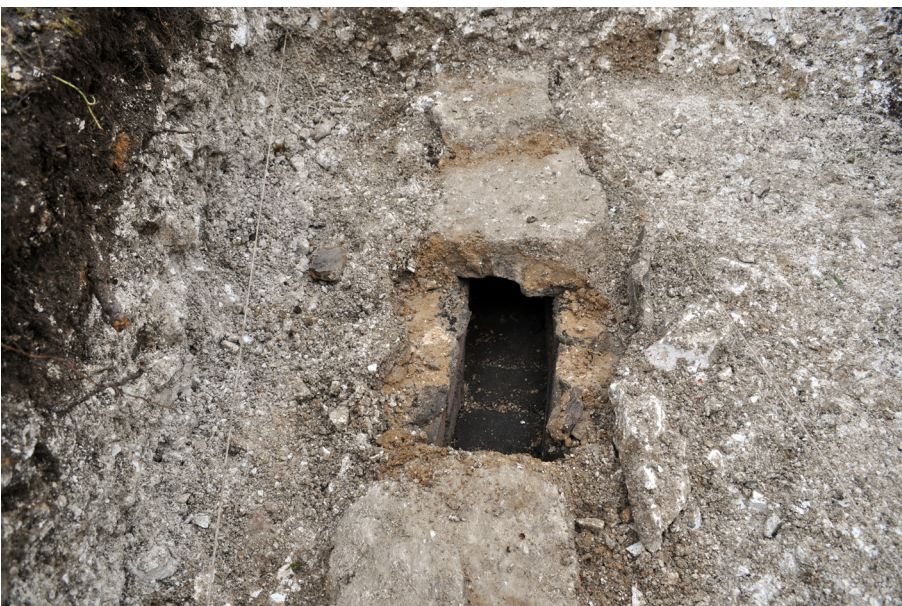
Plate 6: Detail of Drain 305. Viewed from North.

from the NE then curving to run southwards out of the trench (Figure 5). The bricks are of nineteenth century type and the mortar used in the construction of the drain is similar to that used in the remains of Christ Church described above, so it is likely that it is associated with the church. Perhaps it was built to drain water away from the angle between the nave and south transept, which lay just east of the north end of Trench 3.

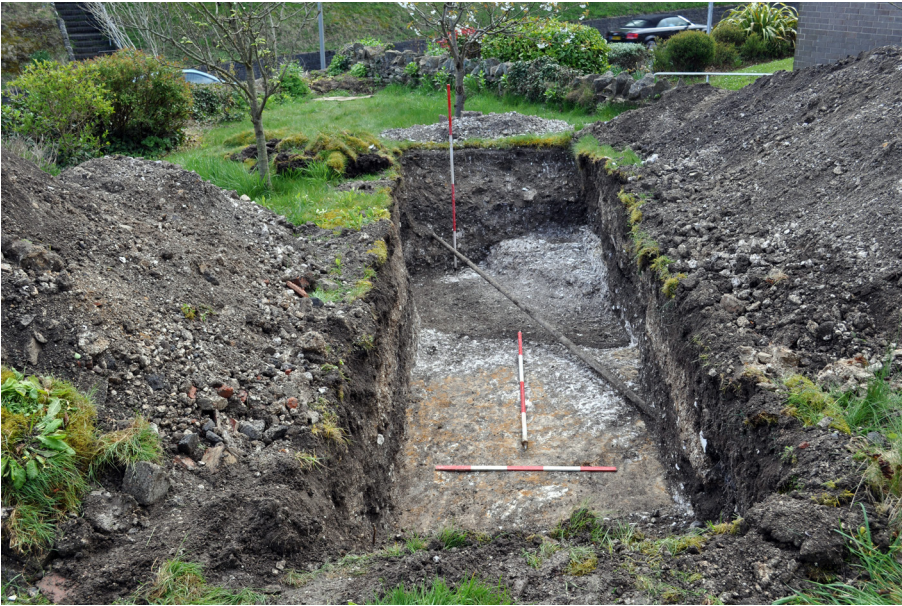
Plate 7: Trench 1 viewed from west with mortar surface 106 in foreground and Feature 107 in background. 1m & 2m scales

Overlying the top of the fill of the Outer Ditch of the Roman town defences and the western part of Feature 107 was a rammed chalk layer (111) between 0.15 m and 0.35 m thick (Figure 3; Plates 7–8). Over the top of this rammed chalk layer was a thin eroded skim of pale yellow sandy lime mortar (106). This mortar skim surface could be traced beyond the edge of Feature 107 and over the top of the natural chalk to the south. Its full extent was not exposed. The interpretation of this surface is uncertain but it is early nineteenth century or later in date and may be associated with the construction of Christ Church in 1846, perhaps it was laid down as a consolidation of the soft Roman ditch deposits, prior to construction.

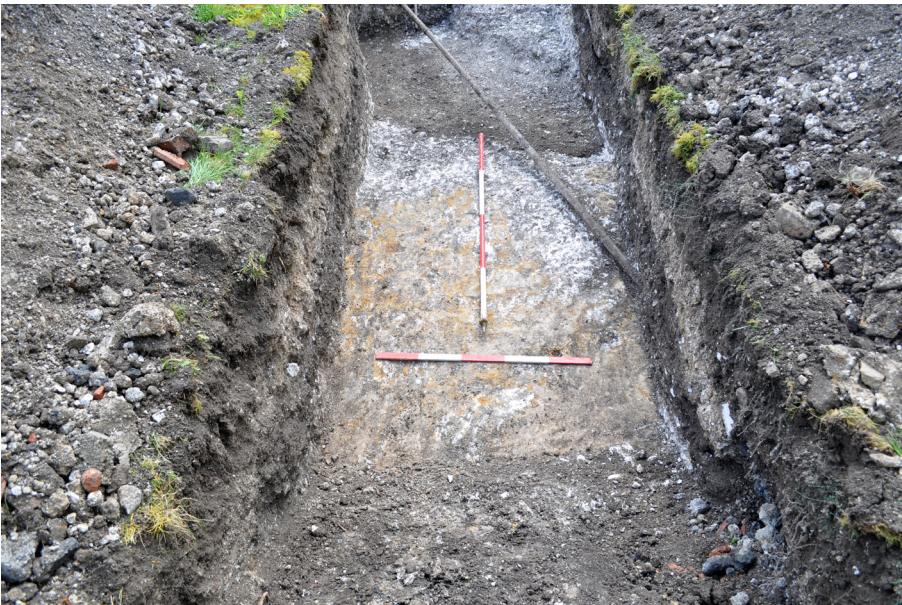
Plate 8: Mortar skim 106 over rammed chalk 111. Viewed from west. 1m & 2m scales

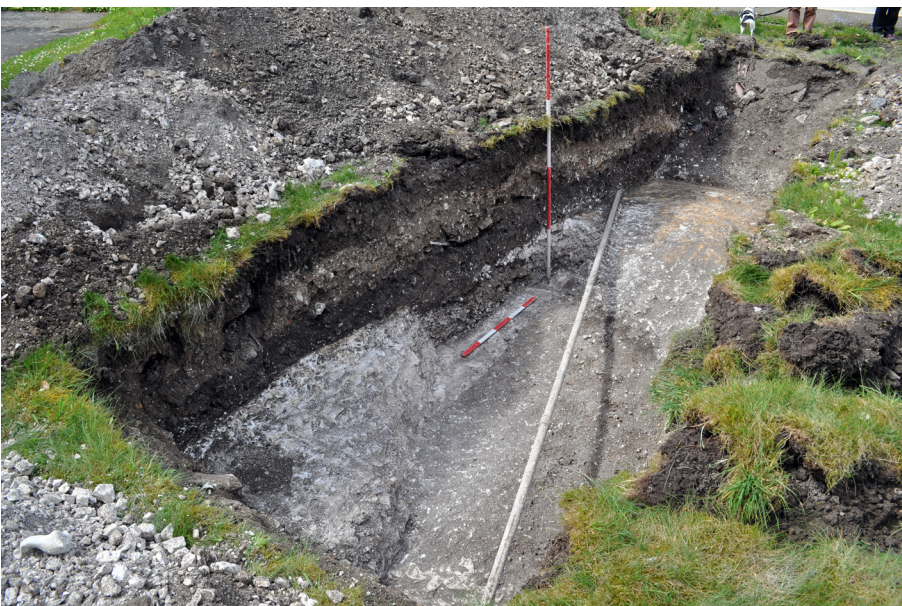
Plate 9: Feature 107 partially excavated. Demolition deposit 101 visible as a lighter band in section. Viewed from north east. 1m & 2m scales

A flat bottomed feature (107) about 0.45 m deep was found at the southern end of Trench 1, cut into the natural chalk bedrock (Figure 3; Plate 9). Only a small part of this feature was exposed, so its full size and shape is not known. Only the southern edge of this feature was defined, but it appears to be a roughly linear cut running approximately ENE-WSW. At the eastern end of the trench this feature was cut by a deeper cut of unknown size, shape and depth (Figure 3). The base and side of the feature did not exhibit much signs of wear or erosion, suggesting it was backfilled fairly rapidly. It was filled with tips of loose chalk rubble and chalky soil (108, 109), with a lens of dark soil (110). This feature is poorly understood, but contains some earlier nineteenth century material and perhaps may be associated with the construction of Christ Church in 1846.
