St Nicholas Church, Winterborne Clenston, Dorset

Observations and Recording During Construction of New Extension

Report No. 53500/3/1

August 2018

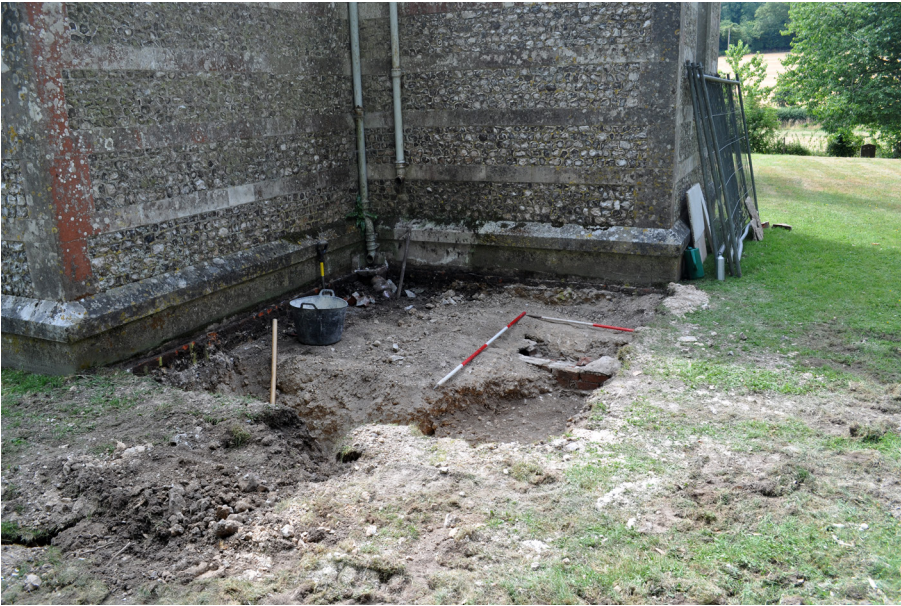
Plate 1: General view of Trench 1, looking South West. 2m scale.

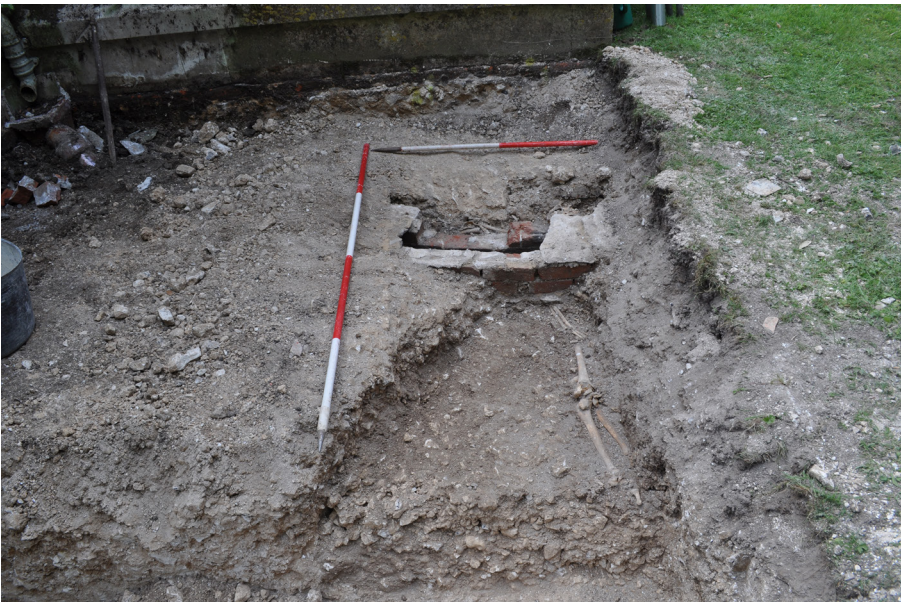
Plate 2: Feature 111 cut by Grave 107 cut by Drain 103, looking West. 1m & 2m scales.

The earliest feature encountered was a vertical-sided cut (111) into the natural, which was only partially exposed. It was aligned roughly NW-SE and was 0.75 m deep with a flat base. The SE end of this feature is probably represented by cut 202 in Trench 2 (Figure 2). This feature was filled by tips of loose chalk rubble and lenses of greyish-brown silty soil. It was cut by Grave 107. The interpretation of this feature is uncertain.

A single grave was exposed during the works. This grave (107) was at the northern edge of Trench 1 (Figure 2; Plates 2–4). The grave cut was rectangular in shape and was 0.7 m deep (below present ground level). Only part of this grave was exposed. It contained a supine adult skeleton (109) with the head to the west, interred in a coffin (110). The presence of this coffin was indicated by a small number of coffin nails and the presence of a tinsplate grip plate of eighteenth/nineteenth century date at the head end (Plate 4). The shape of the coffin could not be determined. The western end of the grave was disturbed by the construction of drain 103.

A brick and stone lined drain (102/103) running in a NNE-SSW direction was found cut through the western part of grave 107 (Figure 2; Plates 2–3). The course of the drain was not exposed except in the area of the new extension

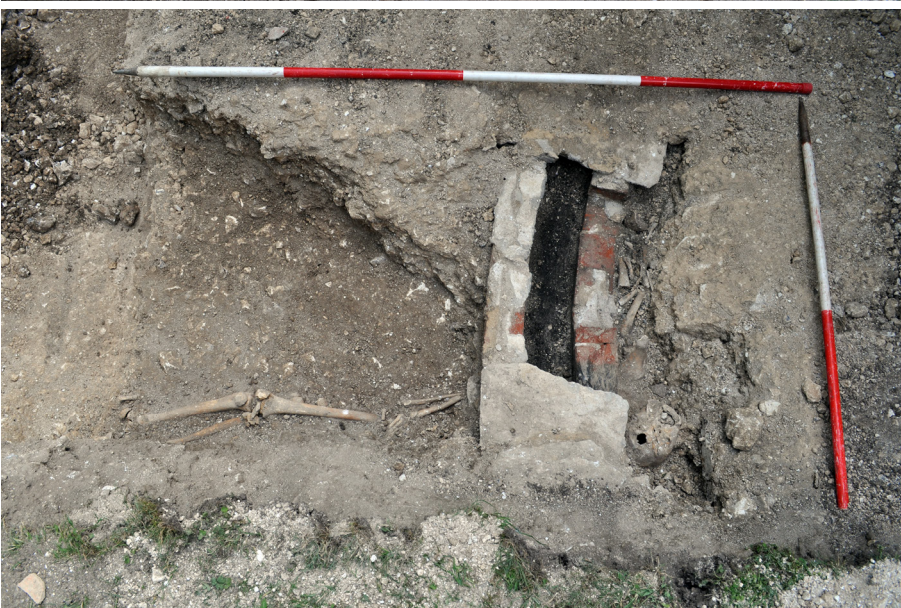
Plate 3: Drain 103 cutting Grave 107, looking south. 1m & 2m scales.

foundation trench. The drain trench (105) was slightly curvilinear and oriented roughly NNW-SSE. It contained a channel consisting of a tabular limestone base (roof tiles?) upon which was constructed two courses of mortared red unfrosted bricks (103) forming the sides of the channel and sealed by a layer of limestone roof tiles (102) mortared in place. The backfill of the drain trench on the western side of the channel contained a large quantity of disarticulated human bone. Some or most of this is likely to be the disturbed remains of skeleton 109.

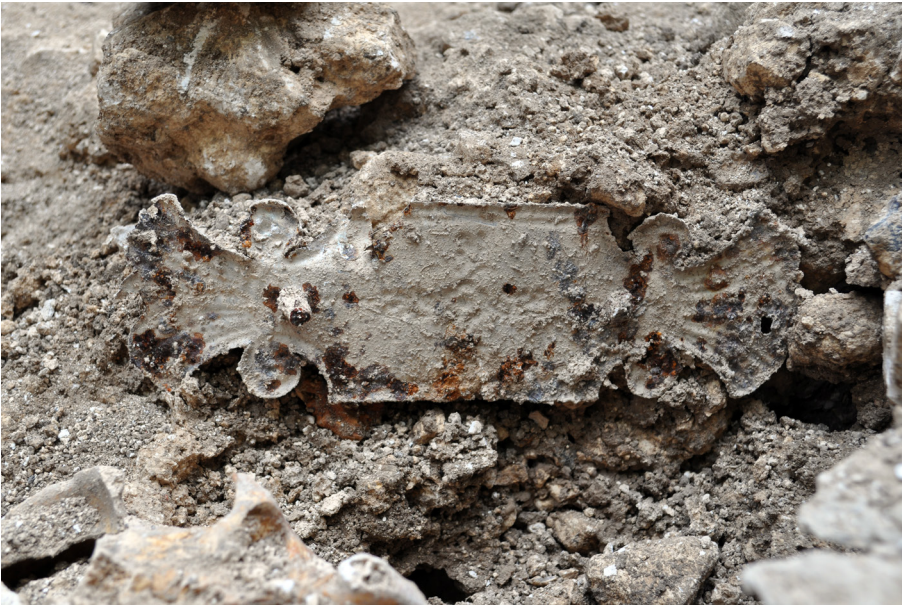
Plate 4: Coffin grip plate 110 at west end of Grave 107 in situ.

A small quantity of finds was noted during the fieldwork. This assemblage consisted of a small quantity of iron coffin nails from context 110 and a pressed tinplate coffin grip plate with cast iron grip of Spitalfields Type 2a (Reeve and Adams 1993, Volume 1 microfiche). This is likely to be late eighteenth to nineteenth century in date.

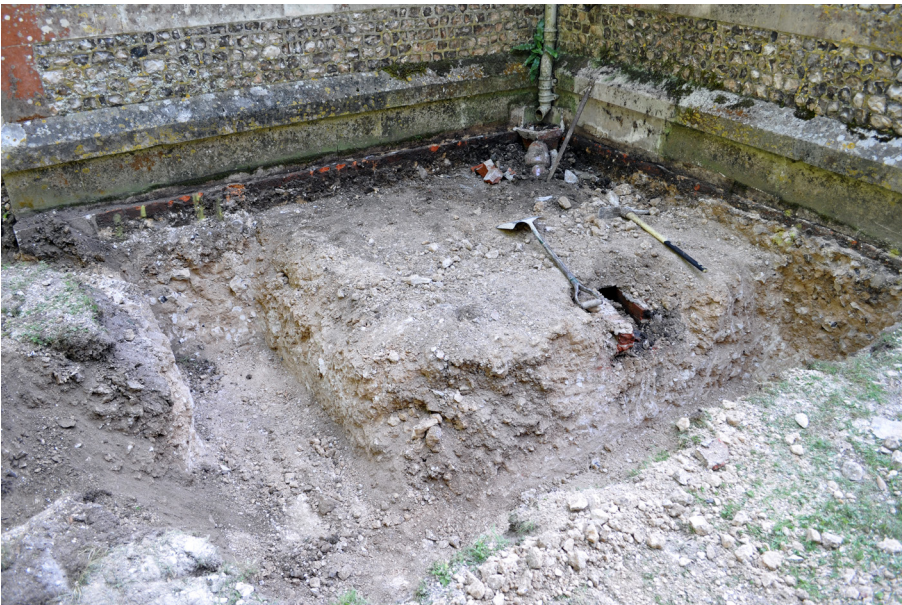
Plate 5: Trench 1 after excavation of new foundation trenches.

The groundworks comprised the stripping of the topsoil across the whole area of the new extension, then the machine excavation of the new foundation trenches, which were about 0.75 m wide and 1.0 m deep. The east wall footing was completely excavated before archaeological recording, but machining of the northern foundation trench was halted when drain 103 was encountered. Subsequently the archaeological features were excavated by hand along the line of the northern footing, with the final part removed by machine. Trenches 2 and 3 for new services were excavated by machine.

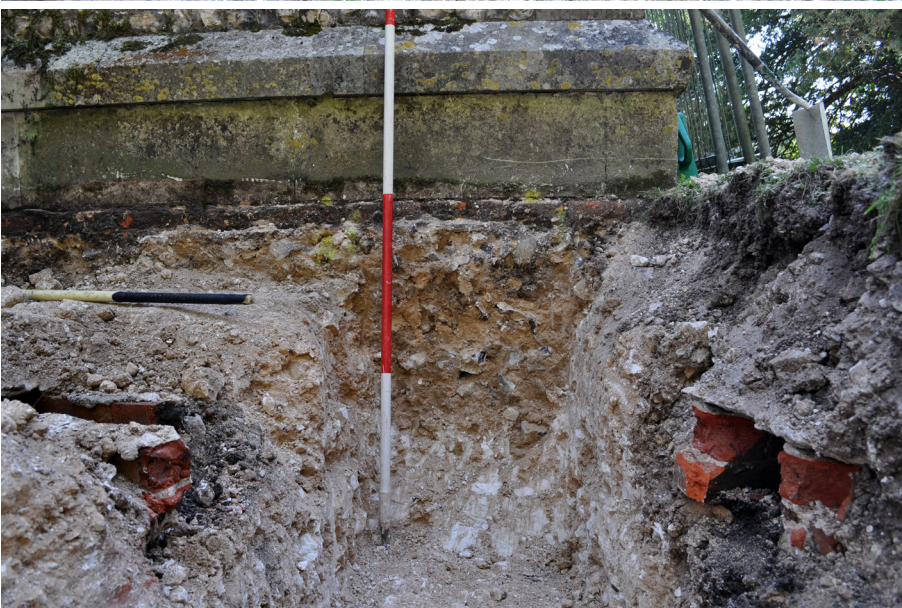
Plate 6: Footings of North Transept. 2m scale (50cm divisions).

The footings of the present church were exposed in Trench 1 where the foundation trenches for the new extension were dug against the church and also in Trench 3 at the east end of the Chancel (Figure 2; Plates 6 and 8). They consisted of a construction trench (113, 303) projecting about 0.4 m out from the church and 0.7 m deep. It was filled with flint nodules in a yellowish-brown mortar matrix. A single course of brick is set on top of this footing upon which the ashlar of the plinth is constructed.

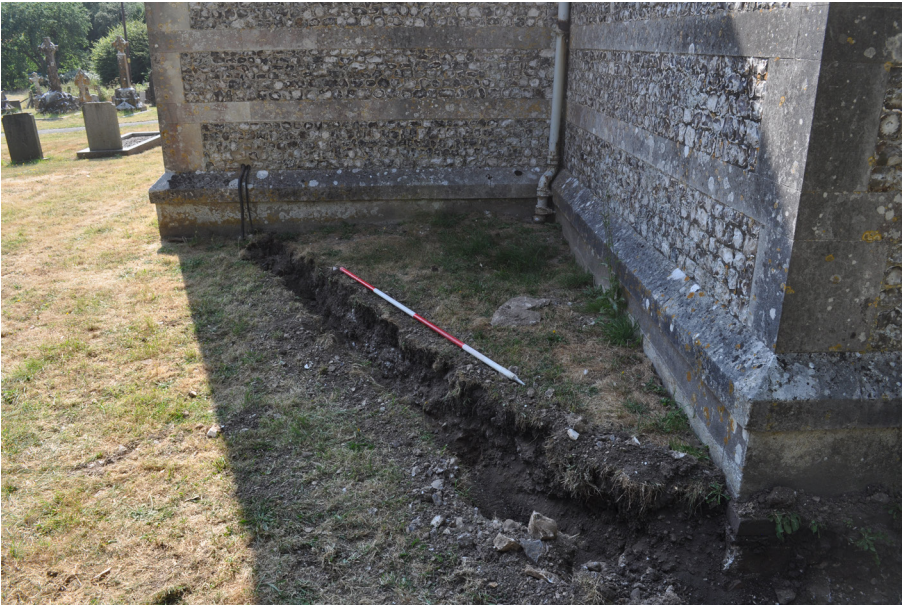
Plate 7: Trench 3 running from South Transept to corner of Chancel. 2m scale.

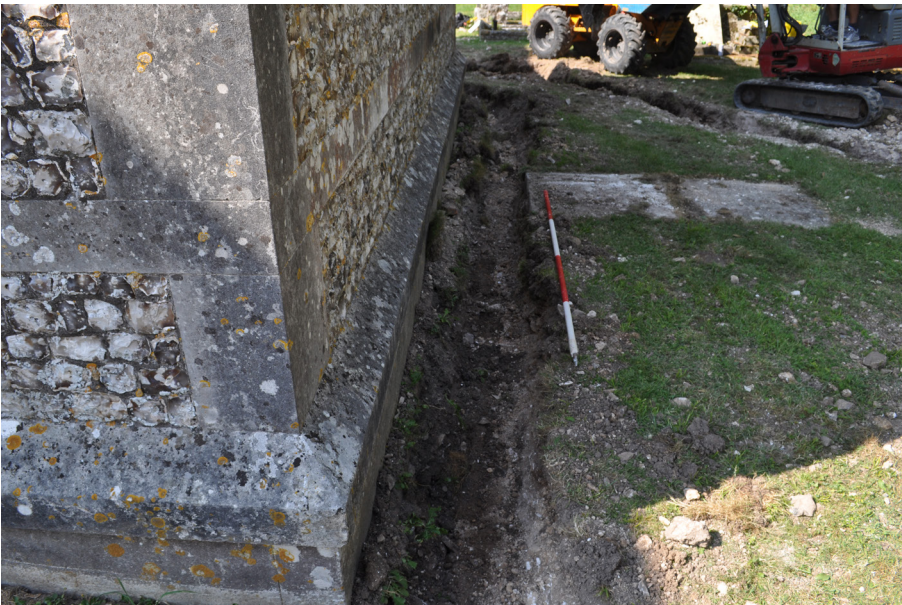
Plate 8: Trench 3 running along East end of Chancel. 2m scale.

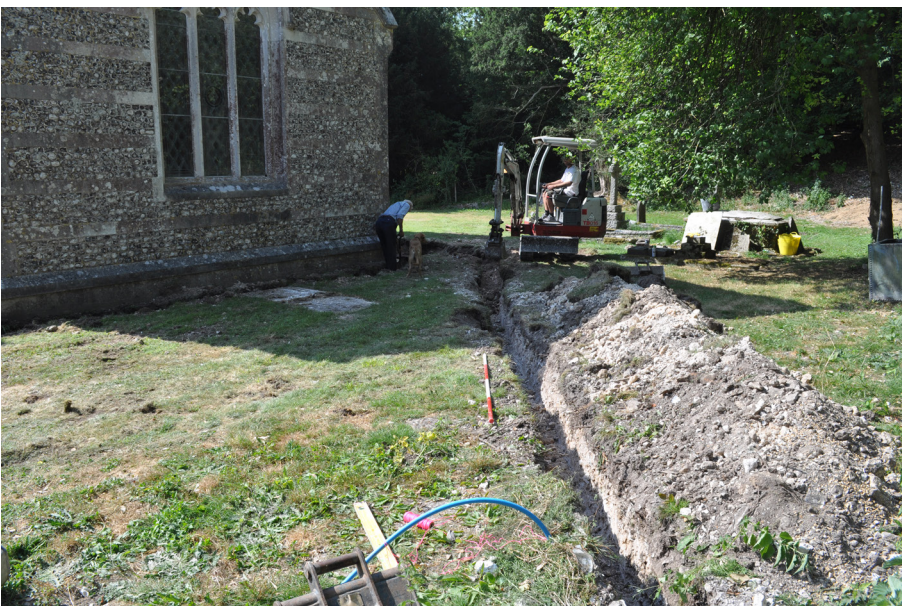
Plate 9: Trench 2 looking North West. 2m scale.
