# Barrington Court, Barrington, Ilminster, Somerset

## Observations and Recording during Installation of New Fibre Optic Cable

Report No. 53506/3/1

Archaeological Observations and Recording during Installation of  
New Fibre Optic Cable, September 2018

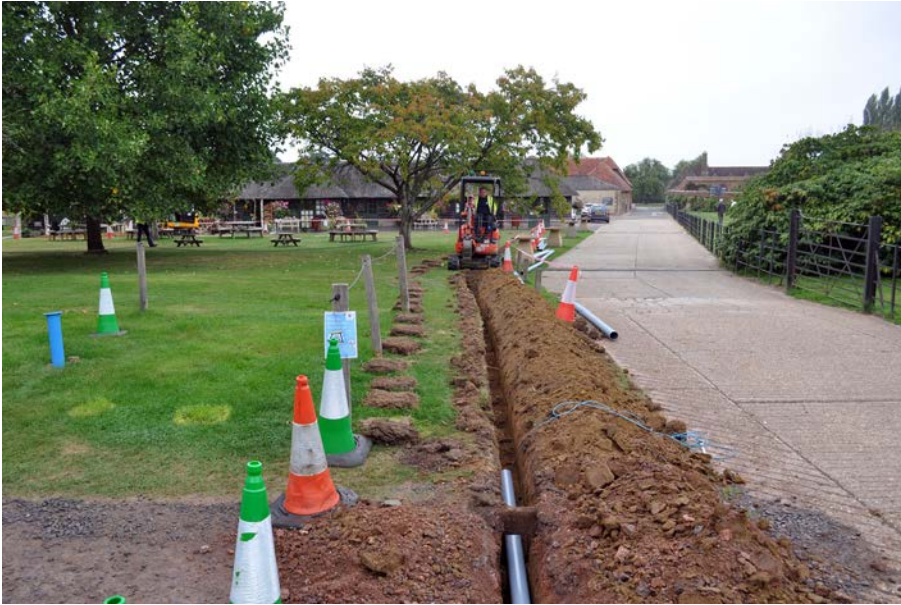
The site lies at the entrance to the National Trust estate at Barrington Court (Figures 1 and 2). The cable trench runs from ST 39618 18154 in Water Lane to the north west end of the reception building at ST 39558 18225, along the side of the entrance drive in the grass of the overflow car park (Figure 2; Plate 1). The topography is relatively flat and lies at a height of about 21 m above OD.

*Plate 1: View along trench from south east.*

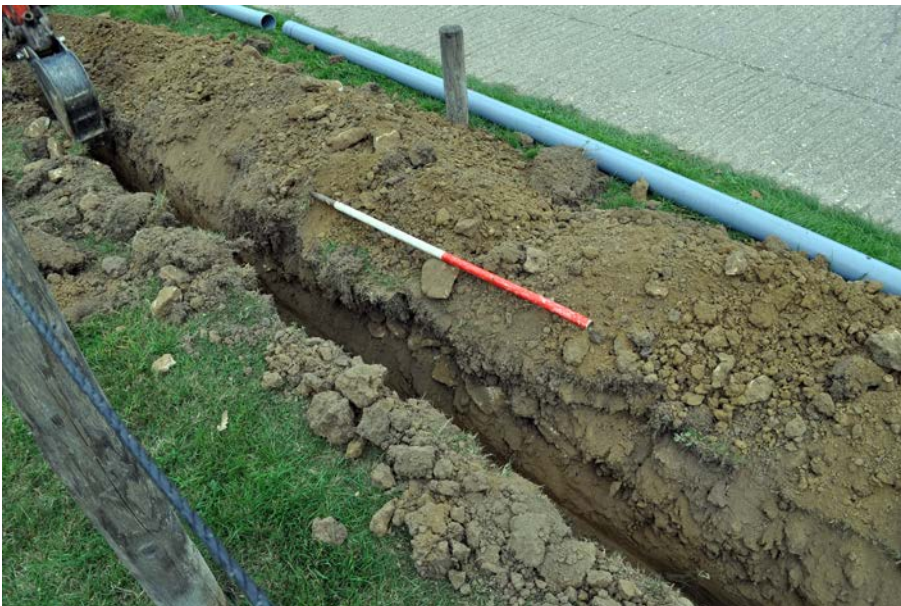
A 0.2 m thick layer of stone rubble (103), traced over a length of 1.85 m, was encountered below the topsoil in the southern end of the overflow car park area (Figure 3; Plate 2). This appeared to fill a slight dip in the natural below.

*Plate 2: Stone rubble layer 103, viewed from south. 1m scale.*

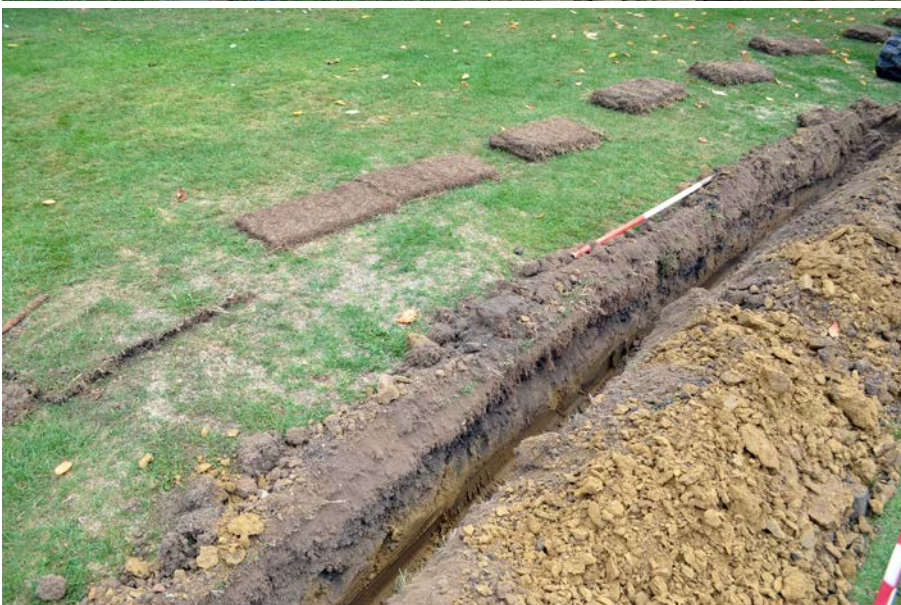
A 0.25 m thick layer of clinker (106) traced over a distance of 8.5 m was recorded in the northern part of the overflow car park (Figure 3; Plate 3). This clinker layer is visible as a slight rise in the surface of the ground.

*Plate 3: Clinker layer 106, viewed from east. 1m scale.*

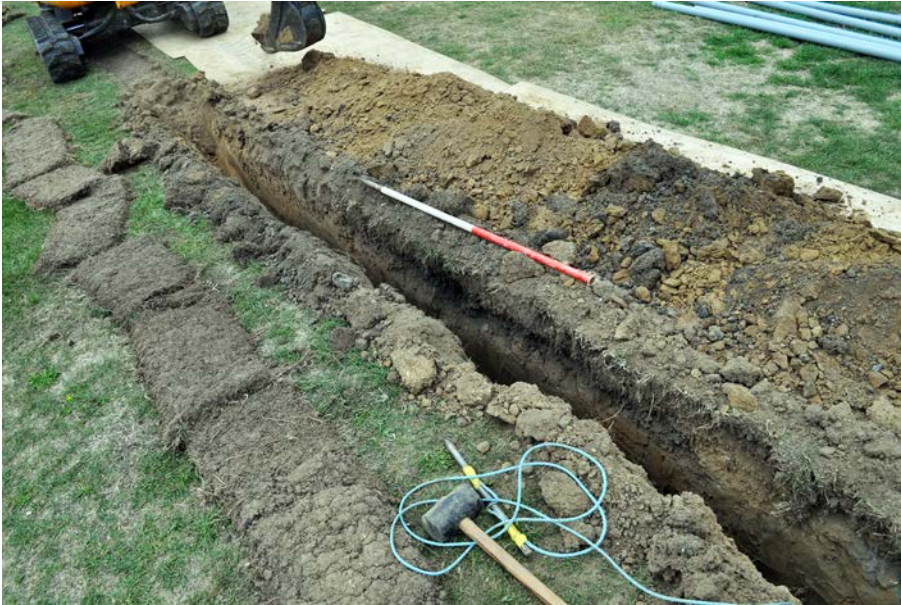
Another deposit of clinker (107) was recorded in front of the reception/café building (Figure 3; Plate 4). This was 0.1 m thick and traced for a length of 1.8 m in the trench.

*Plate 4: Clinker layer 107, viewed from west. 1m scale.*

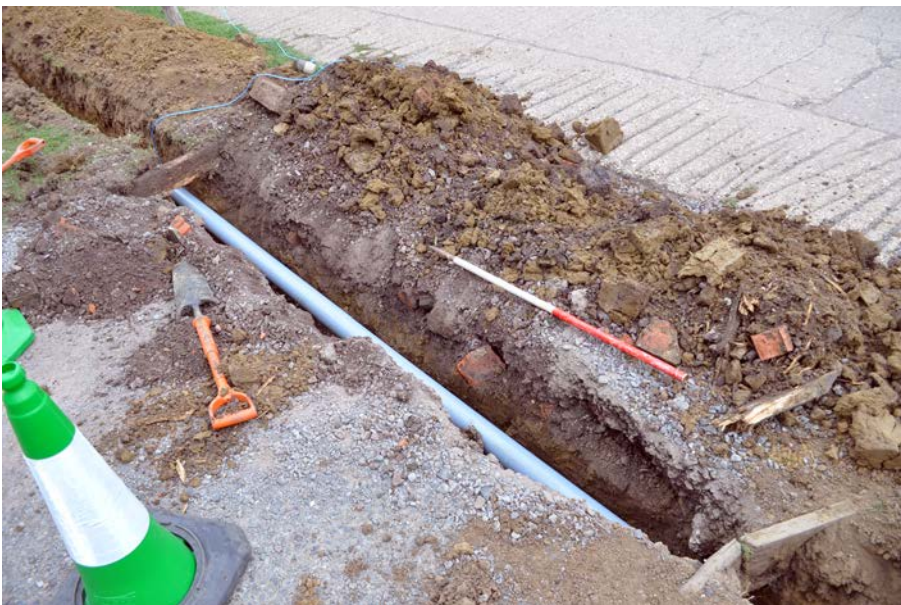
The trench cut through the metalling of the entrance and exit tracks for the overflow car park (Figure 3). The track comprised grey crushed stone (104, 105) with brick rubble below the southern track (105) (Plate 5).

*Plate 5: Brick rubble and stone overflow car park metalling 104, viewed from south. 1m scale.*

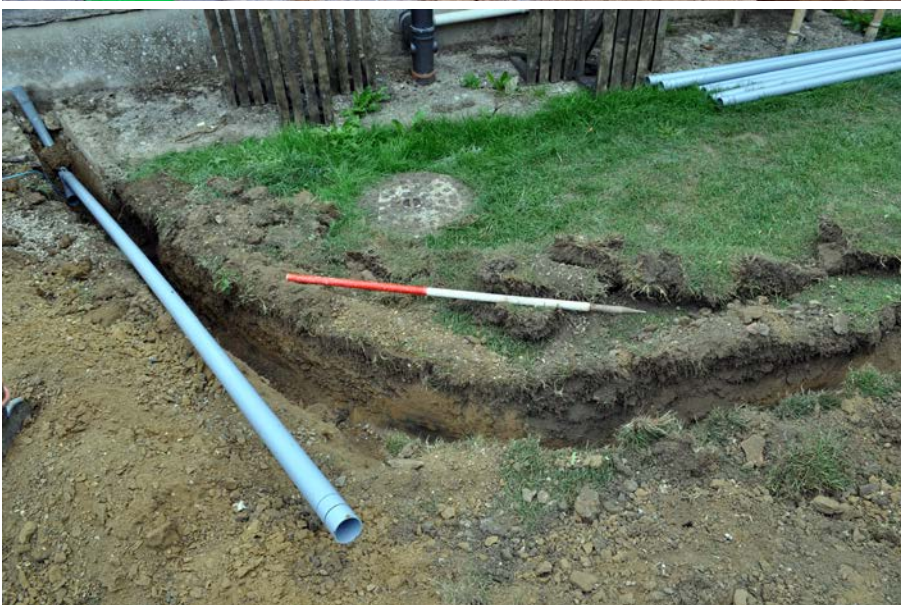
Just southwest of the Reception building where the duct enters the building, a plastic drain pipe covered in a layer of shingle (109), lay beneath the concrete surface (110) adjacent to the building (Figure 3). Slightly further south the duct trench cut through a steep sided cut filled with mixed greyish-brown soil and shingle (108). This feature was cut in two places where the trench turned a corner. This is likely to be associated with the manhole which lies close by (Plate 6).

*Plate 6: Services disturbance 108, viewed from west. 1m scale.*

108	<b>Manhole?:</b> Steeply sloping sided cut into natural, filled with mixed gravel, yellowish-brown clay and greyish brown clay soil. Adjacent to manhole cover. Encountered in two places where trench turns corner.	0.15 – 0.50m+
109	<b>Service Trench:</b> Trench, 0.5 m wide running roughly NNW-SSE, containing a plastic drain pipe and backfilled with shingle.	0.10 – 0.50m+
110	<b>Concrete Apron:</b> Concrete area next to Reception Building, 0.8 m wide and 0.11 m thick.	0.00 – 0.11 m
