# Corfe Castle, Dorset

## Archaeological Observations and Recording during Formation of Beacon Bases and Other Minor Works

Report No. 53513/3/1

December 2018

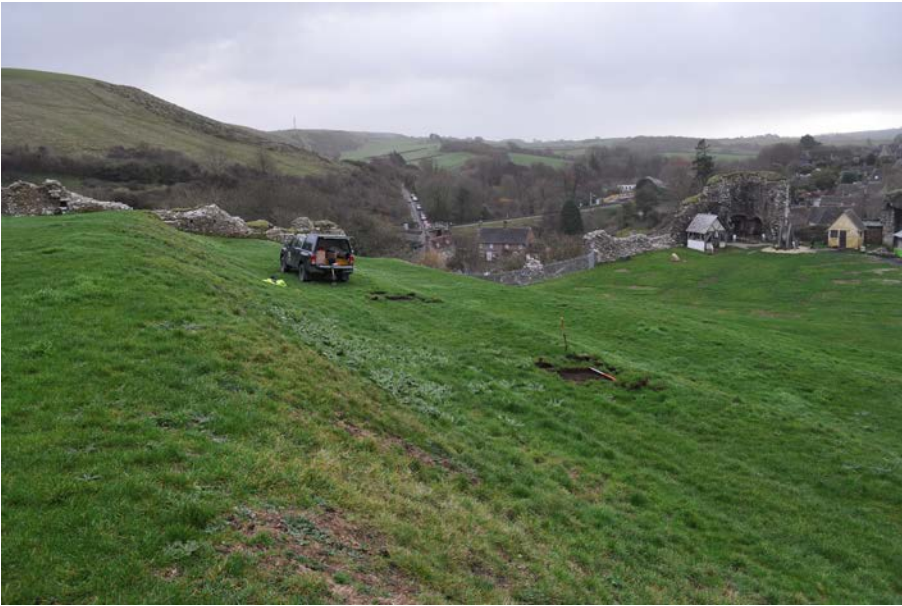
The two new beacon platforms were dug on the forward edge of the second of three terraces in the Outer Bailey of the Castle (Figure 2; Plates 1–3). Trench 1 (SZ 95965 82238) measured 1.06 m by 1.06 m across and 0.10 m deep. The base of the trench revealed a slightly stony layer of dark brown silty loam (101) below the dark brown silty loam turf and topsoil (100). The only find was a 1994 10 pence piece. Trench 2 (SZ 95954 82235) lay about 9.5 m to the west and measured 1.00 by 1.06 m across and 0.12 m deep. It exhibited the same stratigraphy as in Trench 1. The only find was a 2000 1p coin.

*Plate 1: General view of Trenches 1 and 2, looking ESE.*

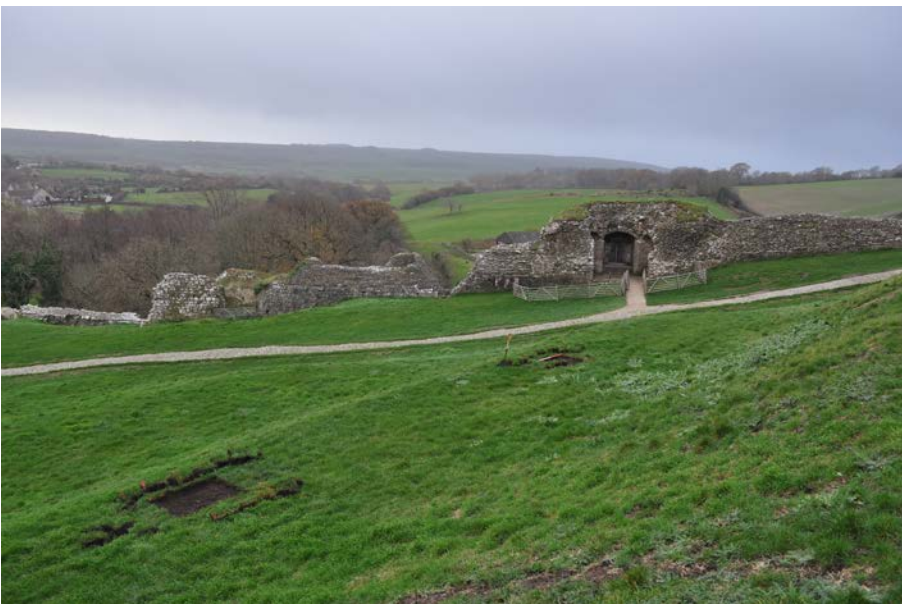
*Plate 2: General view of Trenches 1 and 2 looking WSW.*

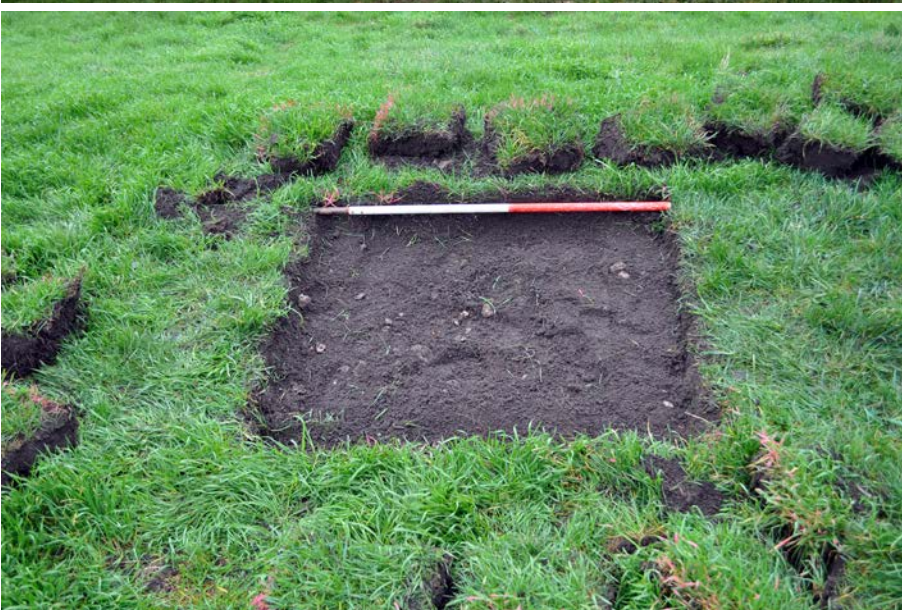
*Plate 3: Trench 1 fully excavated. View from north. 1m scale.*

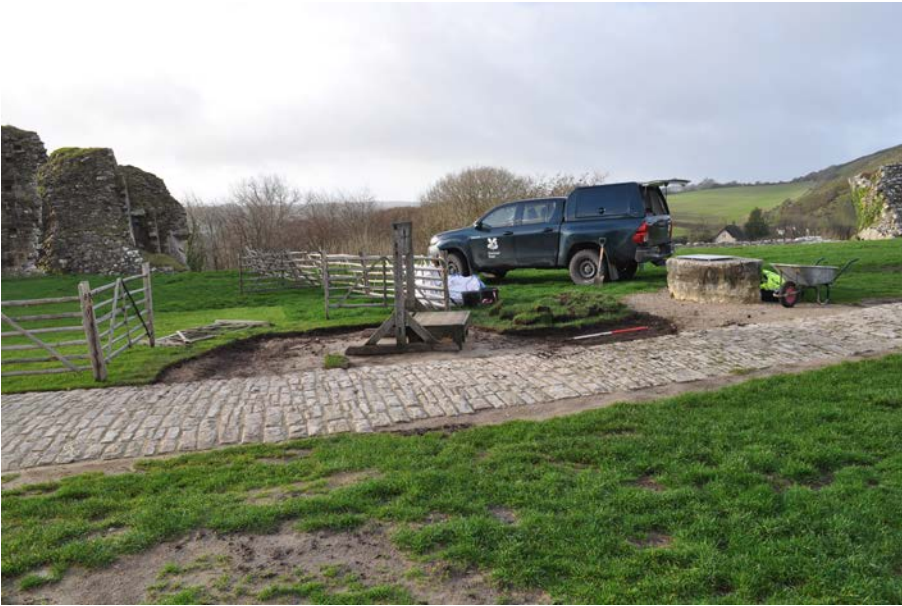
Trench 3 (SZ 95981 82190) was an irregular area of turf removal around the Stocks and the adjacent Information Panel beside the footpath in the southern area of the Outer Bailey (Figure 2; Plates 4–6), in order to extend the gravelled area to combat the ongoing erosion of this area. The dark brown silty loam turf (120) was removed to depth of about 0.2 m revealing the dark brown silty loam topsoil (122) below. This topsoil included a some modern material including fragments of a plastic teaspoon. In the southern part of the trench was a thin layer of gravel (121) at a depth of 0.1m below the turf. This is likely to be part of a previous erosion repair.

Plate 4: General view of Trench 3, viewed from NE.

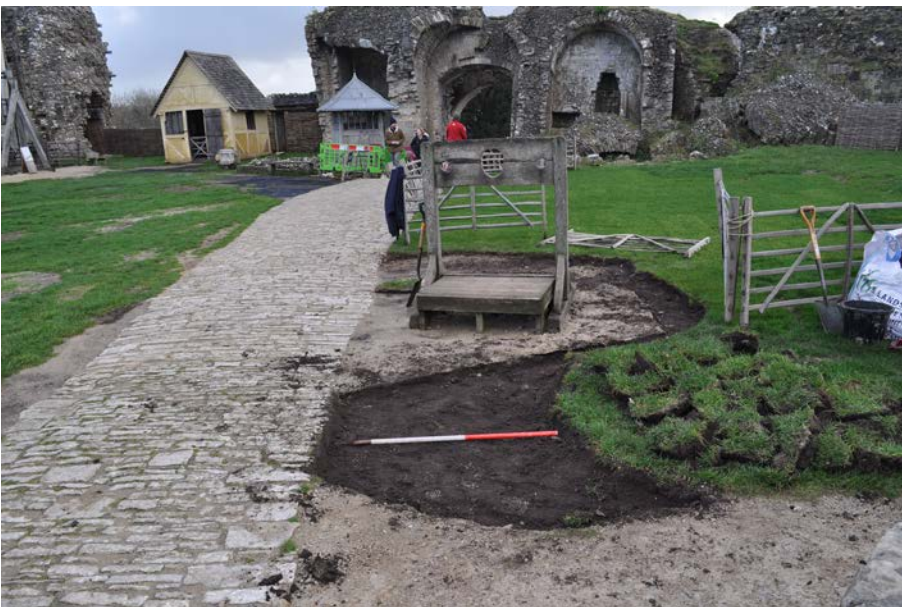
Plate 5: Trench 3 after excavation. View from northwest. 1m scale.

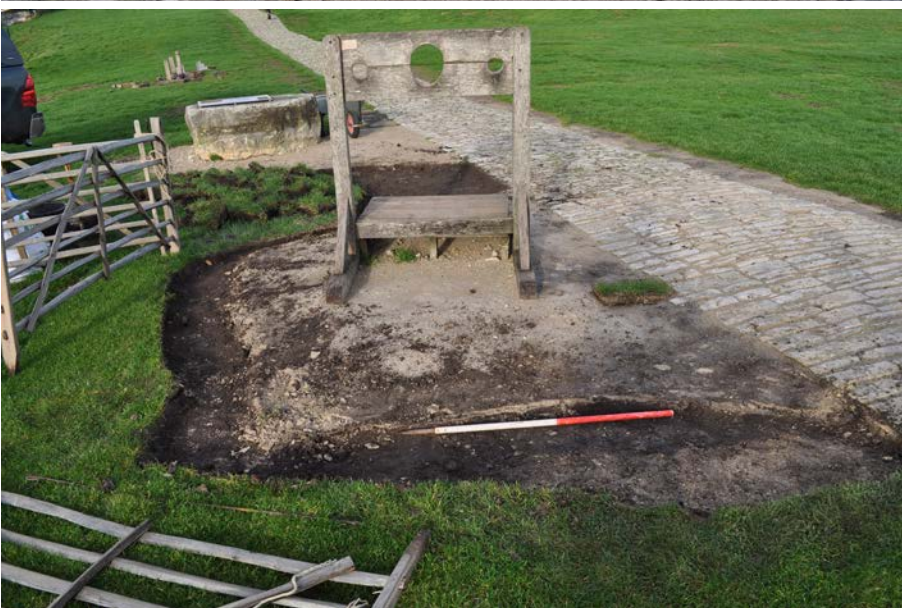
Plate 6: Trench 3 after excavation. View from southeast. 1m scale.

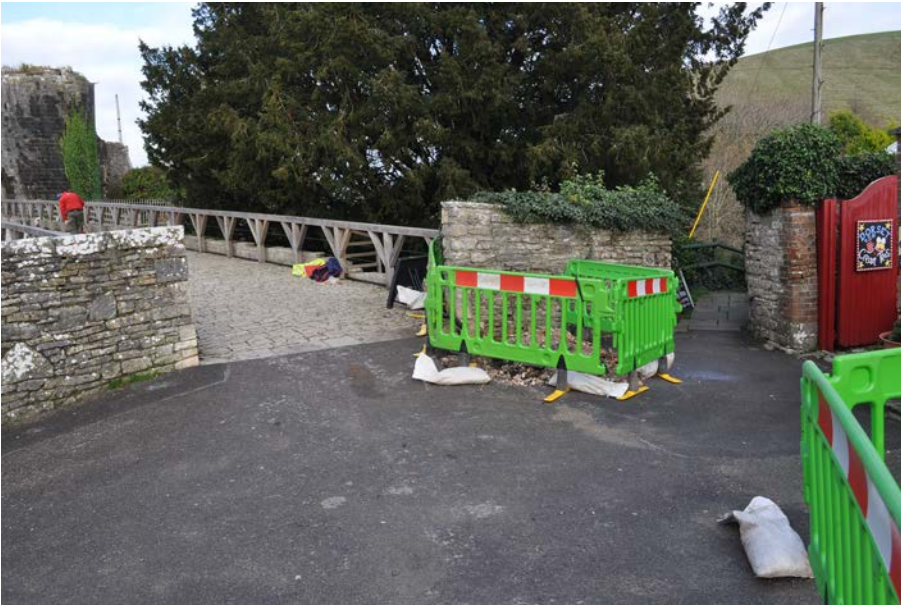
As a result of a major electrical fault, a temporary electricity cable has been laid along the edge of the Outer Bridge. Two holes had been dug in the lane leading up to the castle by the electricity company to find the fault and patch in the emergency cable repair. The new cable needed to be buried below the surface in the pinch point between the boundary walls at the end of the Outer Bridge (Plates 7–8). This small slot was numbered Trench 4 (SZ 96018 82135) (Figure 2). A single paving slab and the minimum number angular stone cobbles were lifted to allow the cable to be inserted. The cobbles (130) were set in a bedding (131) of mortary sand over a cemented mortar layer (132). The short stretch of trench between the bridge and the end of the new cable repair was not observed, but the exposure in the sondage dug by the electricity company indicated disturbed deposits (Plate 9).

Plate 7: General view of location of Trench 4, looking north.

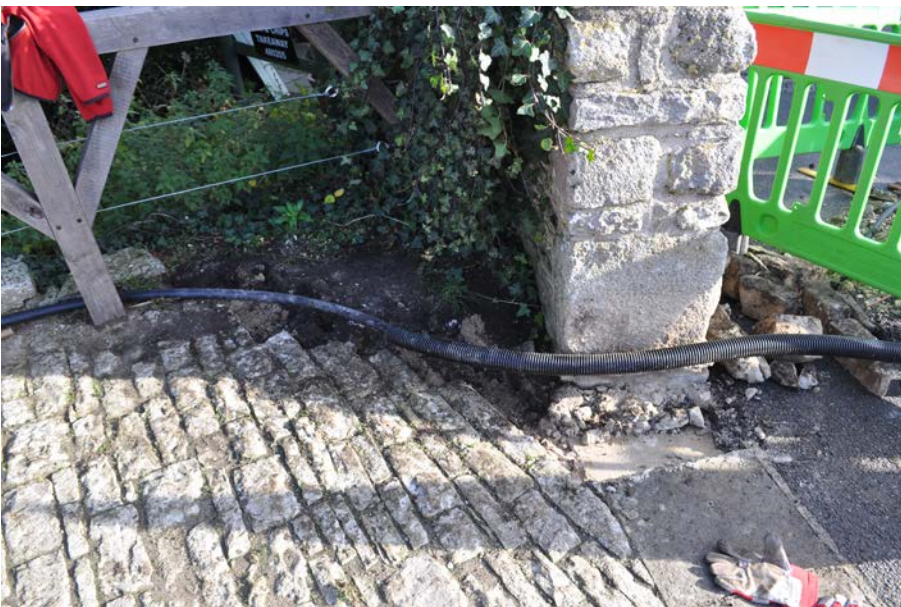
Plate 8: Trench 4 after excavation. View from west.

Context	Description and Interpretation	Depth (m) below ground level
130	<b>Bridge Surface:</b> Angular stone cobbles in yellowish-brown mortar.	0.00 – 0.15m
131	<b>Bedding Layer:</b> Yellowish-brown mortary sand.	0.15 – 0.20m
132	<b>Concrete:</b> Cemented layer beneath 131.	0.20m+
