Bottle Knap Cottage, Long Bredy, Dorset

Observation and Recording during Drainage Improvements

Report No. 53512/3/1

December 2018

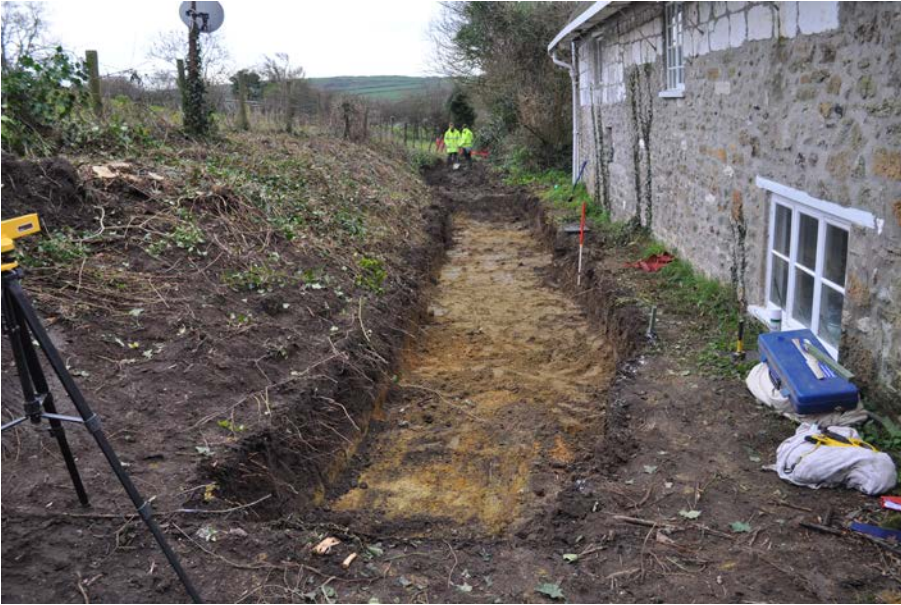
Plate 1: View of trench after excavation, viewed from north. 1m scale.

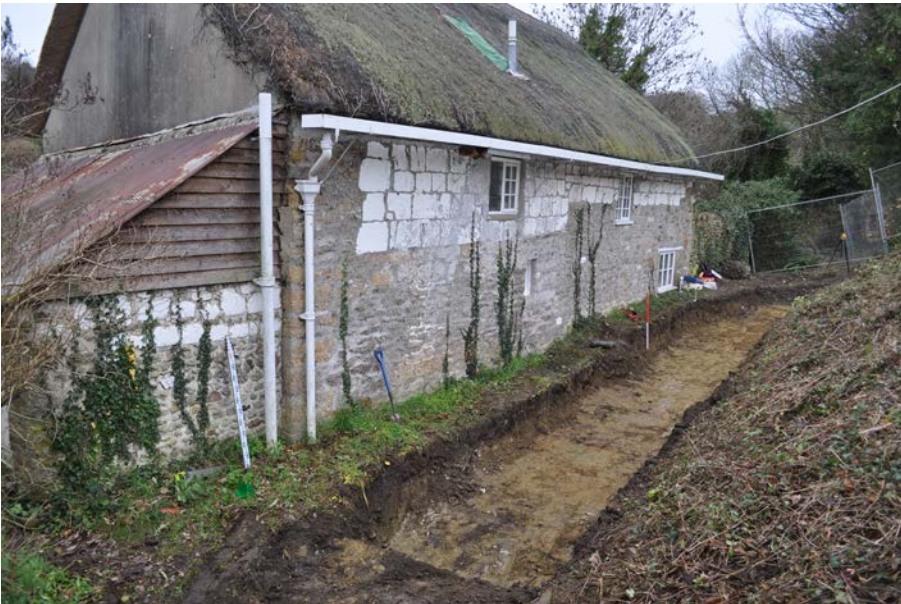
Plate 2: View of trench after excavation, viewed from south. 1m scale.

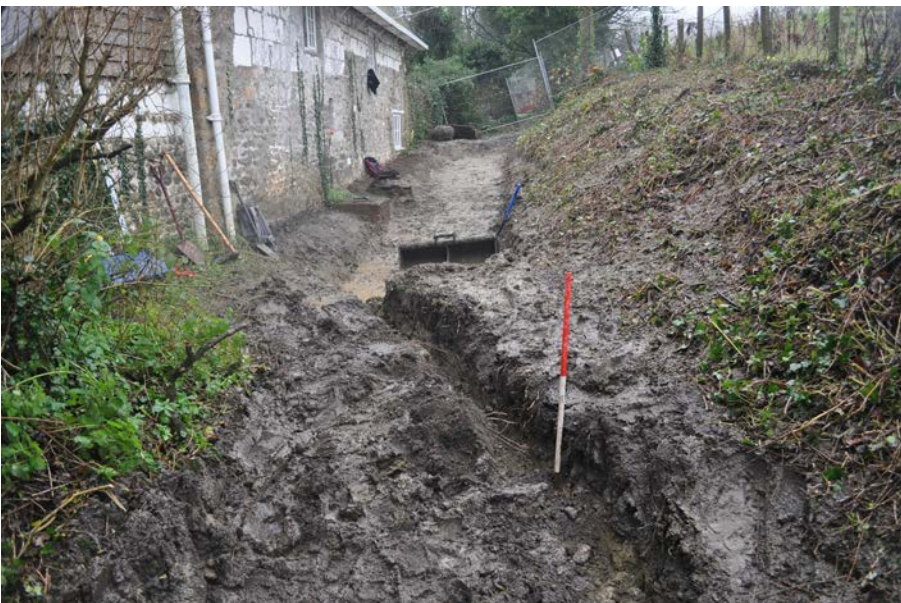
Plate 3: General view of site after excavation of drain trench, looking north. 1m scale.

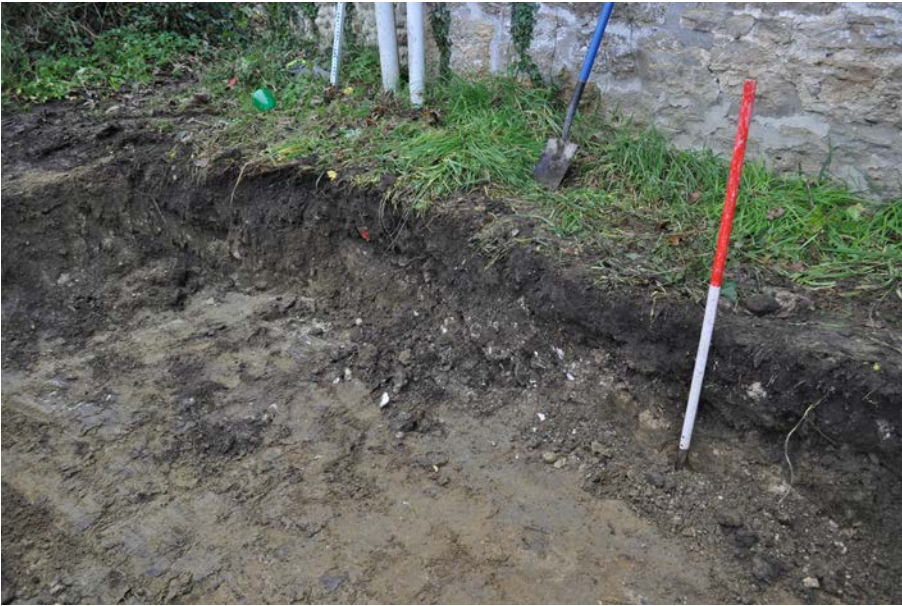
An irregular scoop (105) was partially exposed in the south west part of the trench (Figure 2; Plate 4). This scoop measured about 1.4 m across and had steep to shallow sloping sides. It was cut through the base of the topsoil down on to the top of the natural sand. It was filled with a mixed brown sandy loam (104) with frequent small chalk lumps, moderate to frequent stone rubble and occasional brick and tile fragments.

Plate 4: Scoop 105 sectioned in edge of trench. 1m scale.

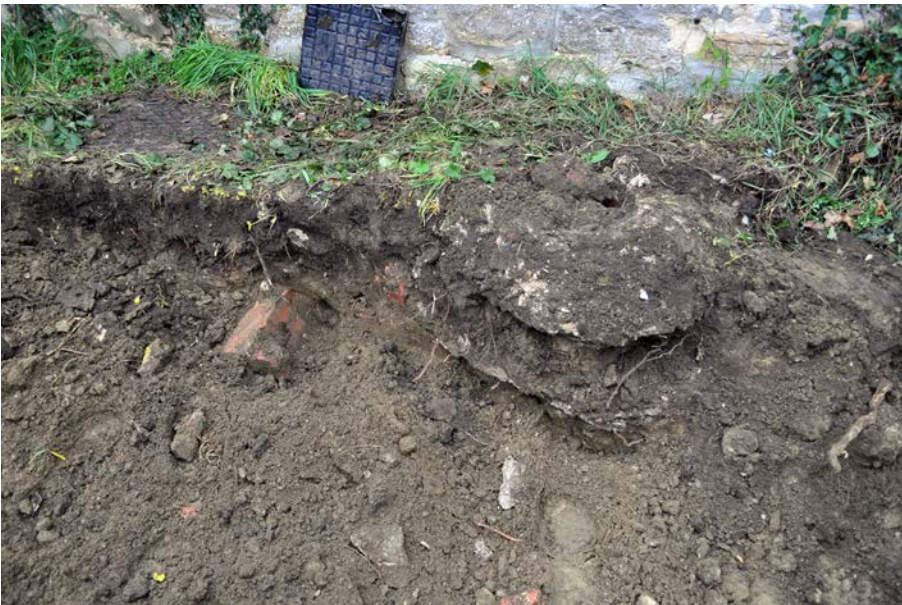
Three drain covers were visible in the strip of ground between the cottage and the track, suggesting significant disturbance from services in this area. The concrete around the central drain cover was exposed in the edge of the trench and fragments of a brick chamber (106) were displaced by the machining, just to the south of this drain (Plate 5). The reshaping of the profile of this strip revealed a metal pipe running N-S just to west of the excavated area.

Plate 5: Part of brick structure 106, disturbed during machining, with concrete of drain to right.
