**STOCK HOUSE, FYNE COURT, BROOMFIELD, SOMERSET**  
**Archaeological Observations and Recording**

**Report No. 53305/3/1**

**May 2009**

## **Archaeological Observations and Recording, April 2009**

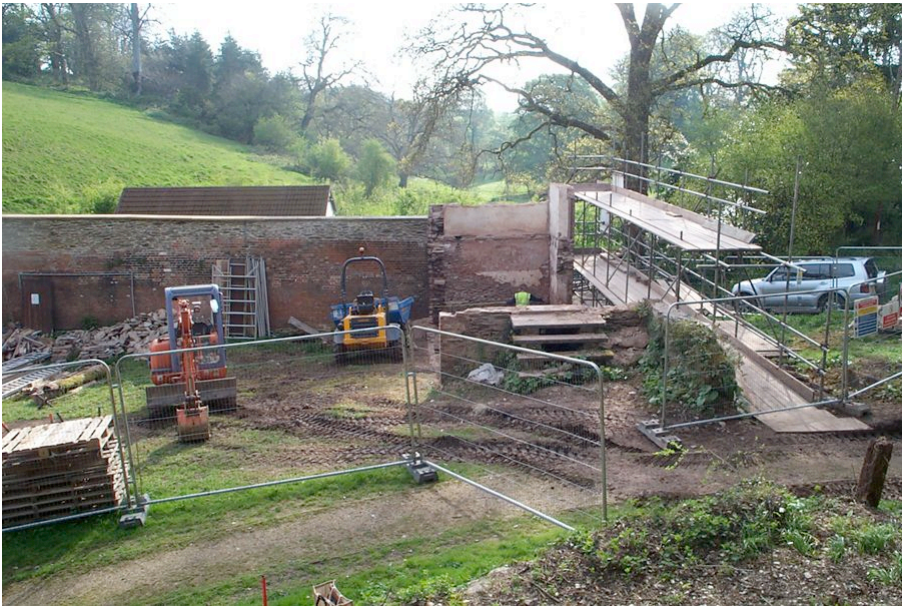
Fyne Court was built for the Crosse Family in the mid-late 17th century, and its grounds are significant for their numerous 18th century garden features, amongst which are a serpentine lake, boathouse, castellated folly, and a string of five lakes. A small artificial lake, with an overflow sluice to the east, lies immediately north of the site and, beyond that, a walled garden is bounded to the north by a derelict vinery building (Figure 2). On the hill slope west of the site is a mound believed to be an artificial viewing platform, and the stock house itself is connected to the southern end of a row of lincays (Plates 1-2).

*Plate 1: General view of site of stock house viewed from west.*

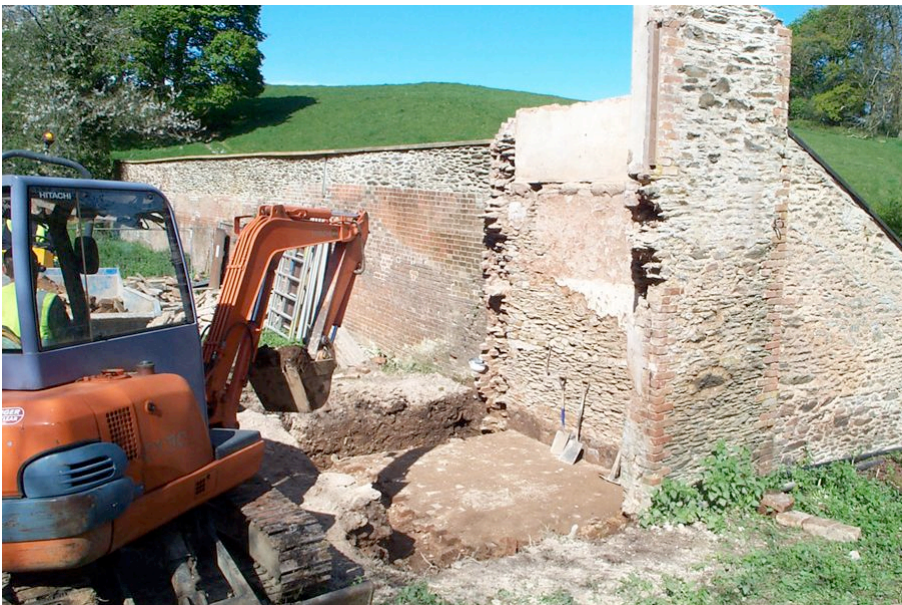
*Plate 2: View of works on Room 1.*

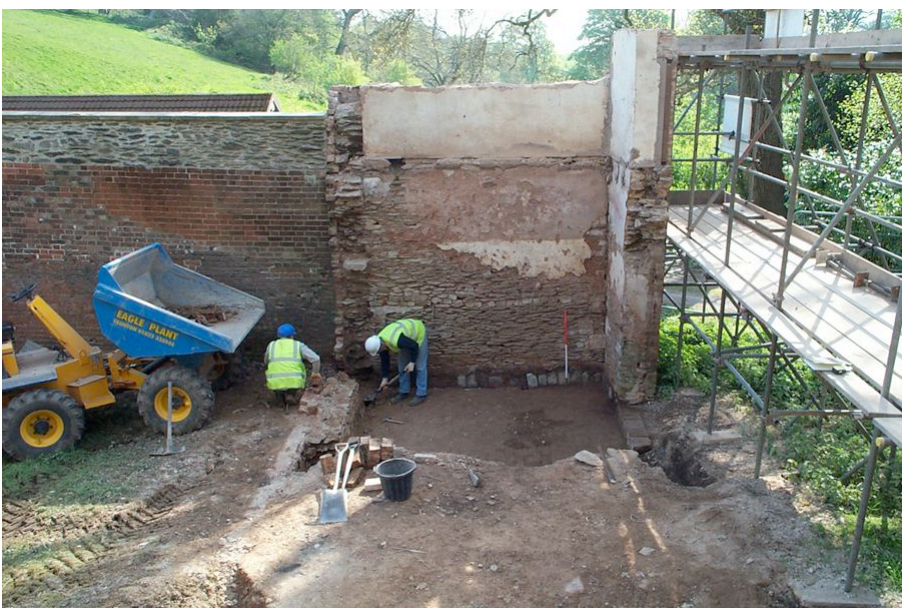
Although the original programme of works for the stock house entailed a limited suite of repairs and underpinning (Scheme of Works prepared P. J. Stow & Associates, reference National Trust/ 27,1233 Fyne Court Stock House Repairs, 17th March 2009), it became evident as works progressed that the building was in greater structural distress than had been suspected, its problems including voiding of wall interstices by nesting rodents. Prior to commencement of the archaeological watching brief, most of the superstructure of the building was dismantled/demolished, leaving only the lower portions of the east and west gable walls intact (Plates 1- 4). Modern concrete floors with associated sub-floor makeup had also been broken-out and removed.

*Plate 3: View along Stock House towards the east.*

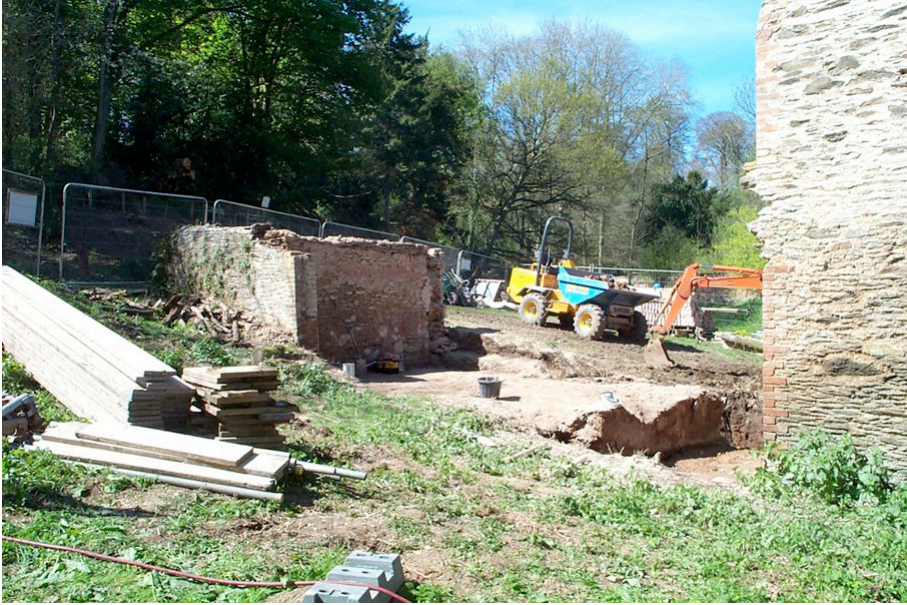
*Plate 4: View Room 2 and east wall of Stock House.*

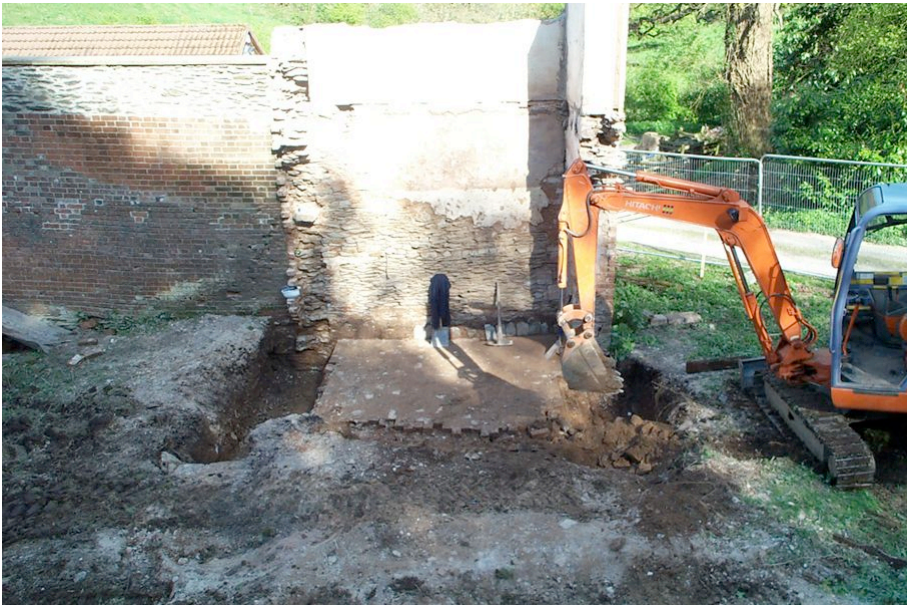
A slightly undulating red brick floor (105), comprising a single layer of bricks and partial bricks, set in semi- and part-staggered east-west rows, was discovered in the sunken eastern ground floor room (Figure 3, Plates 5-6). These were set on a thin irregular hard yellow mortar bedding, deposited directly onto a cut earthen/clay construction terrace. Around the base of the wall, and resting on the edges of the brick floor, roofing slates (102) had been mortared vertically against the inside of the walls (100, 101, Plate 6), potentially as a form of damp- or rodent-proofing. The interior render (patches of which survived) had been applied over these slates.

*Plate 5: Room 1, showing brick floor.*

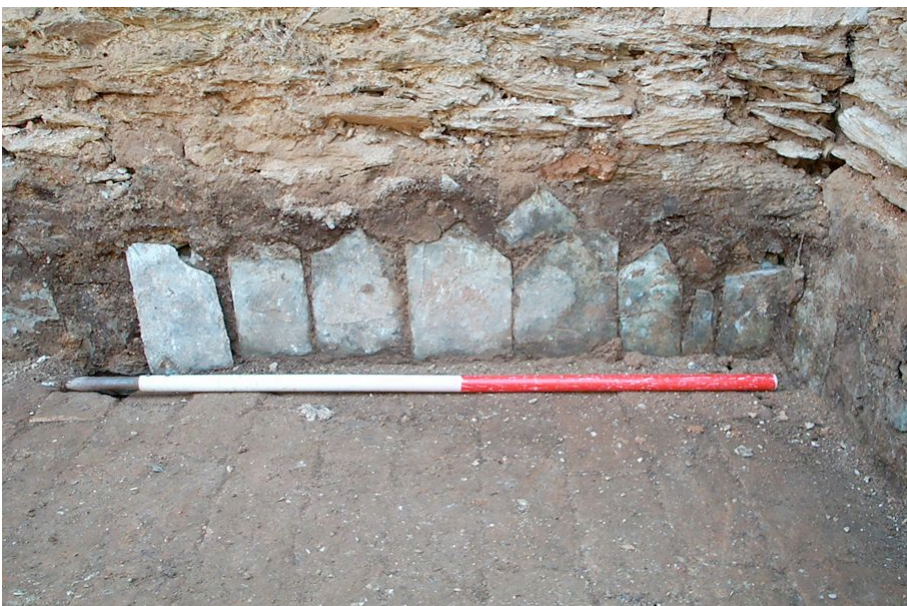
*Plate 6: Detail of slates mortared along edge of brick floor in Room 1.*

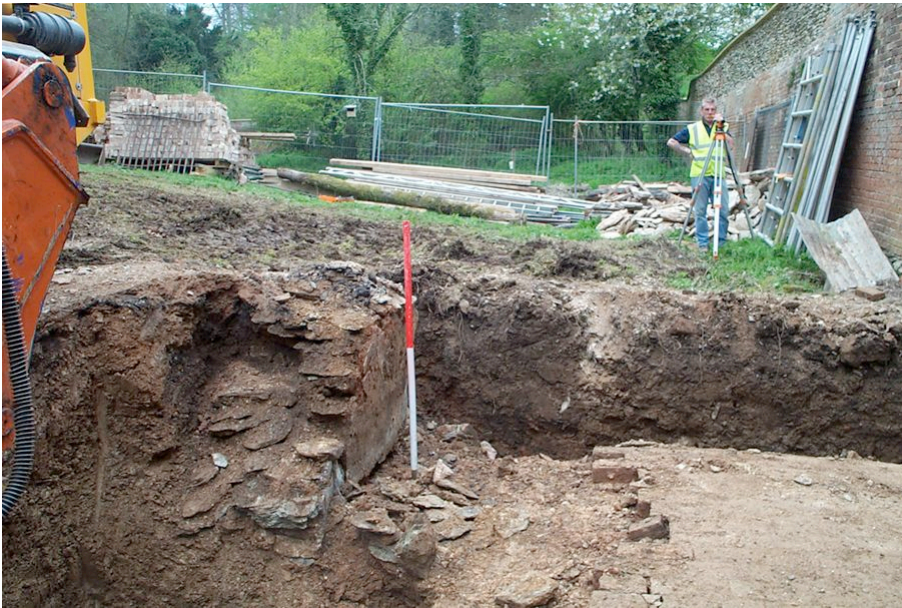
All traces of the original masonry cross-wall 101 were removed during the groundworks (Plate 7). This wall was 0.6 m thick and its base was level with the mortar bedding below brick floor 105. It was constructed against a crude terrace cut into the hill slope and formerly extended to first storey level. The fabric was of poorly lime-mortared, random coursed tabular Morte Slate, rough-faced against the terrace edge but more evenly faced and rendered to the east, where it formed the internal wall of Room 1.

A modern concrete floor in Room 2 (to the west) had been removed prior to commencement of the watching brief. It had lain directly on a terrace of degraded natural bedrock, and on a shallow (up to c. 0.3 m thick), compact wedge of rubbly clay makeup immediately west of the dividing cross-wall 101 (Plate 7)

Plate 7: View of cross-wall 101.

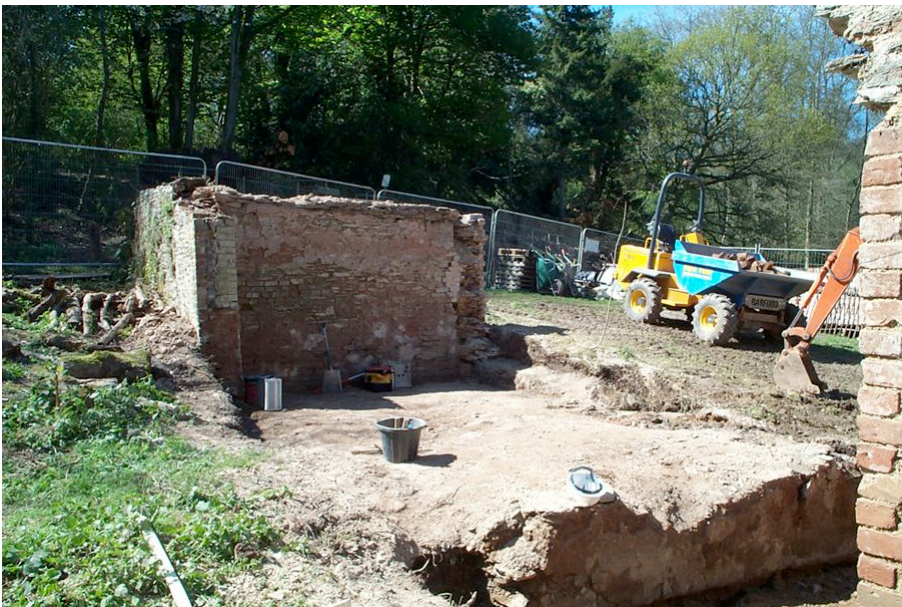
Plate 8: View of Room 2 looking northwest.

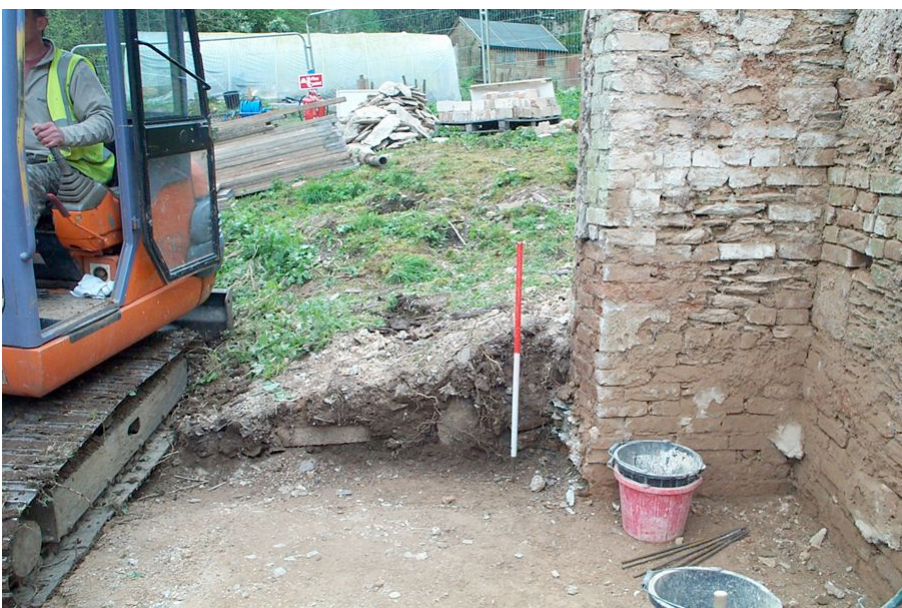
After removal of the wall masonry, it was evident that deposits of soil and other debris had accumulated against the building. This was most clearly seen at the western end of the south wall, where some 0.7-0.8 m of topsoil, rubble and other 19<sup>th</sup>-20<sup>th</sup> century debris had accumulated (Plate 9), derived primarily from a low, mounded and overgrown pile of similar material dumped just to the south-west, between two branches of the adjacent trackway.

Plate 9: View of material accumulated against the west end of south wall of Room 2.
