Gallows Hill, Dorchester, Dorset

Archaeological Observations and Recording during Path Improvements

Report No. 53519/3/1

February 2019

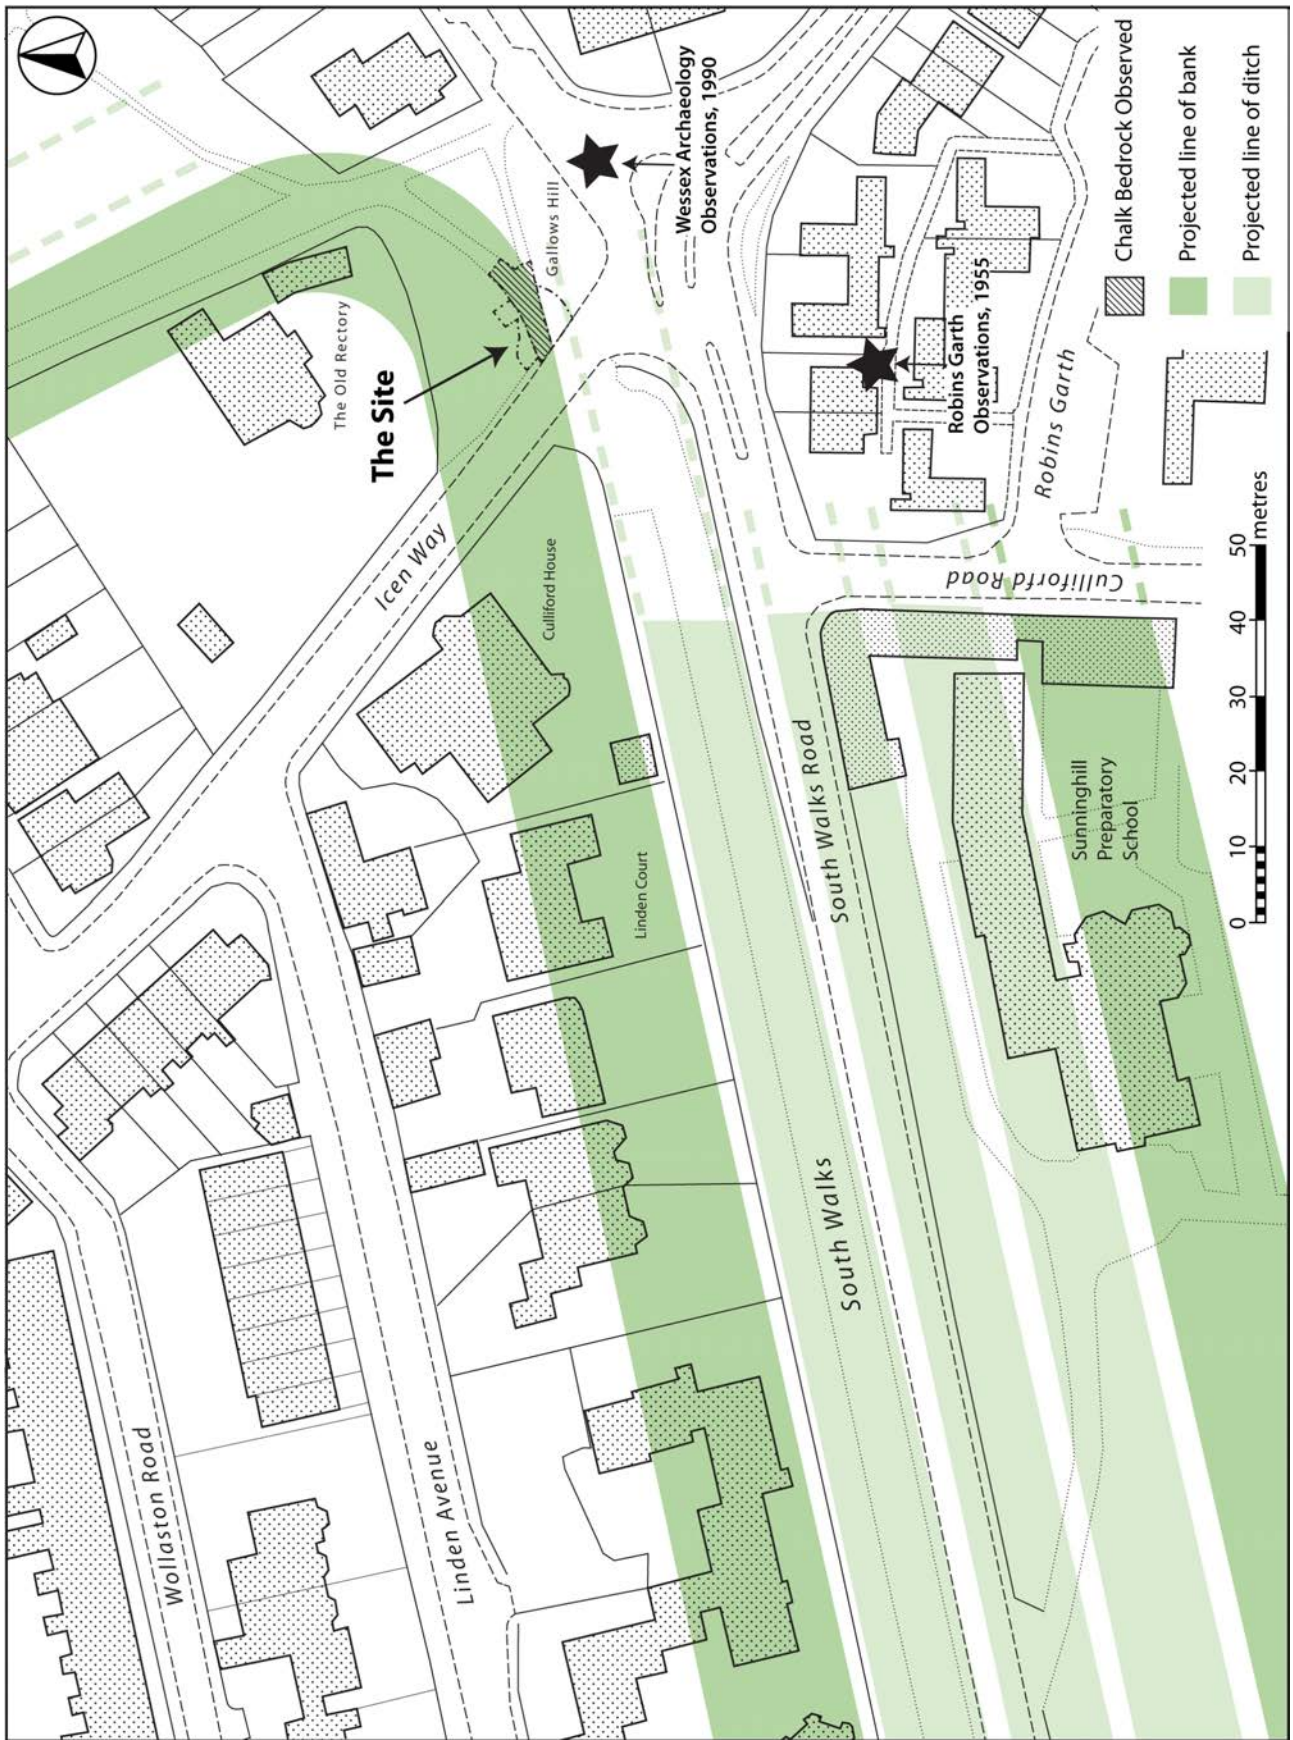
Figure 2: Plan of Observations

The area of groundworks monitored archaeologically is shown on Figure 2. The removal of the existing path and the reduction of the ground levels of the path were observed and most of the reprofiling of the adjacent areas of ground to meet the new path levels (Plates 1–6). The deposits revealed are described in Appendix 1.

The exposure of natural chalk bedrock on Gallows Hill during the present project indicates that the ditches did not cross this area. This is perhaps not surprising as the site is projected to lie beneath the bank (Figure 2). No bank material was recognised during the work, but this is likely to have been removed by erosion, or by the creation of the Walks, or the later construction of the footpath. No evidence for a ditch was observed, but the projected edge of the inner ditch lies just beyond the site.

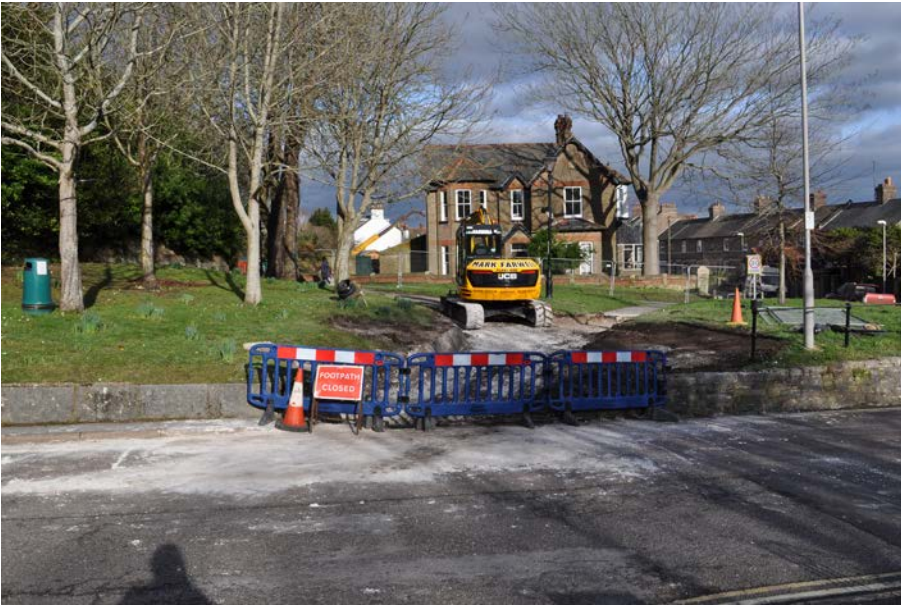
Plate 1: General view of site looking across Icen Way from the west.

The site is located at the south east corner of the historic centre of Dorchester at the junction of South Walks Road and Icen Way, close to the junction of South Walks and Salisbury Walks (centred on SY 6963 9045) (Figure 1). The ground rises up eastwards from Icen Way to form an area of higher ground in the angle between Icen Way and South Walks Road, lying at a height of about 65 m above OD (Figure 2, Plate 1).

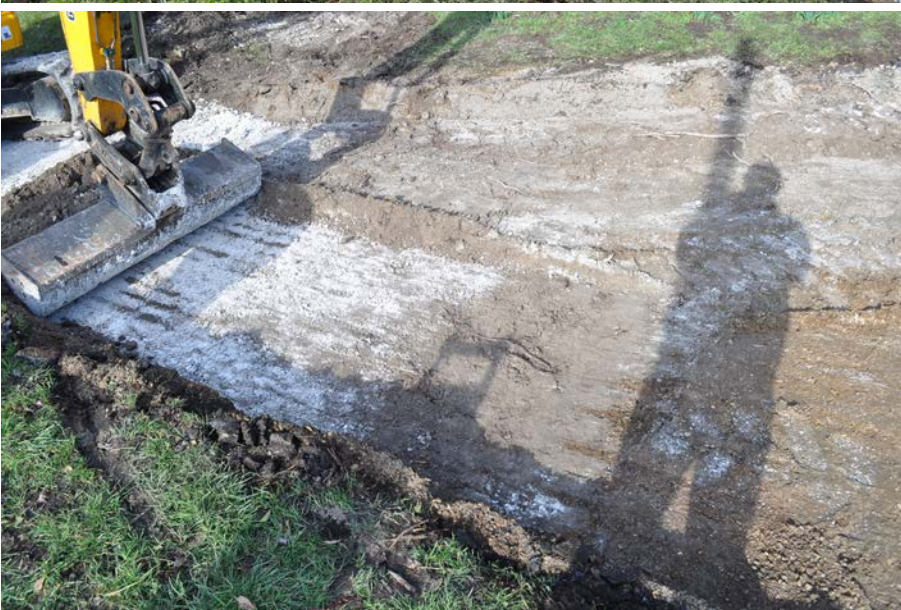
Plate 3: Base of trench during groundworks showing path gravel sub-base 101, over grey silt 102 over natural chalk 103.

Overlying the natural chalk was a thin layer of grey silt (102) with sparse chalk flecks and occasional flint (Plate 3). This was found across most of the area of the footpath and also extended beneath the topsoil in the areas to the north and south of the path (Plates 3–6). A single sherd of eighteenth/nineteenth century pottery was recovered from this layer. The character of this deposit suggests it is a product of erosion of a chalk bank and may be associated with the construction of the walks in the eighteenth century.

The flint gravel sub-base (101) for the tarmac path (100) was set directly on top of the silty layer 102 (Plate 3). A layer of topsoil and grass (104) overlay silty layer 102 to the north and south of the path (Plates 5–6). A single sherd of Roman Black Burnished Ware pottery was noted in the topsoil south of the path.

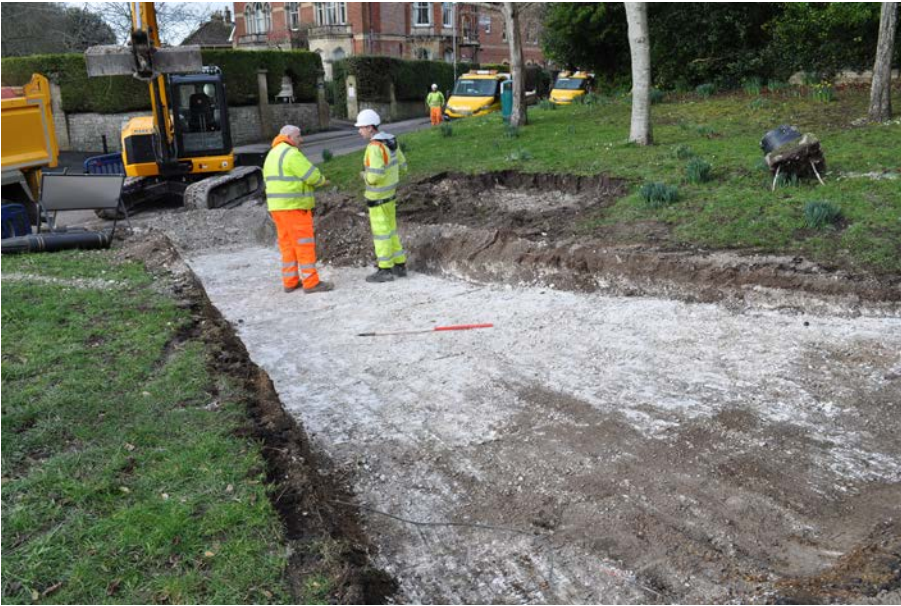
Plate 4: Surface of the natural chalk bedrock 103 in west part of trench. 1m scale.

Natural chalk bedrock (103) was encountered at a depth of 0.28 m below modern ground level (Plates 4-6). The upper surface was weathered but quickly gave way to solid unweathered chalk below.
