# 45A St Mary Street, Weymouth, Dorset

## Archaeological Observations and Recording during Gas Pipe Connection

Report No. 53534/3/1

July 2019

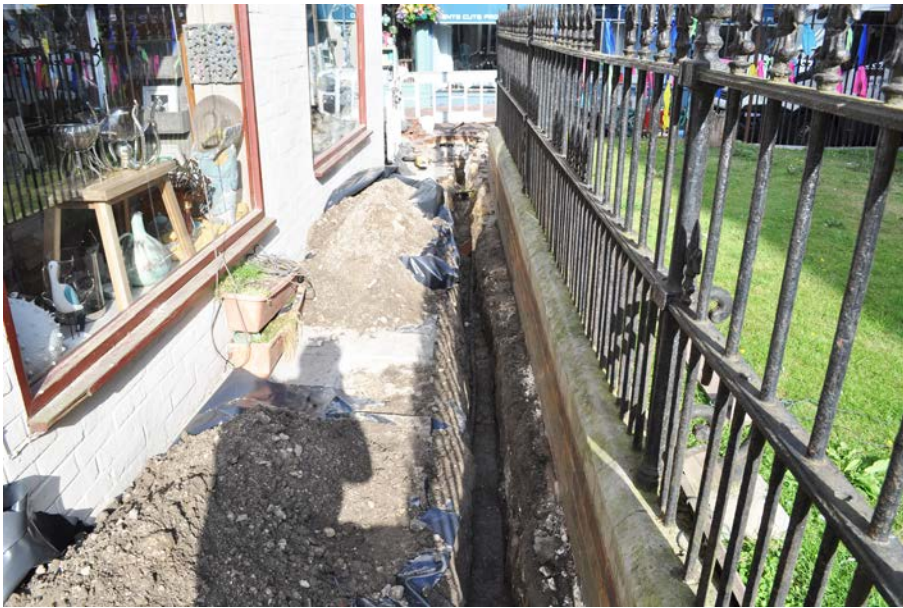
*Plate 1: General view of trench looking west towards St Mary Street.*

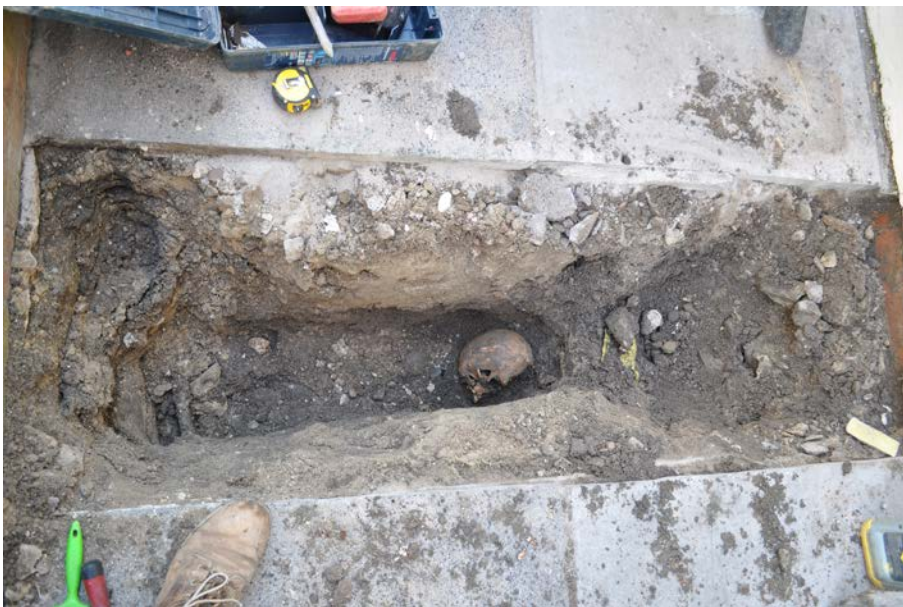
Below the paved surface of Church Passage was a deposit of greyish-brown silty sand (104), which had been cut by the trench for an electricity cable at a depth of about 0.4 m below present ground level and backfilled with the same material. This deposit continued below the base of the trench, so its full thickness and extent is not known. It contained significant quantities of disarticulated human bone, including a skull at the east end of the trench (Plate 2) and a concentration of skull fragments about halfway along the trench, lying directly on top of the electricity cable (Plate 3). Other human bone including fragments of leg bone, rib, shoulder blade, etc were found along almost the whole length of this trench. Quantities of animal bone, clay tobacco pipe, brick, bottle glass and eighteenth and nineteenth century pottery were also recovered.

*Plate 2: Human skull in east end of trench in Church Passage, looking east.*

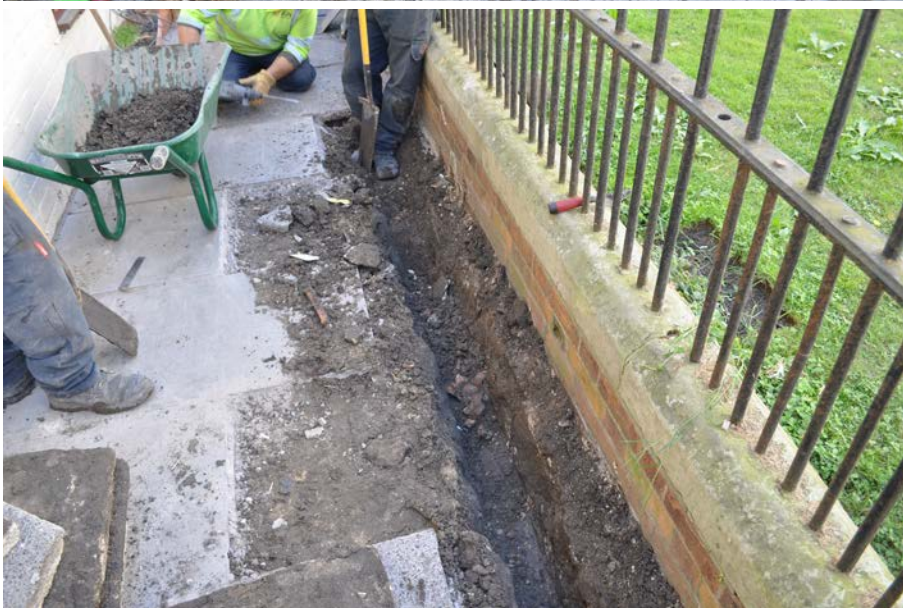
*Plate 3: Group of broken skull fragments overlying electricity cable in trench, looking west.*
