NEW VEHICLE GATES, BRATTON CAMP, BRATTON, WILTSHIRE

Archaeological Observations and Recording

Report No. 53249/3/1

March 2007

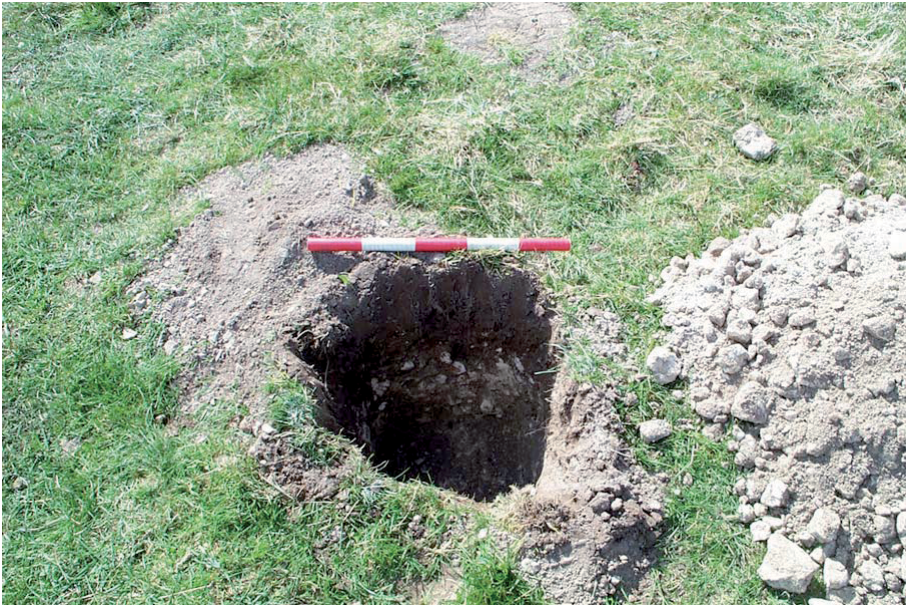
Plate 2: Posthole 1.

This was situated at the northern end of Gate 1 and measured 0.4 m by 0.4 m across and 0.5 m deep. Compact chalk bedrock was observed immediately below the 0.25 m thick yellowish-brown silty loam topsoil.

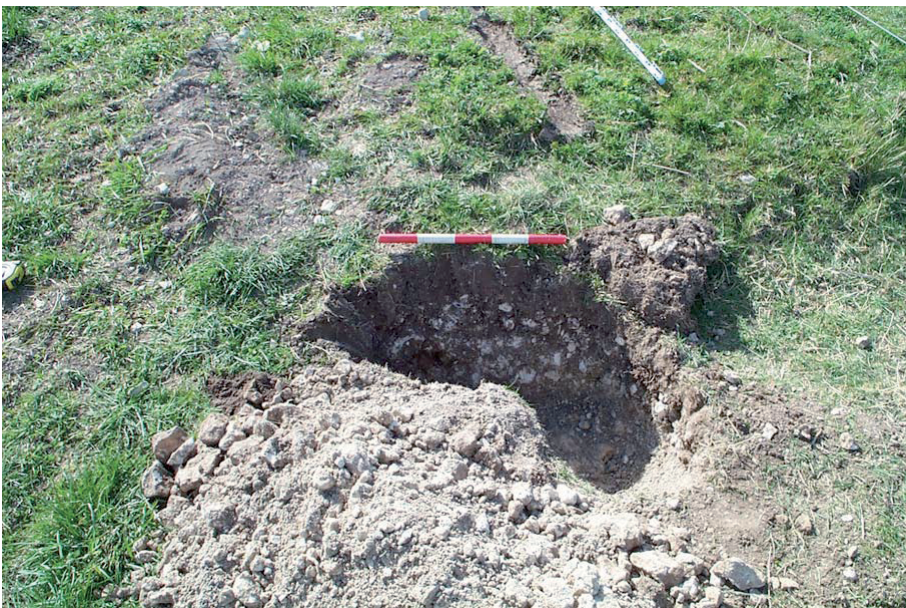
Plate 3: Posthole 2.

This was situated at the southern end of Gate 1 at the junction with Gate 2 and consisted of two postholes excavated together to create an L-shaped trench 0.9 m x 0.4 m across and 0.4 m deep. The sequence of deposits observed comprised compact chalk bedrock at a depth of 0.25 m, overlain by chalk rubble mixed with pale yellowish-brown silty loam, up to 0.15 m thick, probably the result of the consolidation of the entrance to the field. Overlying this was a yellowish-brown silty loam topsoil, up to 0.1 m thick.

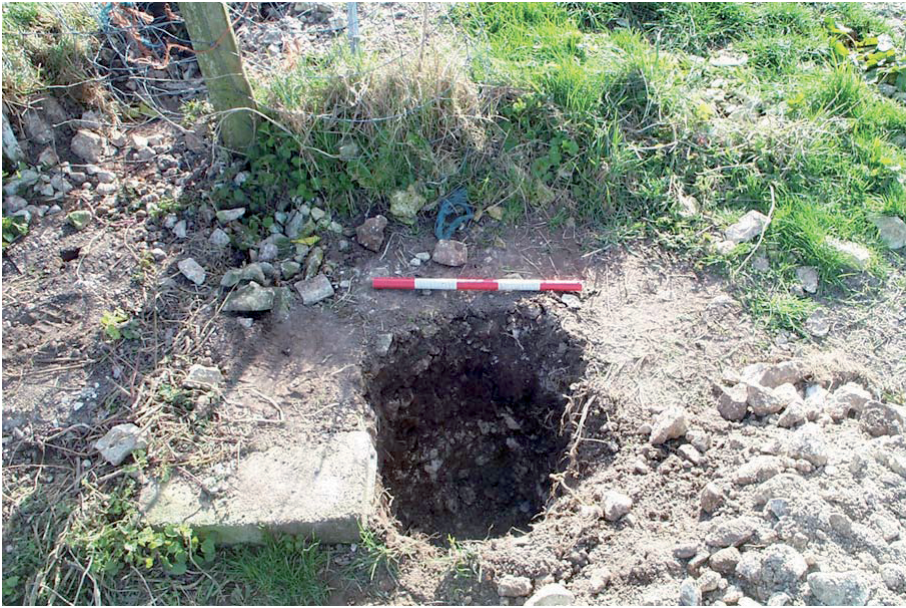
Plate 4: Posthole 3.

This was situated at the eastern end of Gate 2 and measured 0.4 m x 0.4 m across and 0.65 m deep. The sequence of deposits observed comprised compact chalk bedrock at a depth of 0.3 m, overlain by a mid brown silty loam, up to 0.3 m thick, containing frequent chalk rubble and roots. This deposit is probably the result of disturbance caused by the recent removal of an adjacent water trough.

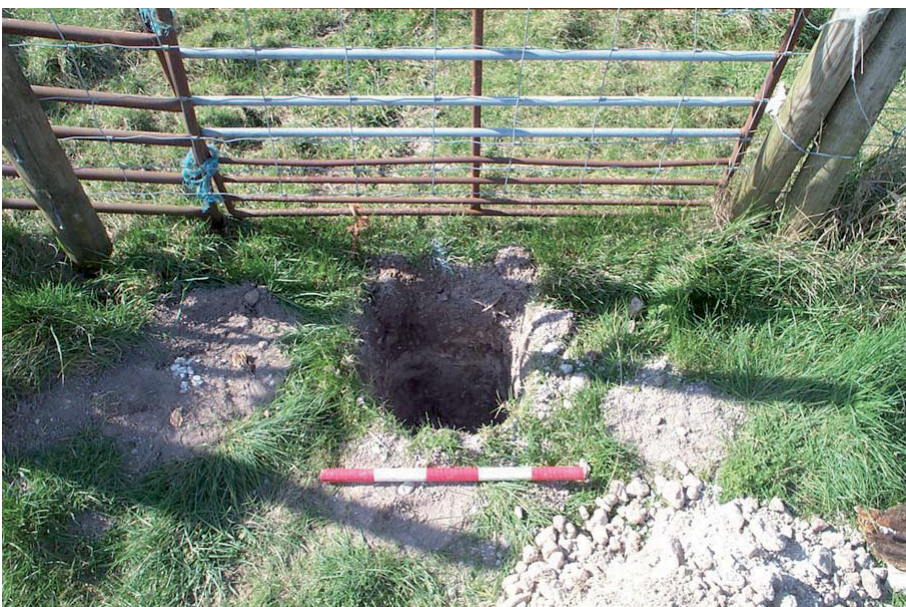
Plate 6: Posthole 4.

This was situated at the southern end of Gate 3 and measured 0.4m x 0.4m across and 0.45 m deep. The sequence of deposits comprised compact chalk bedrock at a depth of 0.25 m, overlain by a pale brown calcareous silty loam topsoil, up to 0.25 m thick.

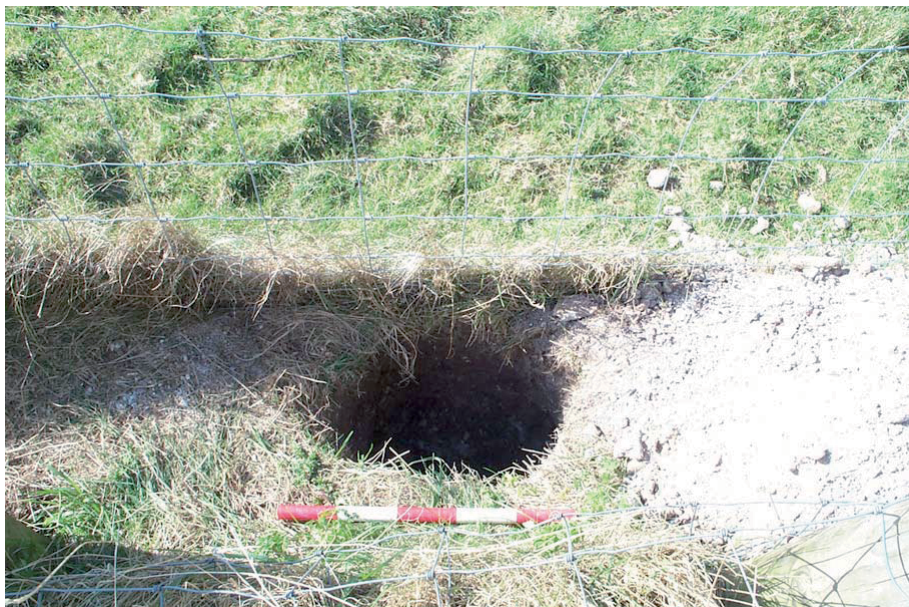
Plate 7: Posthole 5.

This was situated at the northern end of Gate 3 and measured 0.5 m x 0.4 m across and 0.75 m deep. The sequence of deposits comprised compact chalk bedrock containing bands of pale yellowish-brown silt at a depth of 0.35 m, overlain by a pale brown calcareous silty loam topsoil, up to 0.35 m thick. In the northern side of the posthole the remains of a wooden post with concrete base were observed.
