**PROPOSED EXTENSION, LYME REGIS MUSEUM,
LYME REGIS, DORSET
Archaeological Observations and Recording**

Report No. 53167/3/1

December 2006

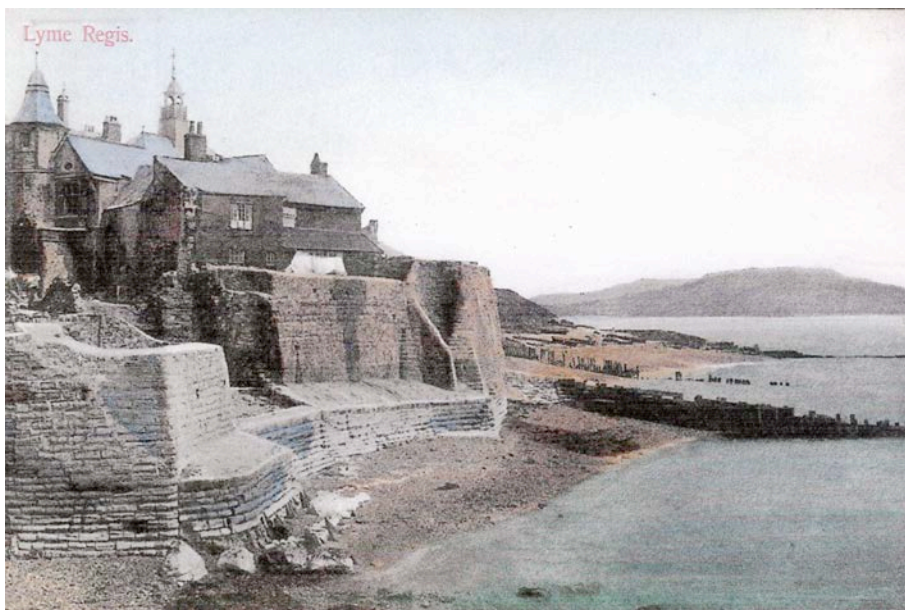
Plate 1: The Museum area just before the Museum was built with the new Town Hall (1887-9), the cottages and the empty site purchased for the museum in 1887.

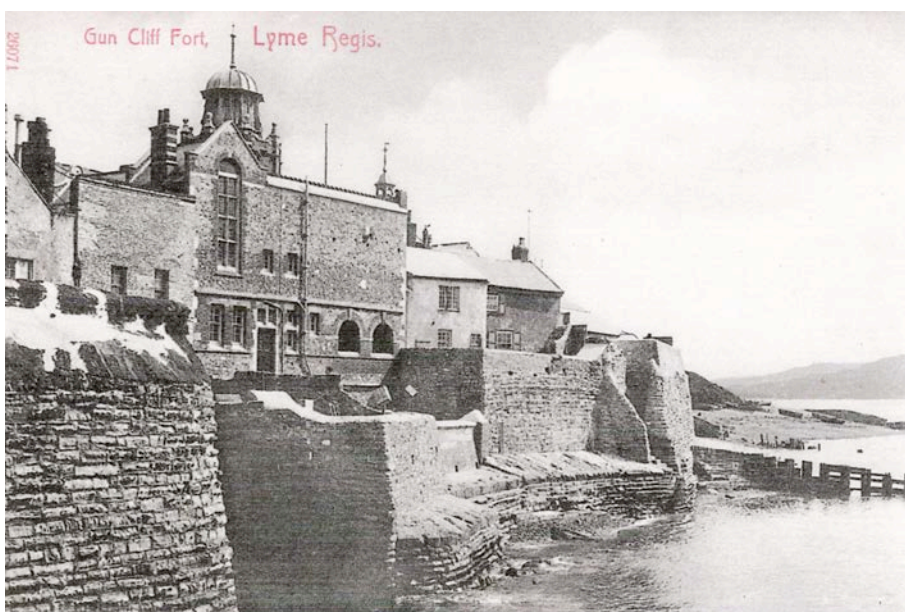
Plate 2: Just after the Museum was built (completed in 1901). The Museum butts up to cottages which seem to have been repaired and look rather smart.

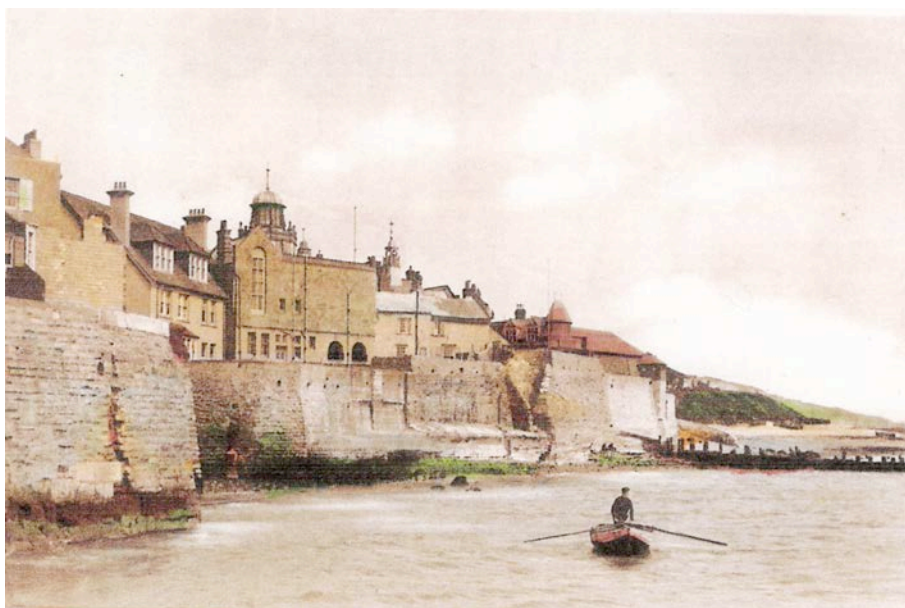
Plate 3: The area in the 1920s with the Museum tile-hung on the upper part and rendered on the lower. The cottages are to the right as is the Drill Hall on the Theatre site.

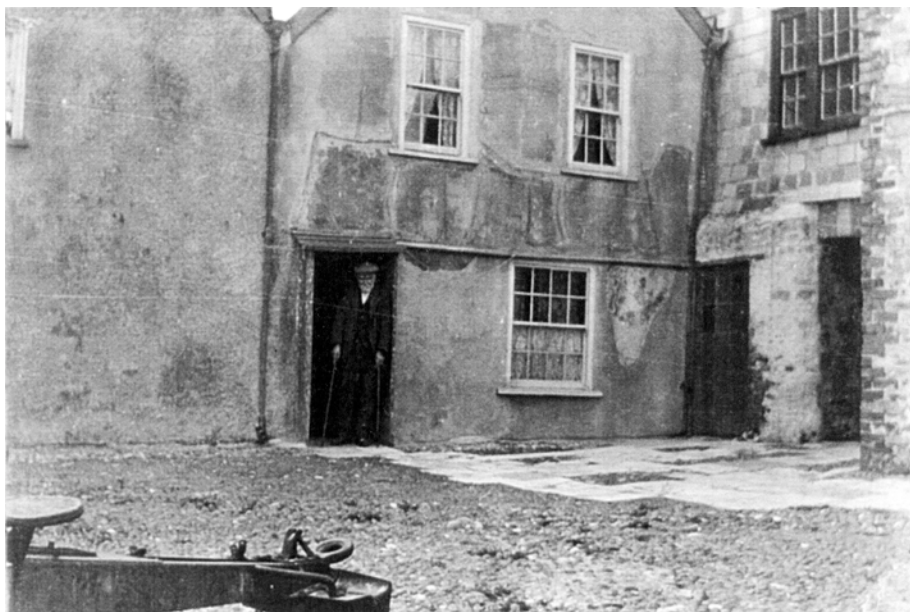
Plate 4: The cottages on the site in 1924 with the Guildhall on the right.

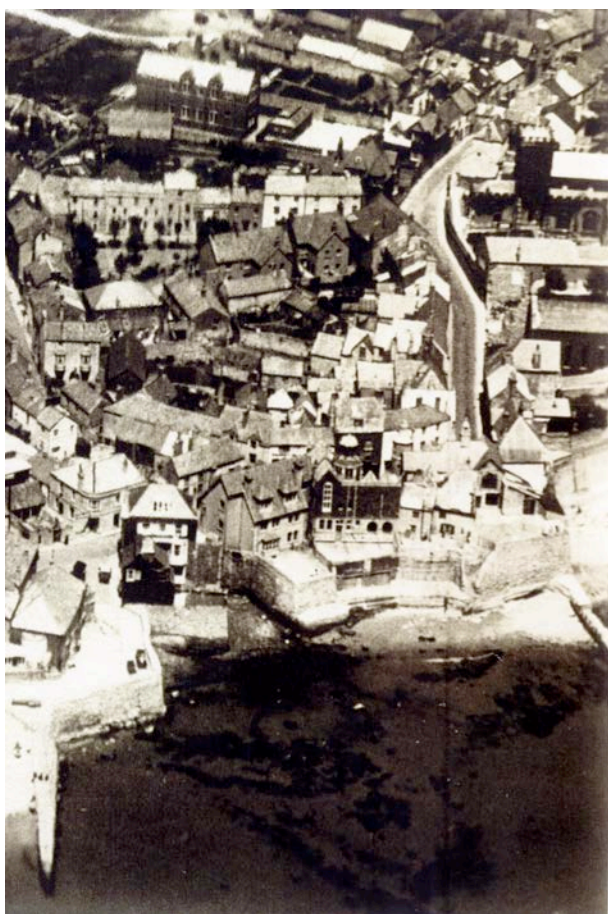
Plate 5: 1920s air photograph showing the museum with the cottages on the right.

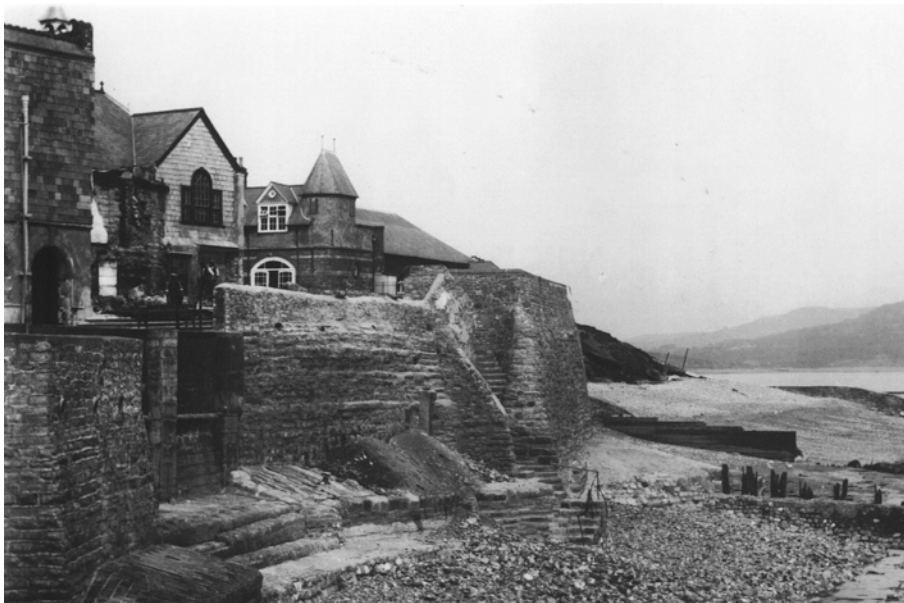
Plate 7: Postcard from 1930 showing cottages in process of being demolished.

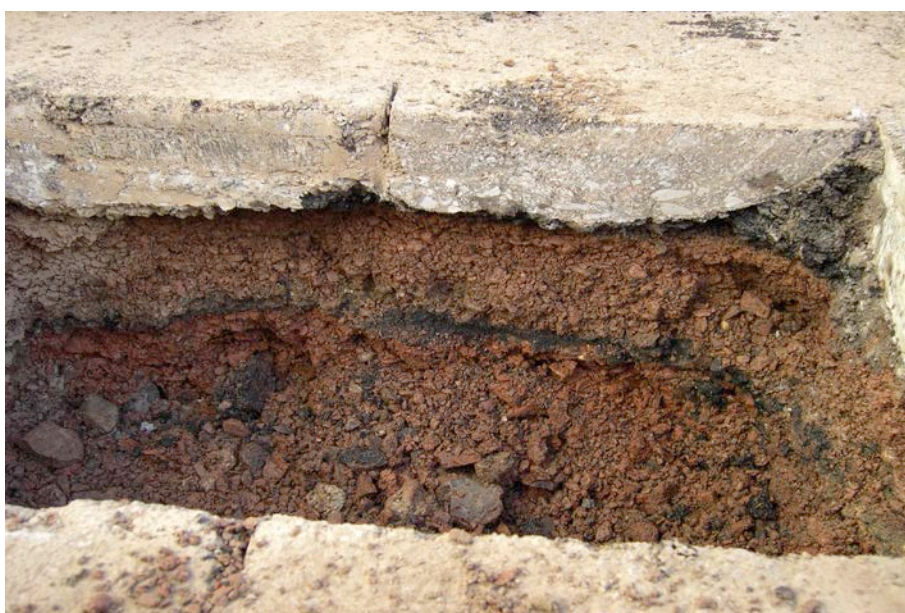
Plate 9: Test Pit 1 - section.

This trench was situated to the rear of the south-west corner of the museum and was 0.7m long by 0.5 m wide. It was excavated to a depth of 0.55 m where a layer of concrete was encountered. Overlying this was a deposit of imported reddish hardcore over which the tarmac had been laid.

No features or deposits of archaeological interest were found.

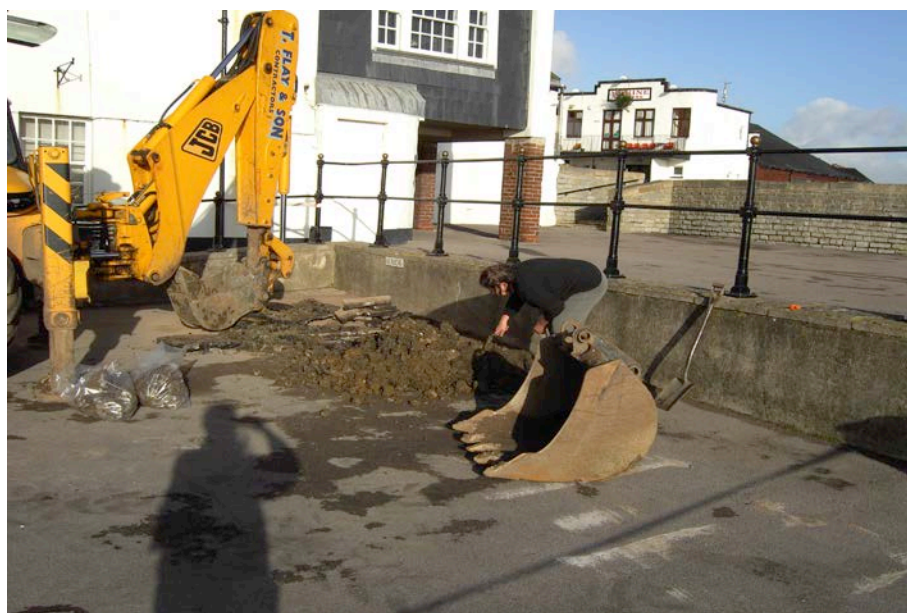
Plate 13: Test pit 4 – location shot.

This trench was situated along the eastern edge of the development area on the line of the front wall of the cottages which had survived on the site until 1930. The trench was excavated to a depth of 0.9 m through a deposit of wet, unconsolidated yellowish grey mixed gravel containing angular and rounded chert and flint up to 0.25 m. This deposit was very similar to that found in Test Pit 2 and at a depth of approximately 0.7 m became more orange.

A winkle shell was the only object found in this deposit.
