**NEW WALL, VICTORY COURT, NORTH SQUARE,
DORCHESTER, DORSET
Archaeological Watching Brief**

Report No. 53149.1

March 2004

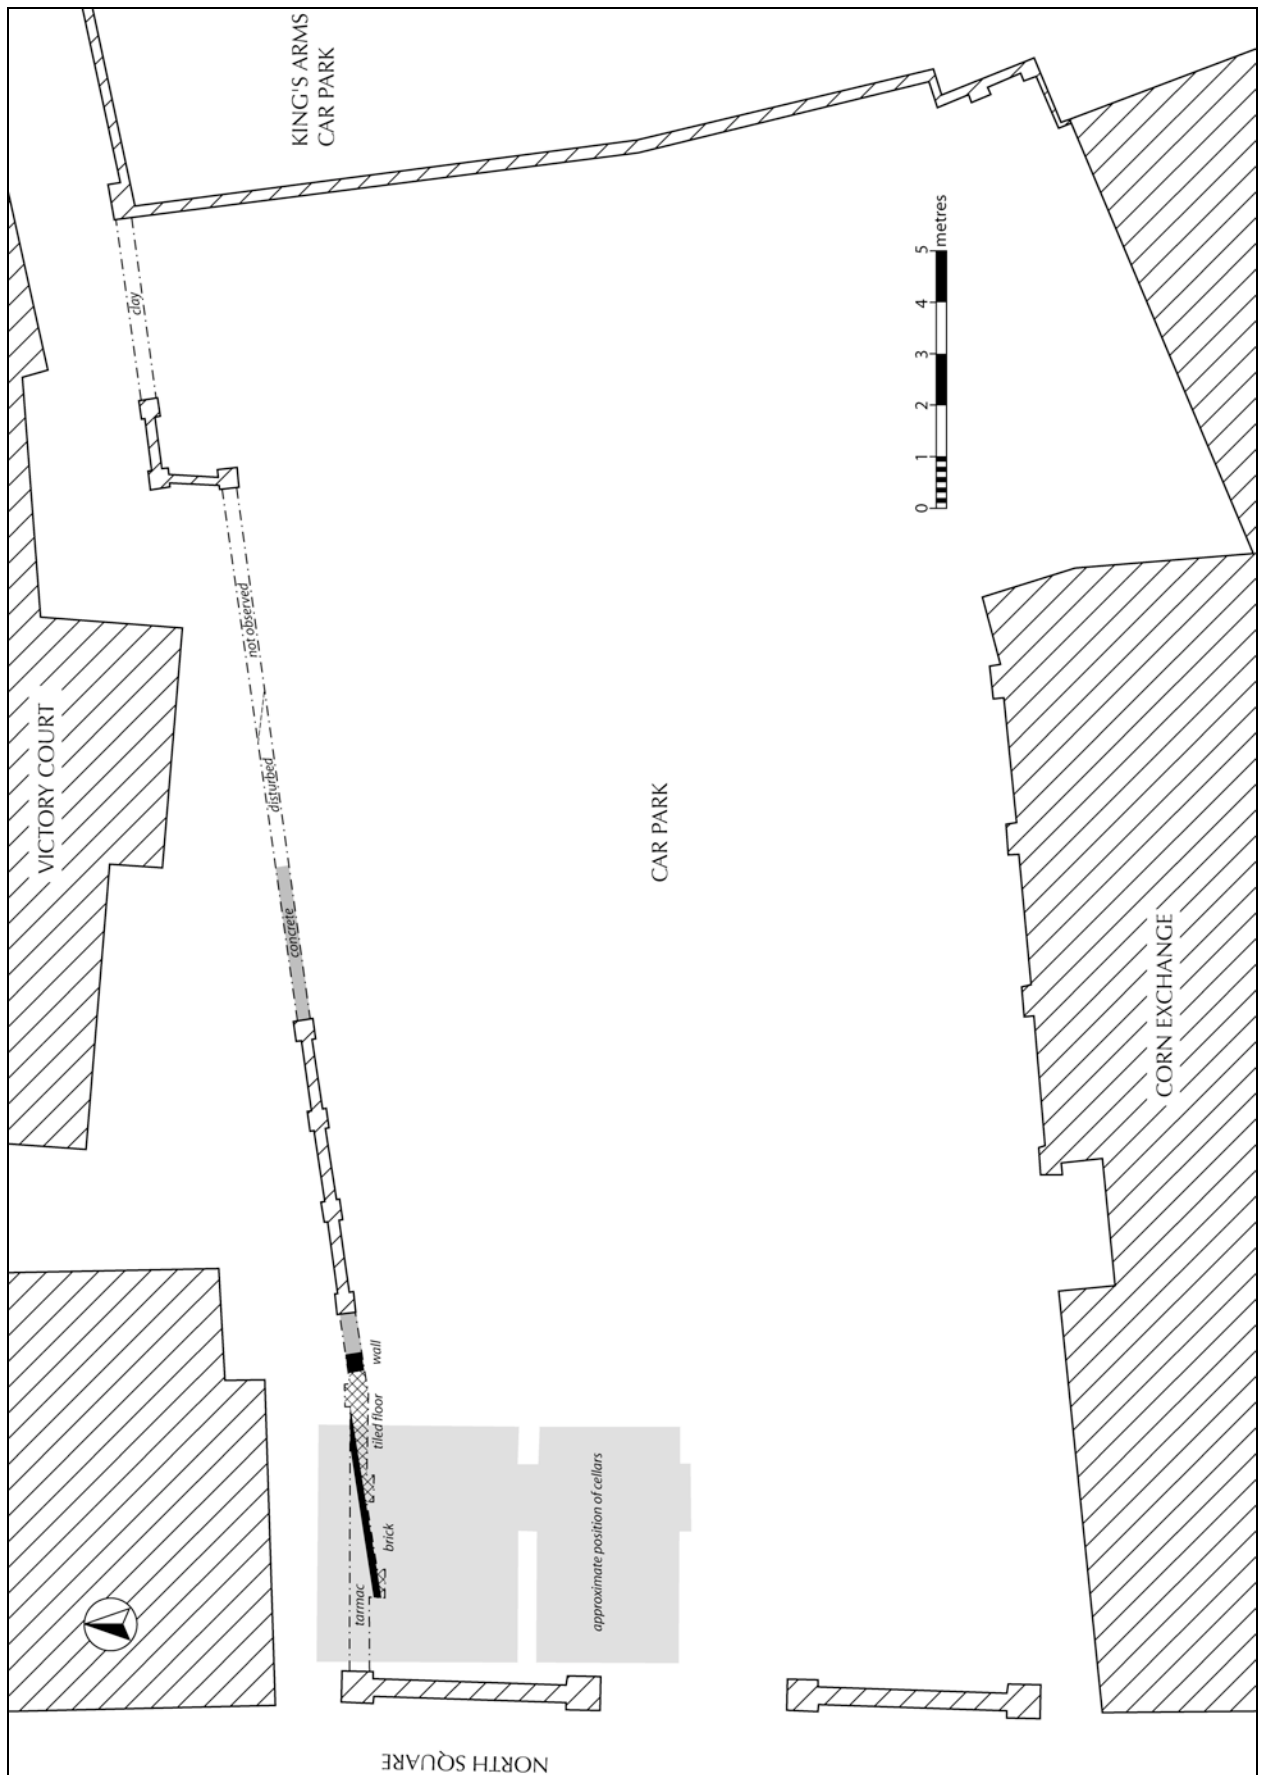
Figure 3: Plan of observations

The footings trenches comprised three separate lengths: the western end between the North Square frontage and the existing wall; the central part between the two short lengths of existing wall; and the eastern part up to the eastern end of the site (Figure 3). The eastern and western parts were observed after excavation but the central part had been partially filled with concrete before observations could take place. The western part of the footings trench revealed traces of the former Market House and of earlier cellars beneath. The central section had been largely disturbed by services. The eastern part revealed a probable levelling layer of clay.

A small part of what is probably the floor of the Market House was exposed in the western end of the trench. This comprised a line of bricks running east–west bordering a tiled floor of quarry tiles to the south (Figure 3; Plate 3). The eastern limit of this tiled floor was against a north-south wall, 0.35 m wide constructed of mortared pale sandy bricks or sandstone blocks. This wall was about

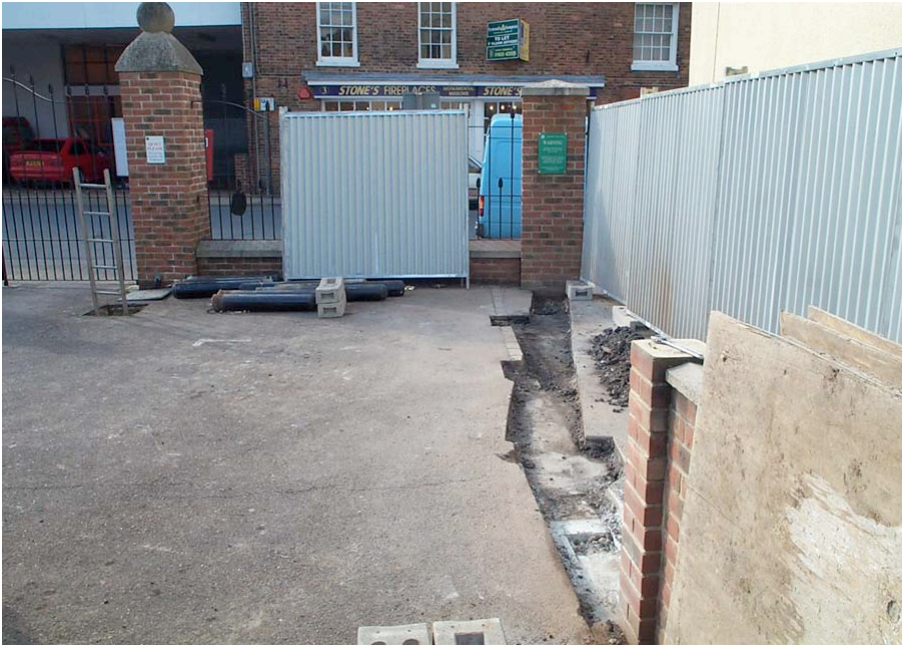
The northern part of the trench at the west end had a tarmac surface immediately below the present car park surface (Plate 1). This may be later in date than the Market House. It seals the access hatch to the cellars described above.

Plate 1: Western part of wall footings trench, looking west towards the road.

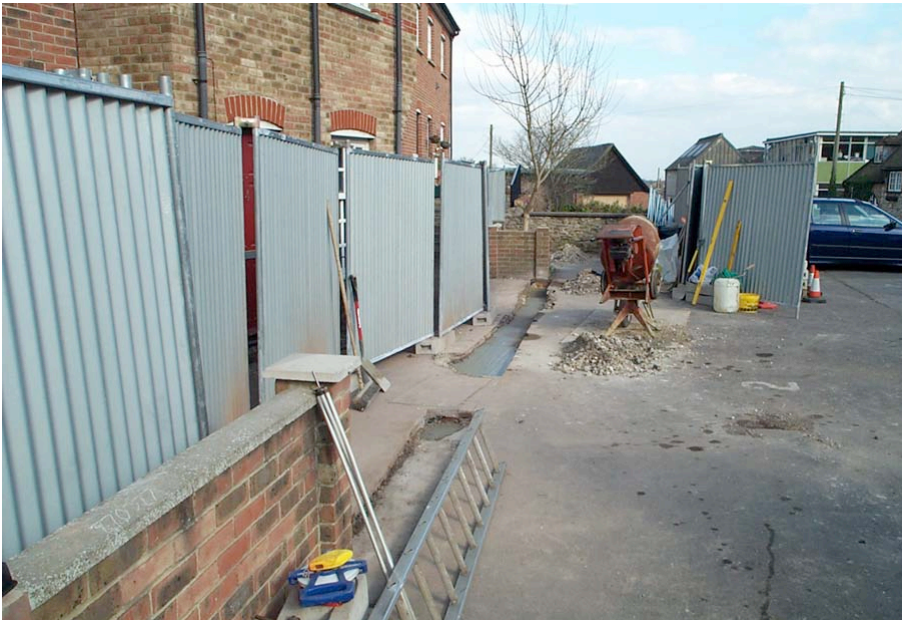
The central part of the trench on either side of the existing wall was disturbed by modern concrete footings (for the existing wall) and by services. At the eastern end of the trench, a layer of mixed dark brown clay infill was found below the present tarmac surface at a depth of about 0.2 m below present ground level. No dating evidence was recovered from this layer.

Plate 2: East end of the footings trench, looking east.

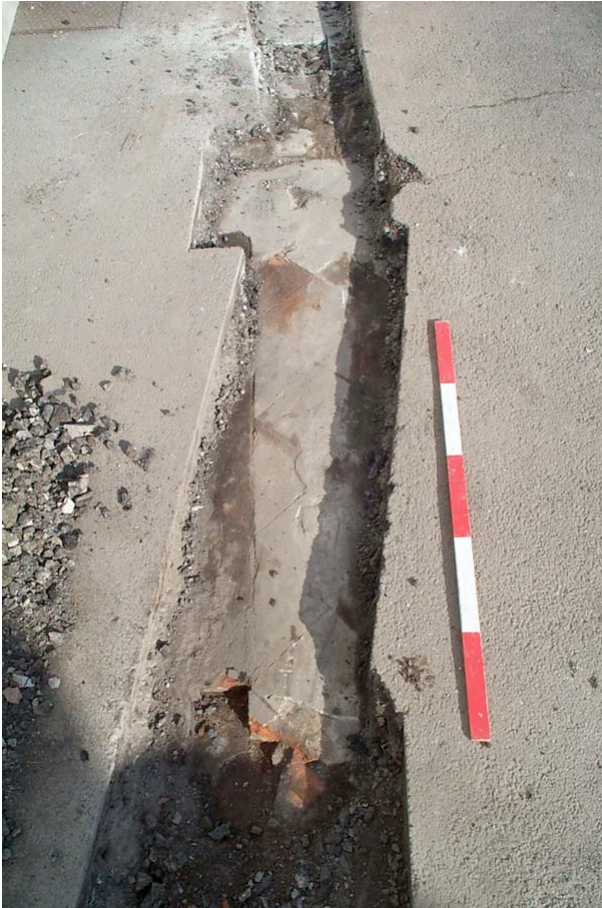
6.4 m to the east of the street frontage. This wall was probably part of an internal partition within the Market House.

Plate 3: Detail of the tiled floor of the Market House with internal wall remains at the top of the photo.

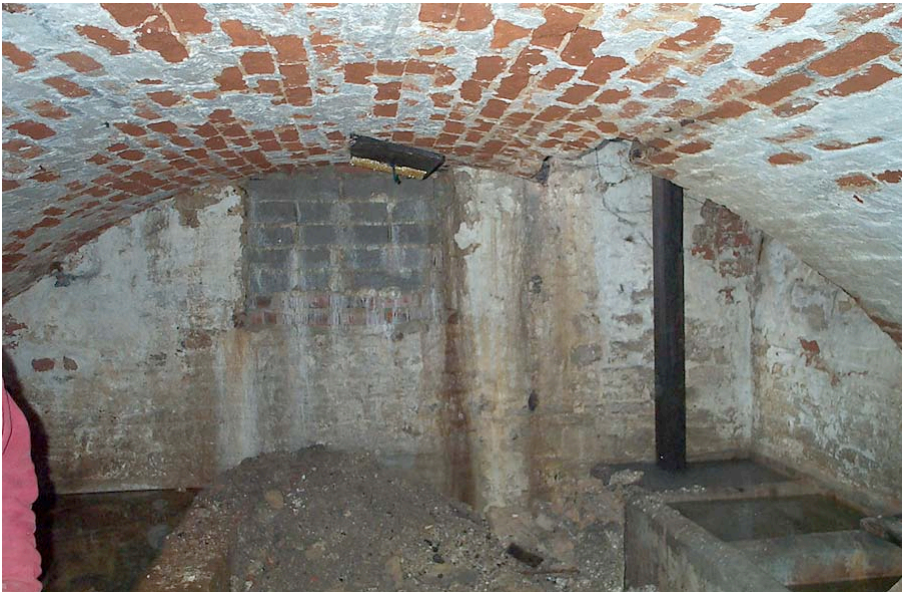
The northern cellar measured approximately 4.0 m by 4.6 m across and 2.15 m high with the barrel vault running from east to west. The cellar was mainly constructed of brick, but with some stone in the upper courses, particularly at the west end. The walls and vaulting were covered in limewash. There was a rectangular cut-out 1.17 m by 1.25 m across in the vaulting in the northwest corner of the cellar, presumably the remains of an access hatch from ground level. This appears to have been an original feature of the cellar. The hatch itself has gone and the upper part has been reinforced in concrete and with a wooden pillar to support the pathway to Victory Court above. In the west wall, there is a rectangular opening 0.95 m by 0.9 m across, which has been blocked with concrete blockwork (Plate 4). There is a large tank or vat in the southwest part of the cellar, constructed of brick with a cement lining (Plate 5). It measured 1.15 m by 2.15 m across internally and 0.65 m deep. A row of seven similarly constructed vats 0.54 m by 0.77 m across and 0.65 m deep runs across the northern side of the cellar (Plates 6 and 7).

Plate 4: West end of northern cellar.

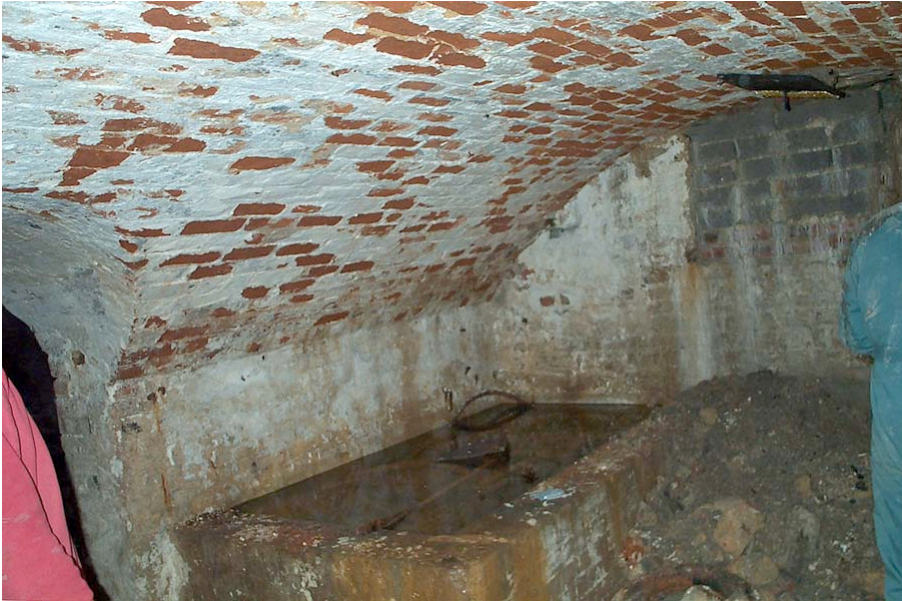
Plate 5: Tank or vat in southwest part of northern cellar.

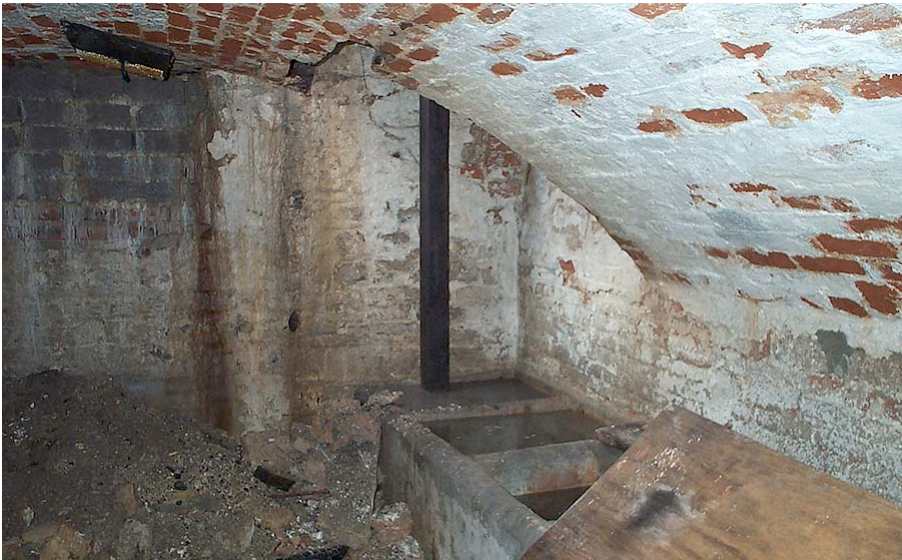
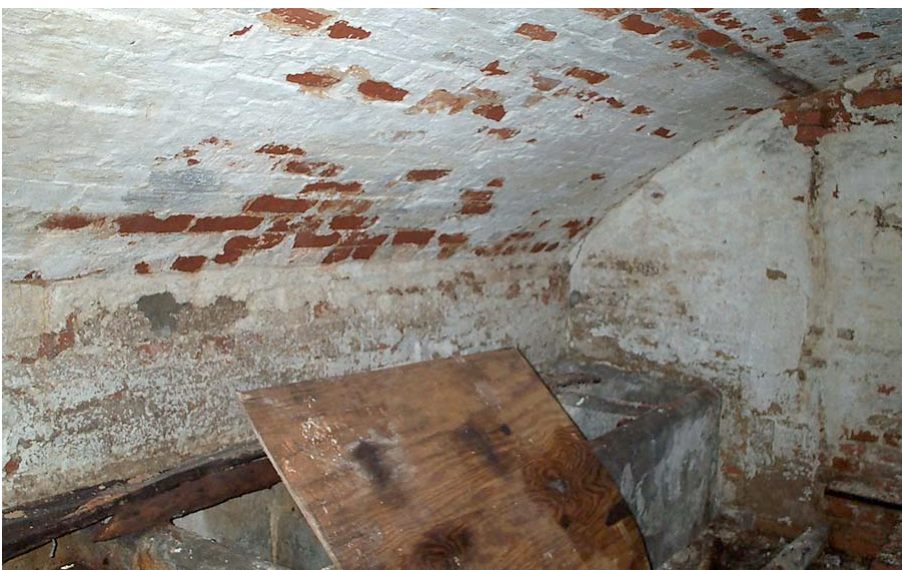
The cellars are likely to pre-date the Market House and are probably related to the large house on the site depicted on the 1810 map. It is possible that they were part of a butchers and the vats were used for curing bacon (Jo Draper pers. comm.).

Plate 6: Vats along northern side of northern cellar, looking west.

Plate 7: Vats along northern side of northern cellar, looking east.

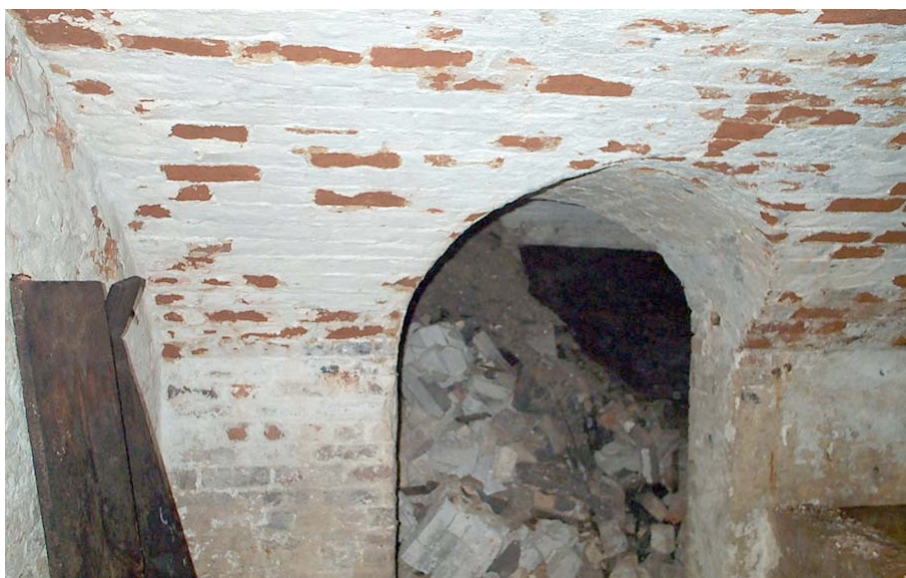
The excavation of the new wall footings just behind the street frontage, broke through into the cellars below. A rapid sketch survey of the two accessible cellars was undertaken. These cellars were aligned along the street frontage and comprised a large brick built barrel vault with a smaller vaulted cellar to the south, joined by a doorway in the southeast part (Figure 4). A further blocked doorway to the south presumably led into the next vault to the south.

Plate 8: Doorway between cellars, looking south.

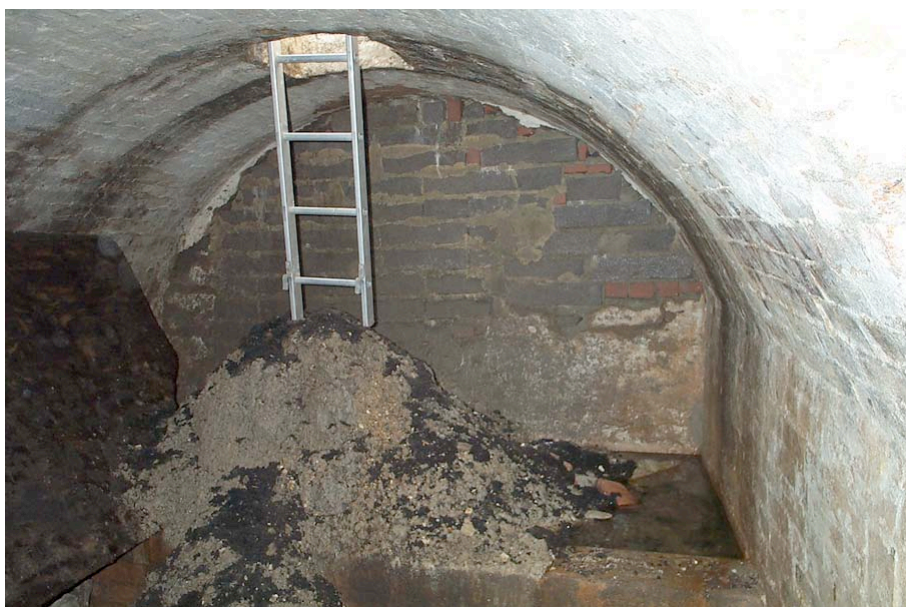
The southern cellar measures about 4.6 m by 2.8 m across and is similar in construction to the northern cellar. Much of the western wall has been rebuilt in modern brick and concrete blockwork (Plate 9). There is a large vat or tank 1.2 m by 2.8 m along the west wall (Plate 9).

Plate 9: Southern cellar, looking west.
