EXTENSION TO CITIZEN'S ADVICE BUREAU, 1 ACLAND ROAD, DORCHESTER, DORSET Archaeological Observations and Recording

Report No. 53154.1

May 2004

Archaeological Observations and Recording, April 2004

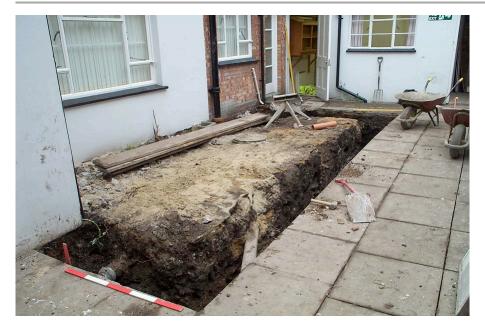
A drainpipe trench (4) ran across the northern part of the trench in a NNW–SSE direction (Plates 1, 3, 5) and another pipe trench crossed the northeast end of the trench in a N–S alignment (Plates 1–2). The remains of another pipe trench (13) were found on the eastern side of the southern end of the trench (Figure 3).

Plate 1: General view of the footings trench viewed from northwest.

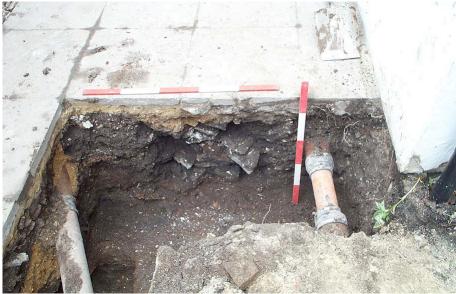
In the northern end of the trench, the remains of a stone-lined pit (26) were revealed in the northern baulk (Figure 3; Plate 2). Most of this feature had been removed during the digging of the footings trench. It appeared to be roughly square and oriented approximately NE–SW. It probably measured about 0.9 m across and was 0.7 m deep. It had vertical sides and a flat bottom with a 0.1 m thick limestone and brick lining constructed in rough courses. It was filled with very loose soft dark brown silty soil (25). No finds were recovered from this feature.

Plate 2: North end of trench showing stone-lined pit 26 and Pit 23 below.

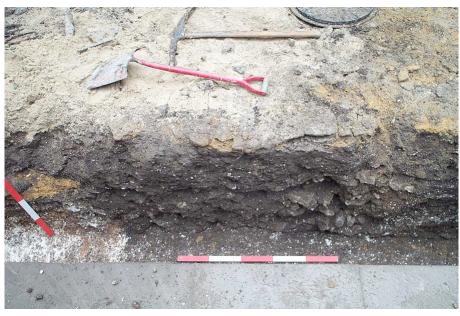
The southern end of layer 5 was cut by a pit (9) with steeply sloping sides over 0.6 m deep. The northern side of this feature had a curving edge cut into the natural chalk but the southern side had been destroyed by later activity (Figures 2–3; Plate 3). This pit was filled with dark brown clay

loam with moderate small stone rubble, occasional small stone rubble and chalk flecks (8). It contained a small quantity of animal bone and some sherds of earlier medieval cookpots.

Plate 3: Pit 9 viewed from west.

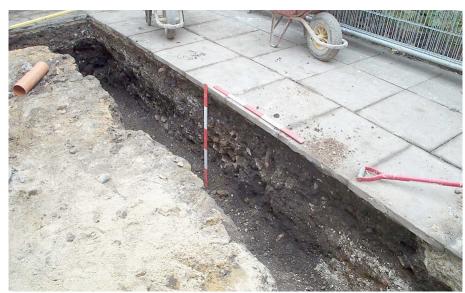
Most of the southern part of the trench was taken up by one large feature (Pit 38). This was probably originally rectangular in plan shape with vertical sides and measured over 2.5 m by 1.8 m across and over 0.6 m deep. This pit appears to have had a stone lining (10), most clearly seen on its northern side where the footings trench had cut through it revealing it to be 0.5 m thick and composed of a mixture of flint nodules and limestone rubble set in rough courses (Plate 3). Part of the trench edge on the west side had collapsed revealing a large quantity of flint nodules behind. This is probably part of the stone lining on the west side of the pit, running about 0.2 m to the west of the trench. The evidence from the western and southern baulk of the trench indicates a single fill of loose very dark brown clay loam (34) with frequent stone rubble, brick fragments and a number of thin lenses of chalk. This layer contained quantities of animal bone and oyster shell, together with a very small quantity of 17th century pottery. In the southeast corner of the pit was a layer of reddish-grey clay with chalk flecks (35) beneath layer 34 (Figure 3). The eastern baulk has a more complex series of fills, generally dipping down to the north (Figure 3). The stratigraphically earliest layer is a dark brown clay loam layer (18). This is overlain by a layer of dark brown clay loam (17) with frequent chalk flecks and some oyster shell. The lower part of context 17 was overlain by a layer of dark reddish-brown clay loam (16) that butted against the stone lining (10). Layers 16 and 17 were sealed by a layer of chalk rubble (15) with occasional flint nodules. The upper part of the pit was filled with a greyish brown clay loam (14) with chalk flecks and some brick fragments. This pit has been tentatively dated to the 17th century based on the very small quantity of pottery recovered from this feature.

Plate 4: Pit 38 viewed from northeast.

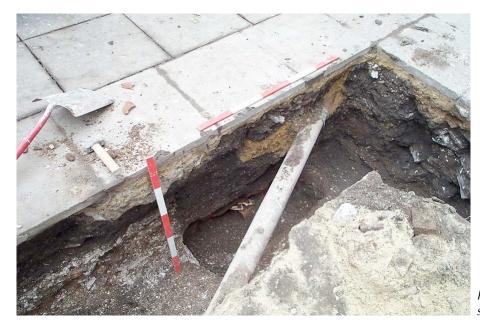
In the northwest part of the trench, the eastern end of a probably rectangular pit (29) was exposed. This pit was 1.1 m wide and 1.15 m deep with vertical sides and a flat bottom (Figures 2–3; Plate 5). The bottom of the pit was filled with two neatly stacked layers of unused ceramic drain pipes sealed beneath a covering of carefully placed ceramic pantiles in a red sand matrix (30). The remainder of the pit was filled with dark brown loam with frequent brick fragments, chalk flecks and clinker (31).

Plate 5: Pit 29, viewed from southeast.
