49 FITZMAURICE ROAD, CHRISTCHURCH, DORSET Archaeological Observations and Recording

Report No. 53159.1

December 2004

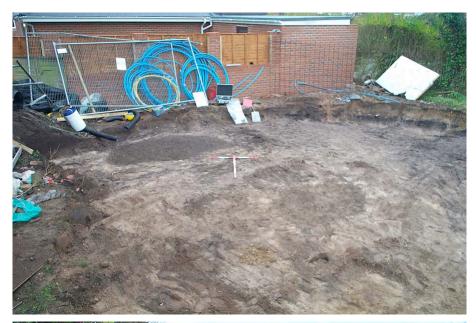
Plate 1: General view of stripped area looking northeast.

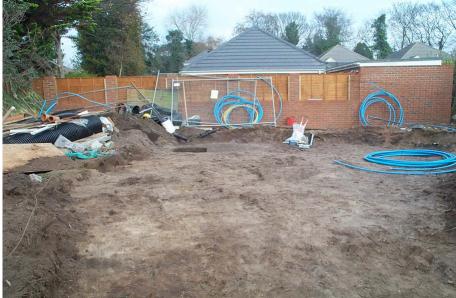
Plate 2: View of stripped area after excavation, looking north.

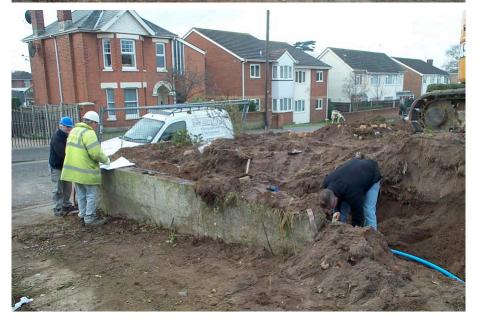
Along the frontage of the site, up to about a metre of relatively recent filling and levelling layers of sandy soil were exposed during the laying of a water pipe (Plate 3). This probably represents the landscaping of the site associated with the construction of the original house on the site.

Plate 3: View of deposits at the street frontage during the insertion of a water pipe, looking southwest.
