**CHARMOUTH HOUSE, THE STREET,
CHARMOUTH, DORSET
Archaeological Watching Brief**

Report No. 53164.1

July 2004

Archaeological Watching Brief, July 2004

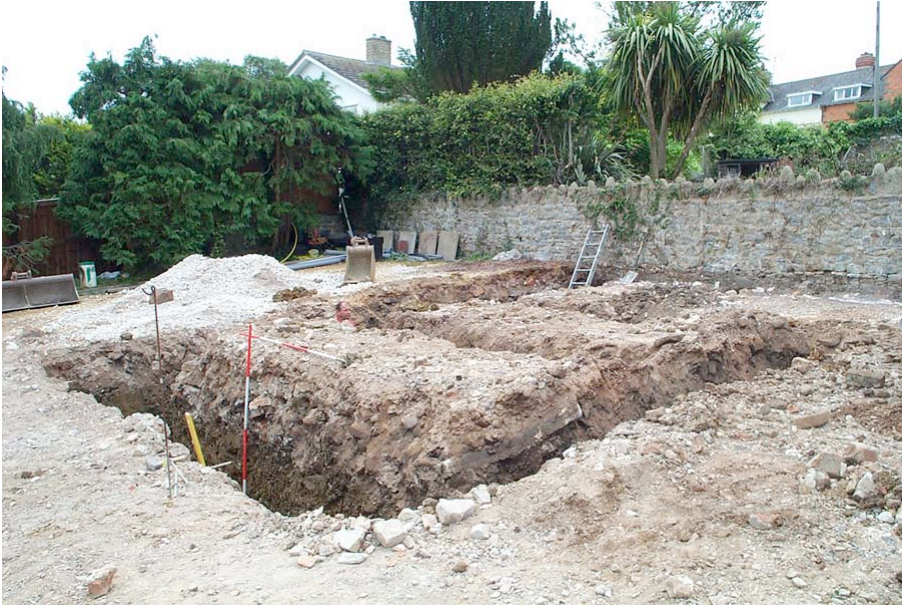
No archaeological features were observed and no finds were recovered.

Plate 1: General view of footings trenches from northeast.

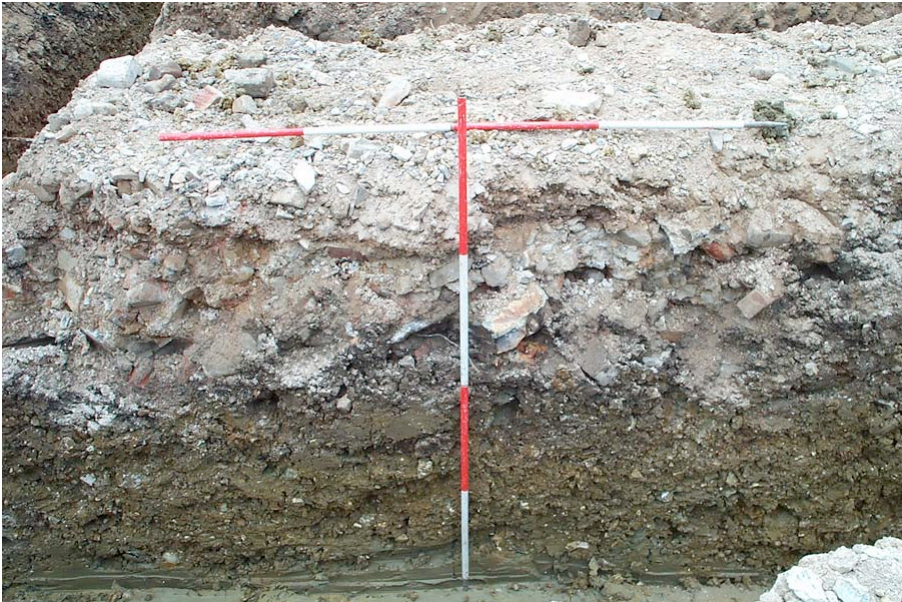
The basic stratigraphic sequence was the same across the whole of the site. Natural grey clay (104) was encountered at a depth of 1.7 m, with a 0.75 m thick layer of natural reddish-grey clay with frequent flint gravels (103) overlying it.

The natural deposits were sealed by a 0.35 m thick layer of dark greyish-brown silty clay loam (102), which is probably a buried topsoil layer. It was sealed by a 0.4 m thick layer of demolition debris comprising bricks, stone rubble, concrete, etc., (101). This is probably the hardcore base for the former hotel car park. The present surface overlying it was a 0.2 m thick layer of stone scalplings, gravel and sand (100).

Plate 2: Detail of the east-facing section of the east footings trench, showing deposits encountered.
