45-46 BROAD STREET, LYME REGIS, DORSET
Archaeological Observations and Recording

Report No. 53165.1

45–46 Broad Street, Lyme Regis, Dorset

Archaeological Observations, October 2004

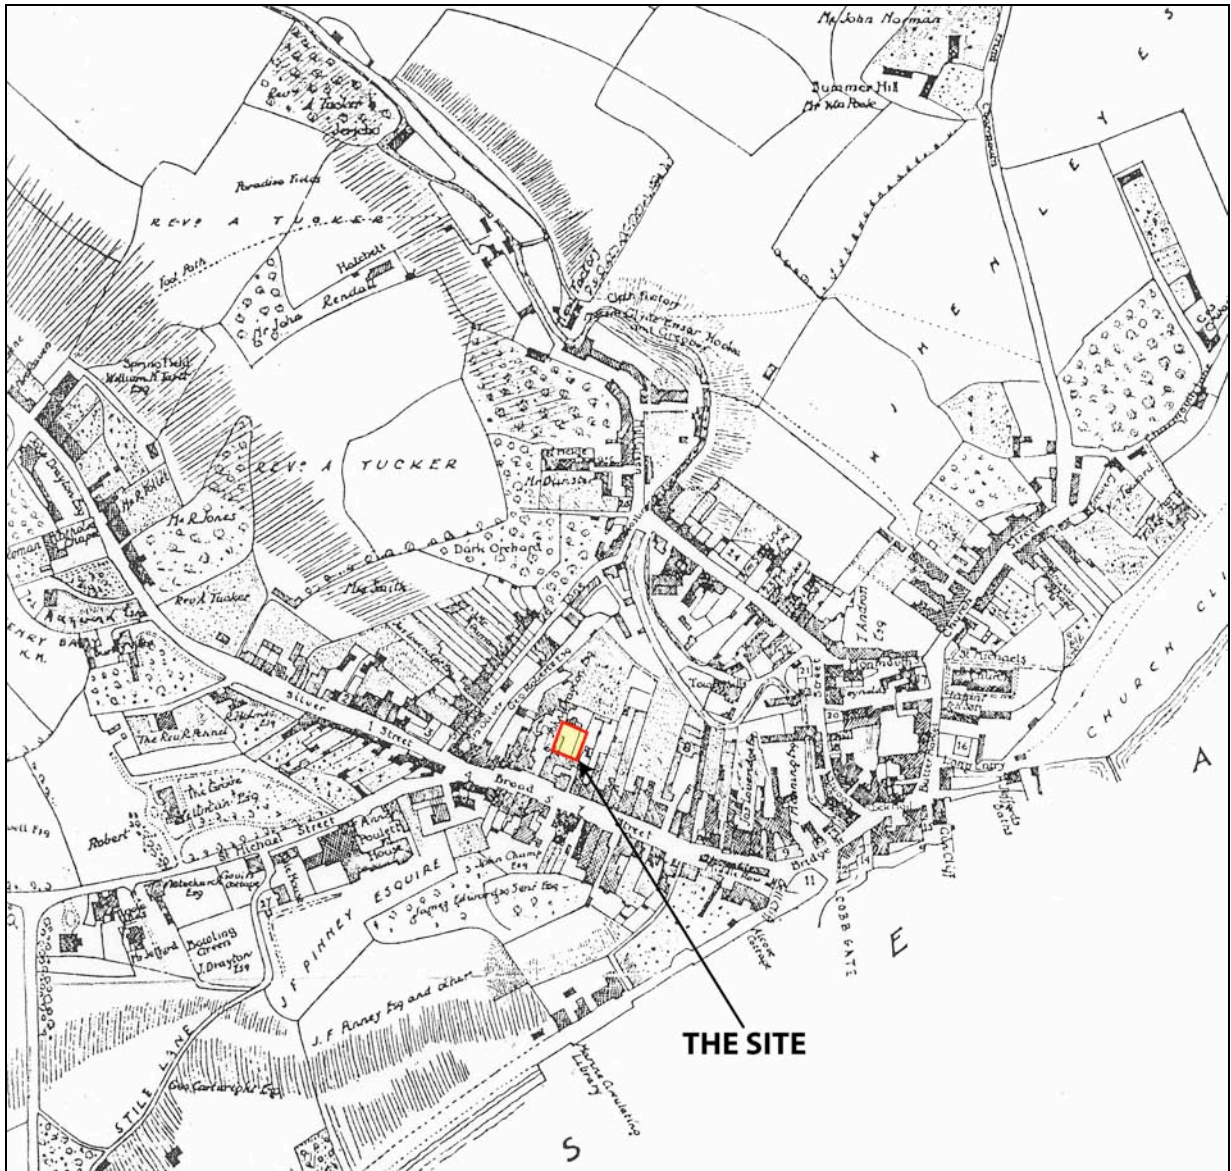
45–46 Broad Street are on the site of the Great House, a late 16th or early 17th century house of great size whose three-storey porch was a prominent feature in the street until it was demolished in 1913. The current buildings on the street side may incorporate some remains of the Great House, whose gardens ran down to the river at the back. Because the ground slopes steeply behind and with poor access to the rear, the outbuildings would have been more useful set immediately behind the house, rather than further to the rear of the property. The 1841 plan of the town (Figure 2) shows extensive outbuildings just behind the house.

Figure 2: Extract from the 1841 plan of Lyme Regis, showing approximate area of site.

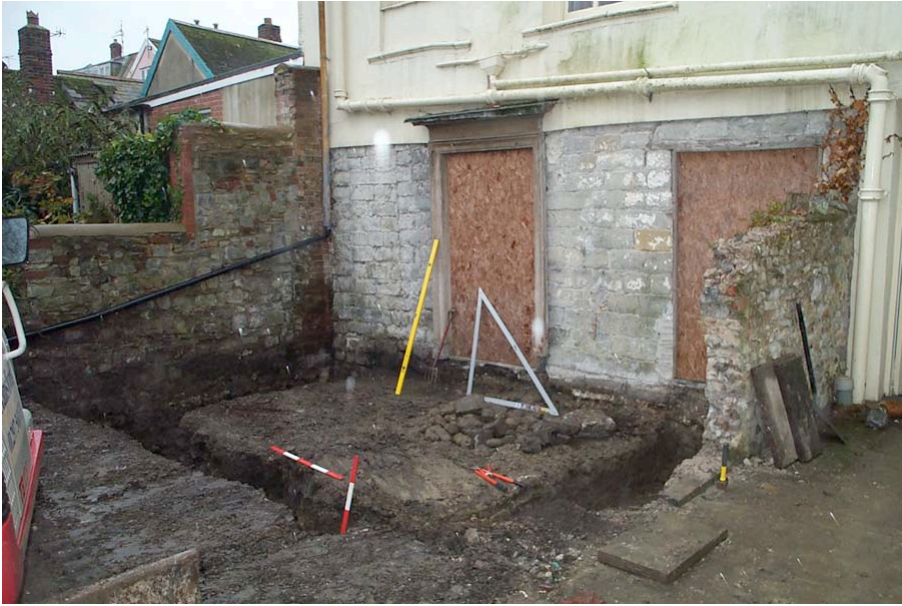
There are two doorways in the area of the new extension, in addition to the present back door, to the west. To the east of the doorways was a blocked window (Plate 1).

Plate 1: General view of site looking southeast.

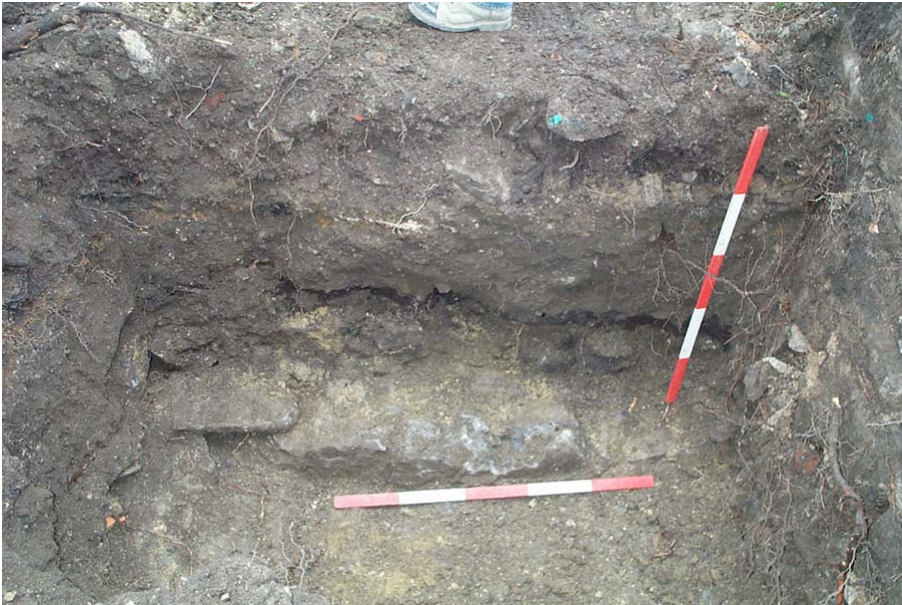
The remains of a substantial stone wall (110) were exposed in the eastern part of the trench. It was constructed of squared stone rubble (about 350 by 250 by 200 mm across), bonded with lime mortar and brown clay. It was 0.8 m wide and survived two courses (0.5 m) high. There was no trace of a construction trench and was founded directly on top of the natural clay 104 (Figure 4, Plate 2). This wall ran along the northern edge of the footings trench with a return to the south about 3.5 m in from the eastern boundary of the site (Figure 3, Plate 3). It continued eastwards beneath the present boundary wall. The projected line of the return to the south meets the present rear wall of the existing building in the eastern doorway (Figure 3). There is no scar for this wall visible on the elevation, suggesting it is earlier than the present buildings on the site.

Plate 2: Wall 110 at the east end of the footings trench, looking north. Note drain in western side of photo.

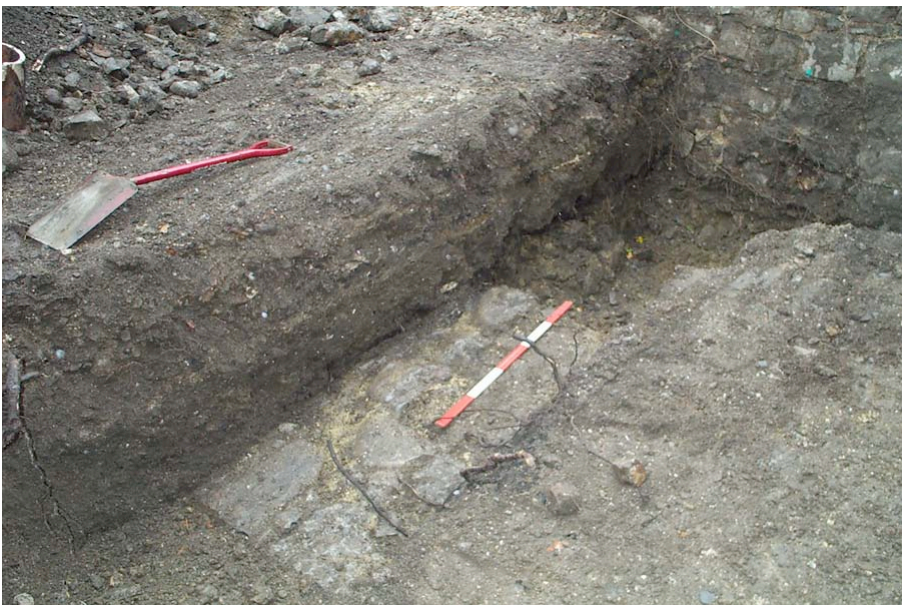
Plate 3: West end of Wall 110, looking northeast.

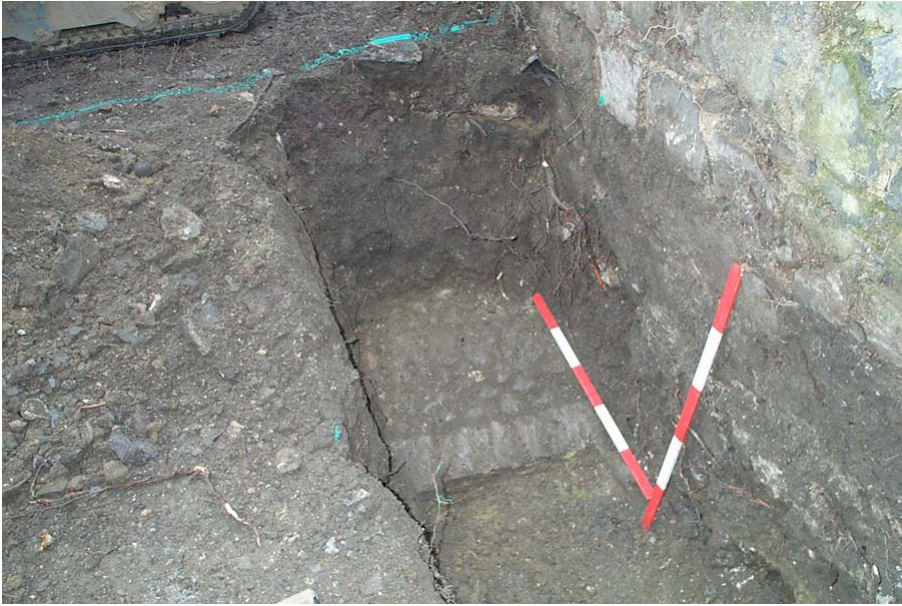
Within the northeast corner of the footings trench, the remains of a cobbled floor (109) were exposed (Figure 3). This comprised tightly packed ovoid pebbles set end on in a stiff strong brown clay, immediately overlying the natural (103). This cobbled surface butted against wall 110 to the north. To the south it was bounded by a stone drain running east–west about 0.6 m south of wall 110. This drain comprised rectangular pieces of Lias laid in a 'V' shape (Plate 4). Another similar drain running north–south exited through wall 110 to the north. The relationship between these two drains was not exposed.

Plate 4: Cobble floor 109 in east end of trench, looking north. The southern side of the drain forming the southern limit of the cobbles has been removed.

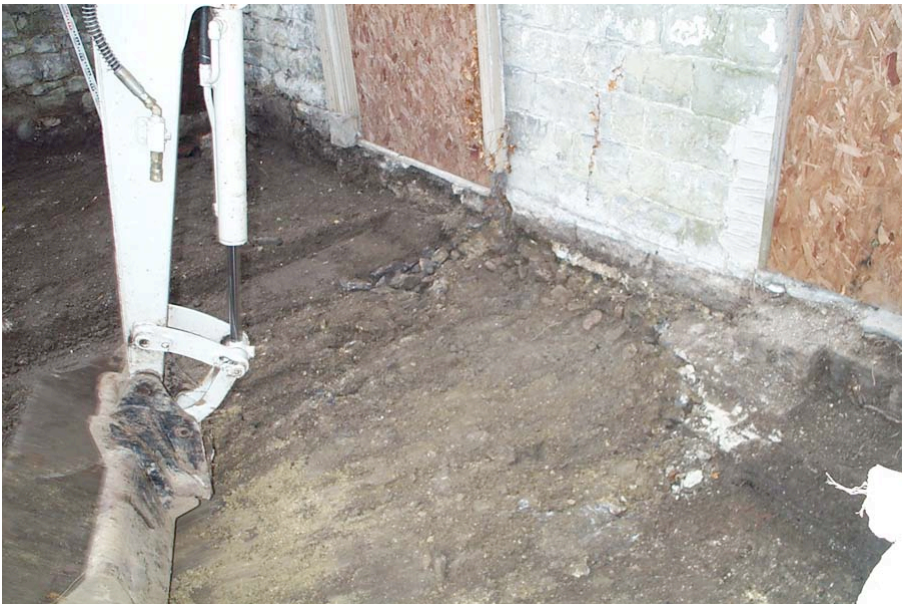
The remains of a small extension or outhouse against the south wall of the existing building were exposed (Plate 5). This was about 2.2 m by 3.5 m across and was largely disturbed by the initial clearance of the site. It comprised a drystone wall (115) about 0.3 m wide, the eastern side of which ran along the top of wall 110 and the western side was under the eastern edge of the western door (Figure 3). The north wall was not identified, but this structure did not appear to continue further north of the northern end of the footings trench. The western wall appeared to be partially bonded into the wall of the existing house beneath the present doorway. There was no evidence that the eastern wall was bonded into the present building, as there is no trace of a wall scar on the existing elevation. Within the area defined by the walls was a cobbled surface of closely set vertical ovoid pebbles in a brown clay matrix (111). This surface sloped down to the north. It was constructed directly over the earlier garden soil 112 (Figure 4).

Plate 5: View of area of new extension during clearance, showing remains of Structure 117. Viewed from northeast.
