DORFORD BAPTIST CHURCH, DORCHESTER, DORSET
Archaeological Observations and Recording

Report No. 53141.2

January 2005

Archaeological Observations, November 2004

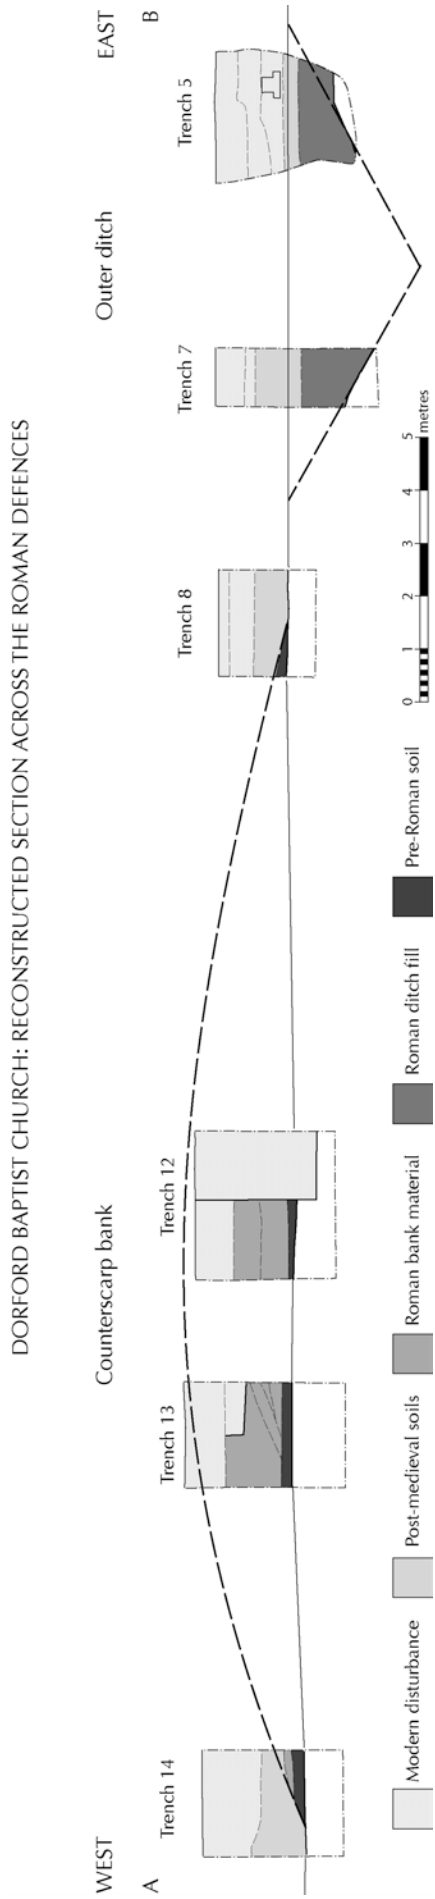
Figure 5: Reconstructed transect across outer ditch and counterscarp bank. (Note: the original profile of the bank has not been fully reconstructed.)

Traces of the counterscarp bank were observed in Trenches 9, 11, 12, 13, 14, 19, 20, and 21. This survived up to 1.0 m high and was constructed directly on top of the reddish-brown clay of the pre-Roman ground surface. It comprised layers of reddish-brown clay and chalk rubble in varying quantities (Plates 5–6). Although no definite bank deposits were recognised in Trench 8, the survival of the pre-Roman buried soil (443), becoming thicker towards the west, in the western half of this trench may indicate that this soil layer was originally protected by the bank. If this is the case, then the eastern edge of the bank probably ran along the line of this trench. The overlying deposit of chalky soil (442) may be eroded bank material. Similar chalky soil deposits (464) were found in Trench 10. The western edge of the bank may run through Trench 14, where the pre-Roman soil (504) and the overlying chalky clay bank material (503) gradually peter out towards the western side of the trench (Figure 5).

Despite the small areas exposed and the difficult conditions on site, this watching brief has clarified a number of points about the Roman town defences at this point and has enabled a transect across the counterscarp bank and outer ditch to be reconstructed (Figure 5) and the course of the defences to be projected across the site (Figure 6).

The results suggest that the counterscarp bank was about 21 m wide and over one metre high and the outer ditch was about 9 m wide and about 2.5 m deep. The projected alignment of the ditch and counterscarp bank is shown on Figure 6. This alignment is similar to the line of the defences north of the site in The Grove, rather than that to the south along West Walks. This implies that the likely course of the approach road is to the south of the present site. The precise position of this road is not known.

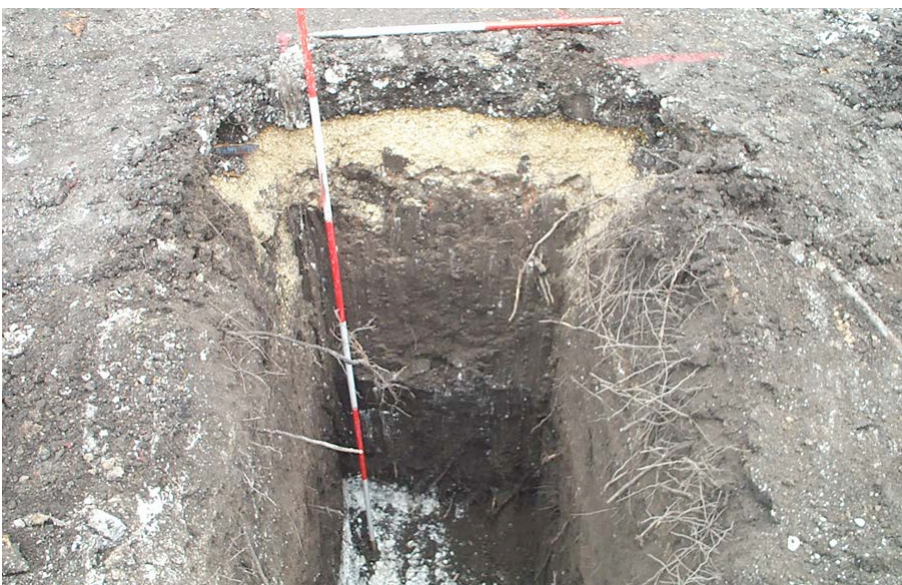
Trenches 5 and 7 were excavated across the line of the outer ditch of the Roman town defences. Trench 5 was on the eastern side and Trench 7 was on the western side (Figure 3, Plates 2–3). The angle and depth of the natural chalk in these two trenches (416, 434), together with the results of earlier observations of this feature (Startin *et al.* 1972) has enabled the overall profile of this ditch to be reconstructed (Figure 5). This ditch was V-shaped and had a projected width of about 9 m and a projected depth of 2.5 m. The fill was a greyish-brown silty clay loam with occasional flint nodules (415, 432).

Plate 3: Trench 7, looking north, showing Roman ditch cut.

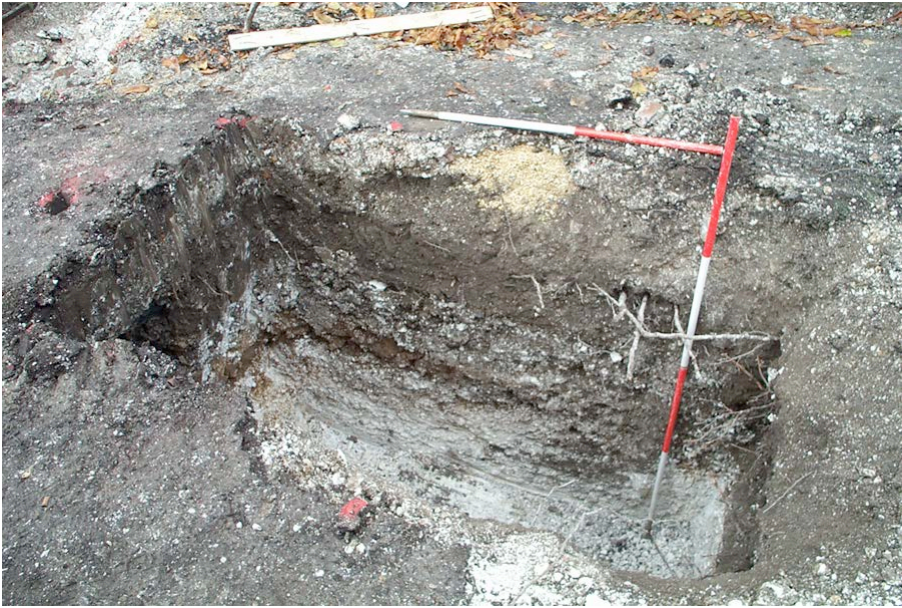
Plate 4: Trench 8, viewed from south.

and 19–21. This was about 0.1 m thick. In Trench 8 (Plate 4), this layer petered out about 0.4 m from the east edge of the trench. In Trench 14, this layer petered out about 1.4 m westwards into the trench. This layer has been interpreted as the remains of the pre-Roman soil, traces of which have been found on many sites within Dorchester.

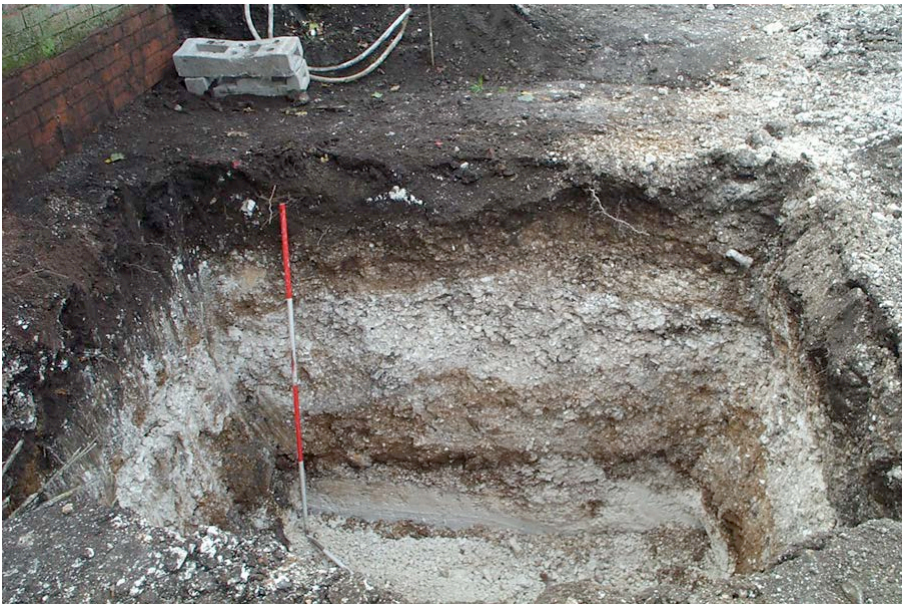
Plate 5: View of Roman counterscarp bank deposits in Trench 9. Viewed from east.

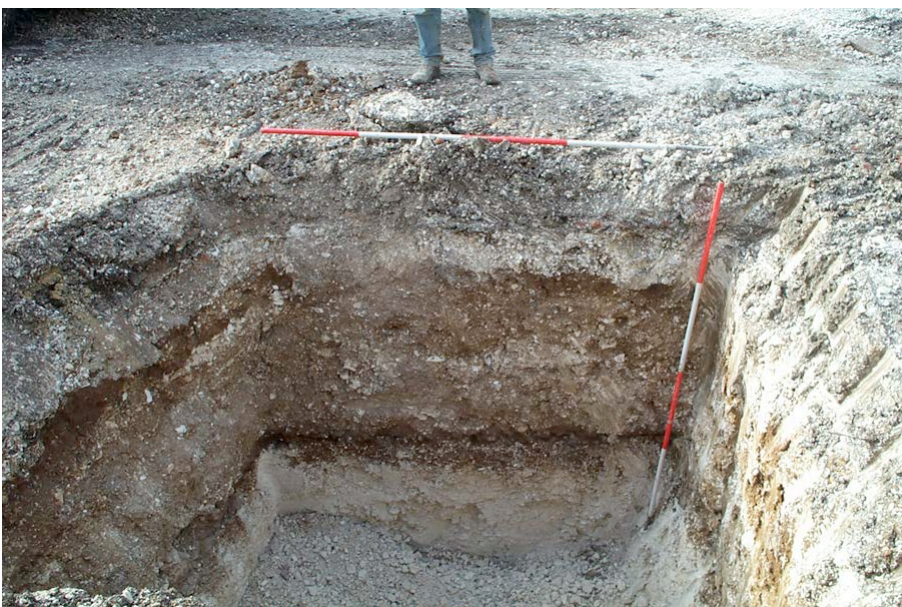
Plate 6: View of Roman counterscarp bank deposits in Trench 21. Viewed from east.
