**CHURCH OF THE HOLY ROOD,
BUCKLAND NEWTON, DORSET
Archaeological Watching Brief**

Report No. 53131.1

Church of the Holy Rood, Buckland Newton, Dorset

Archaeological Watching Brief, July 2003

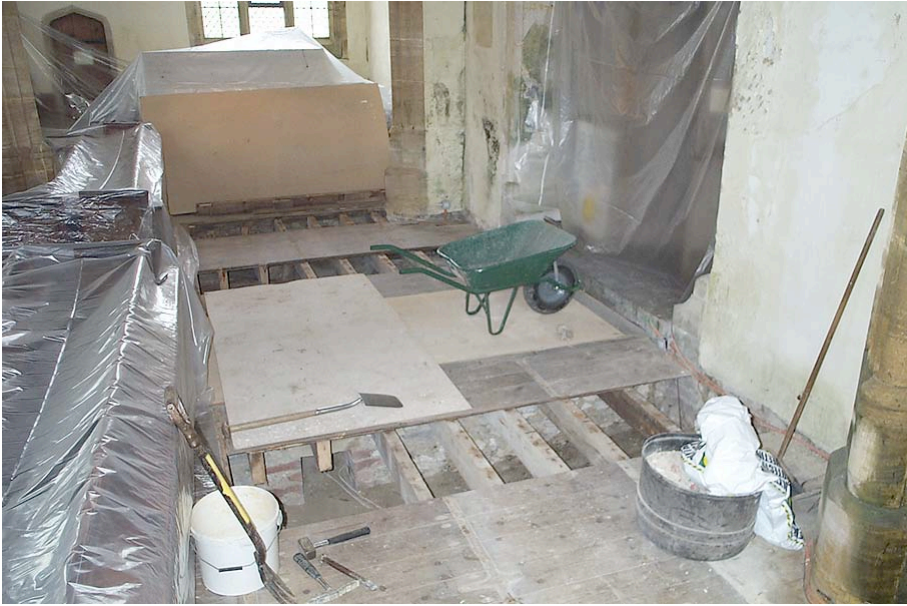
Plate 1: General view from north.

The works included the construction of a new gallery at the west end of the nave for the organ. This is supported by two supports set on about 2.25 m apart, about two metres from the west end of the nave (Plate 1). The floorboards were removed and a foundation trench 0.7 m by 0.7 m across dug down onto solid ground for the concrete base for the supports. The floorboards were also removed in the southwest corner of the nave for the construction of a new stair access to the gallery.

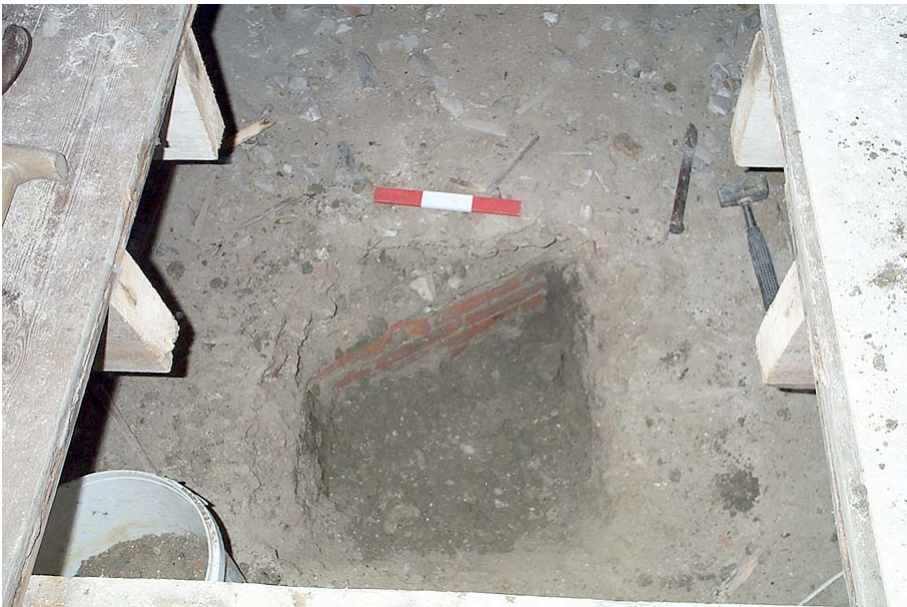
Plate 2: View of Trench 1 after excavation, from west.

On the eastern side of the trench was part of a brick-built duct (103) running in a NNW–SSE direction (Plate 2). It was only partially exposed, but appeared to consist of at least five courses of brick set within a vertically-sided cut into the natural clay 102. It was covered with flat stone slabs, including one of polished Purbeck Marble, presumably a reused piece from an earlier church monument, and was sealed by the mortar layer 100. This duct is part of the hot air heating system and appears to be running from a grille in the nave towards the outlet in the west end of the North Aisle.

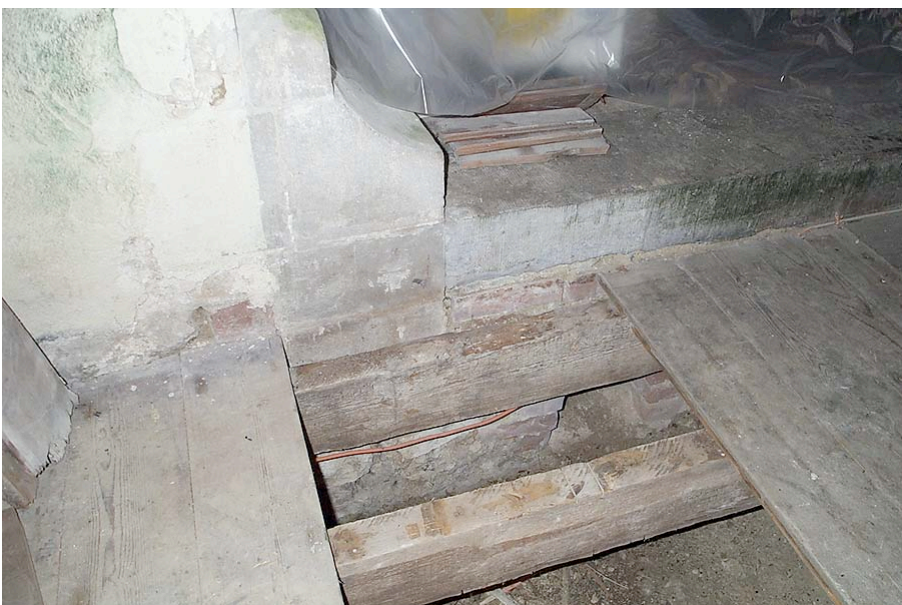
Plate 6: View of 19th century work below floor in west end of nave, from east.

The stone work at the west end of the nave below floor level appears to be all 19th century in date (Plate 6).
