## **DORFORD BAPTIST CHURCH, BRIDPORT ROAD,**

### **DORCHESTER, DORSET**

## **Archaeological Evaluation**

Report No. 53141.1

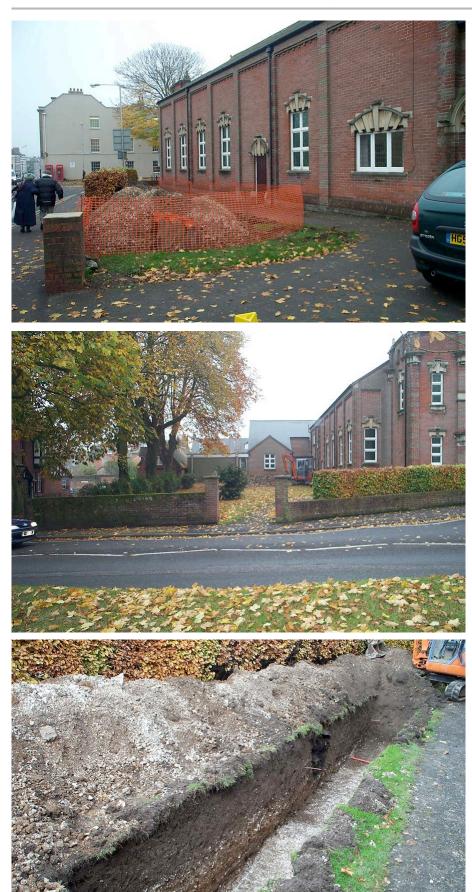
Plate 1: General view of location of Trench 1, viewed from west.

Plate 2: General view of location of Trench 2, from east.

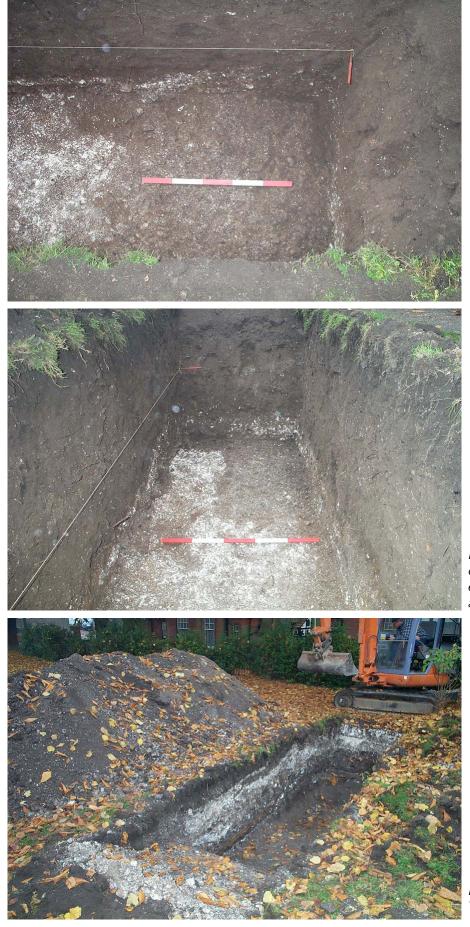
Plate 5: Detail of flint cobbled surface 108 in east end of Trench 1, after excavation.

Overlying the natural chalk in the eastern end of the trench was a hard-packed surface of flint nodules (108) about 0.1 m thick (Plates 4 and 5). The western edge of this cobbled layer was along the edge of the counterscarp bank 108. It continued beyond the edges of the excavated area to the north, south and east. Some worked flint, some small scraps of Roman pottery and tile and an iron nail were found within this layer. Its character suggests that it was a cobbled surface but too little was exposed to be certain whether it was just an isolated small patch or was part of a much more extensive surface.

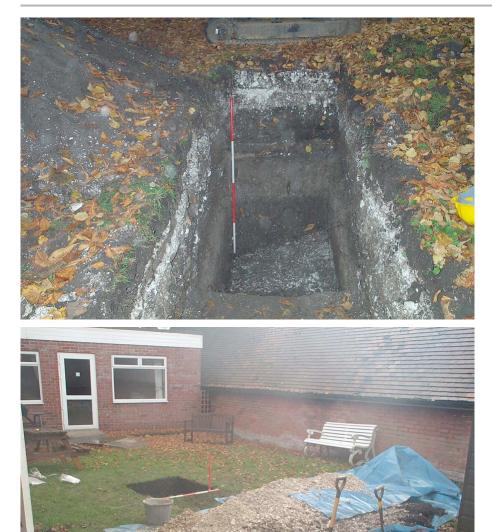
*Plate 7: South end of Trench 2 showing ditch 209.*

The natural chalk (210) was only encountered in a deeper sondage at the southern end of the trench (Plate 7). Here, it was steeply sloping down to the east at a depth of between 1.8–2.4 m below present ground level.

In the southern end of the trench, part of a large feature (209) was exposed. The only evidence for this was the shape of the natural chalk which sloped down at an angle of about 27° to the east (Figure 4). Neither the upper lip nor the base of this feature was uncovered. The shape of this cut suggested that it was linear and was broadly aligned north–south. It was filled with a dark grey silty loam (208) with occasional flint nodules, which was excavated to a maximum depth of 0.6 m. Some Roman pottery and tile was recovered from this fill.

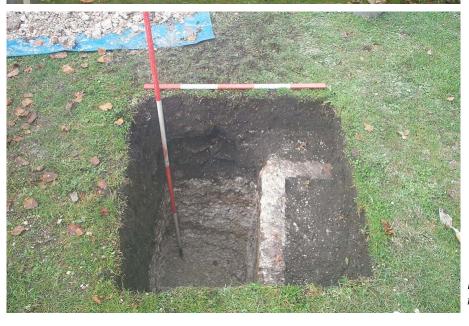
*Plate 9: Trench 3 viewed from west.*

At about 1.1 m below present ground level (77.1 m above OD) was a layer of chalk pieces in a pale grey silty clay matrix (303). Initially it was unclear whether this was a natural or an anthropogenic layer, so a small sondage was dug up to 0.6 m into this layer. This revealed that it became chalkier with depth and was, in fact, the decayed upper part of the natural chalk (Plate 9).
