LIDL STORE, SCHOOL LANE, GILLINGHAM, DORSET
Archaeological Observations and Recording

Report No. 5097.1

April 2002

LIDL Store, School Lane, Gillingham, Dorset
Archaeological Observations and Recording, January–April 2002

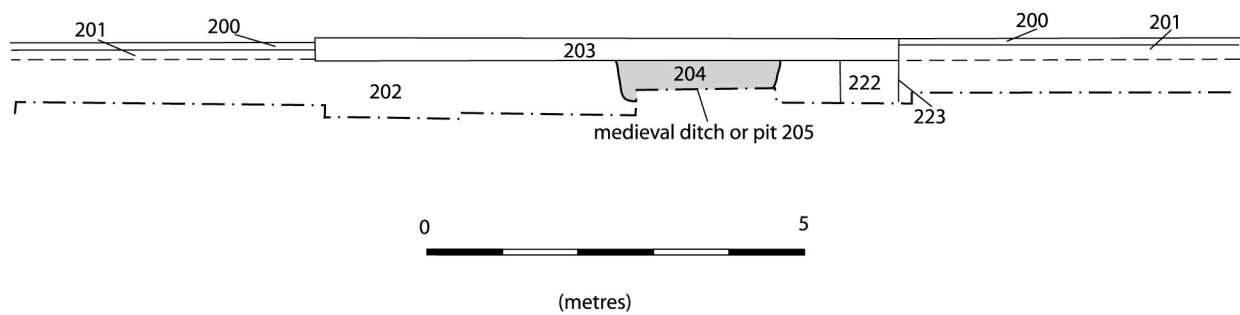
Figure 3: East-facing section across medieval feature 205

Only one feature of archaeological interest was observed. A probable ditch or pit (205) was found crossing the trench beneath floor 203. Its full extent was not discovered as the trench was not excavated deep enough at this point (Figure 3). It was filled with a reddish brown clay loam (204), heavily iron stained, with occasional charcoal flecks. A single piece of medieval pottery of 12th/13th century date was recovered.

AREA B Western Trench (east facing section)

(14.00)	0.35– 0.90	204	Fill of ditch/ pit. Reddish brown clay loam with abundant mineral staining and occasional charcoal flecks. One sherd of pottery was recovered.
		205	Ditch/ pit cutting into clay natural. Has vertical sides and probably a flat base (not certain due to depth of machining) and is 2.20m wide. Medieval

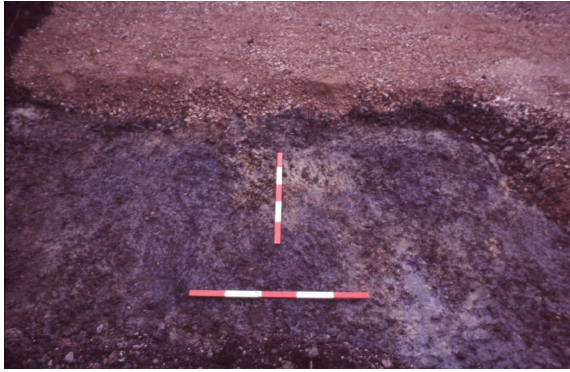
Plate 1: Medieval pits 106 and 108

Adjacent to this spread two discrete features (106, 108) were observed cutting into the clay natural. Both were filled with a similar olive grey clay loam (105, 107) containing a large amount of charcoal and occasional fragments of burnt clay. The upper part of the fill was excavated to obtain dating evidence. Several sherds of medieval pottery and fragments of animal bone were recovered (Table 1). The pottery was of probable 12th /13th century date.

107	108	1.00	1.00	-	Dark olive grey clay loam with abundant charcoal flecks and occasional fragments of burnt clay. Fill of possible rubbish pit.
108	107	1.00	1.00	-	Circular feature situated near to east edge of site. Possible rubbish pit. Medieval.
109	110	6.00	4.00	-	Yellowish brown silty clay loam with frequent fragments of glass bottles, pottery, coal and metal. Fill of rubbish dump.
110	109	6.00	4.00	-	Large oval feature running under south- east corner of area. Rubbish dump. Modern.
111	112	3.00	1.20	-	Yellowish brown silty clay loam with frequent fragments of glass bottles, pottery, coal and metal. Fill of rubbish pit.
112	111	3.00	1.20	-	Rectangular feature near to southern edge of area. Rubbish pit. Modern.
113	114	5.50	13.00	-	Yellowish brown silty clay loam with frequent fragments of glass bottles, pottery, coal, metal and wood. Fill of rubbish dump. Modern.
114	113	5.50	13.00	-	Large rectangular feature running under southern edge of area. Rubbish dump. Modern.

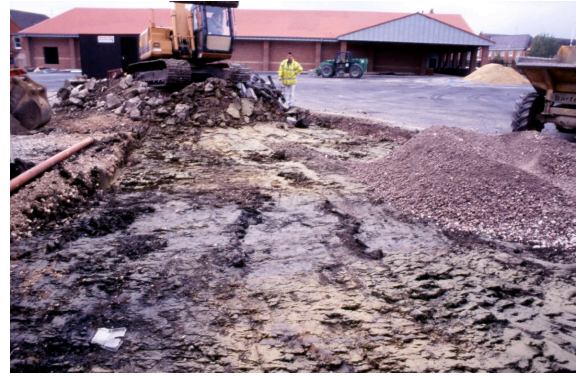
Plate 2: Ditch 116

Immediately to the west of these pits, a large linear feature (116) was observed aligned NW-SE cutting into the natural clay. Only the upper surface of this feature was exposed and it was not excavated, so its character remains uncertain, but is most likely to be a ditch. It had a flattened terminal at its southern end, adjacent to pit 108 and it continued to the north into the area of the site that was not observed. This feature was filled with a charcoal-rich, olive grey clay loam (115) similar to the fills of pits 106 and 108. A small quantity of medieval pottery similar to that recovered from pits 106 and 108, and some animal bone was recovered from the surface of the feature (Table 1).

115	116	-	2.00	-	Dark olive grey clay loam with abundant charcoal flecks. Fill of ditch.
116	115	-	2.00	-	Large linear feature aligned slightly NW- SE near eastern edge of area, immediately to the west of pits [106] and [108].

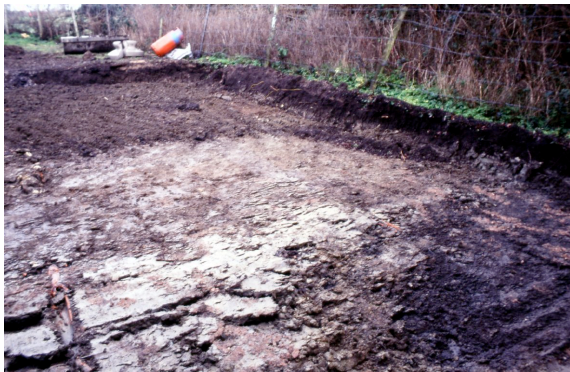
Plate 3: Peat layer 103 and brick clamp 104

Just to the north of this, a large rectangular spread (approx. 5 m wide by over 5 m long) of sandy clay loam containing a large amount of burnt clay and charcoal fragments (104) was observed running under the eastern side of the area. This deposit was about 0.1 m thick and appeared to be within a shallow cut. Although the lack of excavation hampers our understanding of this feature, its size and the quantity of burnt material within it, suggest that it may be the remains of a brick clamp. The lack of brick fragments is perhaps surprising, but it must be noted that the 18th–19th century brick clamp excavated at Shotesham St. Mary, Norfolk, did not contain any brick within the area of the clamp itself, though there was a concentration of vitrified brick in the surrounding area (Wade 1980). A small quantity of material including 18th–19th century pottery, animal bone, tile, and glass were recovered. The pottery suggests an 18th or 19th century date for the clamp.

In the southeastern corner of Area A was a large, oval spread of dark peaty clay (103), which continued eastwards beyond the limits of the site and was truncated to the south by the

modern disturbance 110. The nature of this deposit suggests that it was poorly drained. It was not possible to investigate it properly to determine its nature and origin. No dating evidence was recovered.

Not enough of the possible brick clamp and associated claypits was investigated to be certain of their interpretation or date. However, they are likely to be earlier than the founding of the huge brickworks of the Gillingham Pottery, Brick and Tile Company in 1866 (Young
