**NEW SWIMMING POOL, PENNSYLVANIA CASTLE,  
WAKEHAM, PORTLAND, DORSET  
Archaeological Observations and Recording**

**Report No. 53085.1**

# **New Swimming Pool, Pennsylvania Castle, Wakeham, Portland, Dorset Archaeological Observations and Recording, April–May 2002**

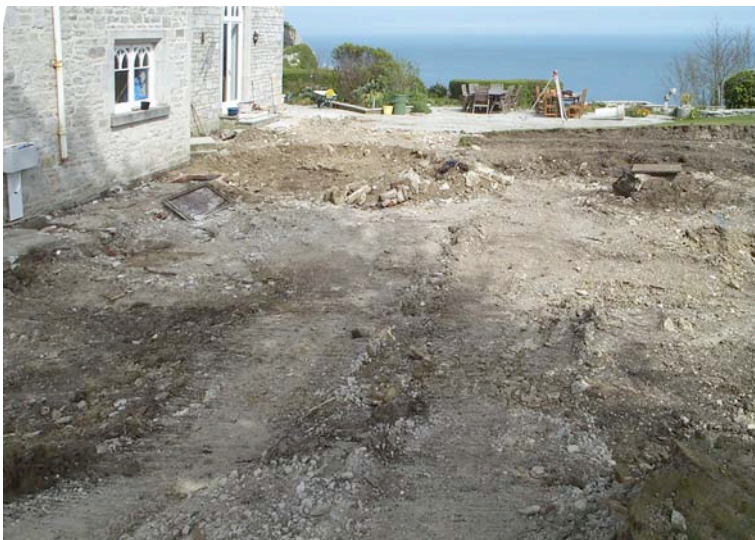
After the initial stripping of the area down to a depth of about 1 m below existing ground levels, the northernmost c. 6 m, adjacent to the existing building, appeared to have more stone rubble than the rest of the site. This may have been a remnant of the former outhouses in this area, but there was nothing that could be positively identified as part of a structure.

*Plate 2: North end of site from west.*

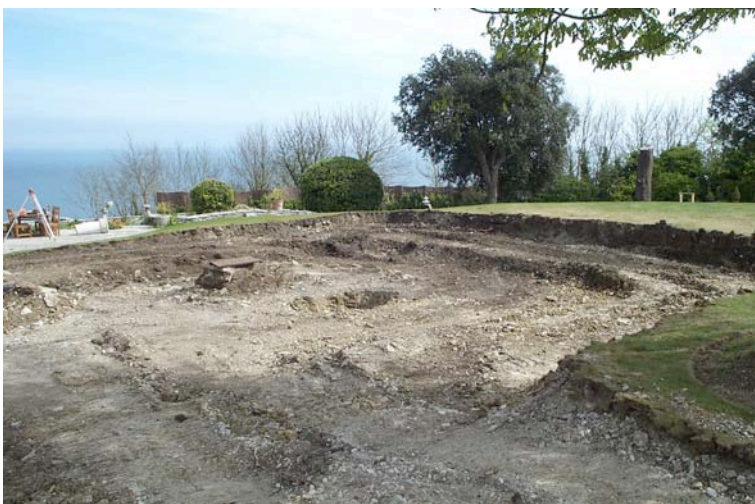
*Plate 3: South end of site from west.*

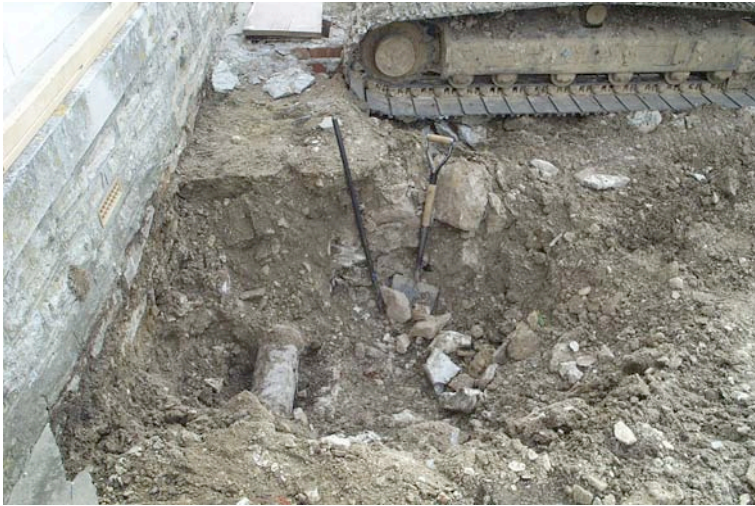
Deeper excavation at the northern end of the site revealed the remains of a stone wall running parallel to and 0.9 m south of the existing southern wall of the building (Figure 2). This wall was 0.4 m wide and was constructed from squared limestone rubble bonded with lime mortar (Plate 4). This was likely to be part of the building range demolished in 1911, perhaps the south wall

*Plate 4: Wall footings from west*

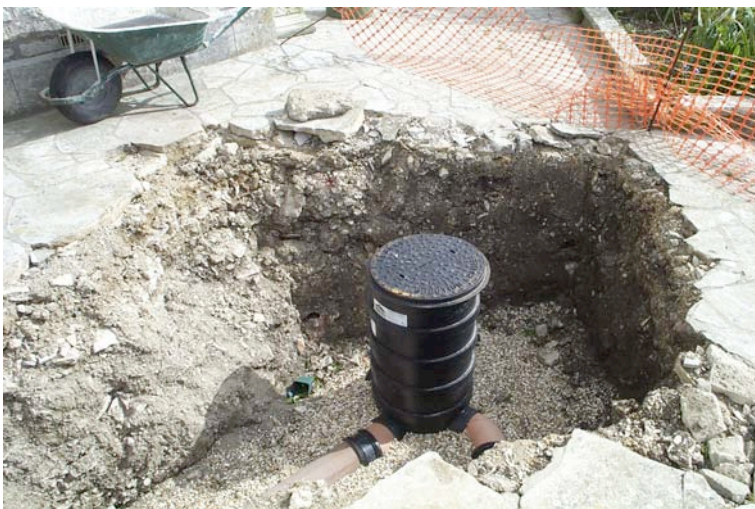
During the excavations for the new drains and soakaway in the northeastern corner of the site, an area of mixed limestone rubble and lime mortar debris was exposed. This had vertical edges and appeared to be oriented roughly north–south. (Plate 5) To the east of this stone and mortar rubble were a series of garden soil layers, but, to the west, the area had been destroyed by the digging of the new drain trenches. This stone rubble may be the destroyed remnants of the eastern wall of the former outhouses (Figure 2). Another patch of stone rubble and mortar debris was exposed about 0.8 m south of the existing building, which may be another remnant from the demolition of the outhouses.

*Plate 5: Stone rubble and mortar debris in soakaway in NE corner of the site, viewed from SW.*
