OSPREY QUAY, PORTLAND, DORSET
Archaeological Observations and Recording

Report No. 53101.1

March 2004

Osprey Quay, Portland, Dorset Archaeological Observations and Recording, October 2002

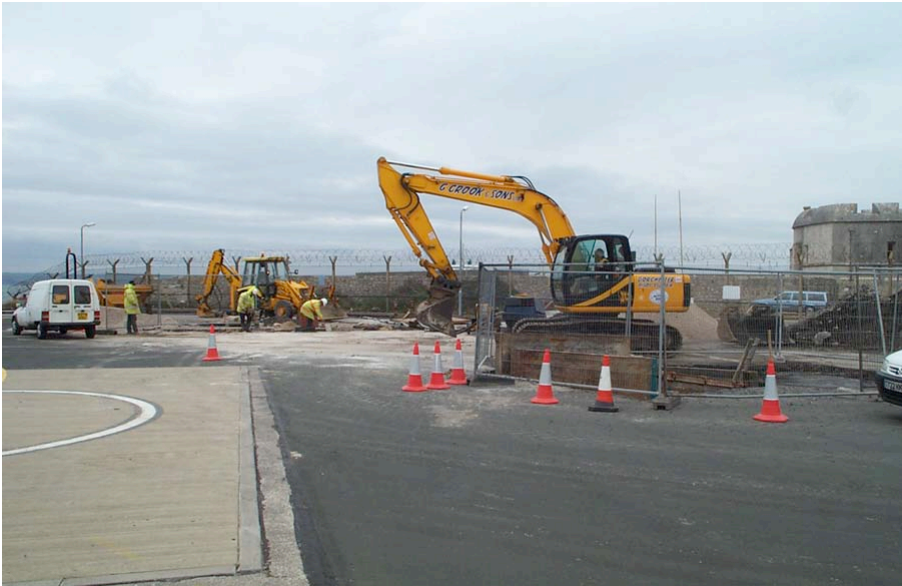
Plate 1: General view looking northeast, with Trench 2 in foreground and Trench 1 in background. Portland Castle on right.

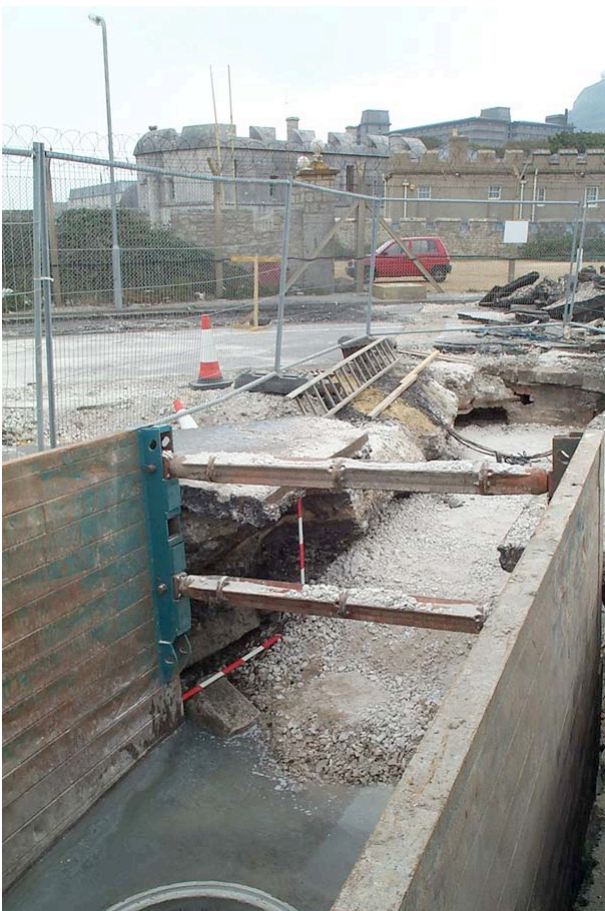
Plate 2: View looking east along Trench 1. Portland Castle in background. Large ashlar blocks visible just behind the shoring.

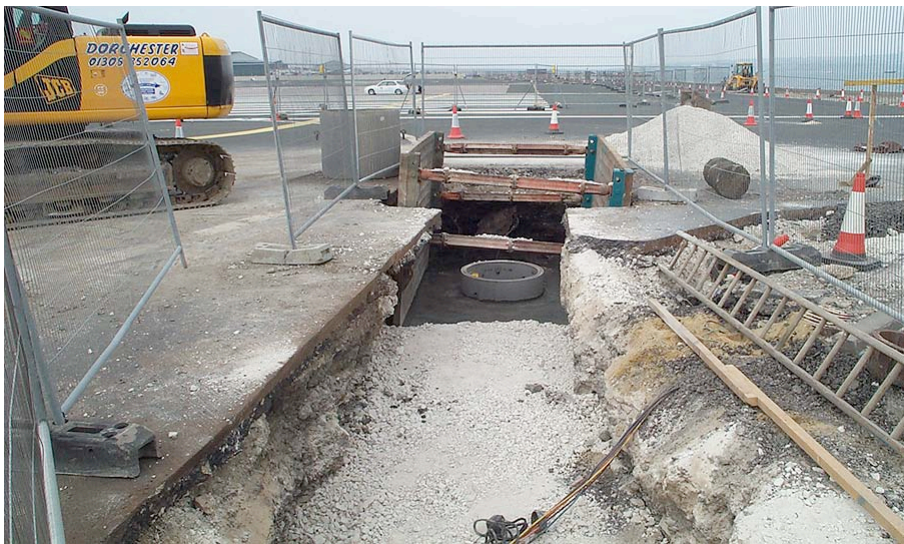
Plate 3: View northwest along Trench 1.

Trench 1 was the northernmost trench, oriented roughly NW–SE, and measuring about 12 m by 1.5–3.0 m across, dug to a depth of about 1.9 m. It crossed the projected line of the castle outworks (Figure 2). At the time of the observations, the new pipes had been laid and the trench partly backfilled to a depth of about 1.1 m in the southeast part (Plate 2). The area of the new manhole in the northwest end of the trench was still open to its full depth but was partly filled with water (Plate 3).

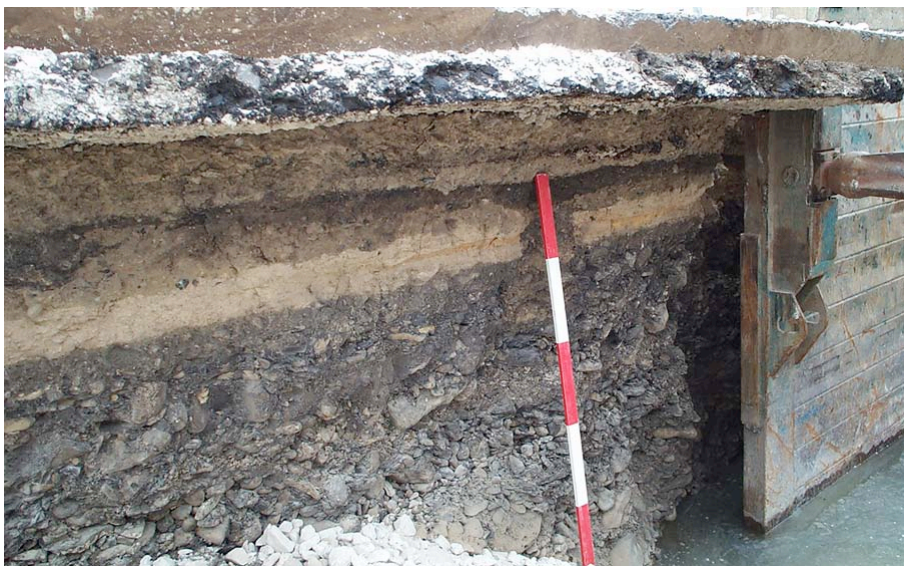
Plate 4: Detail of deposits in south baulk of Trench 1.

A similar stratigraphic sequence was seen along the whole length of the trench. This comprised a series of loose layers and lenses of rounded limestone cobbles and limestone gravel with frequent Kimmeridge clay and with large quantities of shale and mudstone pieces and some flint gravel

also, in varying proportions (Plate 4). The cobbles and stones are poorly sorted and range between 5–25 cm across. Finds visible in this deposit included some iron debris and shell, neither of which was collected. Also within this deposit, on the east side of the trench, were two large ashlar limestone blocks (Plate 5). The largest block was found at a depth of 1.2 m below present ground level and measured 1.37 m long by 0.24 m high. The other block was broken and had fallen out of the base of the section. It measured 0.55 m long by 0.3 m wide and 0.26 m high. Neither block was *in situ*. Above these rubble layers were a series of clayey layers about 0.1–0.2 m thick directly below the tarmac sub-base.

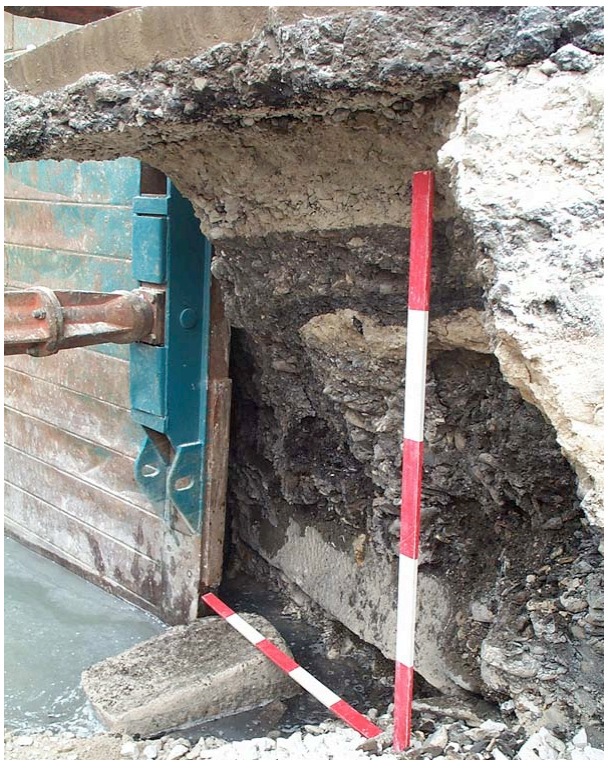
Plate 5: Large ashlar blocks in north baulk of Trench 1.

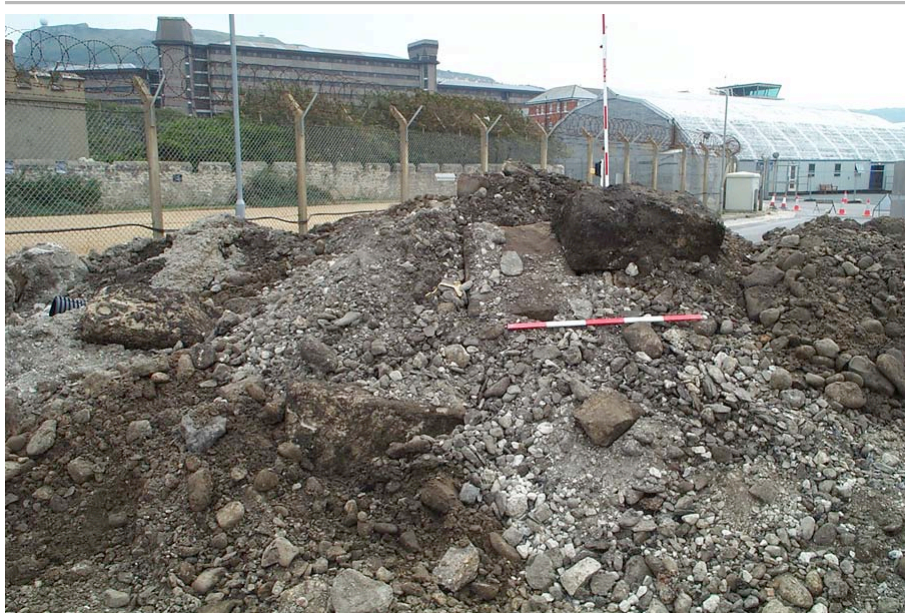
Plate 6: Large ashlar blocks from Trench 1 on spoil heap.

A number of other large ashlar blocks were excavated from this trench and were examined on the spoil tip (Plate 6). Six blocks were visible and were of varying large sizes. The most interesting piece was a section of column shaft, 1.08 m long and 0.41 m in diameter (Plate 7). The whole piece was roughly finished and a large letter 'E' was found chiselled into one end (Plate 8).

A number of large ashlar blocks were found in Trench 1. These may have been derived from the Castle outworks. Certainly, some very large blocks still survive in the stonework to the north and west of the castle, including the area of a possible surviving bastion of the castle outworks, which are thought to have come from the castle (Woodward and Tyler 1995, pl. 2–3). The column shaft is unfinished and still bears a quarry mark so is probably quarry waste or surplus, rather than an architectural fragment from the castle. The possibility exists that some of the other stone blocks may have a similar origin, rather than being derived from the castle.

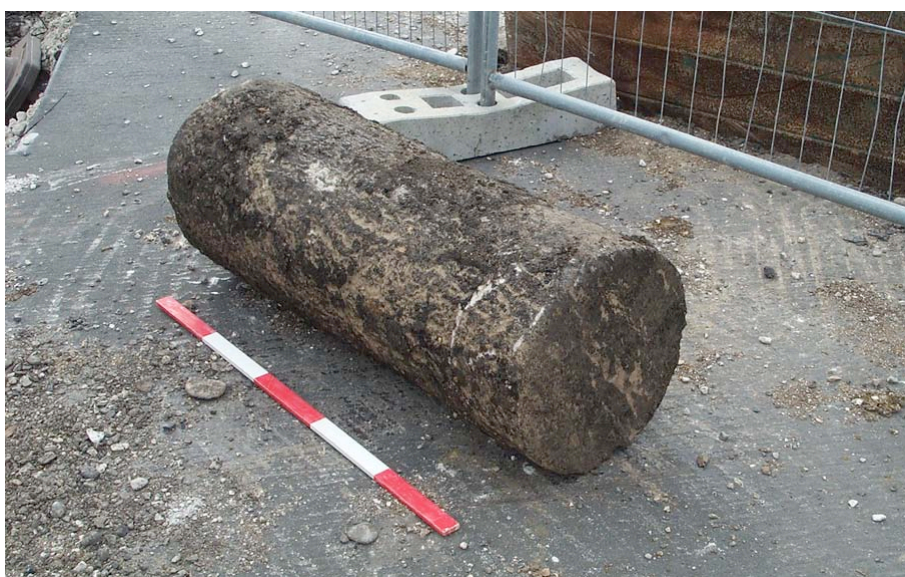
Plate 7: Column shaft from Trench 1.

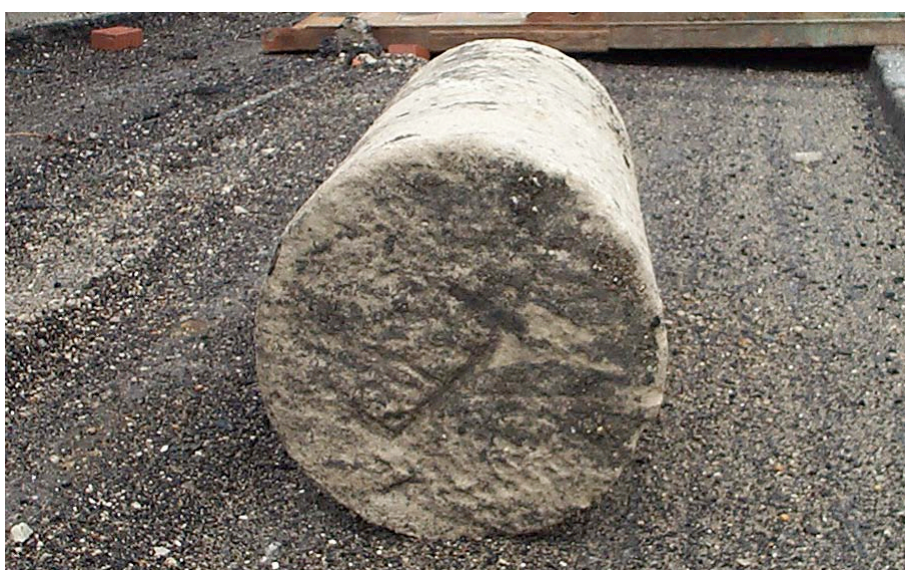
Plate 8: Mark on end of column shaft from Trench 1.

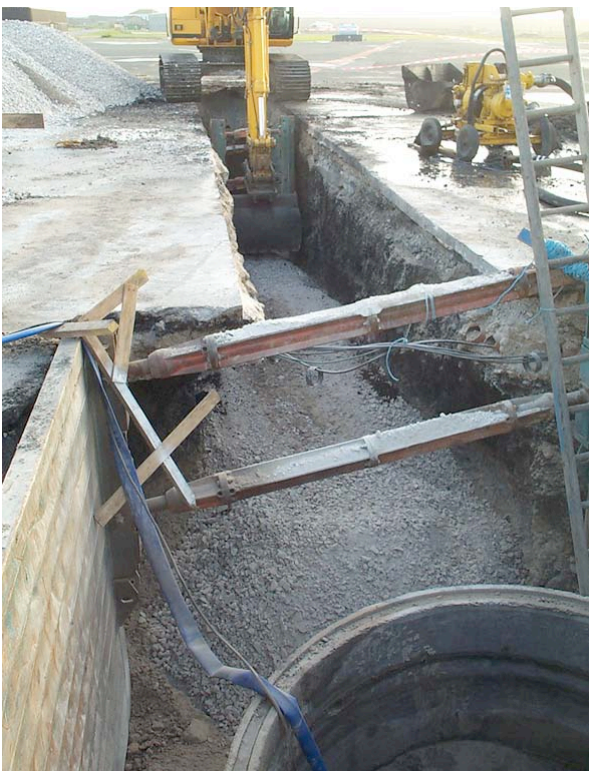
Plate 9: View looking southwest along Trench 2 during excavation.

This was a complex L-shaped trench about 14 m to the south of Trench 1 (Figure 2). It measured about 25 m by 7.5 m in maximum dimensions and was up to 3.4 m deep. The new pipes were laid as the trench was dug, so there was only a small area available for observation at any one time (Plate 9). There were serious problems with the ingress of water in this trench making the recording of the lowest deposits very difficult. Similar deposits were noted along most of its length.

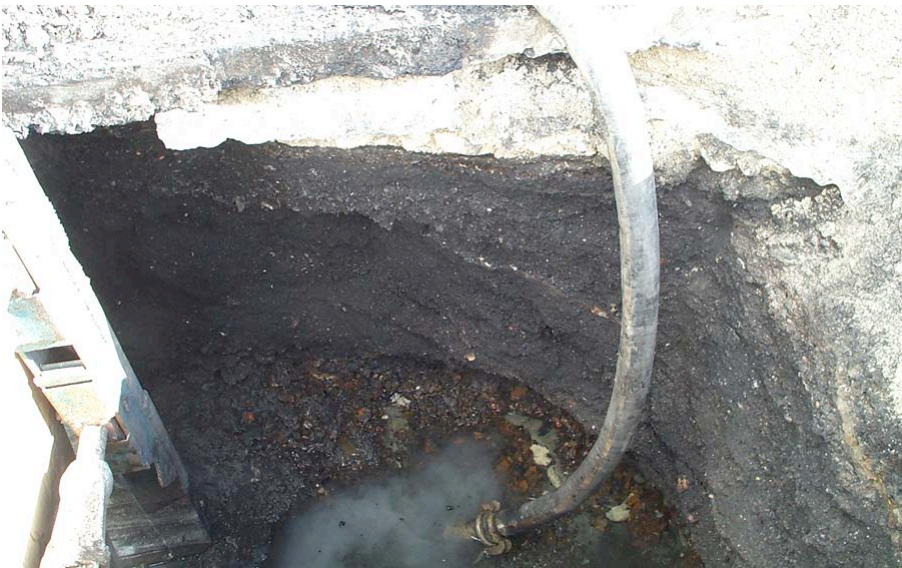
Plate 10: Detail of deposits in south part of Trench 2.

Overlying this natural deposit was a thin layer of broken brick and pebbles, intermittently visible along the length of the trench below the water (Plate 10). Overlying this was a deposit of black clinker and tarmac scrapings up to 2.4 m deep, containing a lot of rubbish including leather boot fragments, cloth, iron, pottery and some brick fragments. The upper part of the trench comprised more recent disturbance, services, etc down to a depth of about 1 m, sealed beneath the present tarmac surface.

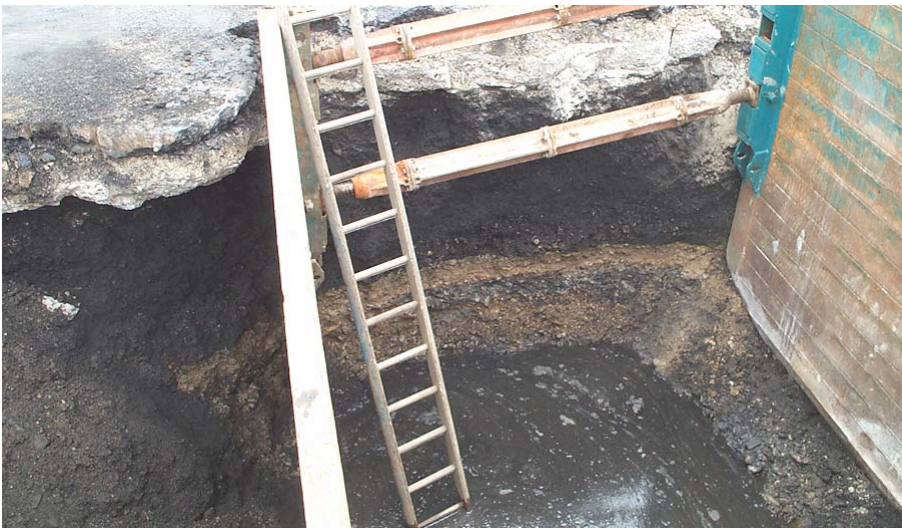
Plate 11: Detail of deposits in north part of Trench 2.

At the northern end of the trench, the layer of clinker and tarmac scrapings was about 1.7 m thick, and overlay a series of sand and gravel layers below (Plate 11).
