# Hive Beach Car Park, Burton Bradstock, Dorset

Archaeological Observations and Recording during Installation of Electricity Supply to Car Park Hut

Report No. 53544/3/1

February 2020

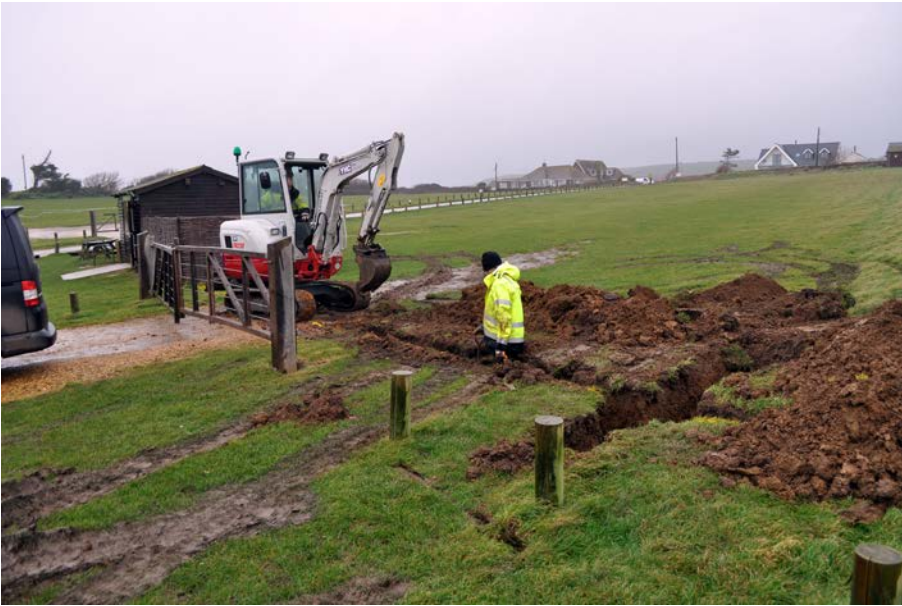
The ground works consisted of the excavation by machine of a trench about 19 m long between the existing electricity supply which runs just inside the fence line on the east side of the car park to the wooden hut at the north end of the car park. This trench was 0.3 m wide and 0.8 m deep. A strip 3.3 m long and 0.3 m wide was dug along the line of the existing electricity cable line to expose the duct (Figure 2; Plates 1–2).

Plate 1: General view of trench during excavation, looking NW.

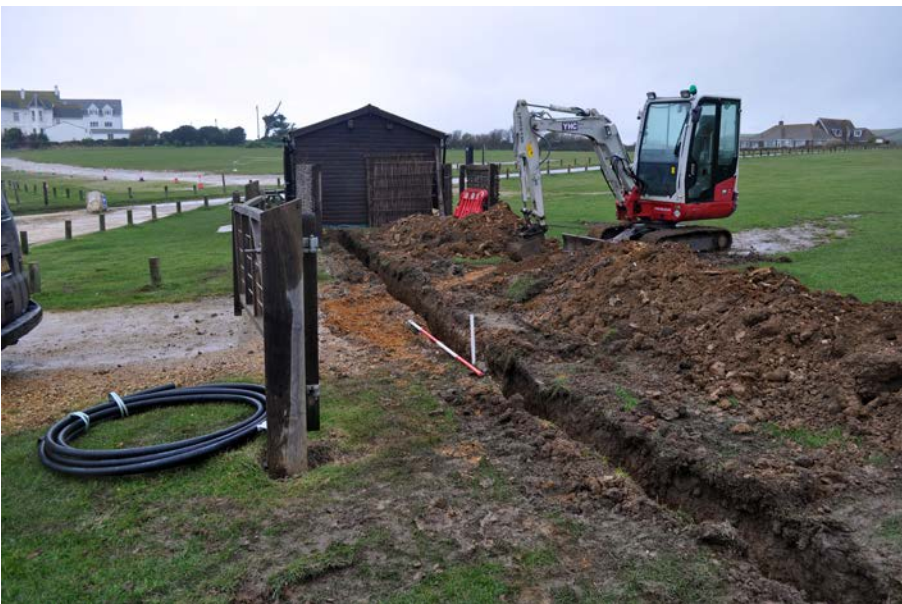
Plate 2: Trench after excavation, looking west. 2m & 1m scales.

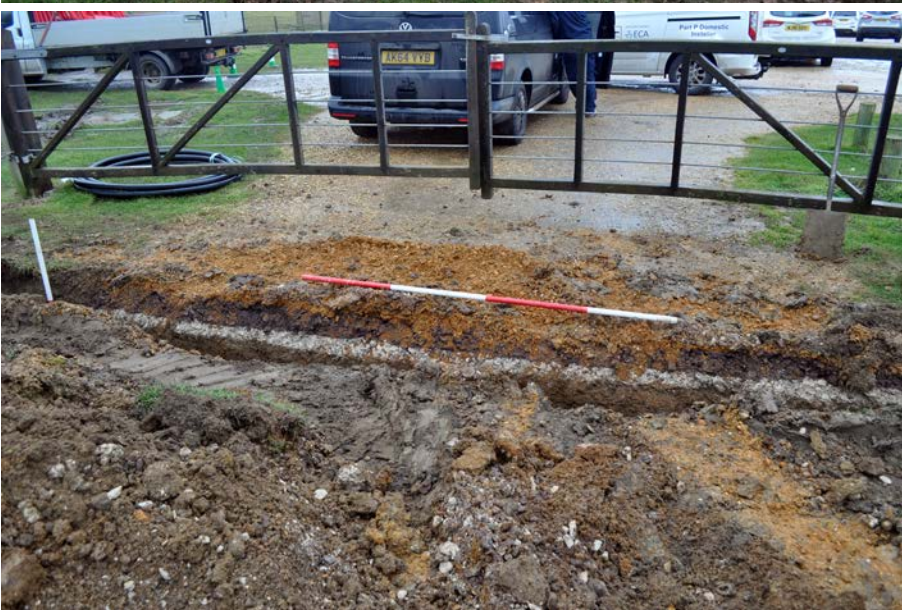
The trench crossed the gateway into the overflow car park to the north, cutting through the car park metalling (Plate 3). This consisted of a 0.22 m thickness of orange gravel over dark grey stone scalplings on a base of pale grey crushed stone (103).

Plate 3: Car Park deposits 103, looking south. 2m & 1m scales.
