New Barn Cottage, Wherwell, Hampshire

Archaeological Building Investigation and Re-
cording

Report No. 53515/5/1

April 2020

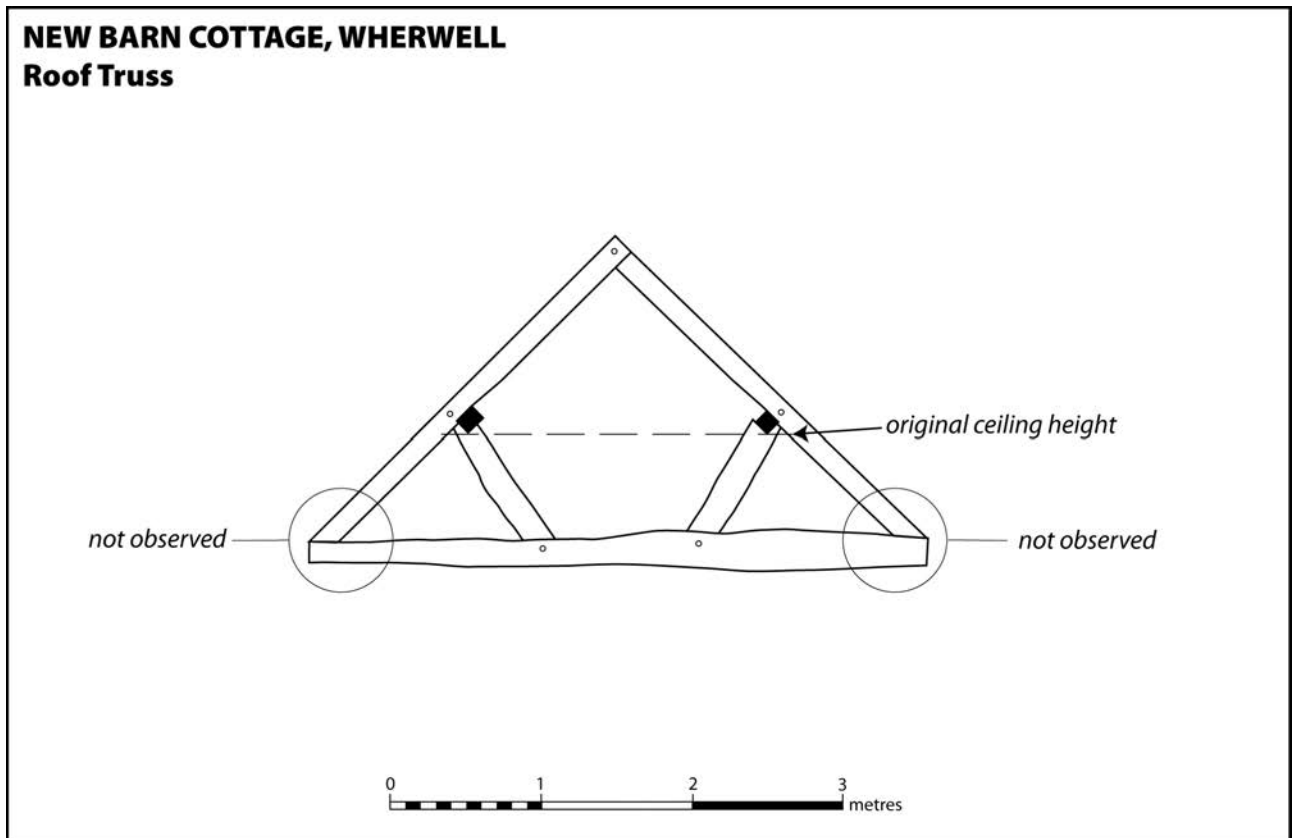
Figure 5: Sketch of Roof Truss 1, viewed from west.

The roof space was open for the whole of its length, except for the space over Room 2 which was divided off by a timber stud partition on the east side of Truss 1. This partition was whitewashed below the earlier ceiling level and unpainted above (Plates 41–42).

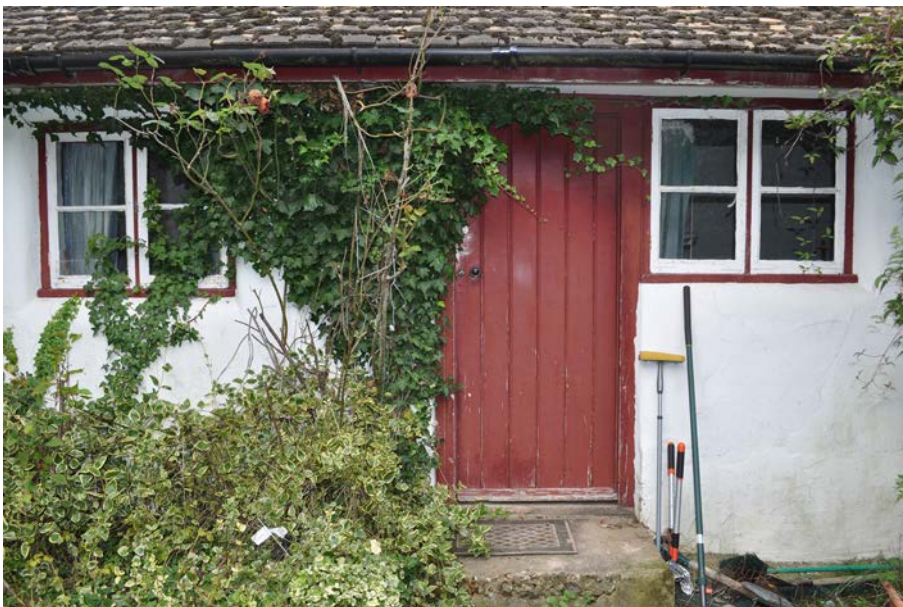
The front elevation has a rendered cob wall battered towards the top. There are two brick steps up to the front door (D1), which lies just to right of centre with two windows (W1, W2), one on either side of the door (Figure 4; Plate 5).

Door D1 (0.80m by 1.86m) is a ledge-and-brace plank door of vertical boards with beaded edges, hung on modern strap hinges, with modern handles and locks (Plates 5 and 17).

Window W1 to left of door D1 is rectangular, almost square (0.92m by 0.77m), wooden-framed two-light side-opening casement, with single glazing bars (Plate 5) and a painted timber lintel over. W2 is similar to W1, but the frame extends up to eaves level.

Plate 5: Door D1 and windows W1 and W2 in south external elevation.

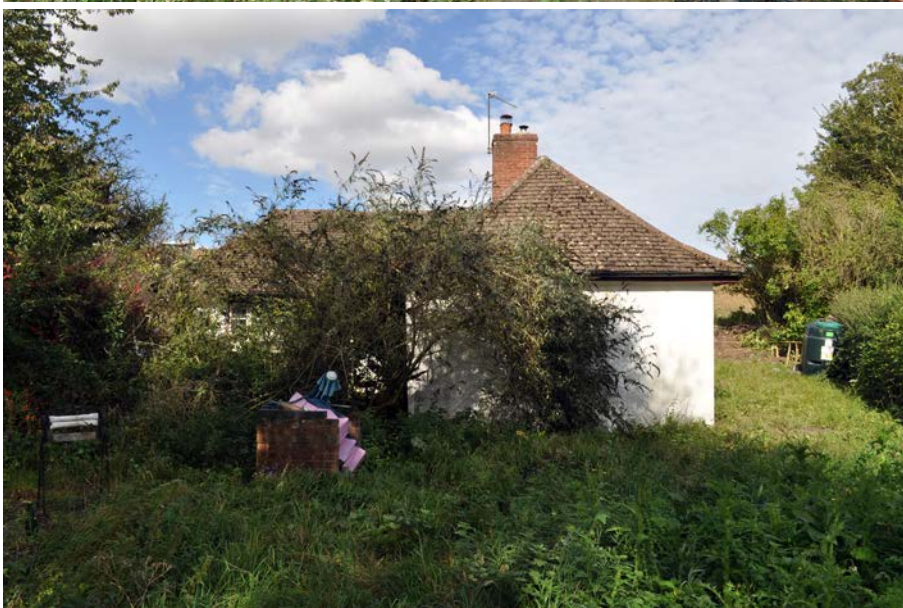
This end wall is almost completely obscured by modern timber cladding erected just in front (presumably to protect from weather) (Figure 4; Plate 6). It is a rendered cob wall with a distinct batter towards the top. At the right (east) corner, the wall is vertical for a width of 0.3 m, perhaps indicating a corner post or similar.

Plate 6: View of cottage from south.

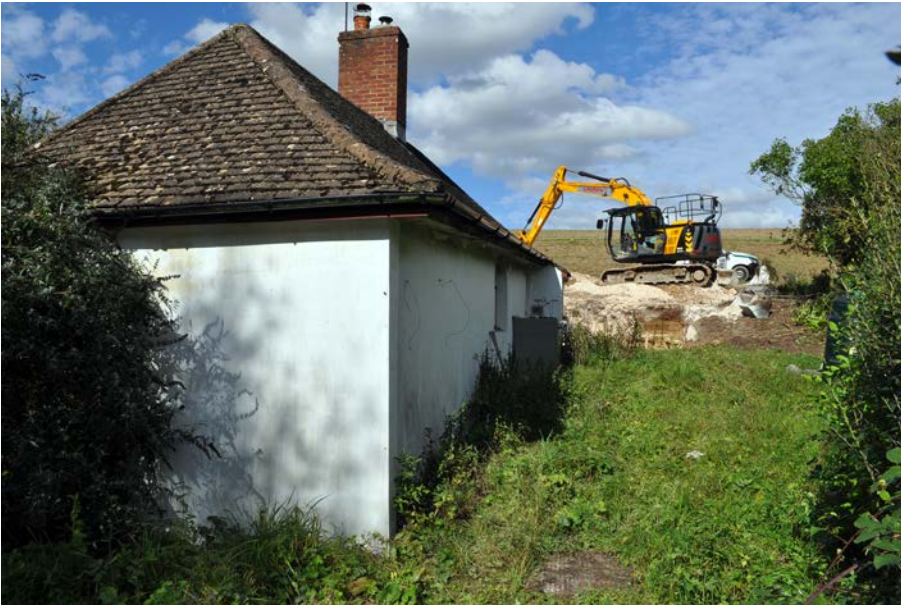
This back wall rises up towards north more-or-less following the slope (Figure 4; Plate 7). It is a rendered cob wall, battered towards top, with some areas of painted brick and two windows (W5, W6) (Figure 4). At the right (north) end is a small projecting rectangular larder with shallow pitched roof and a rectangular ventilation opening (W7). There is a modern boiler between windows W5 and W6.

Plate 7: View of rear of N-S range showing cottage rising up slope.

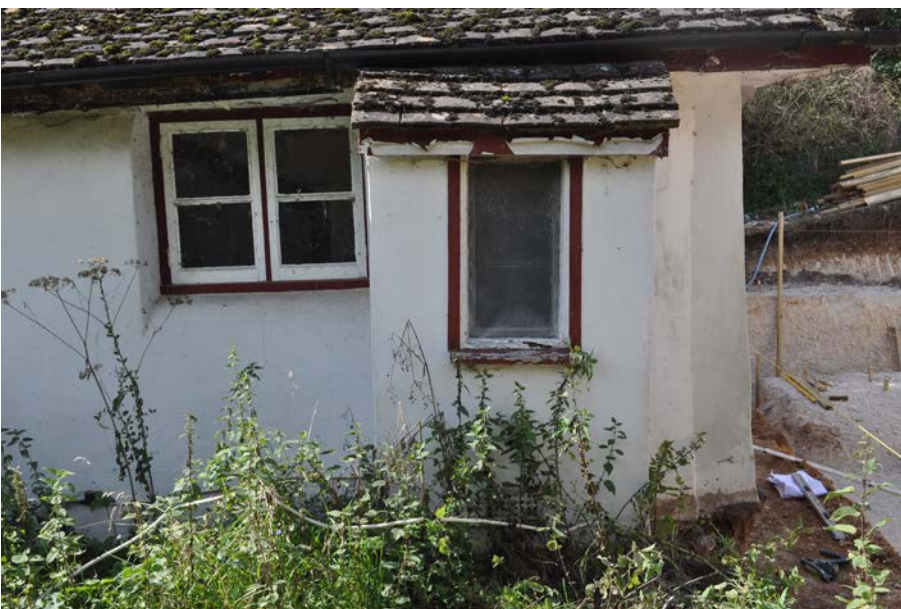
Window W5 to the left is a rectangular (1.22m by 0.90m) modern timber-framed two-light window with one side and one top-opening casement (Plate 10), similar to windows W8–W9. Window W6 to the right is a rectangular, almost square (0.89m by 0.74m), timber-framed two-light side-opening casement, with single glazing bars (similar to windows W1–W4), with a painted timber lintel over (Plate 8).

Plate 8: Inserted larder at north end of east elevation. Window W6 to left.

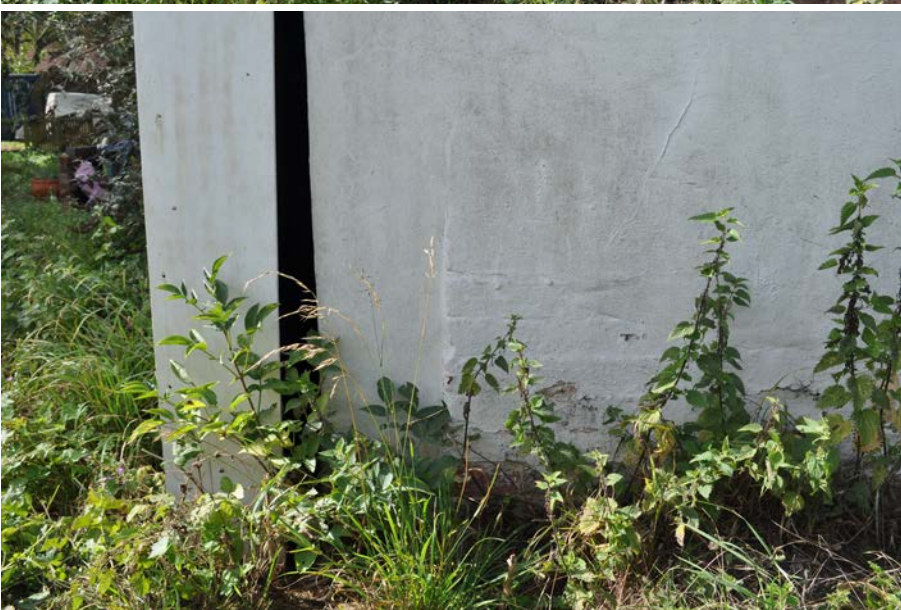
Near the base of wall are areas of painted brickwork, which may be evidence of a brick base for the cob, or areas of repair (Figure 4). At both the ends of the elevation, the brick continues further up the wall and terminates about 0.3m before the corners (Plate 9). At the corners the wall is vertical rather than battered.

Plate 9: Detail of south end of east elevation showing painted brick-work.

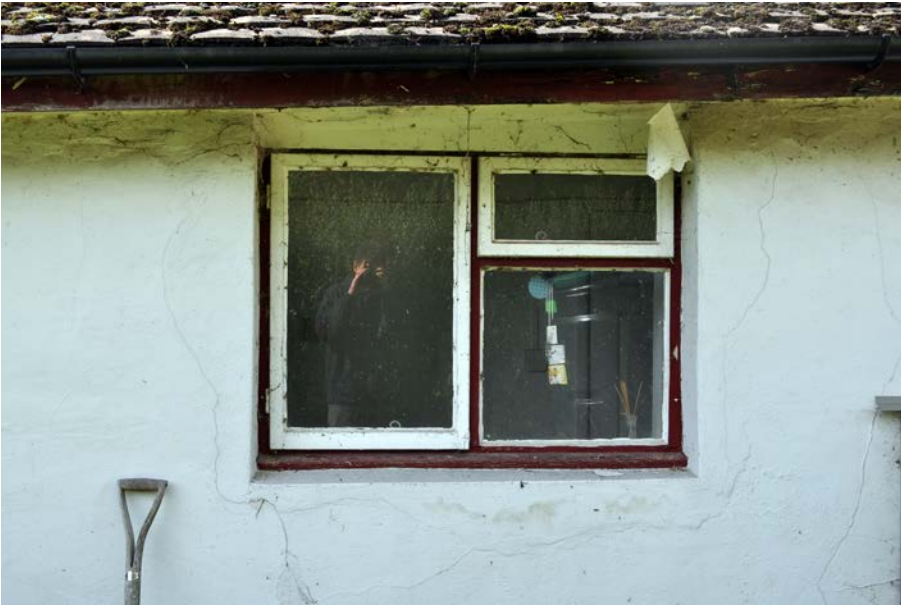
Plate 10: Window W5 in east elevation.

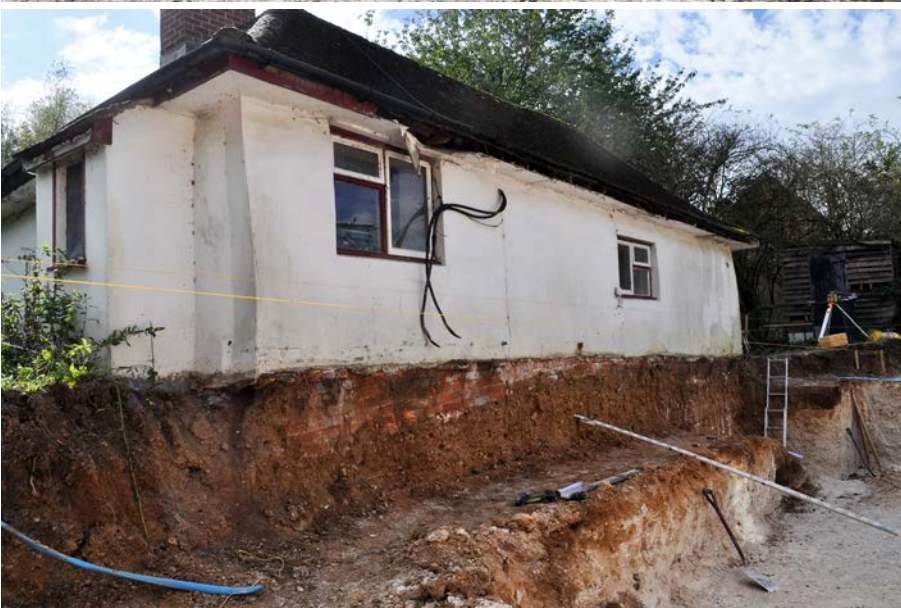
The groundworks for the new extension have exposed the brick footings for the cob wall. This is in two parts divided by a straight joint 4.25 m from the east end (roughly along the line of the west wall of the east range) (Figures 3–4; Plates 12–15). To the left (east), the brick courses dip down from three exposed courses (0.28m below ground level) at the straight joint to seven courses (0.65 m below ground level) to the east (Plates 12–13). The brickwork terminates about 0.25 m from the east end of the elevation. To the right (west) of the straight joint, the brick courses are laid horizontally, with up to four courses (0.39m) visible below the render.

Plate 12: North external elevation showing brick footings below cottage revealed in groundworks for new extension. Viewed from ENE.

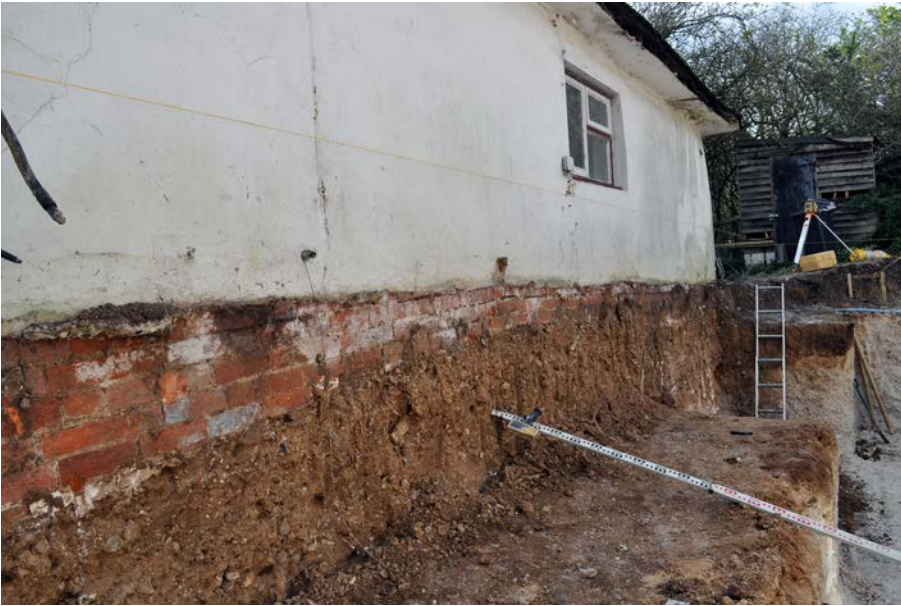
Plate 13: Detail of brick footings looking west.

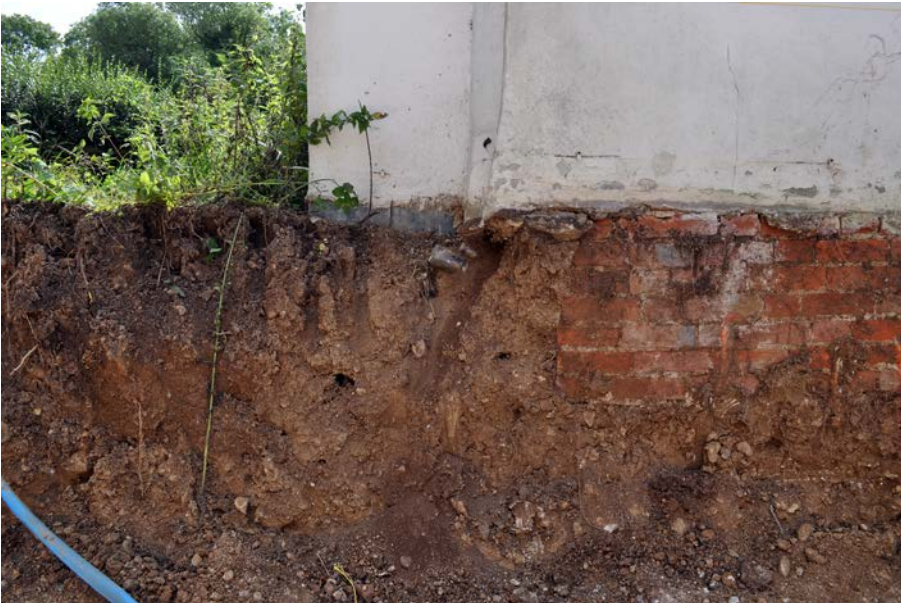
Plate 14: Detail of east end of footings of north elevation.

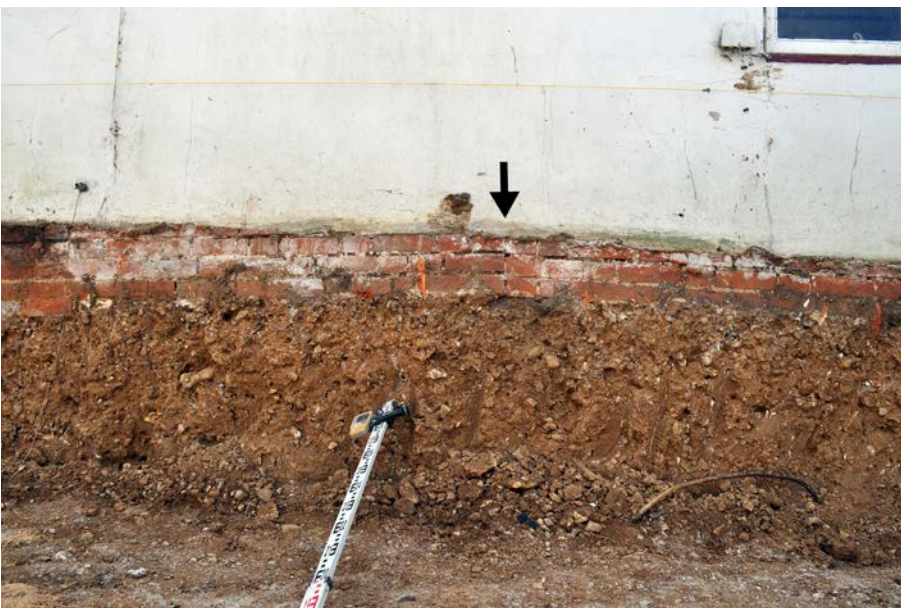
Plate 15: Detailed view of brick footings showing straight joint (arrowed).

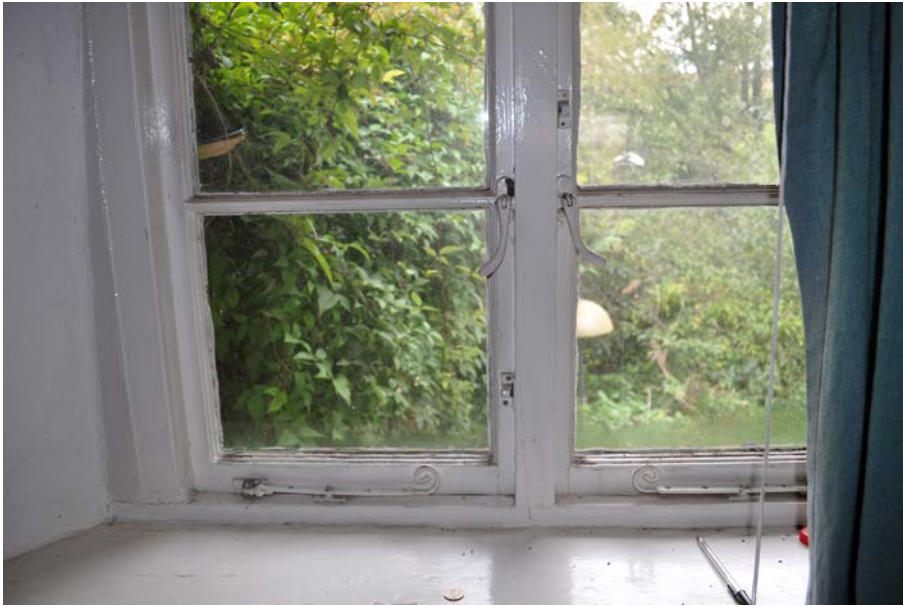
The room is lit by window W2 in south wall and window W9 in north wall. Window W2 has a splay on one side and the other is formed by the door frame D1, with a wooden internal sill. It has spiral-ended stays and swollen knob catches of late nineteenth or twentieth century date (Plate 22). Window W9 has modern window furniture.

Plate 22: Detail of Window W2 showing window furniture.

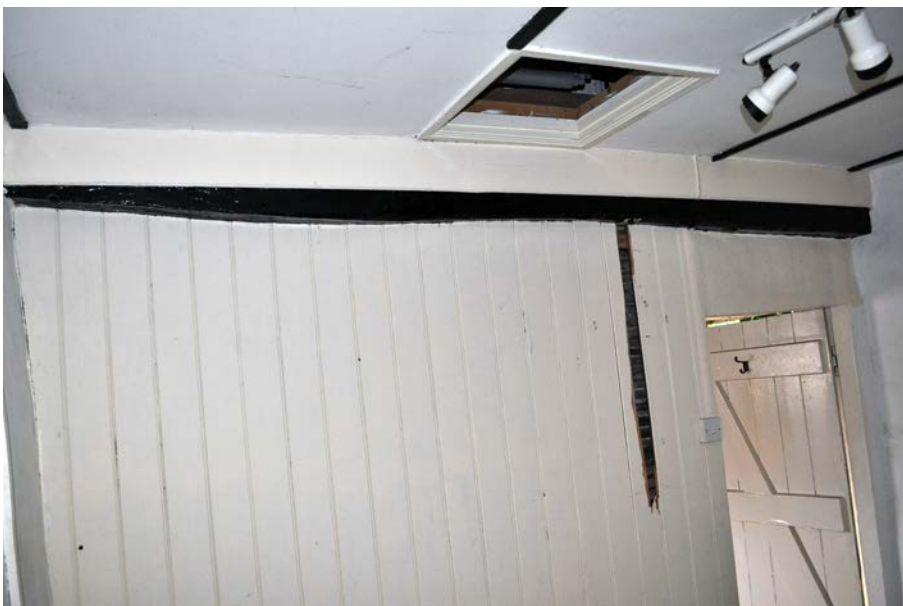
The north, south and west walls are battered and covered with painted lining paper. The partition wall with Room 1 has painted modern tongue and groove wooden cladding over timber studwork under the soffit of an exposed beam (Truss 1) (Plate 24).

Plate 24: East side of Room 2 showing exposed part of Truss 1 and timber cladding below, with door D2 to right. Note also hatch into roof space in ceiling.

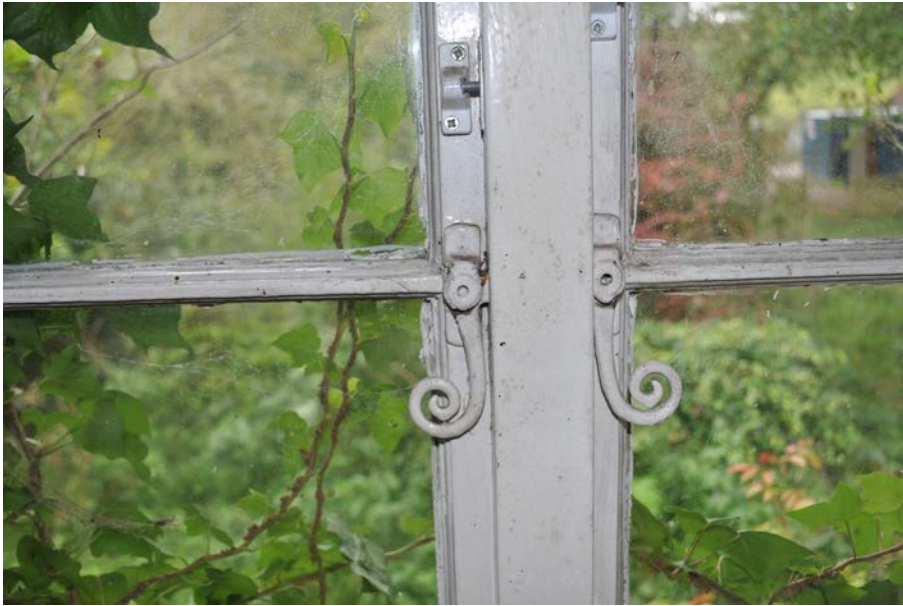
Room 2 lies at the west end of the west range and is accessed from Room 1 by door D2 (Figure 3). The room is lit by window W1 in south wall. This has a wooden lintel and a modern wooden internal sill (Plate 23). It has spiral-ended window catches and stays, possibly of nineteenth or early twentieth century date (Plate 25).

Plate 25: Detail of window catches on window W1.

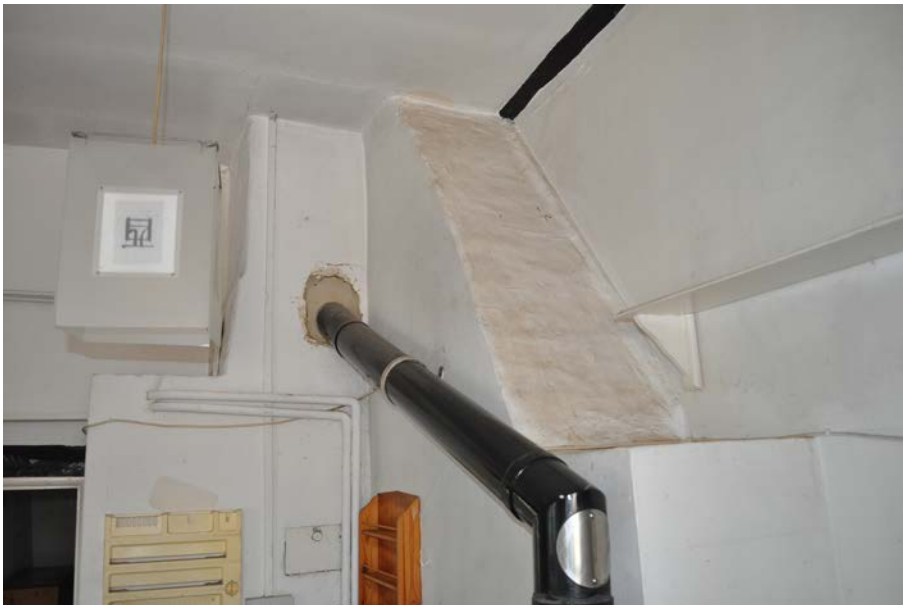
Plate 29: Detail of L-shaped flue in SW corner of Room 3.

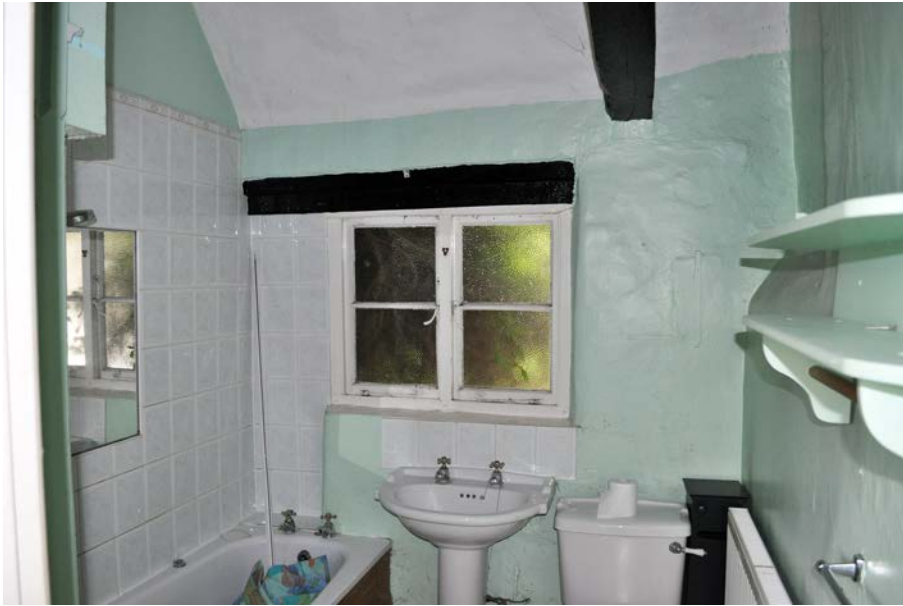
There is an indication of a blocked doorway (D7) in the west wall immediately south of window W3 (in the same area as the painted brick blocking visible on the external face of this wall). The timber lintel over the window continues south beyond this room into Room 6 (Plates 31 and 35). The wall beneath this lintel is half thickness and is vertical rather than battered. It is assumed to be of brick, but is currently clad in modern ceramic tiles. This blocking is about 0.93m wide and 1.90m high.

Plate 31: West wall of Room 4, with window W3 and part of blocked door D7 to left. Note end of roof truss 3 above.

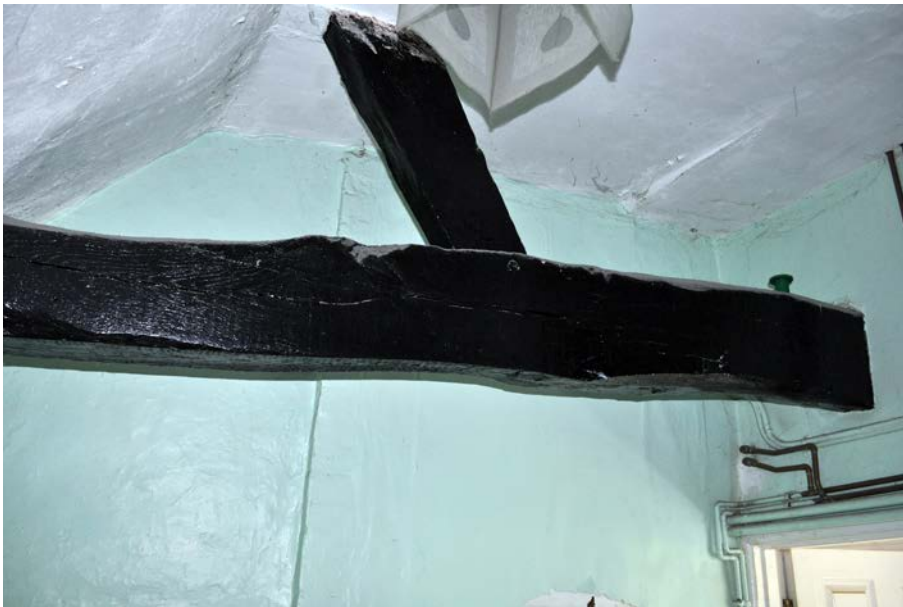
Part of a black-painted raking strut roof truss (Truss 3) is exposed in the northern part of this room and this continues into the corridor (Room 5) (Plates 31–33). It lies about 0.3 m inside the north side of the room. The ceiling is painted lath and plaster. There is an access hatch in the ceiling in the south end of the room.

Plate 32: Exposed part of Truss 3 in Room 4.

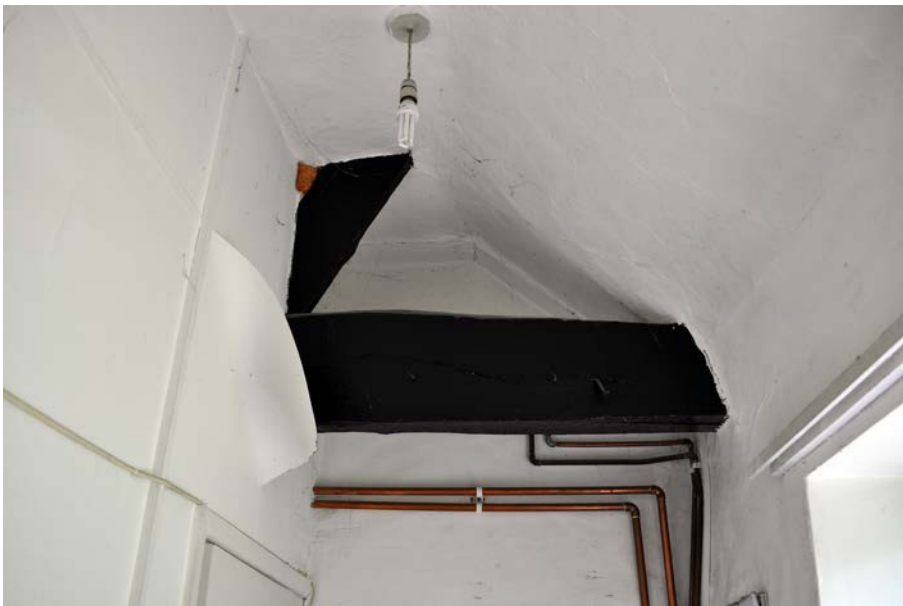
A part of the black-painted raking strut roof truss (Truss 3) is exposed in the northern part of the corridor (Plate 33). The ceiling is painted lath and plaster.

Plate 33: Exposed part of Truss 3 in Room 5.

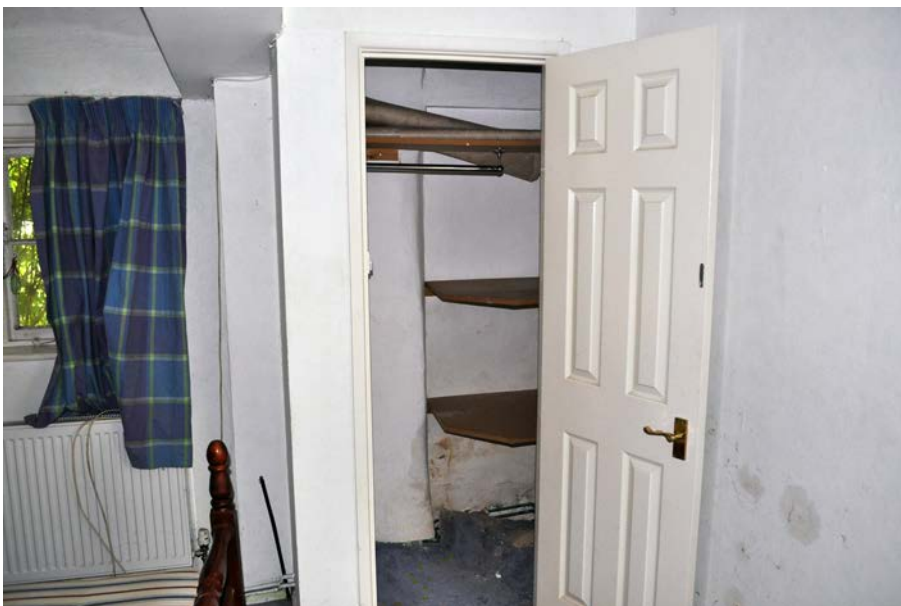
Plate 36: South side of blocked door D7 visible in modern wardrobe in Room 6.

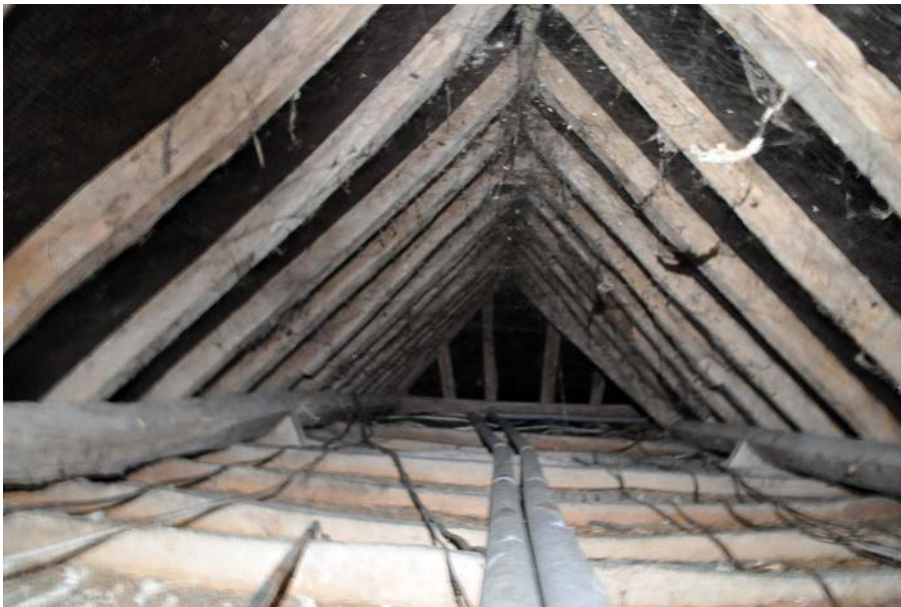
The cottage has a hipped roof with sprocketed deep overhanging eaves and is covered in modern concrete tiles (Plates 3, 4, 6, 11, 16). The structure of the roof is partially visible through the inspection hatches in Rooms 2 and 4. The roof space was not accessed during this survey. Four raking strut roof trusses (Trusses 1–4) are incorporated into a common rafter roof with ridge plate and with a single purlin along each side (Figure 5; Plates 38–42). The trusses appear to have been adapted to clasp the purlins, as all have evidence of trimming of the soffit of the principal rafters to aid the insertion of the purlins. In Truss 3, an additional fillet of wood has been added to wedge the purlin (Plate 40). Above Room 2 (at the west end of the west range), the rafters, other than the hip rafters, are modern replacements.

Plate 38: View east along roof space of E-W range showing rafters and Truss 2 (identifiable by ends of struts claspings purlins in middle distance).

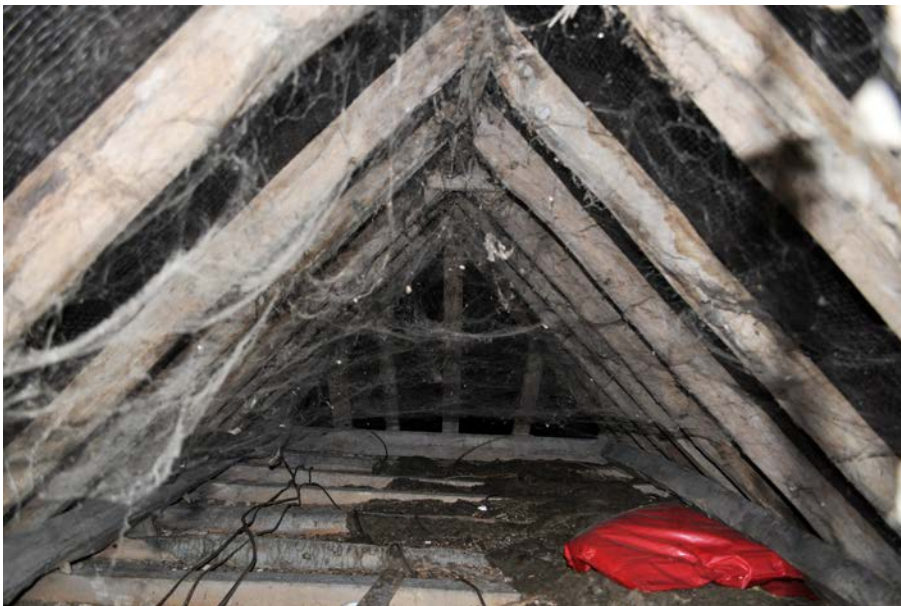
The ceiling is painted plaster. There is a roof truss (Truss 4) in the north part of the room. This has been boxed in but its presence can be seen in the roof space through the hatch in the bathroom (Plate 39).

Plate 39: View south along roof space in N-S range with truss 4 in middle distance.

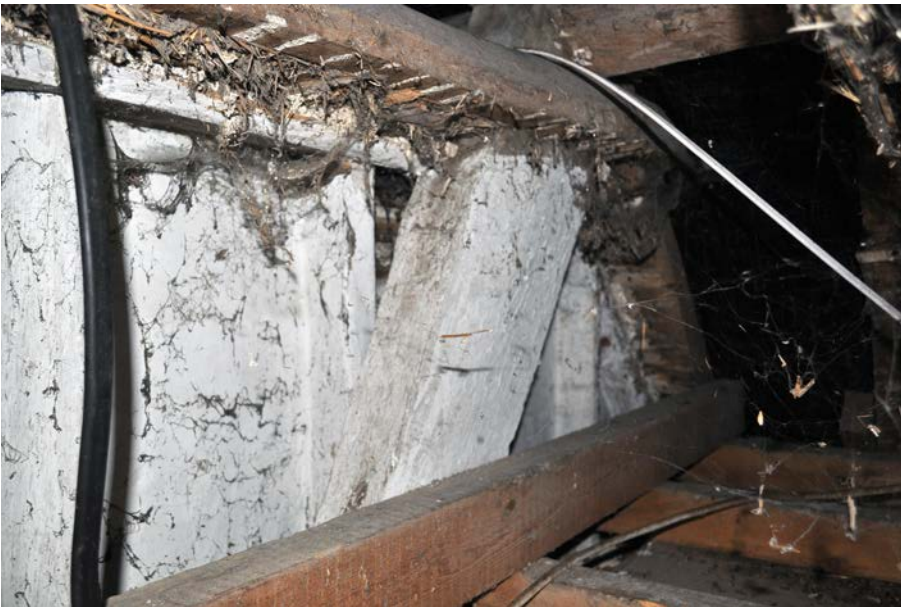
Plate 41: Detail of south end of Truss 1 showing whitewashed strut and partition below removed ceiling level.

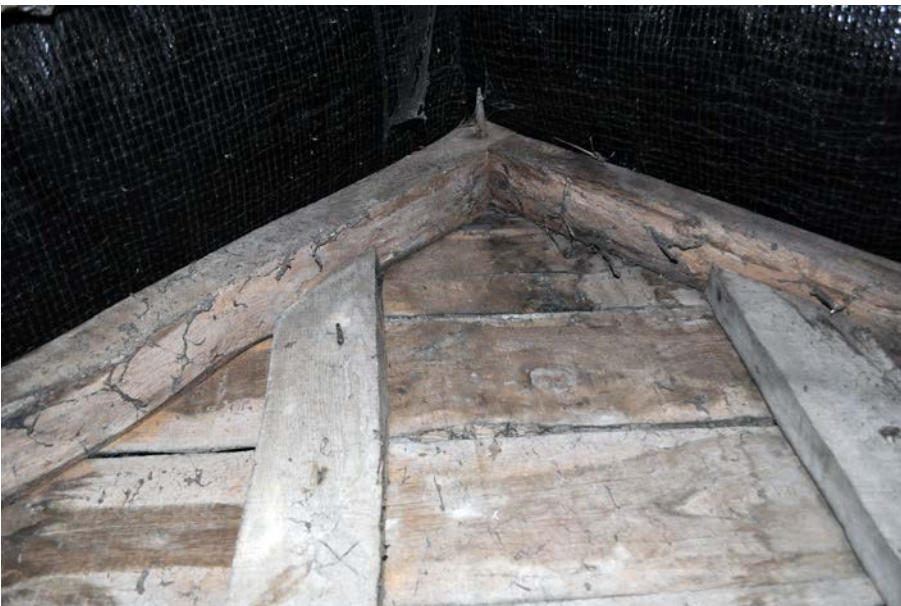
Plate 42: Upper part of west face of Truss 1 and timber partition above former ceiling level.
