South Street, Dorchester, Dorset

Archaeological Observations and Recording during Installation of New Refill Water Point

Report No. 53556/3/1

November 2020

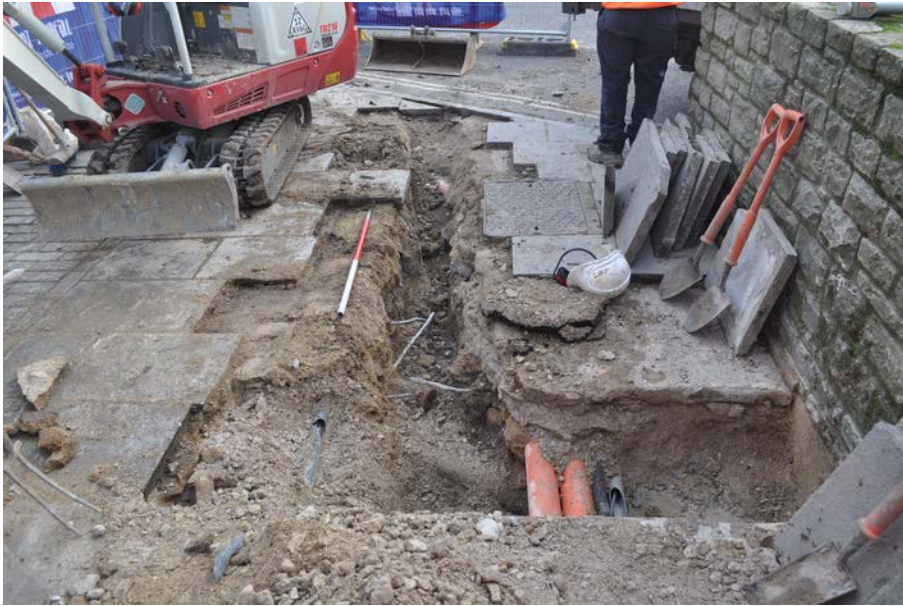
Plate 4: Trench in pavement after excavation, looking east. 1m scale.

The works included the removal of the existing paving slabs followed by the hand excavation of a trench between the new refill station base position out to the road in order to connect with the water main (Figure 2). The area of the new base measured 0.6 m by 0.6 m across and the trench was about 5.5 m long, 0.5 m wide and up to 0.45 m deep (Figure 2; Plate 4). The digging of the trench was complicated by the presence of a large number of services and thick areas of concrete. It proved impossible to insert the soakaway for the new refill station beneath the pavement and it was moved to beneath the road adjacent to the water main. The trench in the road was enlarged several times, firstly to locate and expose the water main and secondly to enable the construction of the soakaway. The trench in the road measured 2.2 m by 1.8 m across and up to 1.45 m deep at time of recording (Figure 2; Plate 6).

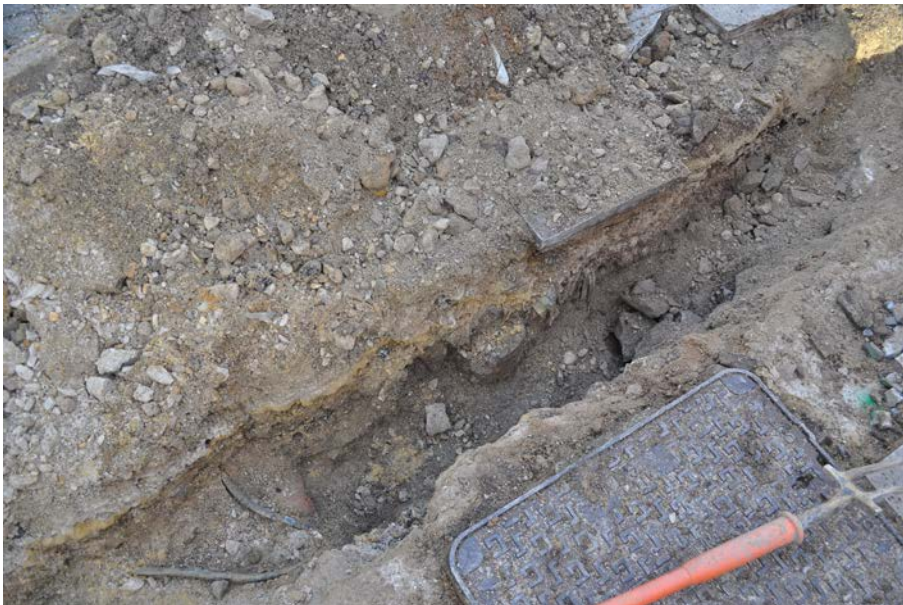
Plate 5: Cast iron lamp post remains, looking north.

The remains of a vertical circular cast iron structure (103) with yellowish mortar/concrete benching was found beneath the pavement (Figure 2; Plate 5). This was set into soil layer 102 and was only partially within the trench and is thought to be the broken-off remains of a former lamp post.

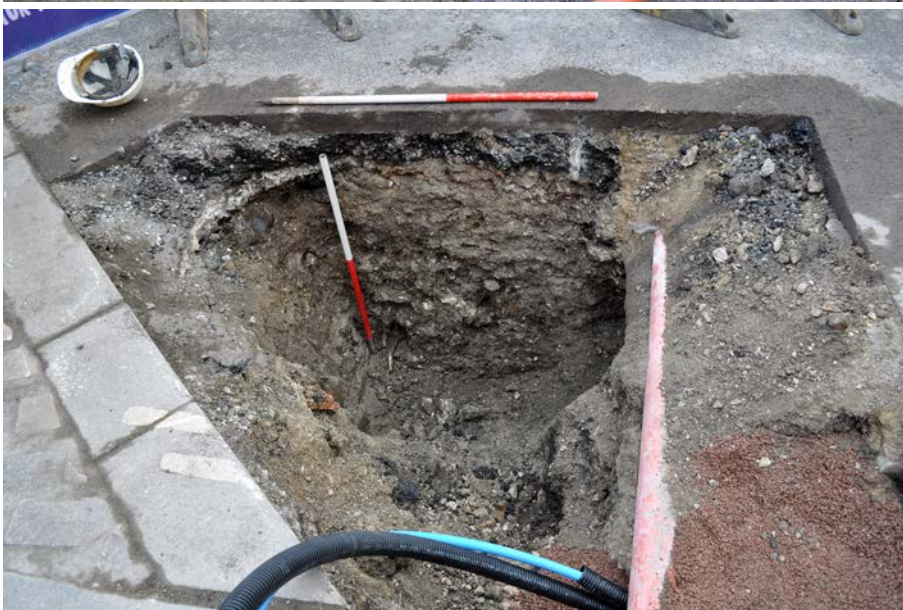
Plate 6: Trench in road showing soil layer 106. 1m scale.

The lowest deposit revealed during the works was a soil layer (106) over 0.8 m thick that was exposed in the trench in the road (Plate 6). This mid brown silty clay loam soil had mottles of reddish-brown clay and dark brown clay loam, and contained moderate to frequent chalk flecks and pieces, moderate flint nodules, and occasional limestone fragments. The base of this soil layer was not exposed but it continued down to a depth of over 1.45 m below modern ground level. A similar soil (102) was exposed at the base of the trench in the pavement and may be part of the same deposit.

The only deposit that is not clearly modern in origin is the soil layer 106 (and possibly 102). This soil was over 1.45 m depth below the road surface and no trace of the natural chalk was observed. Natural chalk was found at a depth of 1.05 m below the road about 5.4 m to the south and at 1.75 m depth about 2.8 m to the south during observations in 2002 (Bellamy and Pearce 2002) and in both of these exposures the top of the natural chalk appears truncated. These depths of natural chalk, taken together with the 1912 observations of a 35° angle slope in the natural chalk at the south end of South Street, just to the north of the site, (RCHME 1970) and the observation of the northern edge of the ditch in a gas main in South Street (Keen 1979), suggest that the site lies over the inner ditch of the Roman town defences (Figure 3) and that the soil deposit 106 was part of the upper fill. It is broadly similar in character to the upper fills of the outer ditch recorded at South Gate Junction in 2017 (Bellamy 2017). If this is the case, then the inner ditch appears to continue across the southern end of the present South Street. The position of the South Gate is uncertain, but projecting the lines of the Roman approach road from Radipole, the NE-SW street running across
