Nothe Fort, Barrack Road, Weymouth, Dorset

Archaeological Observations and Recording during Drainage Works
on the North Terrace, January 2021

Report No. 53547/3/1

January 2021

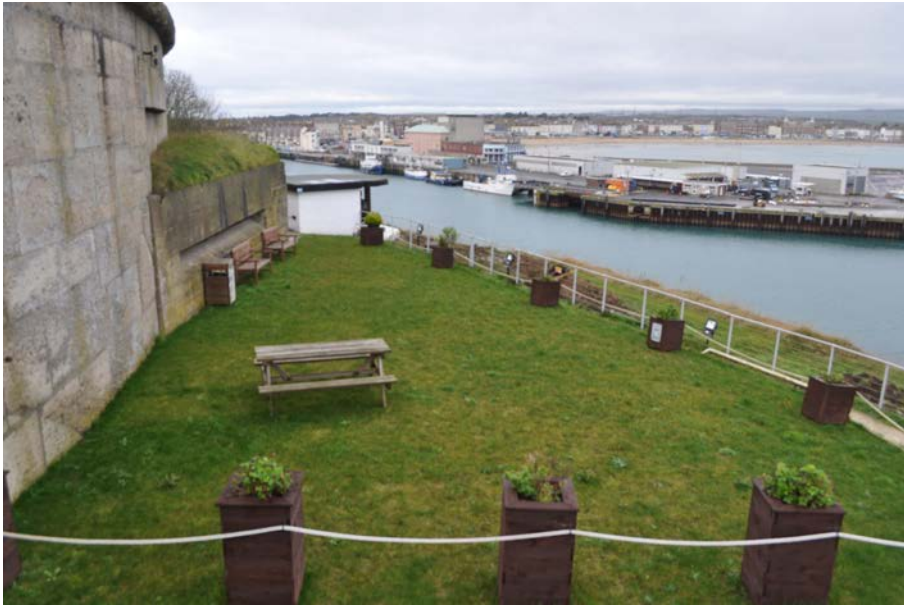
Plate 1: View westwards from the upper slope of the north terrace, with the excavated drain trench just beyond the metal fence.

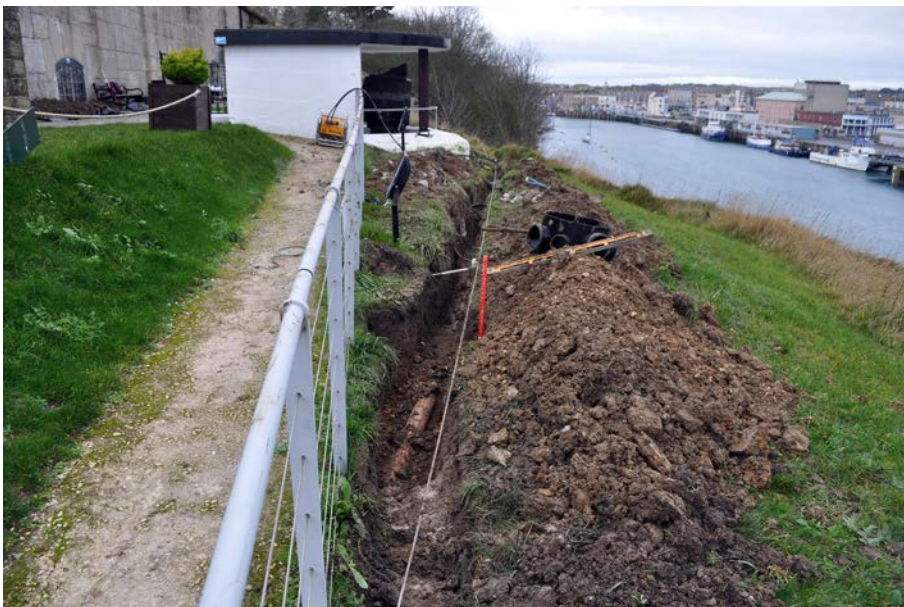
Plate 2: View of the emptied existing drain trench, looking east. 1m scale.

The eastern 19 m of the drain trench was dug along an existing foul sewer, which revealed a backfill of mixed reddish-brown and greyish-brown silty clay (101) over the plastic pipe. The backfill was sealed by a 0.15 m thick topsoil (100).

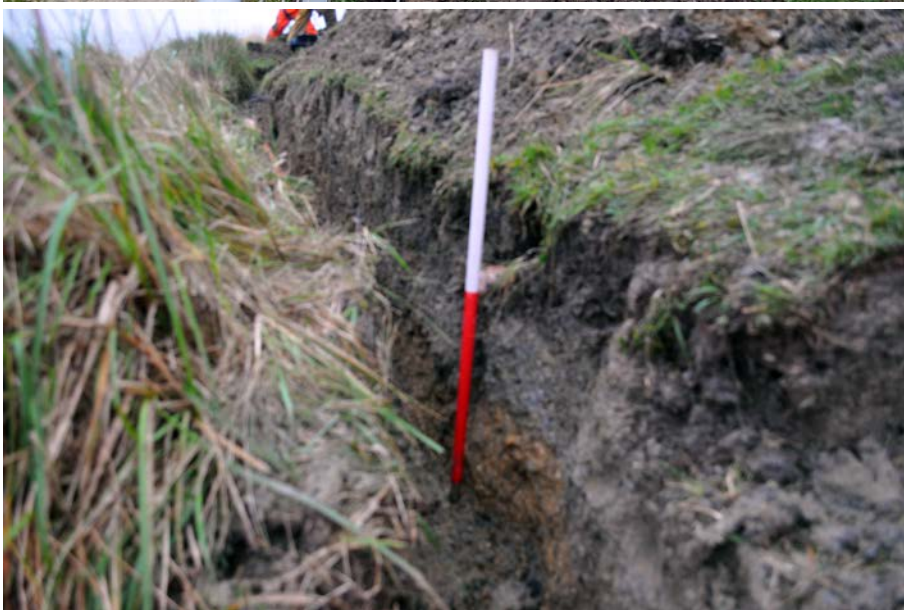
Plate 3: Detail of clay layers in east end of new drain trench, looking west. 1m scale.

The western 7.5 m length of the drain trench was dug through the earthen slope on the northern edge of the fort (Figure 2). This revealed a dark greyish-brown clay topsoil (100) 0.2 m thick overlying a 0.3 m thick layer of fairly soft friable mid grey clay (102), which overlay a deposit of firm reddish-brown clay with moderate small stone (103) over 0.2 m thick that continued below the base of the trench.
