**NEW FOUL DRAIN AND OTHER WORKS, LYTES CARY,
CHARLTON MACKRELL, SOMERSET
Archaeological Observations and Recording**

**NEW FOUL DRAIN AND OTHER WORKS, LYLES CARY,
CHARLTON MACKRELL, SOMERSET,
Archaeological Observations and Recording,
August 2005 – April 2006**

Report No. 53204/3/1

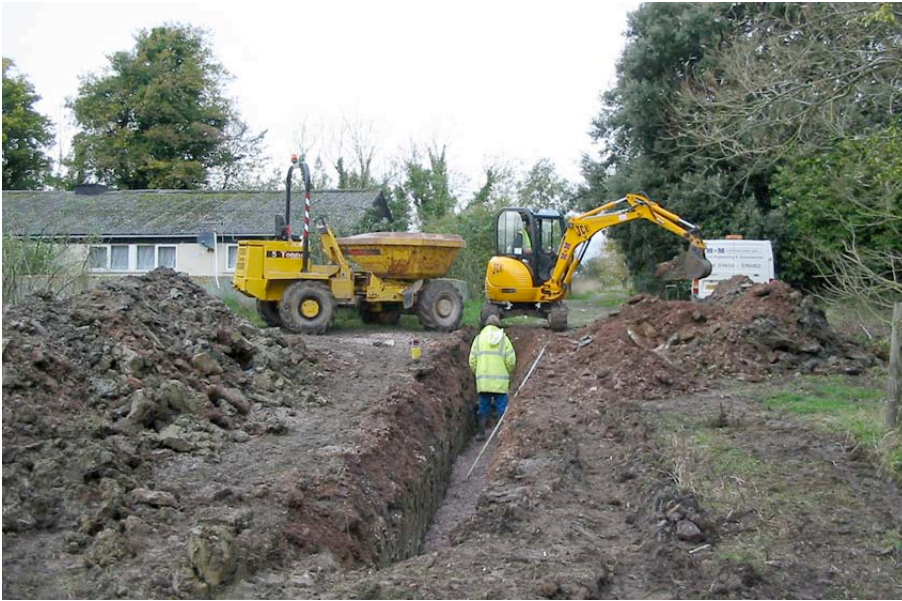
Plate 1: General view during excavation of foul drain trench (Trench 1), looking North.

The groundworks for the foul sewer (Trench 1) comprised the machine excavation of a continuous trench 0.7 m wide and 1.2 m deep (Plate 1), from the west side of Lytes Cary house along the track to a manhole connection to the south of the house, along the course shown on Figure 2. The observation of the pipe trench was partial, as defined by the Institute of Field Archaeologists, with a suitably qualified archaeologist present as and when seemed appropriate. For much of its course, the drain trench was dug immediately adjacent to a water main observed by Terrain Archaeology in 2004 (Bellamy 2004). The results of this earlier watching brief were largely negative and it was

The observed part of the trench was 74 m long by 0.7 m wide and up to 1.2 m deep. The underlying natural was a compact brown clay (101) containing bands of stone and patches of dark bluish-grey clay towards the base of the trench. Above this was the make-up of the track, which comprised a distinctive layer, up to 0.5 m thick, of tightly-packed pitched Lias slabs (102). This was identical to the track make-up further to the north. It was observed southwards up to about 10–20 m from the southern end of the pipe trench. The track to the south of the farmyard is now partly covered with topsoil and grass. At the east end of the farmyard, the pitched stone track structure was sealed by a layer of compact reddish-brown gravel scalplings (103), up to 0.35 m thick, part of the existing track through the farm. Most of the above deposits were sealed by a 0.2 m thick layer of greyish-brown clayey loam topsoil (100).

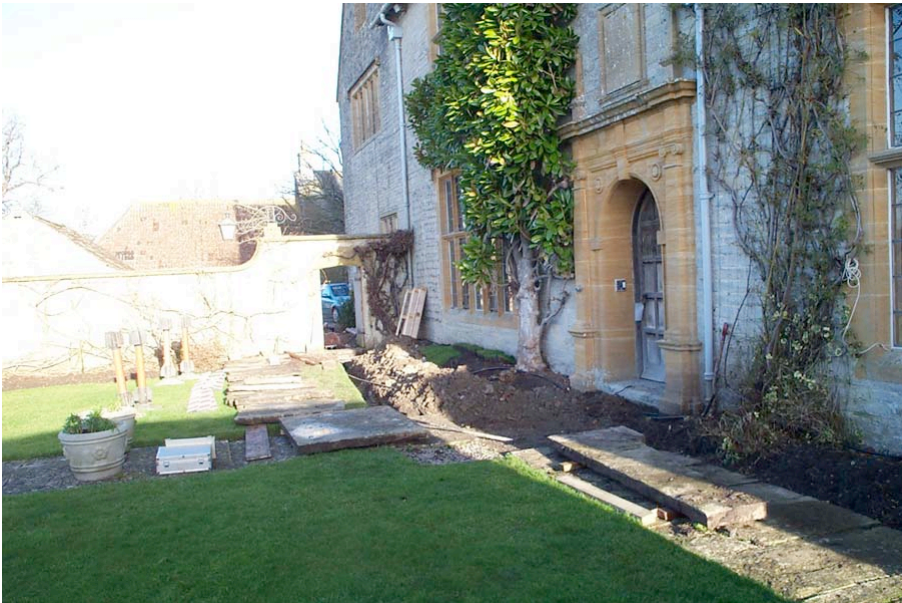
Plate 2: General view of Trench 2 along West Wing of Lytes Cary House, looking North.

Trench 2 ran parallel to the West Wing of the Manor House from the end of Trench 1 in the yard through the gate to the garden and up to the door (Figures 2 and 5). It was 11.5 m long, up to 0.5 m wide and 0.6 m deep and was excavated by hand after the removal of the Lias flagstone path (Plate 2). The trench was not deep enough to expose the underlying natural clay.

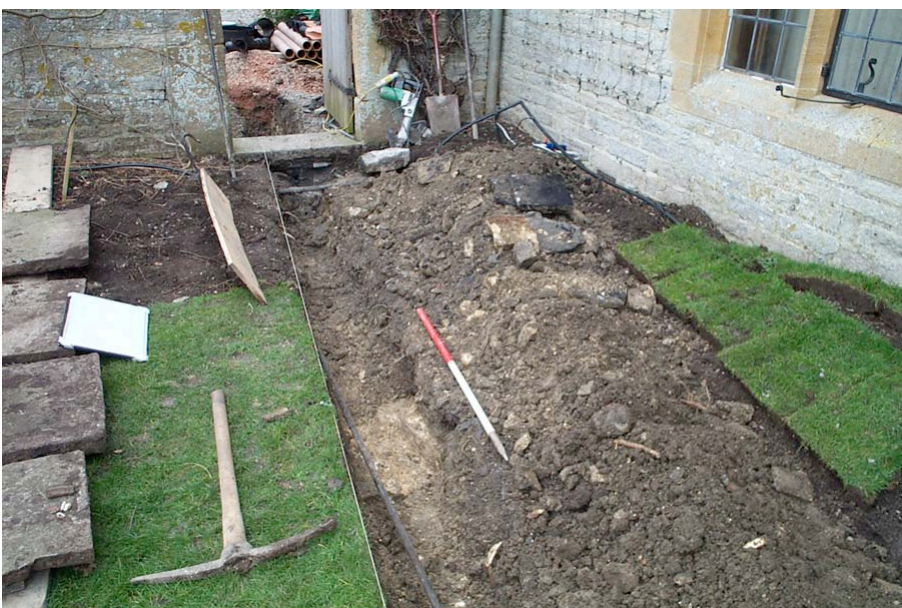
Plate 3: Wall 110 exposed in base of Trench 2.

The truncated remains of two walls were found running roughly perpendicular to the West Range (Figure 5). The northern wall (110) was 0.6 m wide and comprised roughly coursed limestone, bonded with lime mortar (Plate 3). This wall is on the precise line of the south wall of an outhouse built on the end of the North Wing during the 19th century, as shown on the 1903 Ordnance Survey map (Figure 3). It is likely that wall 110 is the remains of the south wall of this building, which was demolished when the West Wing was constructed in c. 1907. No traces of any internal surfaces were found, but these may be more deeply buried. About 1.5 m to the south was another similar mortared limestone wall (113), 1.0 m wide (Figures 5–6; Plate 4). This footing is on the line of the north wall of a garden on the south side of the house (Figure 3), which was constructed pre-1886 and enlarged from a paddock shown on the 1809 enclosure map (SVBRG 2005). It is likely that this is the remains of this garden wall and which was also demolished in order to construct the West Wing in c. 1907.

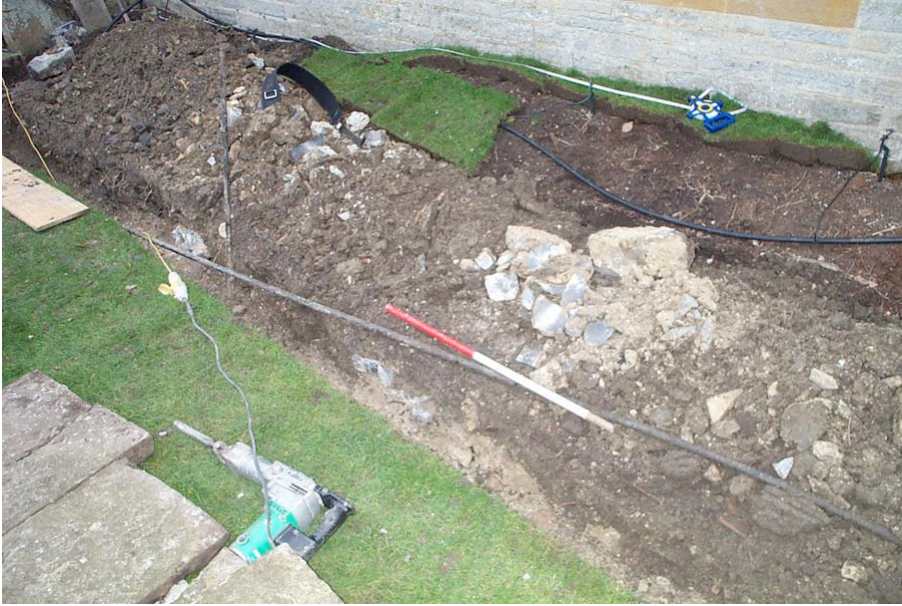
*Plate 4: Wall 113
exposed in Trench 2.*

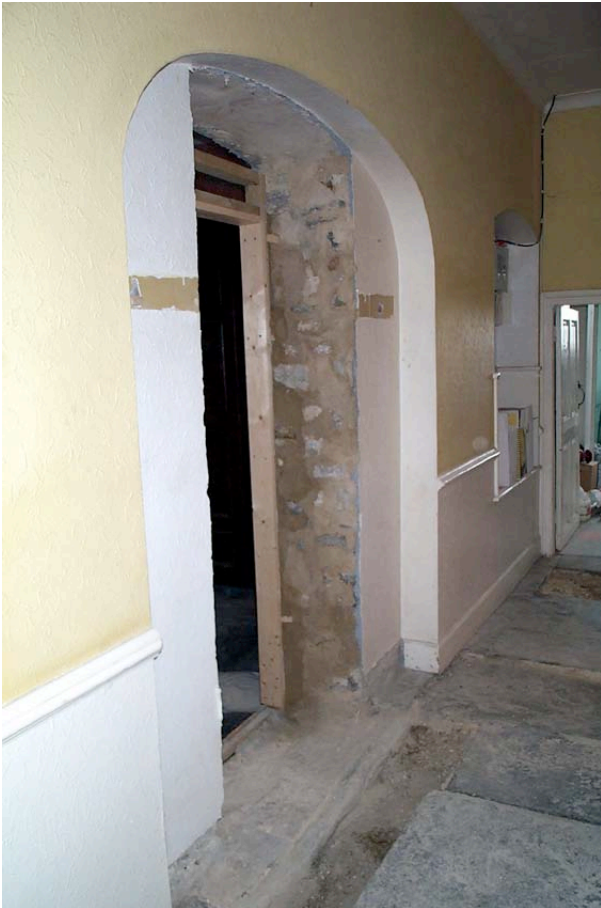
*Plate 5: View westwards along corridor in
North Wing of the house showing location
of Trench 3.*

Trench 3 was located across a blocked doorway between the Gallery in the West Wing and the corridor to the Kitchen in the North Wing (Figure 7, Plate 5). This part of the house is thought to have been built in the mid 17th century and may have been originally constructed as a brewhouse (SVBRG 2005). The Gallery was added in c. 1907. The stone blocking of the opening was removed prior to the archaeological observations. This trench was dug to allow access for pipework from the Gallery into the corridor. It was L-shaped, running beneath the doorway then turning along the corridor of the North Wing towards the Hall (Figure 8) and measured 1.5 m by 0.4 m across and up to 0.55 m deep.

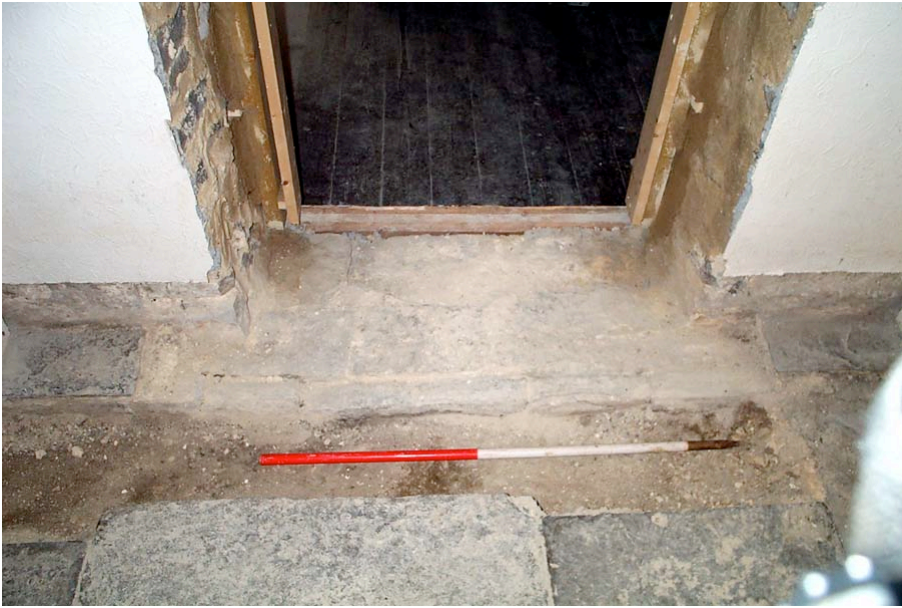
Plate 6: View of wall footings 119 in Trench 3.

The footings of the south wall of the North Wing were exposed and a section cut through them (Plates 6–7). The footings (119) comprised Lias blocks (up to 700 mm x 400 mm x 120 mm across) mainly laid horizontally, but with vertically-set slabs along the northern side, bonded with lime mortar (Figure 8). Along the northern edge of the footings was another row of vertical Lias slabs, which appear to be sitting in the top of the footings trench (Figure 8). The function of this vertical setting is unclear, but may be the remains of a stone drain running along the inside edge of the room.

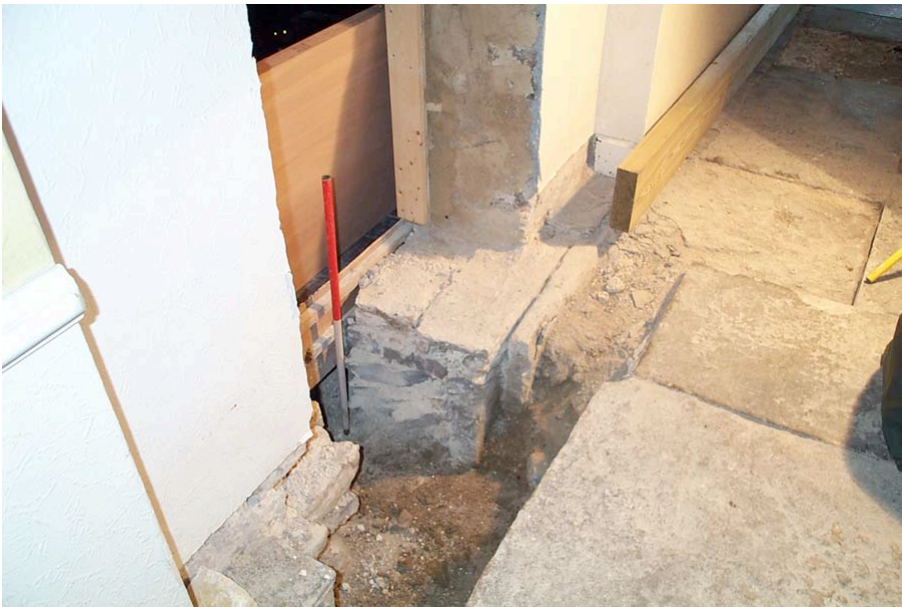
Plate 7: View of trench cut through wall footings 119.

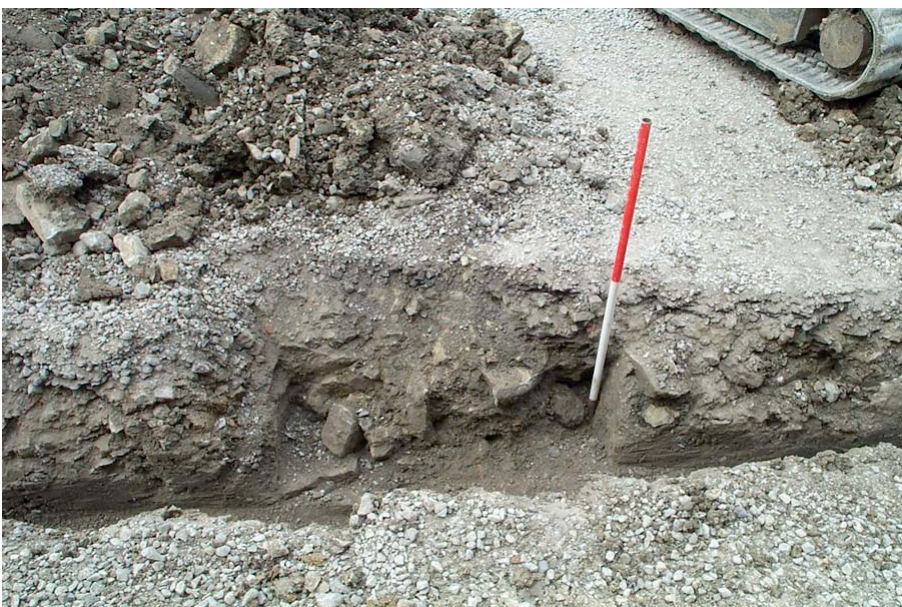
Plate 8: Feature 124, looking north, in Trench 4.

The underlying natural consisted of a compact mid brown clay (125) containing Lias fragments. At the eastern end of the trench, a vertically-sided, possibly rectangular feature (124) was found cut into the natural clay (Plate 8). This feature was one metre wide and over 0.35 m deep and was filled with a firm, mid yellowish-brown clayey loam (123) containing a large quantity of large, partly void, limestone and Lias stone rubble. There appeared to be no structure to the rubble and it may, therefore, represent a soakaway associated with earlier drainage for the house.

Evidence from the trench excavated in the yard outside the North Wing of the house would indicate that this area has been used as a yard for some time and the arrangement of outbuildings has probably changed very little. The large stone-filled feature found near to the door of the North Range may have been a soakaway.
