**LAMBERT TOMB, ST MICHAEL'S CHURCH,
WINTERBOURNE STEEPLETON, DORSET**
Archaeological Evaluation

Report No. 53148.1

February 2005

Lambert Tomb, St Michael's Church, Winterbourne Steepleton, Dorset Archaeological Evaluation, February 2005

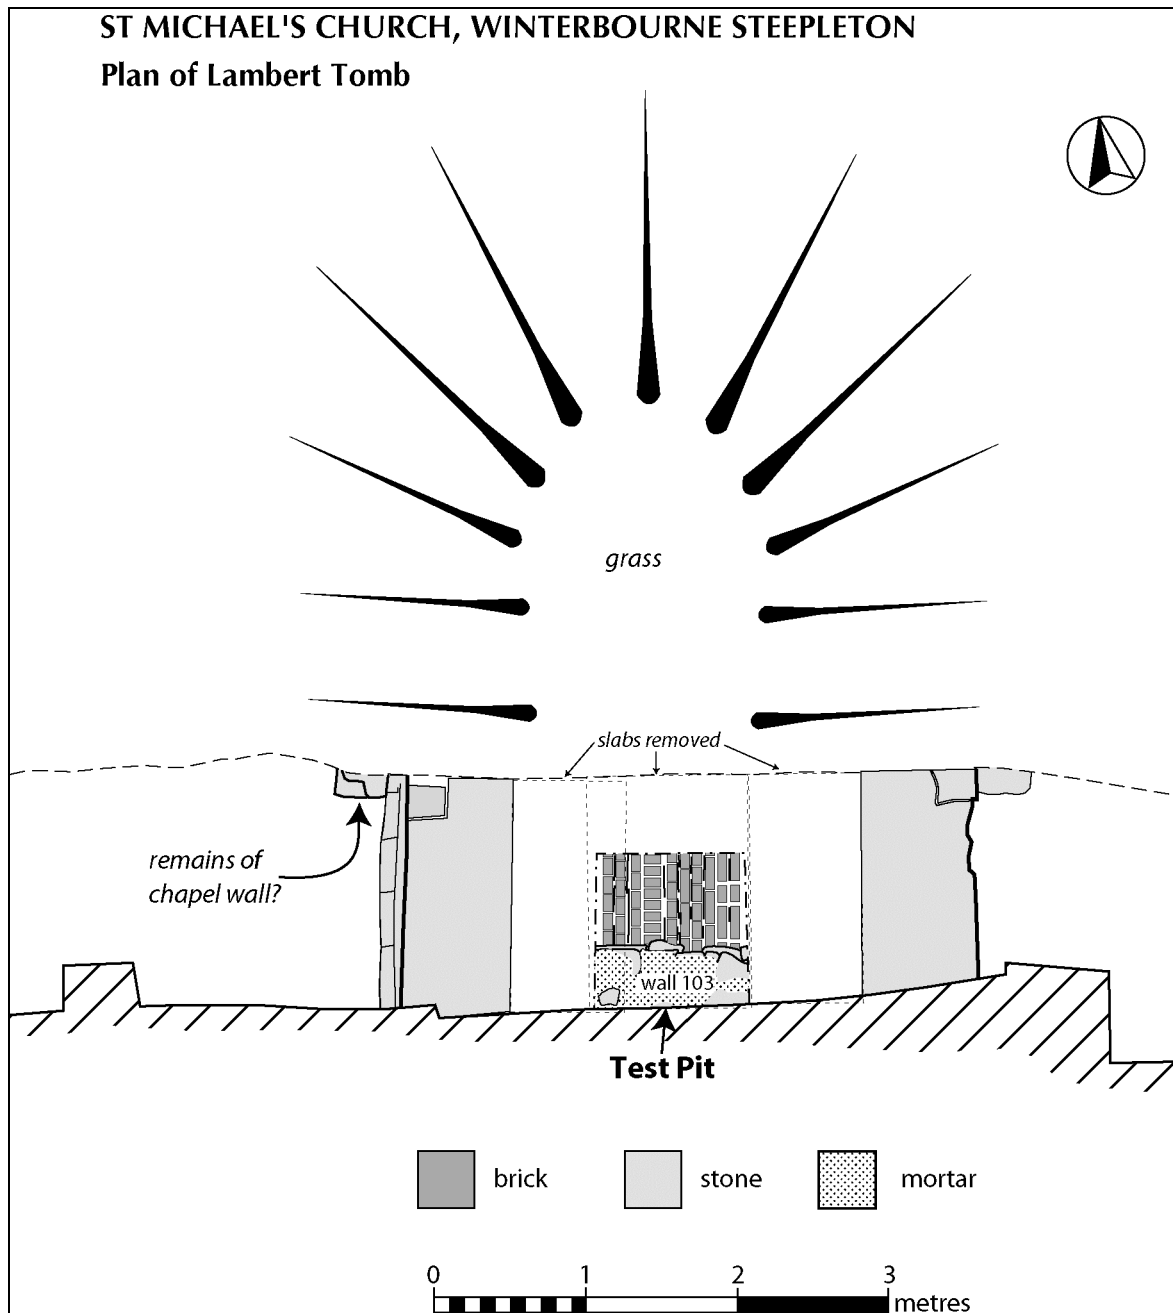
Figure 2: Plan of the Lambert Tomb, showing location of Test Pit.

A single hand-excavated test pit (Test pit 1) was excavated through the highest point of the Lambert Tomb, against the exterior of north wall of the church (Figure 2). The original size of the test pit was 1 m by 1 m, but the remains of a stone retaining wall were found at the southern end and consequently the size of the pit was reduced to about 0.6 m by 1 m, in order to leave the wall *in situ*. It was dug to a maximum depth of 0.92 m. Excavation was halted when structural remains were encountered.

The results of the test pit excavation have provided sufficient information to enable the general structure of the Lambert Tomb to be understood, but not enough to allow a complete reconstruction to be attempted. The plan and section of the tomb are shown on Figures 2 and 3.

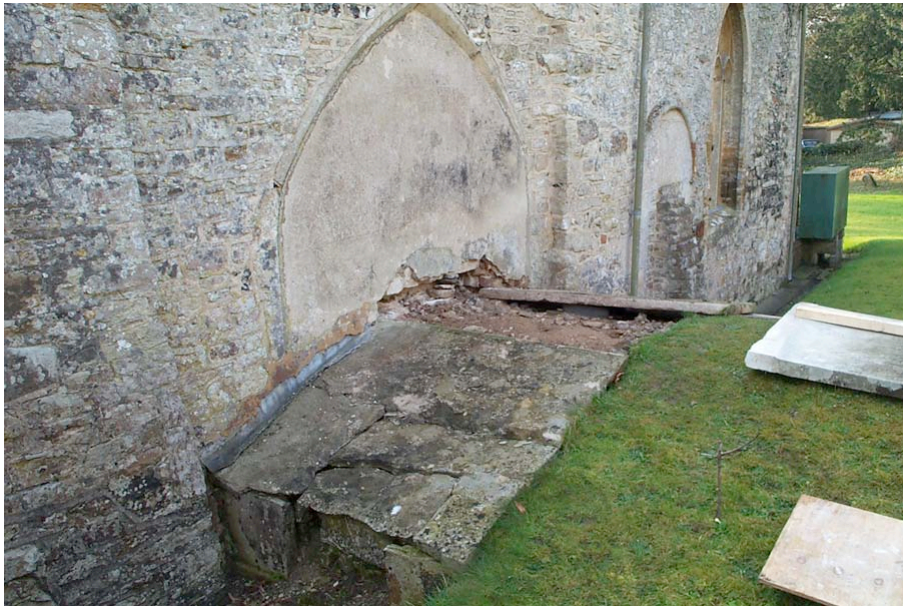
Plate 1: View of stone structure of the Lambert Tomb during stone removal. Viewed from northeast.

Prior to the commencement of the archaeological evaluation, the three central stone slabs had been removed by Sue and Laurence Kelland, exposing the soil layer beneath.

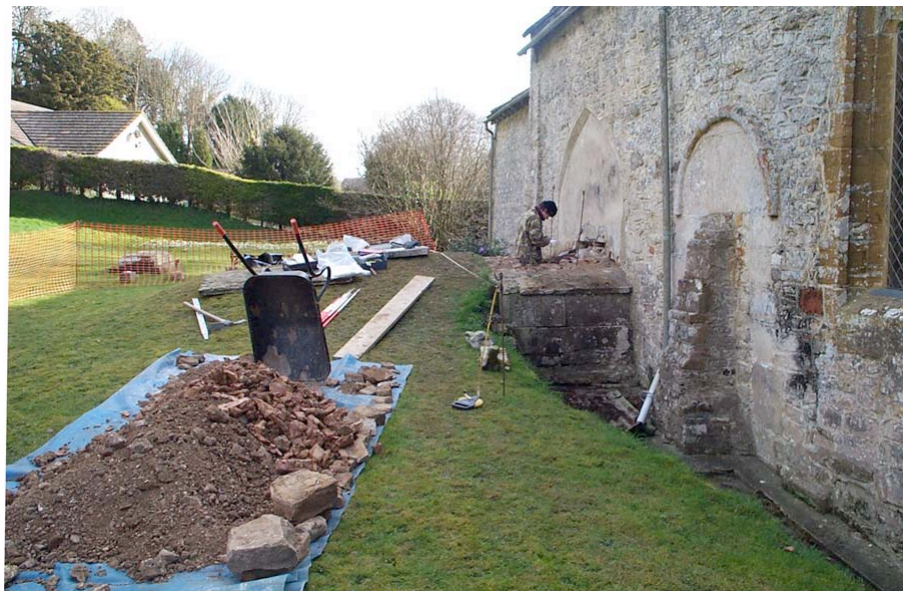
The east and west stone walls of the tomb extend 1.5 m from the church wall, and comprise lower courses of large limestone blocks with the main part of the wall formed by more finely dressed tabular slabs set near-vertically (Plate 2). One of the near-vertical slabs from the eastern side has fallen loose and is lying on the ground nearby. These walls are in a poor state of repair. It is roofed by four large rectangular limestone slabs, jointed together, with a large rectangular gravestone, bearing the inscription "LAPIS SEPVLCRALIS LAMBERT MDCCLXIV", set horizontally at the apex. The southern ends of the slabs are slightly rebated into the church wall, with the junction between the rendered wall and the slabs protected by some now rather tatty lead flashing. The easternmost and westernmost slabs have had a square section removed at the northeast and northwest corners respectively. These have been replaced with another stone of a similar size, and may represent the location of some sort of ironwork railing structure, now removed, around the slabs. The easternmost and westernmost slabs are in poor condition, with stone flaking off the upper surfaces. The easternmost slab is broken into several pieces.

Plate 2: General view of tomb during excavation. Viewed from west.

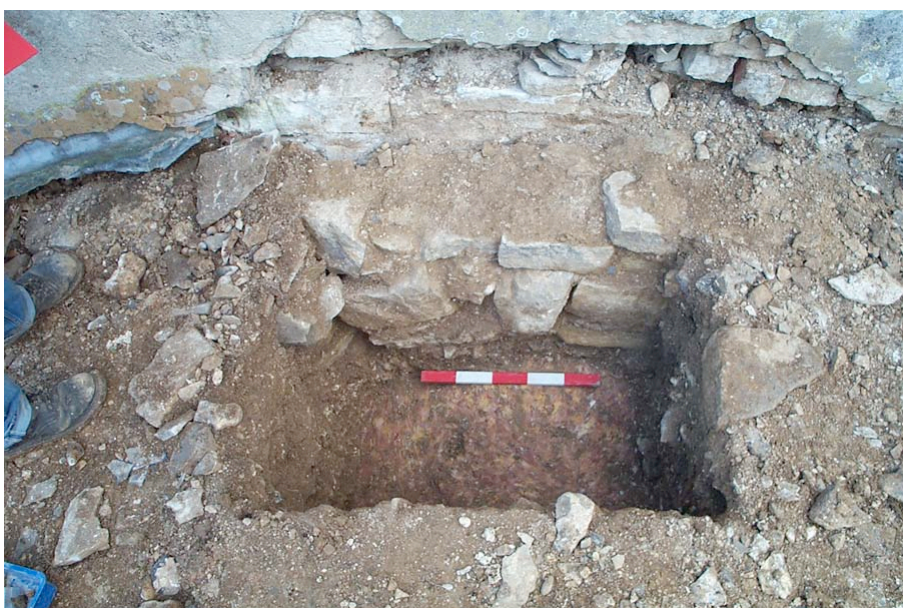
The vault was then sealed by a capping of hard-packed mottled orange, buff, and rust coloured clay (105), with sparse natural flint gravel cobbles between 20–40 mm across. The upper surface of this clay layer echoed the curve of the underlying barrel vault. This clay was probably applied to seal and waterproof the vault.

The earthen structure of the mound was then built over the burial vault and its clay capping. Initially there appears to have been a 0.2 m thick layer of compact light brown clay loam (108) with frequent chalk fragments and occasional small lumps of mottled clay deposited over the clay capping 105. A rough wall (103) was built on top of this layer, butting against church wall. It was 0.3 m wide and 0.45 m high, and comprised large roughly dressed limestone blocks, up to 300 mm by 180 mm across, bonded with a medium compact buff brown lime mortar. The top of this wall appears to have been disturbed and some of the upper course is missing (Plate 3). The stone in this wall may be reused stone from the North Chapel. The function of this wall is not known. It may have been built to support the stone slabs which form the roof of the structure, or may have helped to contain the soil and prevent it from lying directly against the church wall.

Plate 3: Test pit 1 during excavation, showing wall 103 and top of clay capping 105. Viewed from north.

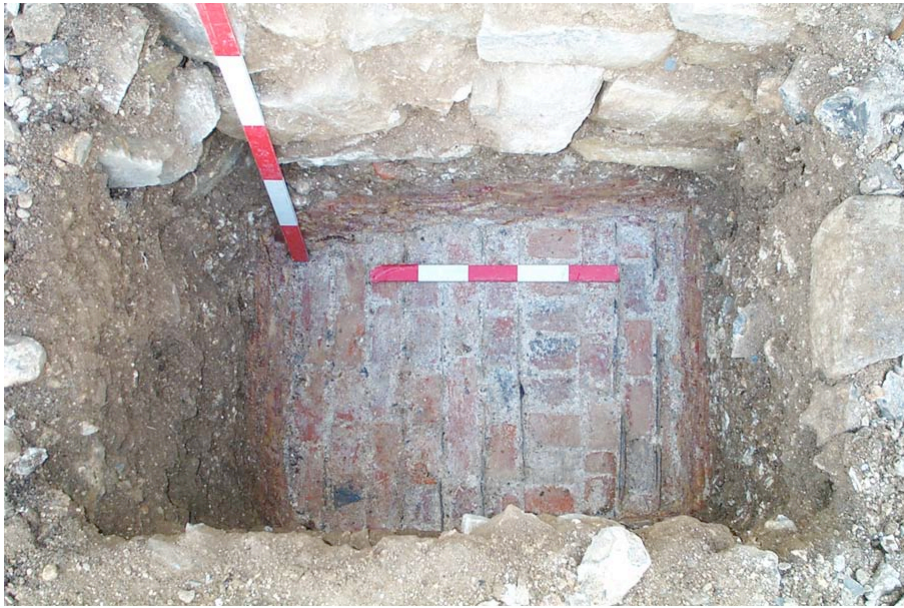
At the core of the mound is a brick vault (107). Its full dimensions and shape are not known. The upper surface of the vault was encountered at a depth of between 0.76 m and 0.89 m below the top of the tomb (at between 91.96 m and 91.81 m OD). The apex of the vault lay in the western part of the test pit (Figure 3). This was some 0.2 m – 0.5 m to the west of the apex of the blocked north chapel arch in the north wall of the nave. Not enough was exposed to enable the full width of the vault to be projected. The upper surface of the vault lay some 2.7 m below the top of the former opening of the chapel; corresponding measurements inside the church show that the upper surface of the vault is some two thirds of the way up the wooden wainscoting. Access to the tomb from within the church would have been down a flight of steps. The vault dipped down to the north (Plate 6).

The bricks of the vault were handmade, measuring 225 x 110 x 60 mm ($8\frac{7}{8} \times 4\frac{3}{8} \times 2\frac{3}{8}$ inches) and are probably 18th century in date. They were laid in a rather irregular fashion. With large pieces of slate inserted into some of the joins to fill up the splay caused by the barrelling (Plate 4). Some of these pieces of slate stood proud of the bricks to a maximum height of 20 mm. The mortar was a compact off-white lime mortar with small sharp crushed flint fragments (10 mm max.) intermixed. The bricks and slate were covered by a thin layer of mortar (106), between 20–30 mm thick. This mortar was similar to the mortar in between the bricks — i.e. an off-white lime mortar with crushed flint inclusions, but in layer 106 the flint inclusions were larger (up to 30 mm) and more frequent.

Plate 4: Test pit 1 after excavation, showing top of brick vault 107. Viewed from north.

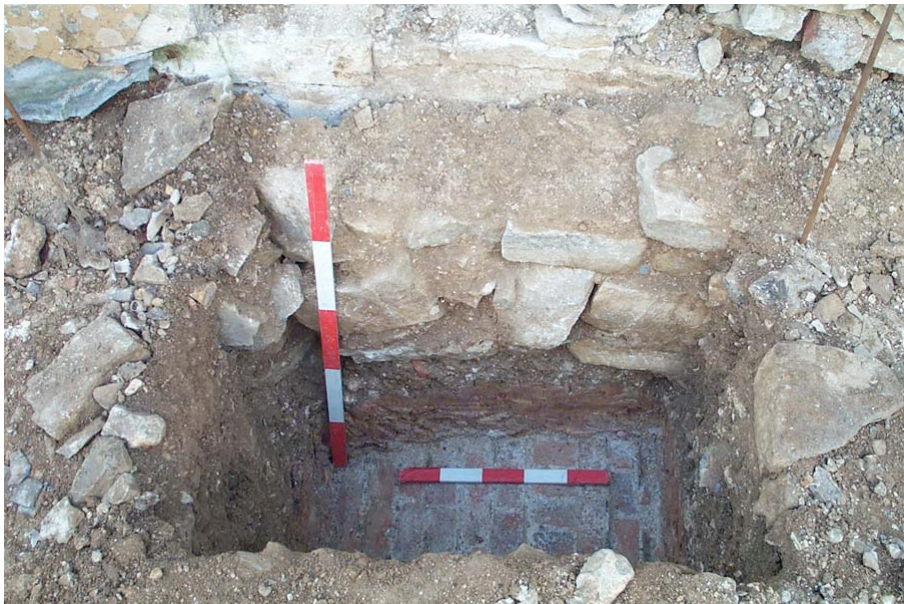
Plate 5: Test pit 1 after excavation, showing detail of north-facing section.

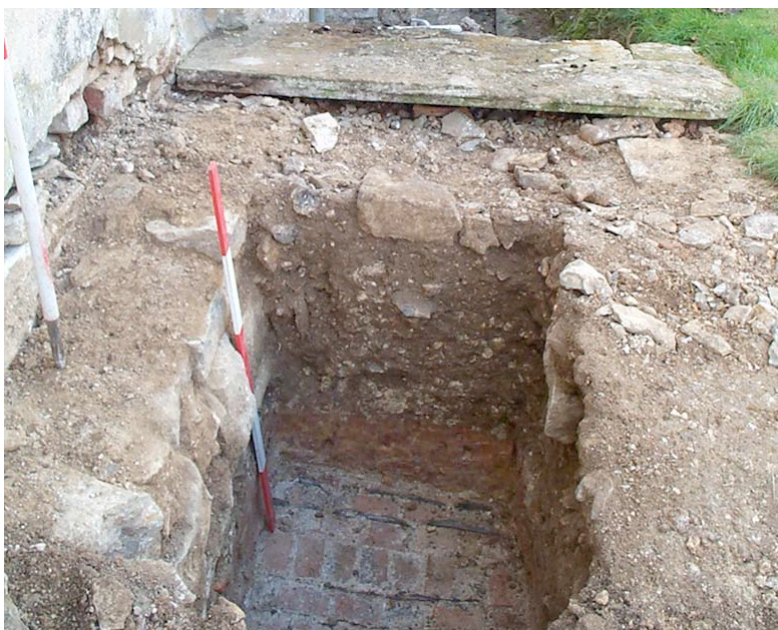
Plate 6: Test pit 1 after excavation, showing detail of east-facing section.
