**FENCING WORKS, BRATTON CAMP, WESTBURY,  
WILTSHIRE**  
**Archaeological Observations and Recording**

**Report No. 53313/3/1**

**July 2010**

**Archaeological Observations and Recording, June 2010**

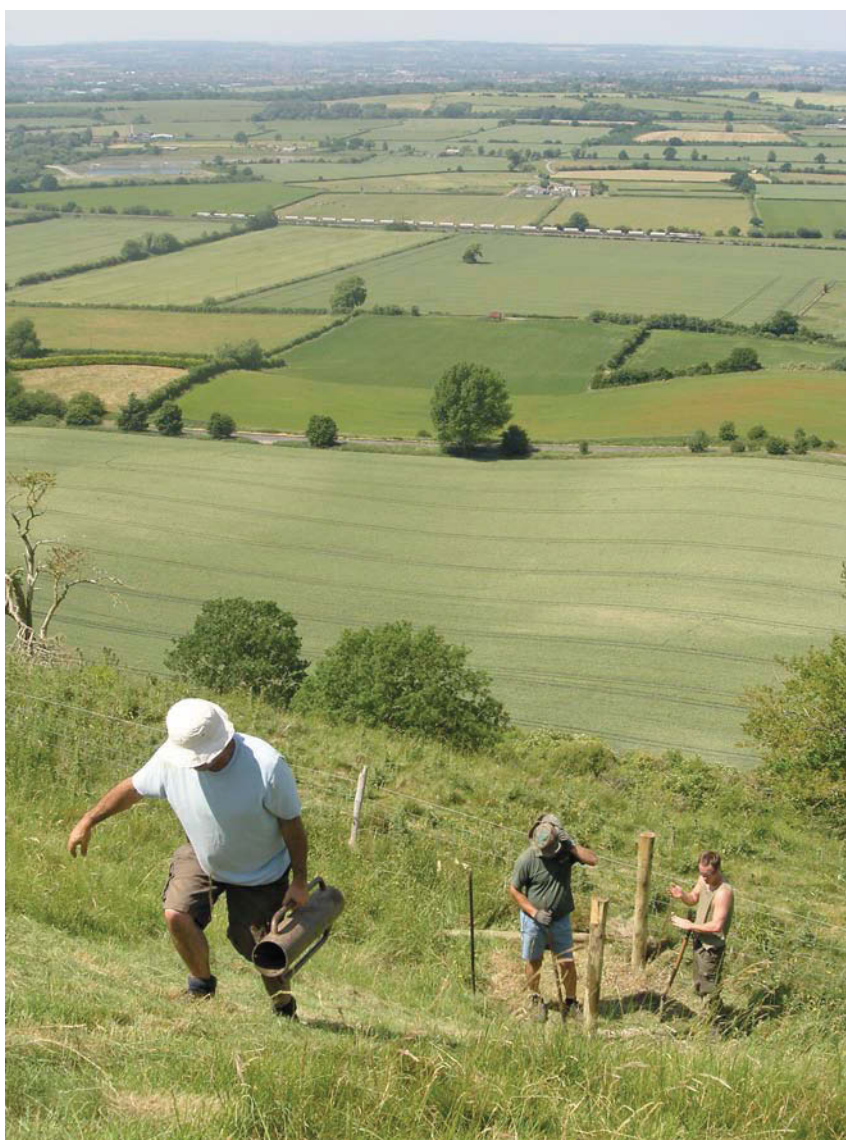
Front cover: *View of fencing works (post holes 5 and 6) looking north from the ramparts of Bratton Camp*

Post hole 5 was situated NNW of Hole 2, part-way down the natural escarpment slope, adjacent to the inner edge of a level 'bench'. It was circular with a diameter of 0.4 m, and was about 0.6 m deep (the post was partly percussion-driven). The exposed soil profile comprised 0.2 m of turf dark humic loamy silt over 0.2 m of dark humic loamy silt containing common 'pellety' chalk. Below 0.4m below ground level was denser fragmented chalk: It is unclear whether or not this represents a natural deposit.

Post hole 6 was situated about two metres NNW of Hole 5, against the existing post and wire fence along the centre of the escarpment bench (see above). It was circular with a diameter of 0.4 m, and was about 0.6 m deep (the post was partially percussion driven). As with Hole 5, the exposed soil profile comprised about 0.2 m of turf dark humic loamy silt over about 0.2 m of dark humic loamy silt containing common 'pellety' chalk. Below about 0.4 m below ground level was denser fragmented chalk: It is unclear whether or not this represents a natural deposit.

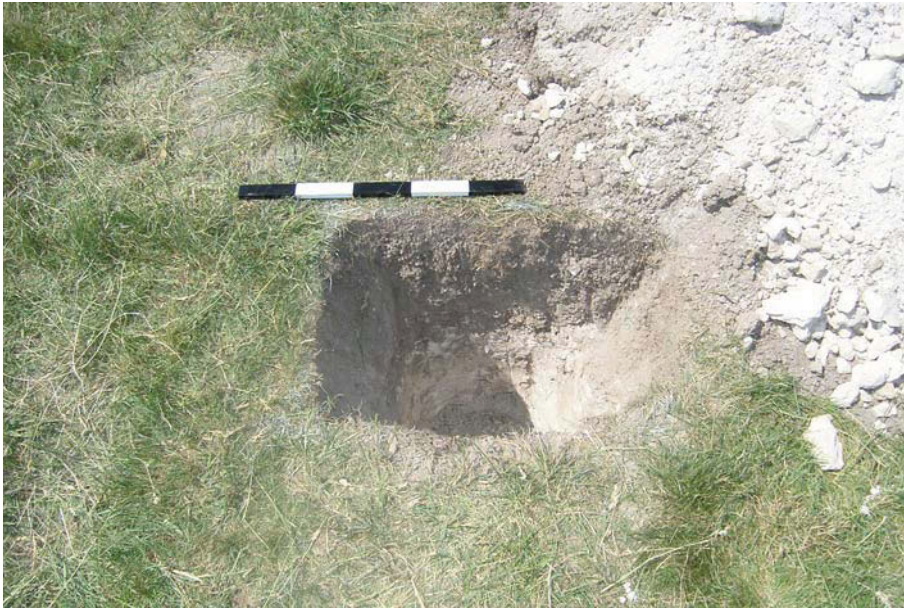
Plate 1: Detail of post hole 1 (0.5m scale).

Post hole 1 (plate 1) was situated about two metres NNW of the existing post and wire fence flanking an agricultural access spur off the Portway. It was rectangular, 0.5 m x 0.3 m across, and about 0.8 m deep. The exposed soil profile comprised 0.35 m of turf and friable mid-light brownish-grey loamy silt with occasional small chalk and flint pieces over clean, bedded chalk bedrock.

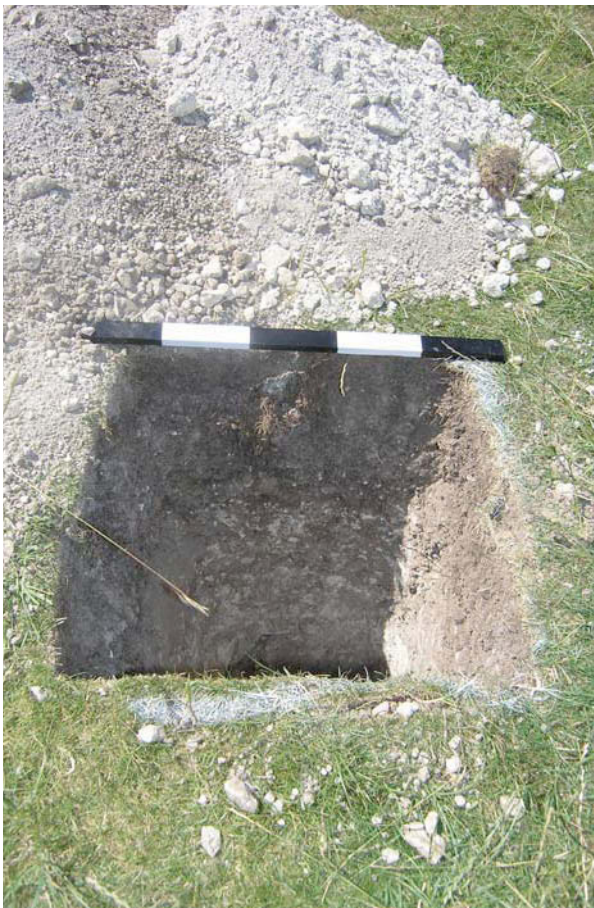
Plate 2: Detail of post hole 3 (0.5m scale).

Post hole 3 (Plates 2 & 3) was situated about 70 m NNW of the existing post and wire fence (see above), some two metres SSE of Hole 2. It was square, 0.4 m x 0.4 m across, and about 0.8 m deep. The exposed soil profile comprised 0.2 m of turf and friable mid-light brownish-grey loamy silt with occasional small chalk and flint pieces over clean, bedded chalk bedrock.

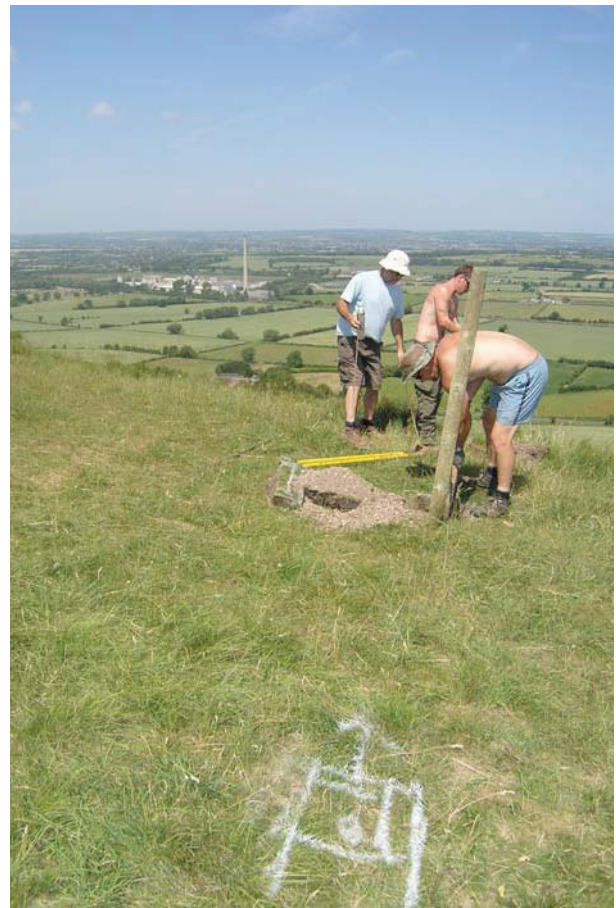
Plate 3: Location of post holes 2 and 3, position of post hole 4 marked in the foreground.

Post hole 2 was situated about 72 m NNW of the existing post and wire fence (see above), almost precisely on the upper lip of the escarpment slope. It was circular with a diameter of 0.3 m, and was about 0.5 m deep. The exposed soil profile comprised 0.2 m of turf and friable mid-light brownish-grey loamy silt with occasional small chalk and flint pieces over clean, bedded chalk bedrock.

Post hole 4 was situated about 67 m NNW of the existing post and wire fence (see above), some three metres SSE of Hole 3. It was rectangular, 0.5 m x 0.4 m across, and about 0.8 m deep. The exposed soil profile comprised 0.25 m of turf and friable mid-light brownish-grey loamy silt with occasional small chalk and flint pieces over clean, bedded chalk bedrock.

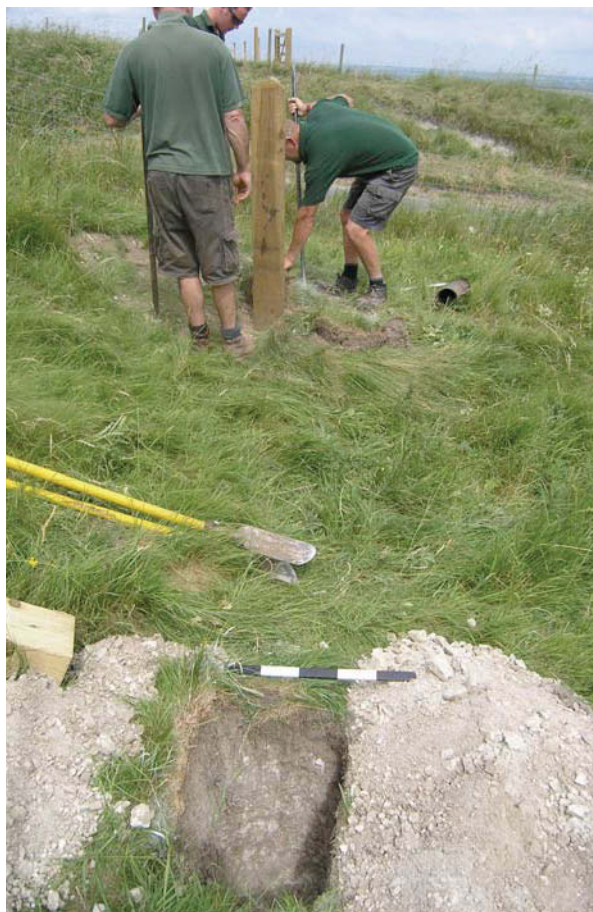
*Plate 4: Post hole 8 with new gate post marking location of post hole 7.*

Post hole 7 was situated about 2.5 m SSE of the existing post and wire fence flanking the Portway. It was situated near the base of the upper rampart scarp and was rectangular, measuring 0.7 m x 0.3 m, and about 0.8 m deep. The exposed soil profile comprised 0.6 m of turf and friable mid-light brownish-grey loamy silt with occasional small chalk and flint pieces over similar soil containing more frequent (c. 30%) fragmented chalk. Natural chalk was not seen.

Post hole 8 (Plate 4) was situated about five metres NNW of the existing post and wire fence (see above), 2.5 m SSE of Hole 7. It was also sited on the lower slope of the rampart scarp. It was rectangular, measuring 0.6 m x 0.3 m, and about 0.8 m deep. The exposed soil profile comprised 0.4 m of turf and friable mid-light brownish-grey loamy silt with occasional small chalk and flint

pieces over similar soil containing more frequent (c. 30%) fragmented chalk. Natural chalk was not seen.
