**MAINTENANCE DREDGING & BEACH REPLENISHMENT,  
LYME REGIS & WEST BAY HARBOURS, WEST DORSET  
Archaeological Desk-based Assessment**

**Report No. 53327/1/1**

**October 2010**

**Archaeological Desk-based Assessment**

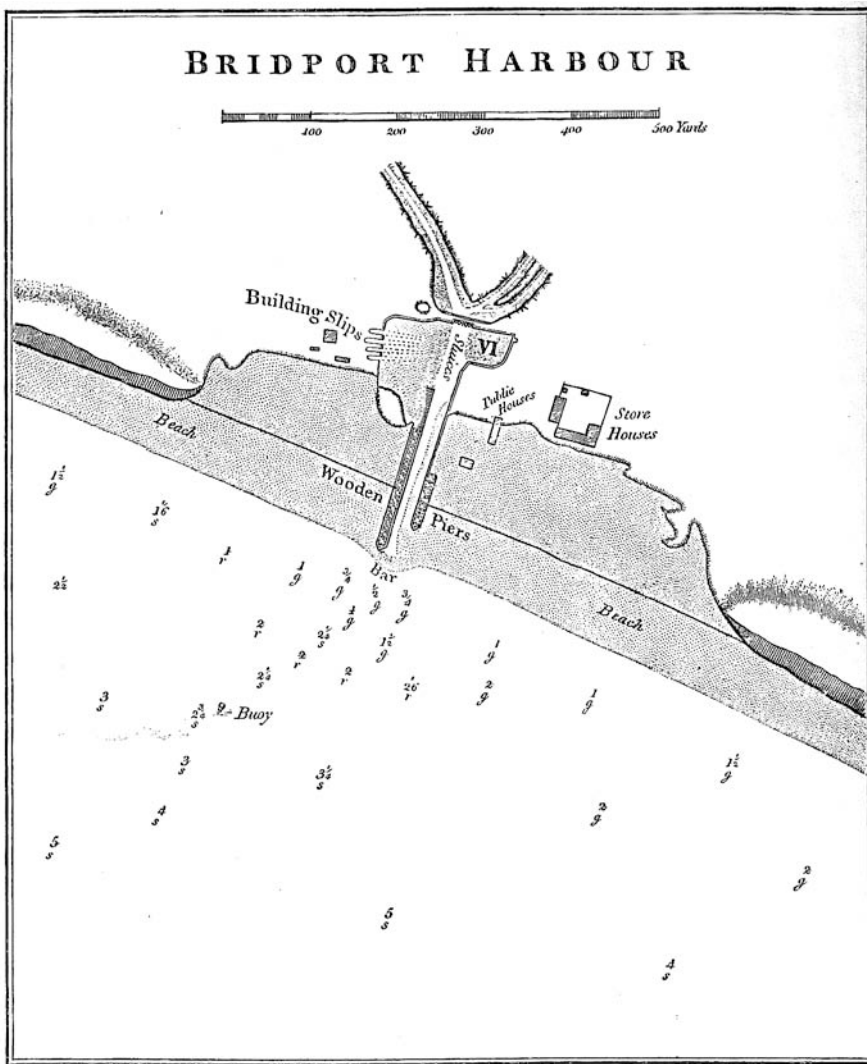
1787.

Figure 8: Plan of Bridport Harbour, 1787 from chart by Lieut. Mackenzie (reproduced in Symonds 1912).

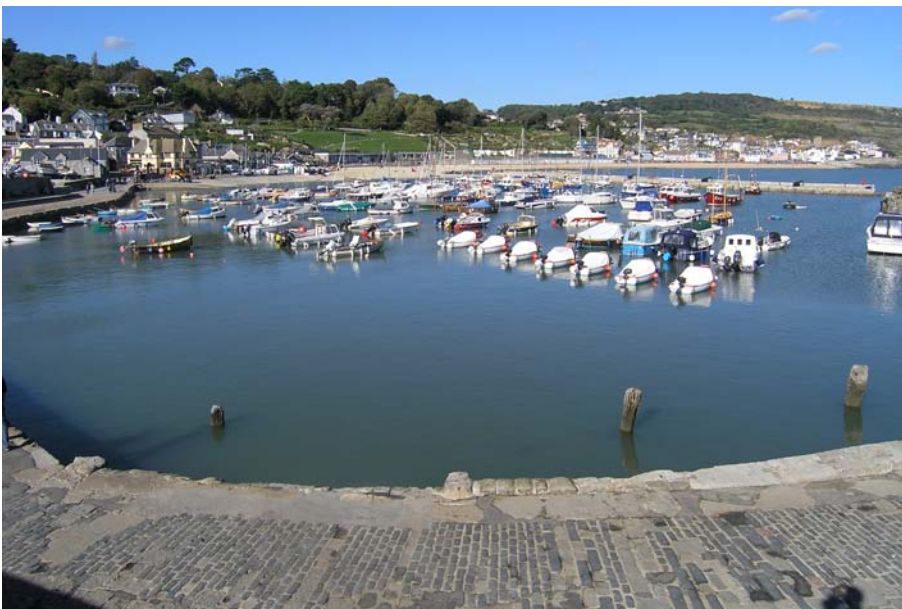
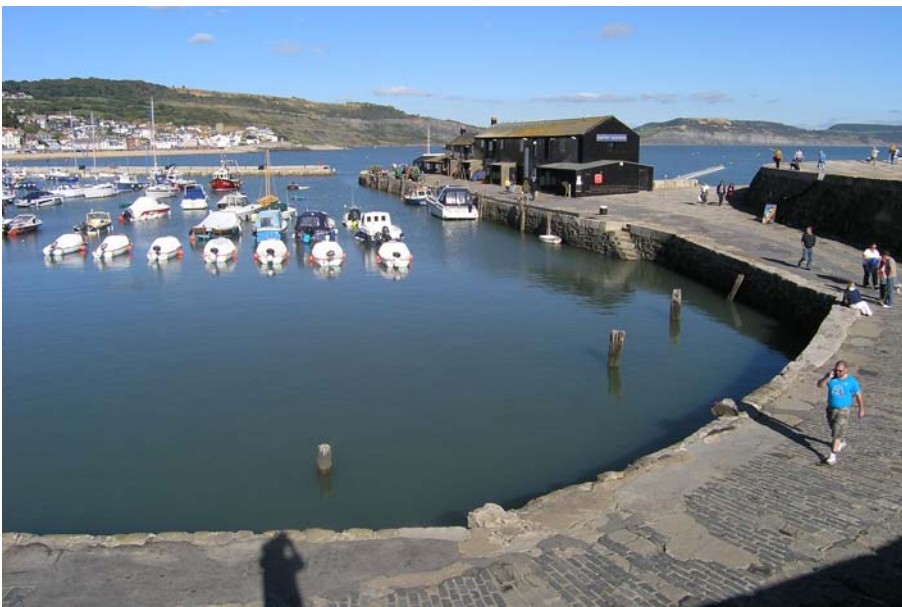
*Plate 2: View across Lyme Regis harbour looking towards the town beach and Marine Parade. Note the remains of timbers from the 1853 tramway in foreground.*

*Plate 3: View across Lyme Regis harbour towards harbour entrance. Note the remains of timbers from the 1853 tramway in foreground*

A site walk-over was undertaken, unfortunately the tide was fairly high and no features within the harbour were visible. The only feature noted was the timber posts forming the remains of the 19<sup>th</sup> century tramway (Plates 2-3).

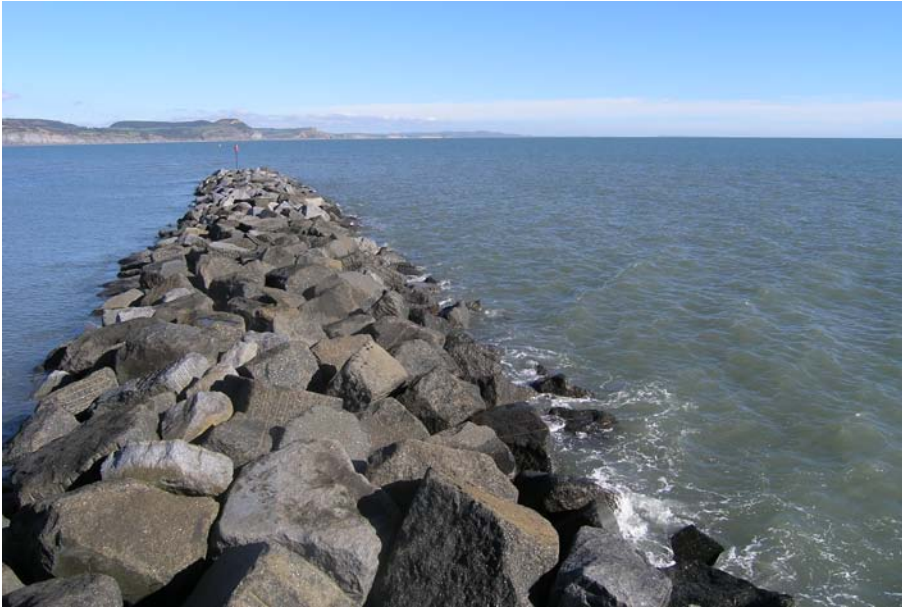
*Plate 4: View along rock armour at end of South Arm of the Cobb.*

Regis Phase II coastal defence project. The rock armour extension to the south arm of the Cobb, by design, provides Lyme Regis with increased protection from storm events. This additional protection has had the effect of altering the erosion and deposition patterns of the harbour and its immediate approaches.
