**WWII BUILDING, HIVE BEACH CAR PARK,  
BURTON BRADSTOCK, DORSET**

**Archaeological Evaluation**

**Report No. 53303/2/1**

**March 2009**

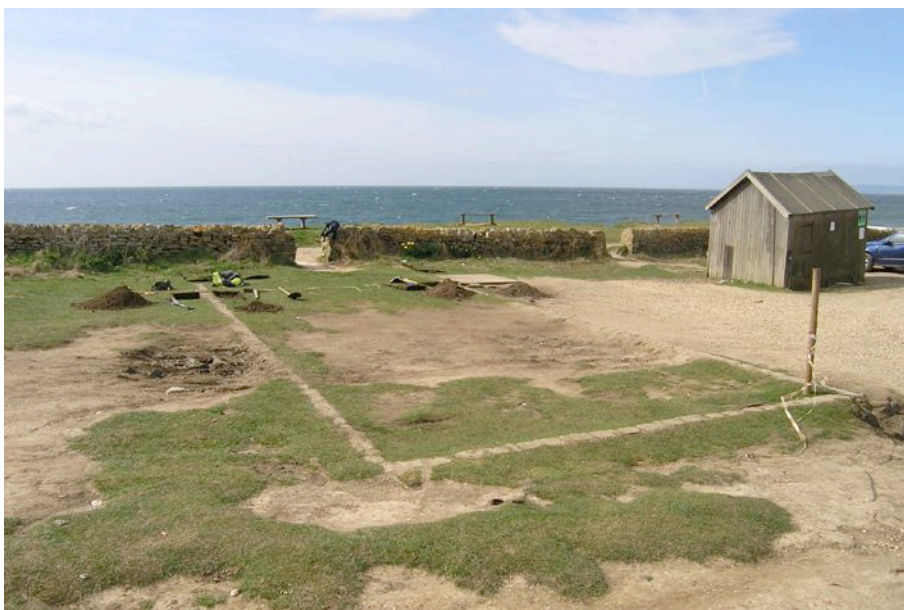
*Plate 3: View of Building 1 from northeast.*

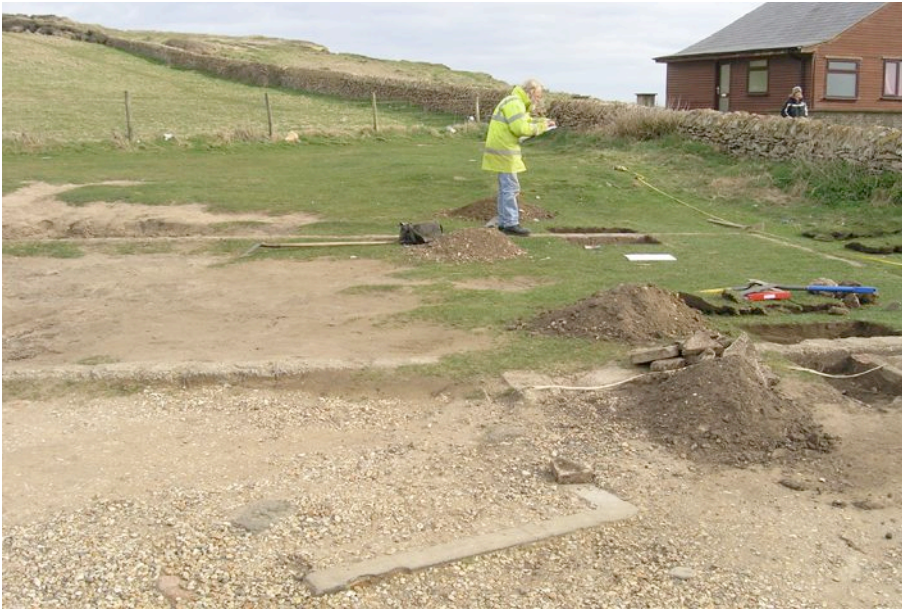
On the west side, beyond the Trench 2, the building had been disturbed and the concrete blocks removed. A single displaced block remains in this area, which has quantities of stone and concrete rubble visible in the soil. One metre to the west, a broken (now L-shaped) piece of brickwork with a concrete skim may be the dislocated edge of an entrance step.

*Plate 4: View of test pits during excavation, with disturbed entrance step in foreground.*

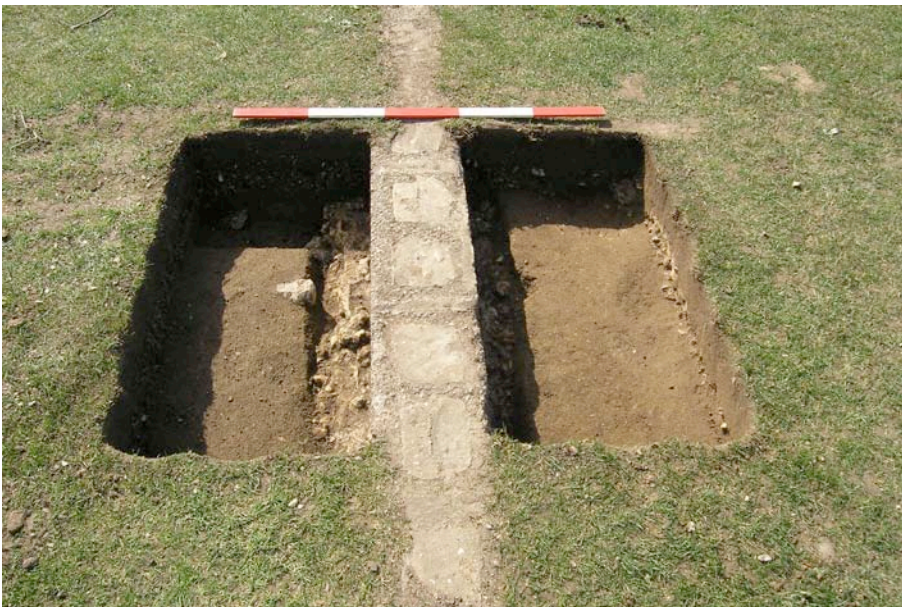
*Plate 5: Trench 1 after excavation.*

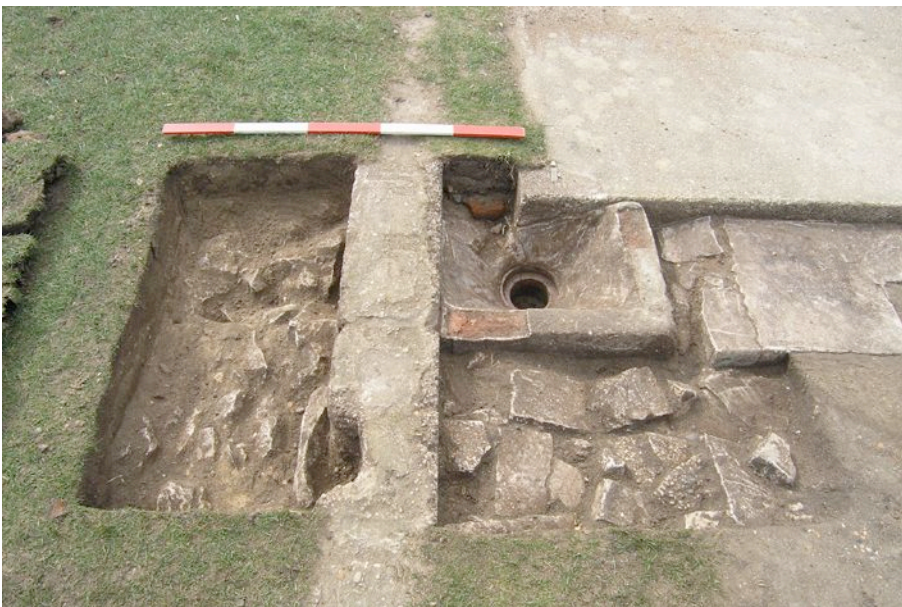
Of unknown purpose, a small vertical sub-rounded recess 0.10 m across had been crudely cut into the inner face of the blockwork (105) in Trench 2. This was carried out after the voids in the concrete blocks were filled with cement, but before sand and rubble layer 102 was deposited: A slightly curved piece of tabular limestone had been set vertically against the rebate, as if to brace an upright post or support.

Immediately outside the hut base blockwork (105) in Trench 2, a rectangular drain sump (110) measured 0.55 by 0.40 m (Plate 6). The northwestern and northeastern arms of this were of red brick construction encased in cement, and with a steeply-sloping internal cement bowl some 0.20m deep funnelling to a vertically-set stoneware foul-pipe (internal diameter 0.10 m / 4 ins). The drain sump butted/bonded to both the hut base blockwork (105) and to the edge of the external square concrete slab (109), although no other relationship was found between blockwork and slab. A rebate in the southeastern corner of the bowl suggests the existence of an outflow into the drain from a cement channel between 105 and 109.

*Plate 6: Trench 2 showing drain sump 110, stone rubble 102 and slot in concrete base 105.*

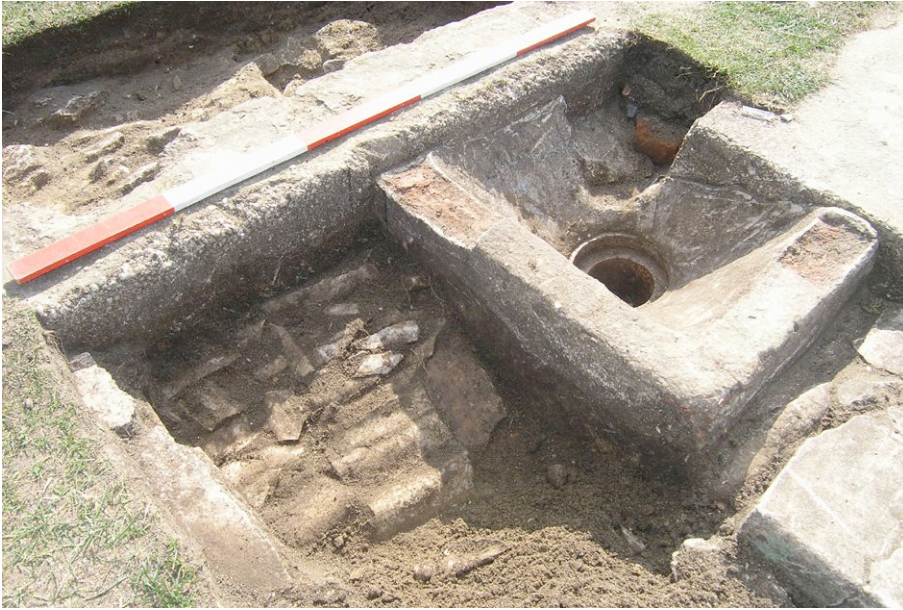
*Plate 7: Trench 2 showing corrugated asbestos roofing material.*

Finally, it should be noted that in the event of further fieldwork undertaken, the presence of potentially hazardous (friable) asbestos products might necessitate a specific safety method statement, and require that the landowner put in place appropriate protocols for its safe remediation and disposal.

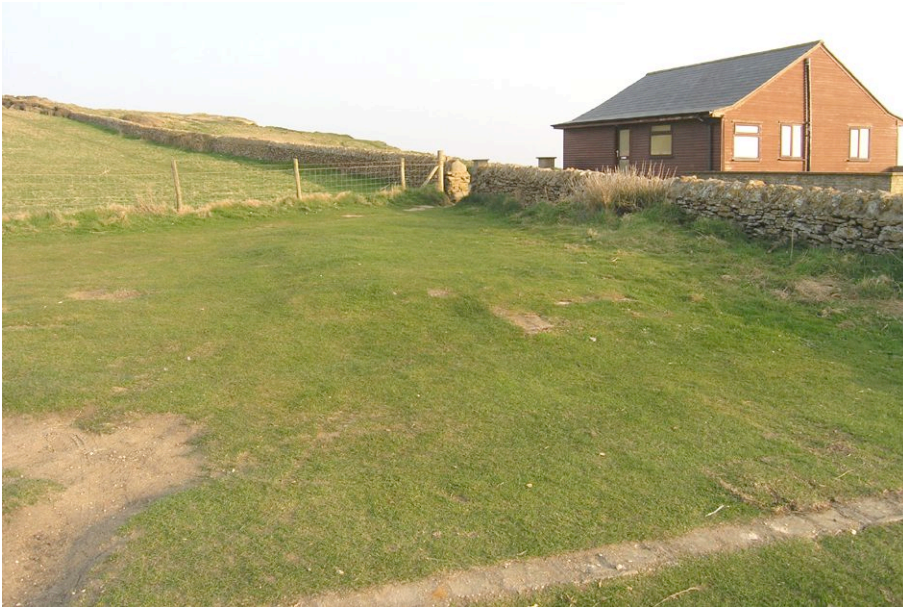
Some three metres southeast of the hut base, a slightly raised (c. 0.30 m high) sub-rectangular platform was noted (Figure 3; Plate 8). This structure is estimated as c. 4 m wide and at least 6 m long, and was aligned perpendicular to the southern end of the hut base (parallel with the existing stone car park boundary wall). A small erosion scar at its western end revealed a red brick-edged concrete slab. This was confirmed by additional lifting of a small area of turf, but no additional evaluation was undertaken. The approximate outline of the platform was plotted at 1:50 scale in relation to the hut-base (see Figure 3).

Additionally, the fieldwork has identified a second structural platform, Building 2, probably of similar date, immediately to the east. It is not certain that this platform ever held a superstructure and it may have been simply the base for some installation.

*Plate 8: View of Building 2.*
