**NEW INTERPRETATION PANEL, FIDDLEFORD MANOR,
FIDDLEFORD, STURMINSTER NEWTON, DORSET
Archaeological Observations and Recording**

Report No. 53339/3/1

April 2011

Archaeological Observations and Recording,

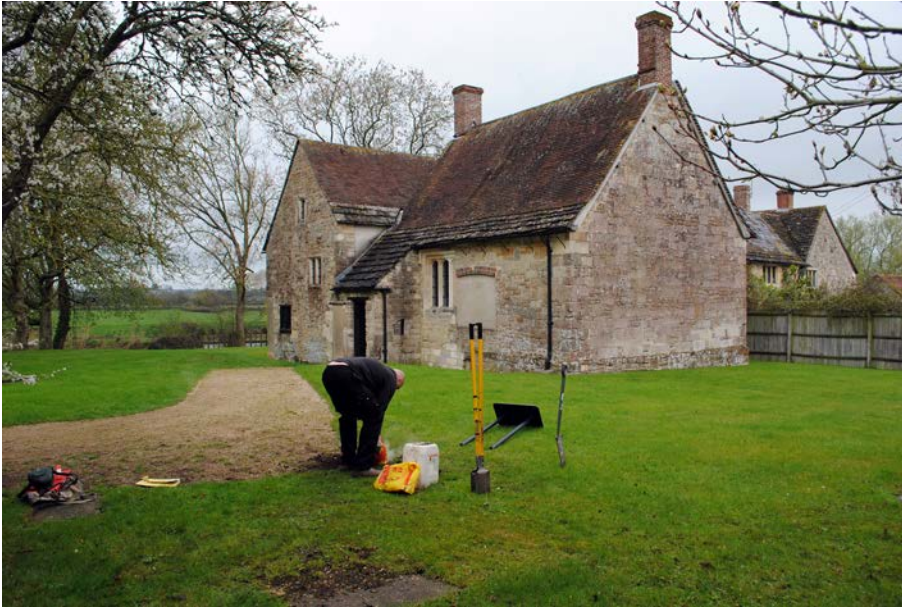
Two post holes were dug by hand for the erection of the new interpretation panel in the grass immediately adjacent to the northeast angle of the gravel path (Figure 2; Plates 1-3). The post holes were 0.2 m in diameter and 0.62 m deep and spaced 0.36 m apart (centre to centre). Dark yellowish-brown clay natural was encountered at a depth of 0.60 m below the current ground surface. Above this was a layer of dark greyish brown humic silty clay soil containing occasional charcoal flecks and sparse brick and mortar fragments and flecks near the top. No differentiation in this soil layer could be determined in the eastern post hole. In the western post hole this layer lay beneath a 0.03 m thick layer of gravel sealed by a 0.07 m thick turf layer. This gravel layer was undoubtedly associated with the construction of the current gravel path to Fiddleford Manor.

Plate 1: General view of location of new interpretation panel, looking ENE.

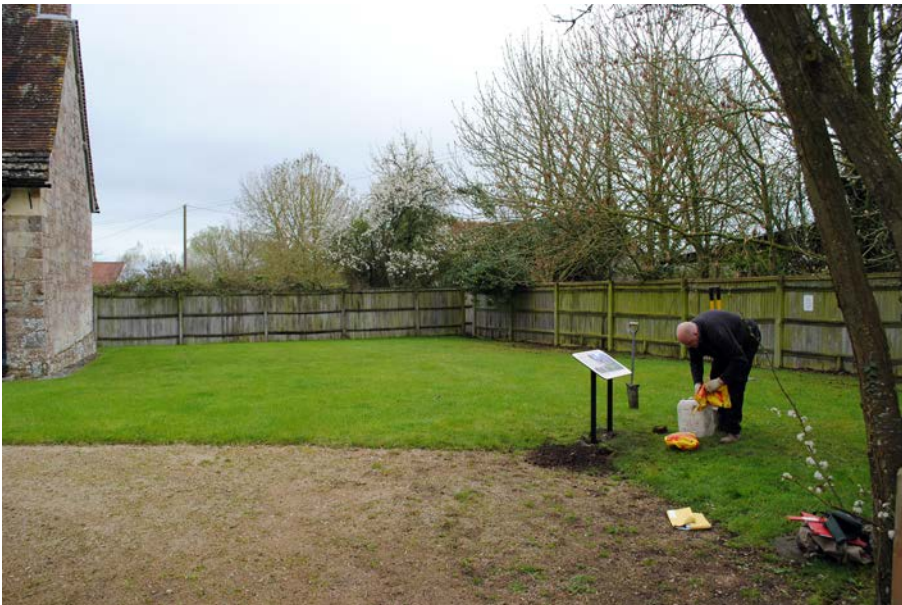
Plate 2: Location of new interpretation panel looking north.

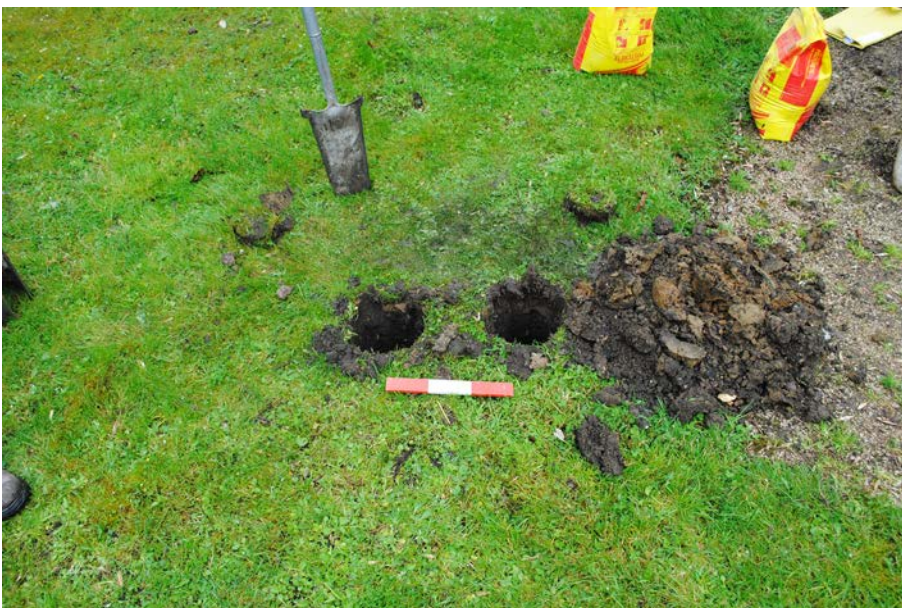
The watching brief revealed no deposits or features of archaeological significance. The soil deposits observed were probably associated with gardening activity.

Plate 3: Post holes for new interpretation panel, looking south. 0.3 m scale.
