**A1/A46 MAINTENANCE LAY-BYS (SITE 3A, 14, 15),
NOTTINGHAMSHIRE**

**ARCHAEOLOGICAL WATCHING
BRIEF REPORT**

Site code: NMLN 07
NGR: Site 3A – 479480 357830
Site 14 – 467975 338360
Site 15 – 480675 356075
PCA Job No: 07-339

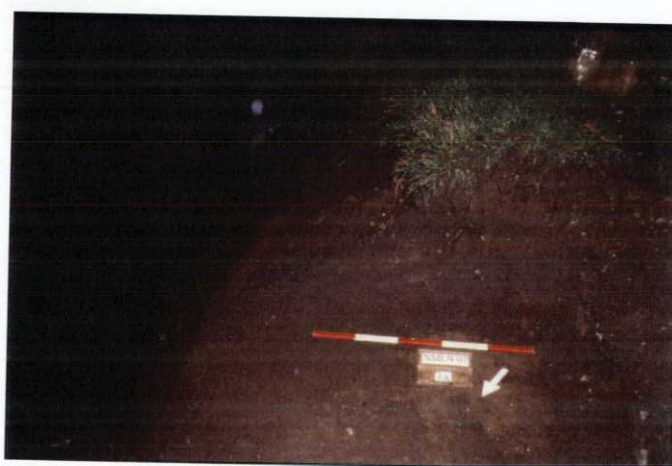
Plate 2 (right): The exposed section at the south end of Site 3A, looking SSE.

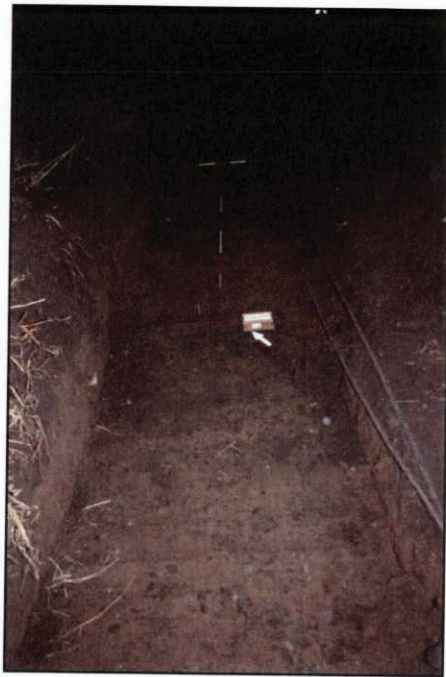
Plate 4 (above): General view of the stripped area at Site 14 from ch. 18 – 30 showing the exposed layer (141), with natural (142) patchily exposed.

The modern topsoil, present over the whole area, varied in thickness between 0.25 and 0.35m. This material (context 141) consisted of a dark greyish brown sandy clay containing rare small rounded pebbles and quantities of modern refuse. The topsoil sealed a layer of mid-yellowish brown/buff sandy clay subsoil (context 002), which was still present at the formation level over the majority of the length of the strip. The presence of several loose concrete kerbstones and paving slabs within this deposit demonstrates that it has been heavily disturbed by road construction or later landscaping. In the southern 11.5m of the strip, the underlying geological material (mottled pink and grey Mercia Mudstone – context 142) was patchily exposed.

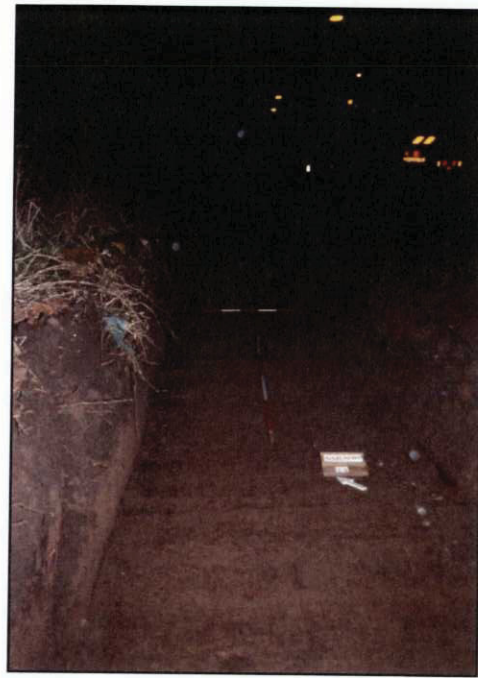
Plate 5 (above): General view of the stripped area at Site 14 from ch. 30 – 48 showing the exposed layer (141).

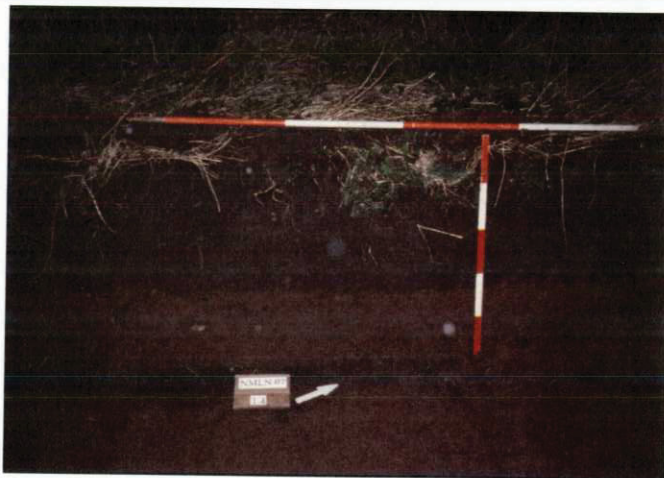
Plate 6 (left): Exposed southeast facing section at ch. 27 of Site 14, looking northwest.

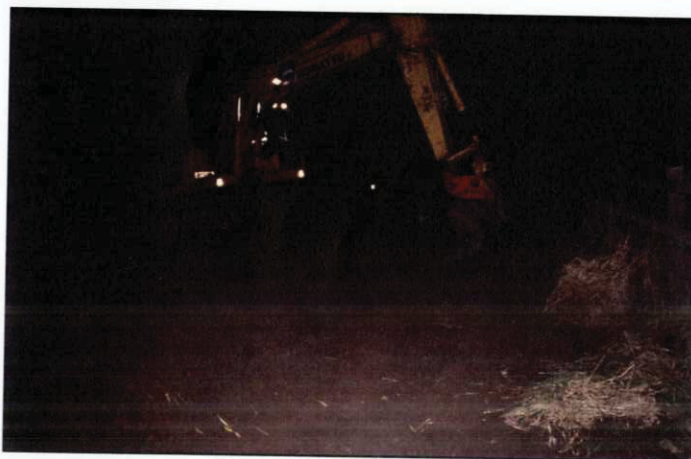
Plate 9 (right): Working
shot, Site 15: partial
topsoil stripping at north
edge of site in the vicinity
of ch.10, looking west.

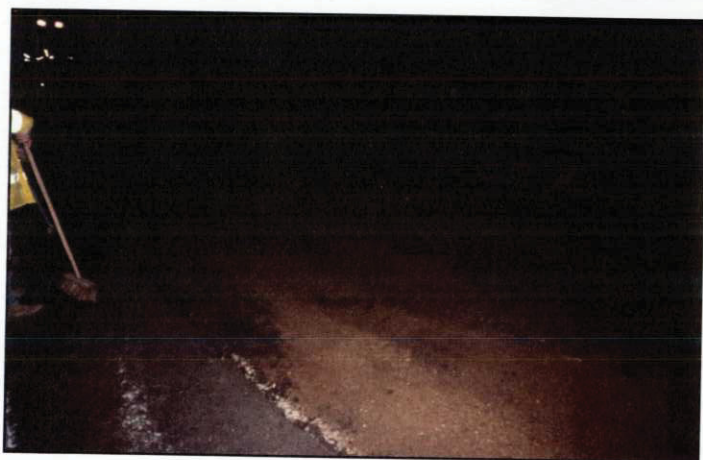
Plate 10 (left): General
view of the stripped area at
Site 15 showing the exposed
layer (151), taken from ch.
20, looking NW.

The modern topsoil, present over the whole area, was between 0.3m and 0.35m thick. This material (context 150) consisted of a dark brownish grey silty loam containing occasional small rounded pebbles, and is of modern origin as it was separated from the layer below by a layer of geotextile. The underlying layer (context 151) comprised a compacted mid-reddish brown coarse sand and pebble hardcore which was identified by the contractors as the covering layer of a French drain known to run adjacent to the carriageway here.
