Report on an Archaeological Evaluation

Proposed Route of the A19 Easingwold By-pass

York Archaeological Trust
1991

ARCHAEOLOGICAL SURVEY
OF THE PROPOSED ROUTE OF THE
A19 EASINGWOLD BY-PASS

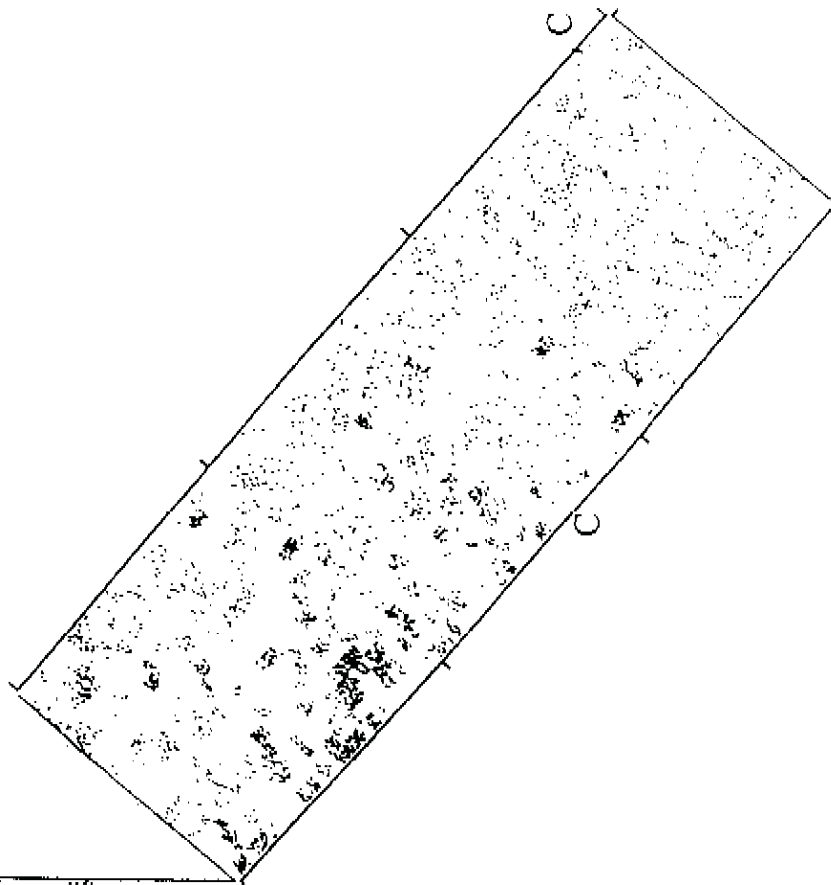
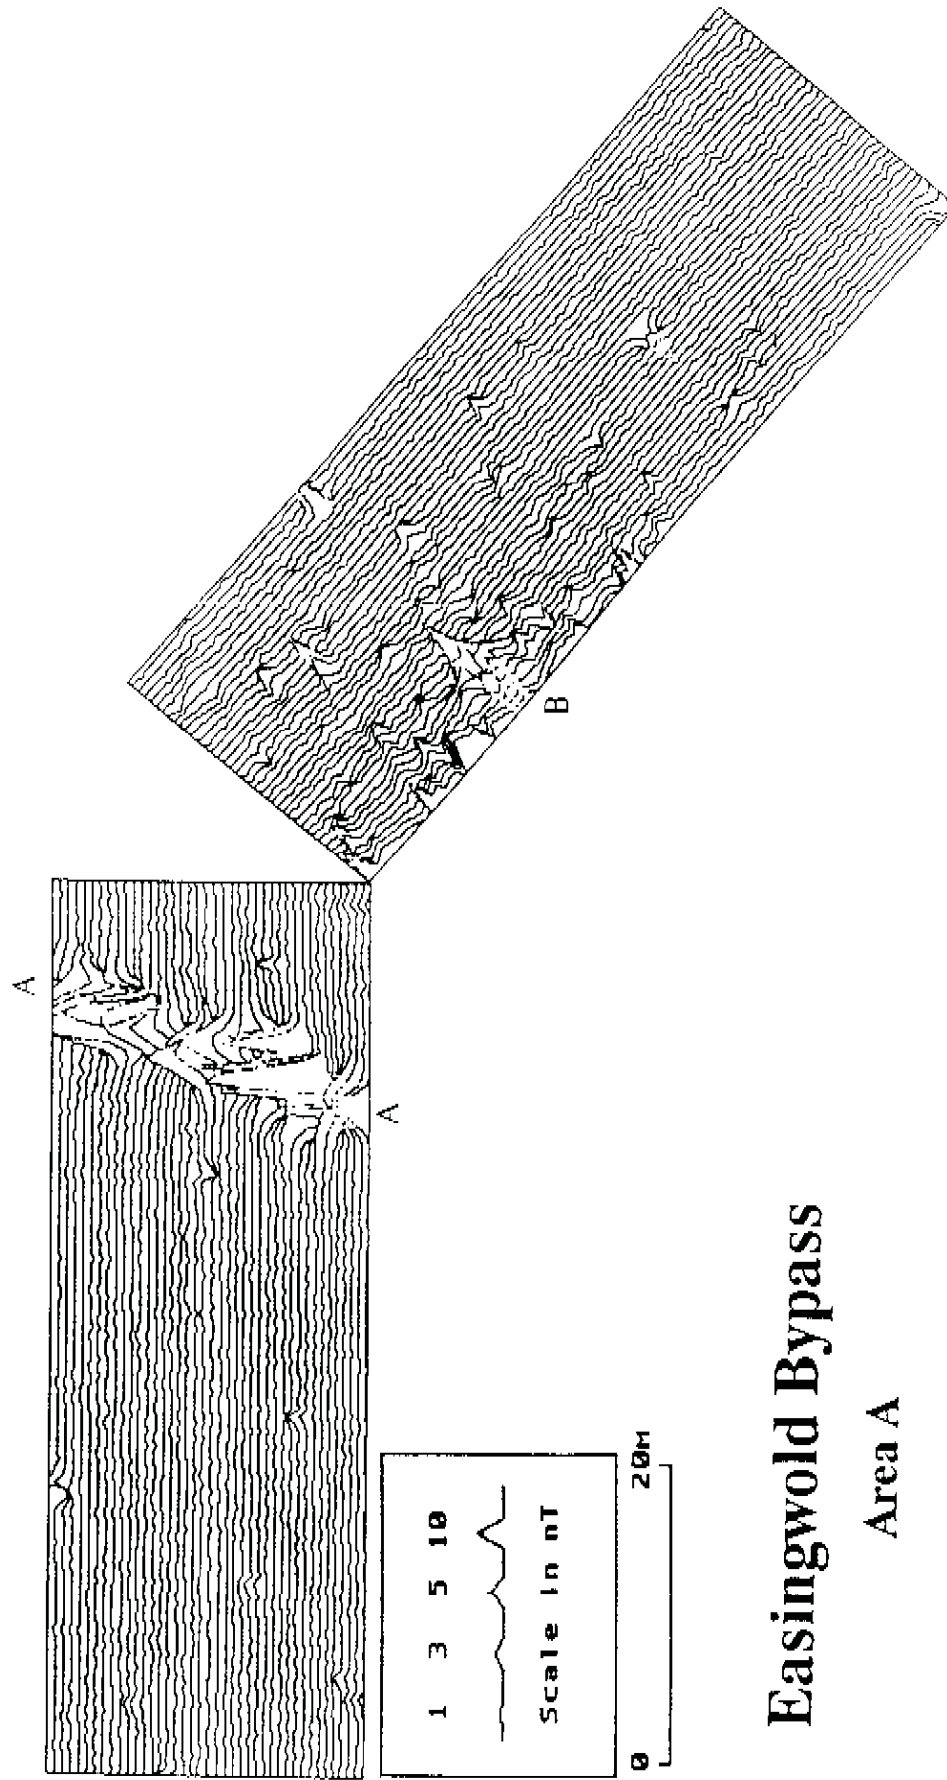
Area A

The most obvious anomaly in this area is annotated "A" in Figure A2, and is probably due to a metal pipe. Also to be noted is the area of magnetic disturbance (B), which can be seen from visual observation of the ground surface to be due to modern dumping.

3.2.1 - The results of the magnetometer survey were largely disappointing. In 0027 the traverse, dog-legged to incorporate parts of the area of the pottery scatter (2.5.1) and the low plateau and encircling depression (2.3.3), revealed only a metal pipe (running from an iron drain cover visible in the middle of the field) and a possible east-west aligned field drain. Anomalies in the south-eastern area of the traverse, the vicinity of the pottery scatter, were caused by debris from a demolished building (2.5.1; Fig.5 : Appendix 2, A1/2).
