ENVIRONMENTAL STATEMENT

A1 MOTORWAY DISHFORTH TO NORTH OF LEEMING

VOLUME 2
CULTURAL HERITAGE

CULTURAL HERITAGE

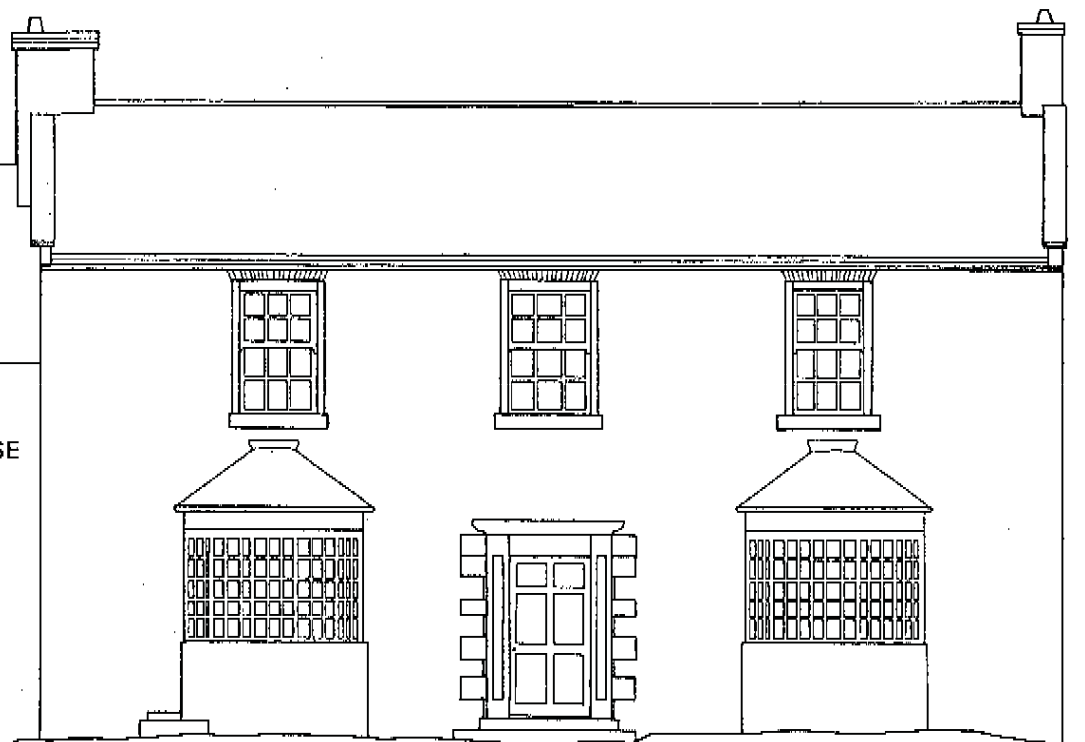
FRONT ELEVATION

- 9.2.3 The building is constructed of hand-made bricks with some sandstone dressings; the roof, which has a central valley, is covered with pantiles. The front elevation is of three bays, and includes a doorway with rusticated sandstone jambs and a bow window to either side. To the rear there are a number of features of interest, including a blocked central doorway with sandstone ashlar jambs and various blockings to the windows (see figure 10).
