Landscape

*A228 Leybourne & West Malling Bypass
Environmental Statement
Volume 2 (part)*

Kent County Council

July 1995

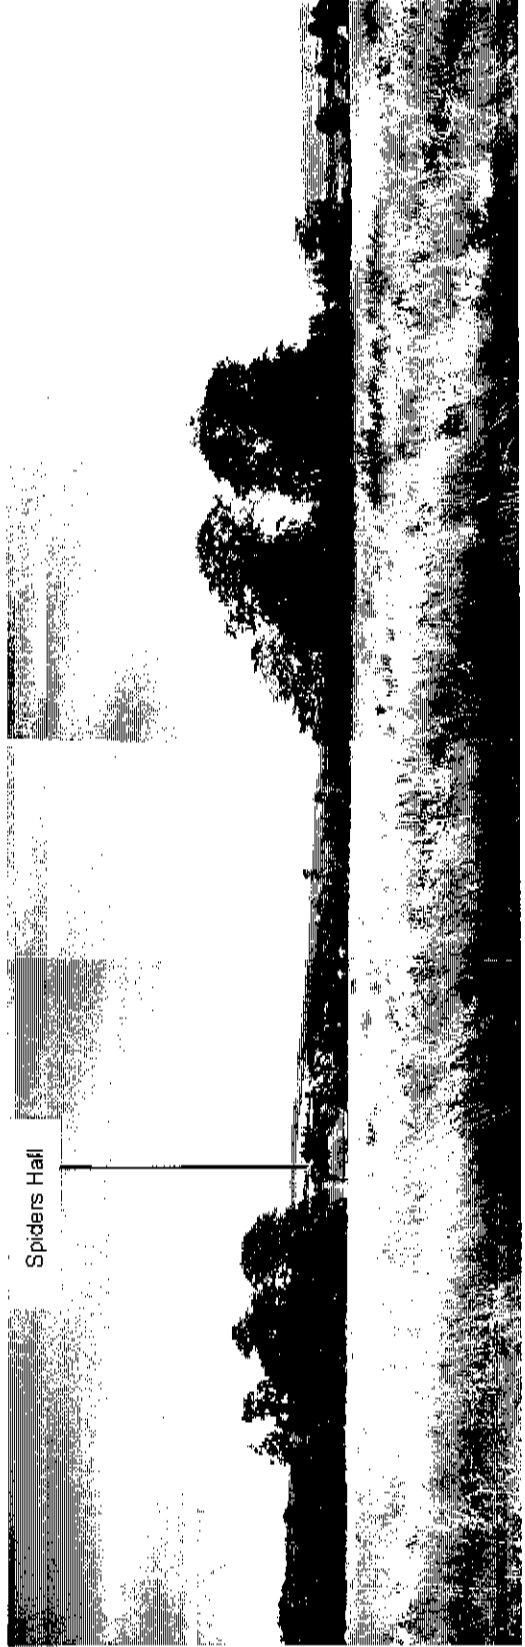
ANNOTATED PHOTOGRAPH

How accessible and visible is the area to the public? Is it by road, footpath or bridleway?
Footpath MR132 crosses area.

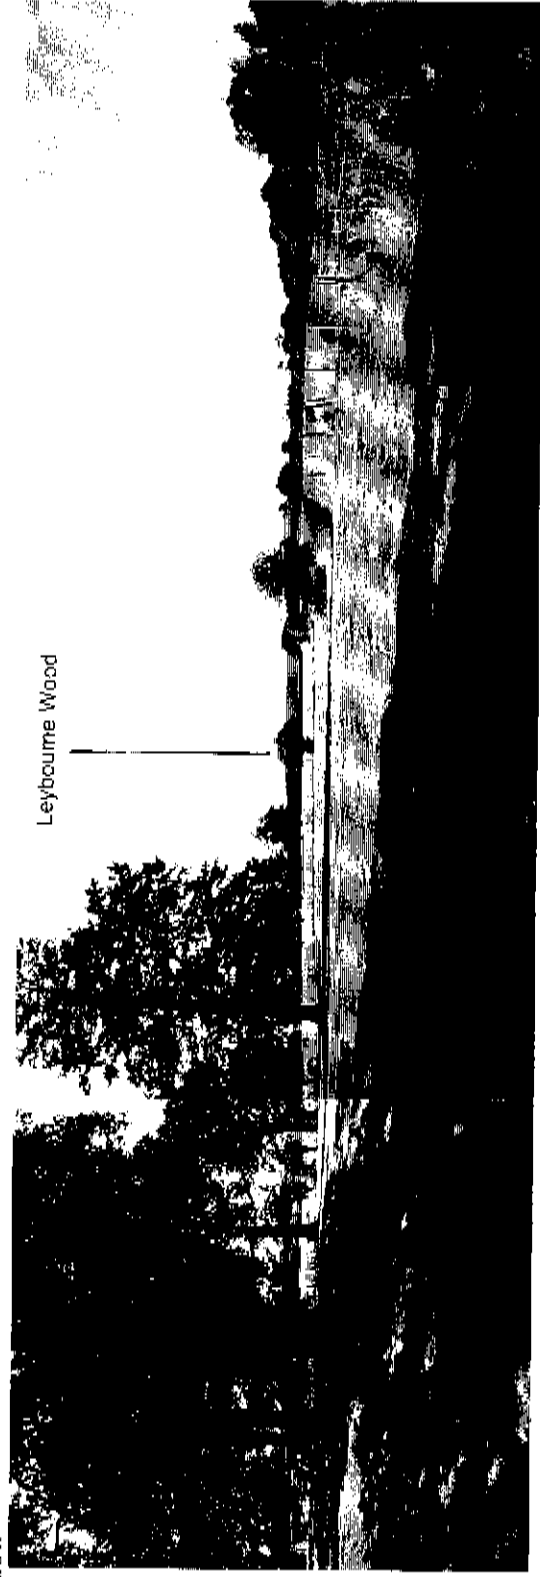
How accessible and visible is the area to the public? Is it by road, footpath or bridleway?
 Visible from Park Road. Public footpath MR 130 crosses area in middle distance.

Leybourne Wood

Leybourne Park Farm

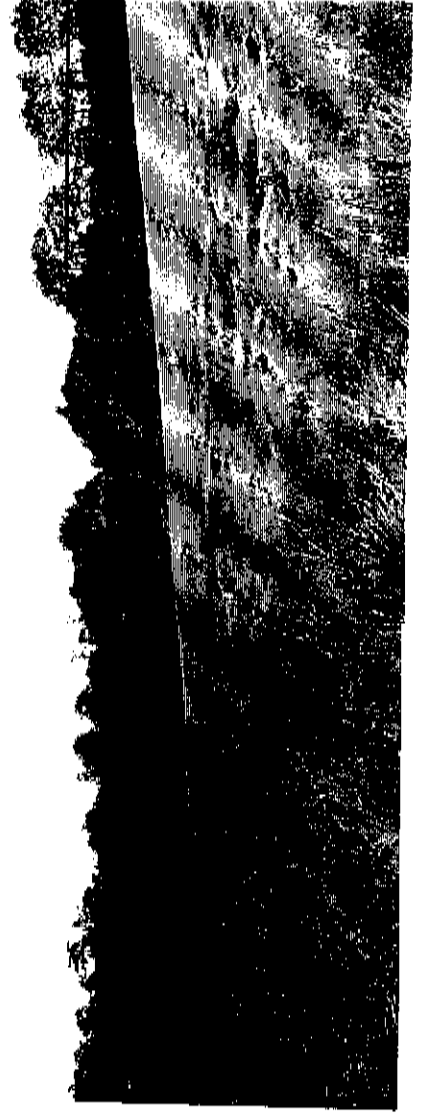
ANNOTATED PHOTOGRAPH

DESCRIPTION	
General description	Arable field with woodland edge
Any significant seasonal differences?	
Deciduous vegetation and crops	
How accessible and visible is the area to the public? Is it by road, footpath or bridleway?	Visible from road. Access via unofficial footpath.

Chimneys Farm and Pump Close

Edge of Leybourne Wood

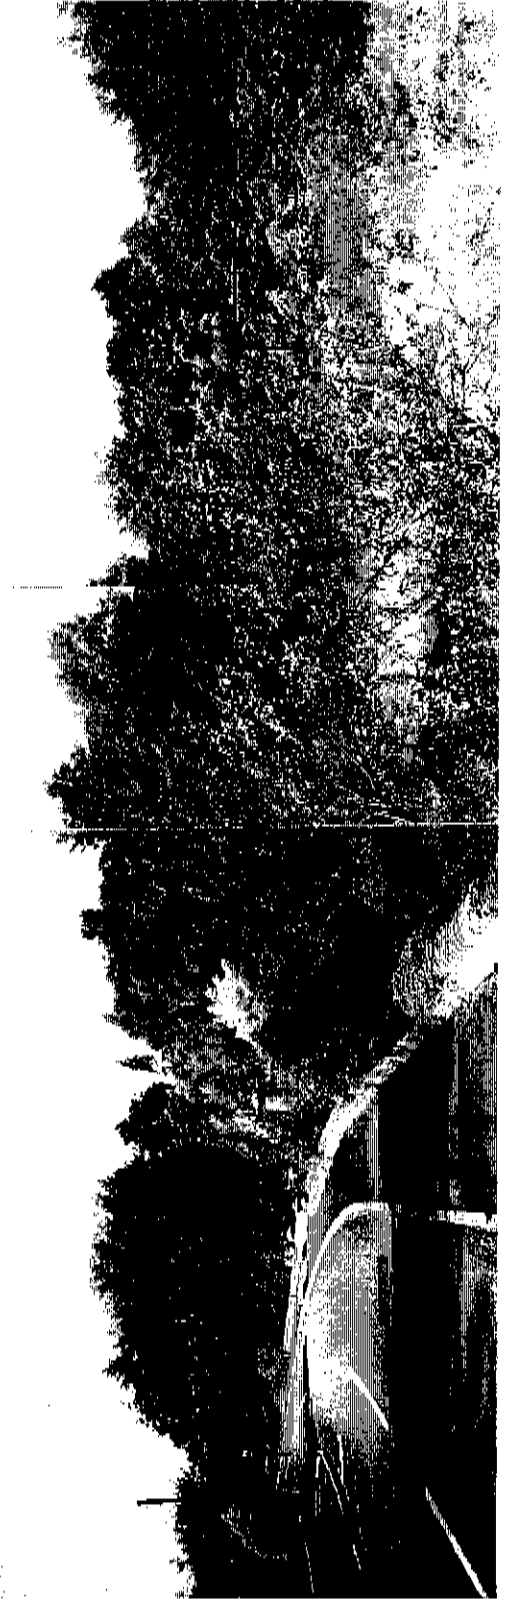
ANNOTATED PHOTOGRAPH

DESCRIPTION	General description
Small grassland area with streamside trees and woodland edge	
Any significant seasonal differences?	
Deciduous vegetation	
How accessible and visible is the area to the public? Is it by road, footpath or bridleway?	
Visible from road. Access by unofficial footpath

Pump Close

Snodland Mill Stream

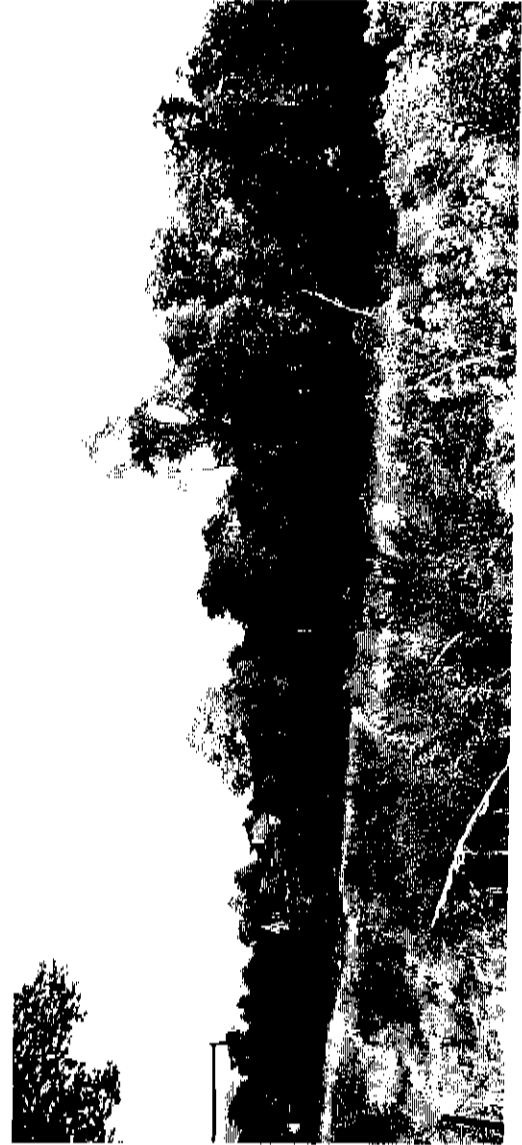
DESCRIPTION	General description	Rough grass dropping down to stream, with streamside trees and housing on A20
	Any significant seasonal differences?	
	Deciduous vegetation	
	How accessible and visible is the area to the public? Is it by road, footpath or bridleway?	
	Access by footpath MR 138

A20 London Road

Snodland Mill Stream

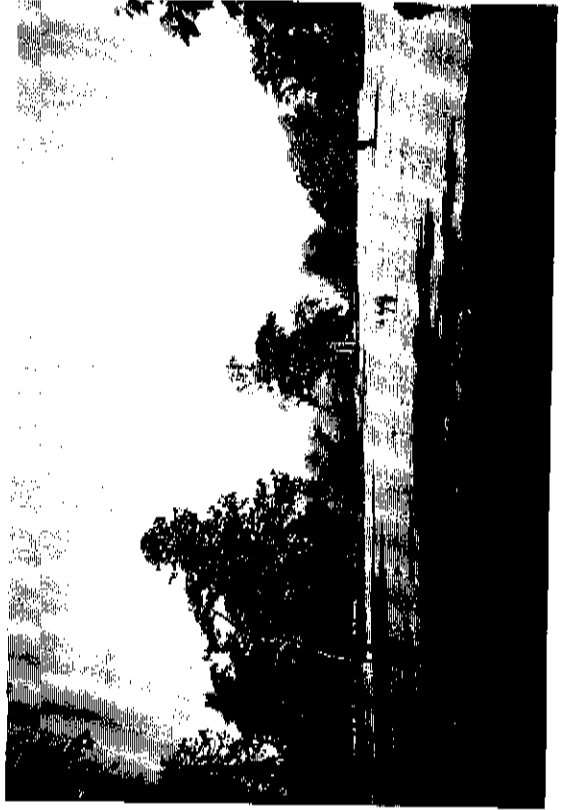
ANNOTATED PHOTOGRAPH

DESCRIPTION
General description
Parkland with groups of semi-ornamental trees
Any significant seasonal differences?
Deciduous vegetation
How accessible and visible is the area to the public? Is it by road, footpath or bridleway?
Visible from unofficial pedestrian access to More Park school

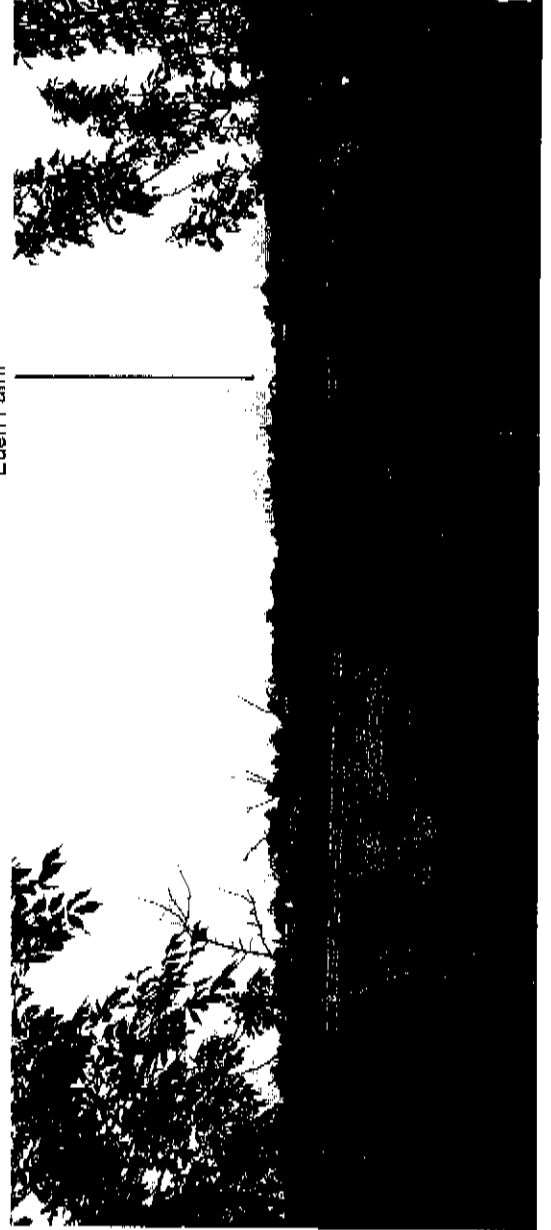
ANNOTATED PHOTOGRAPH

DESCRIPTION
General description
Orchard and paddock, with distant views of open arable land and tree belts
Any significant seasonal differences?
Deciduous vegetation
How accessible and visible is the area to the public? Is it by road, footpath or 'hedge-way'?
Visible from road. Footpath MR116 crosses the area on the left of the view

Eden Farm

Orchard is over mature and likely to be removed or deteriorate in near future

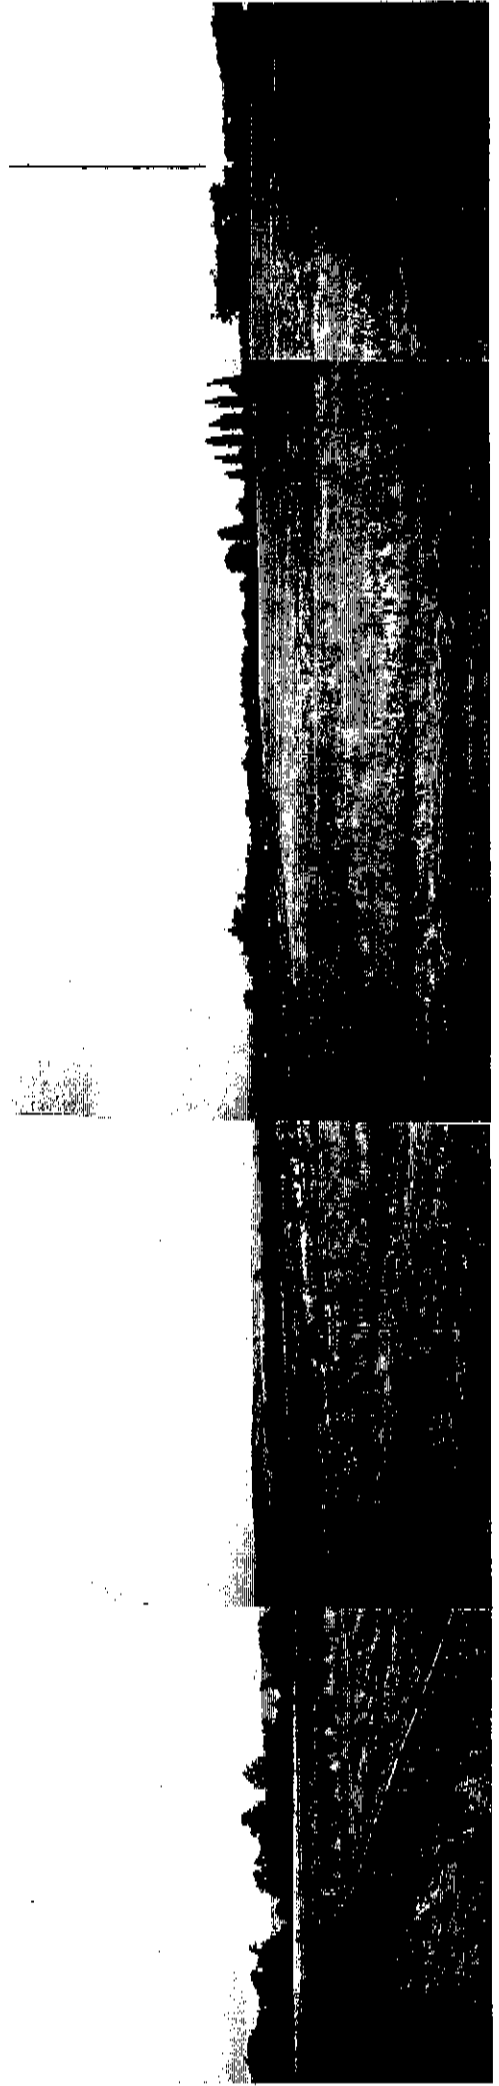
ANNOTATED PHOTOGRAPH

Properties on Broadwater Road

Existing West Mailing bypass in cutting

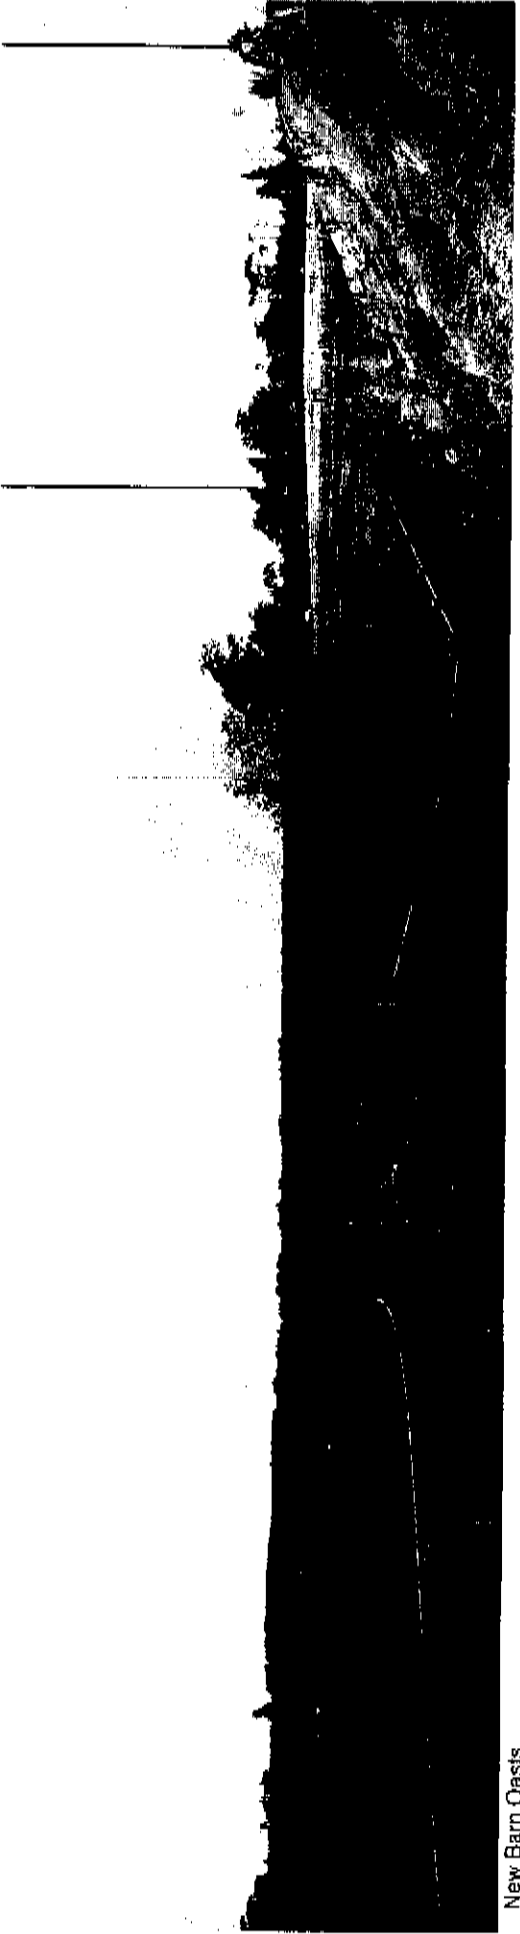
ANNOTATED PHOTOGRAPH

Rathshan
 Lavenders Road overbridge

New Barn Oasts

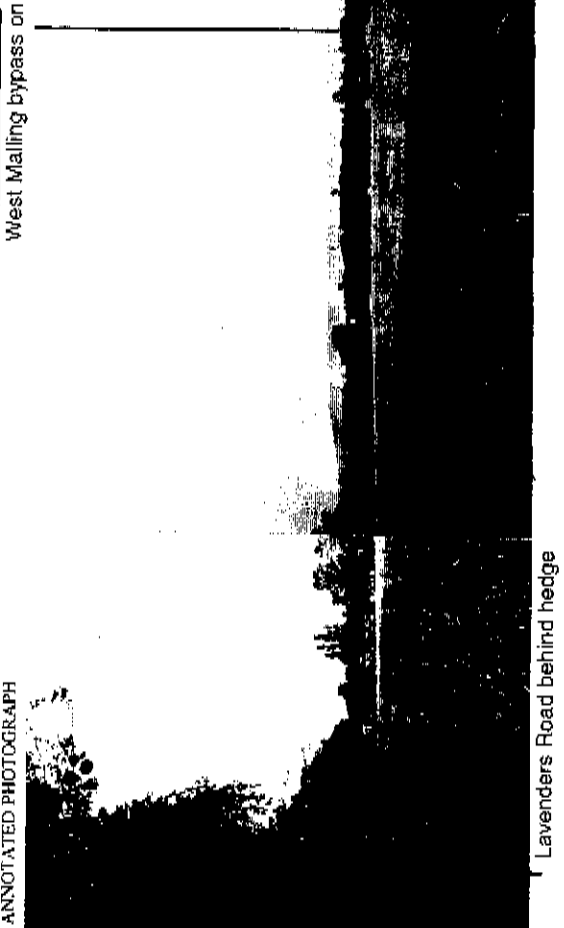
Any significant seasonal differences?
 Deciduous vegetation and arable crops

How accessible and visible is the area to the public? Is it by road, footpath or bridleway?
 Visible from road. Footpath MR 143 crosses area in middle distance

Lavenders Road behind hedge

West Malling bypass on embankment

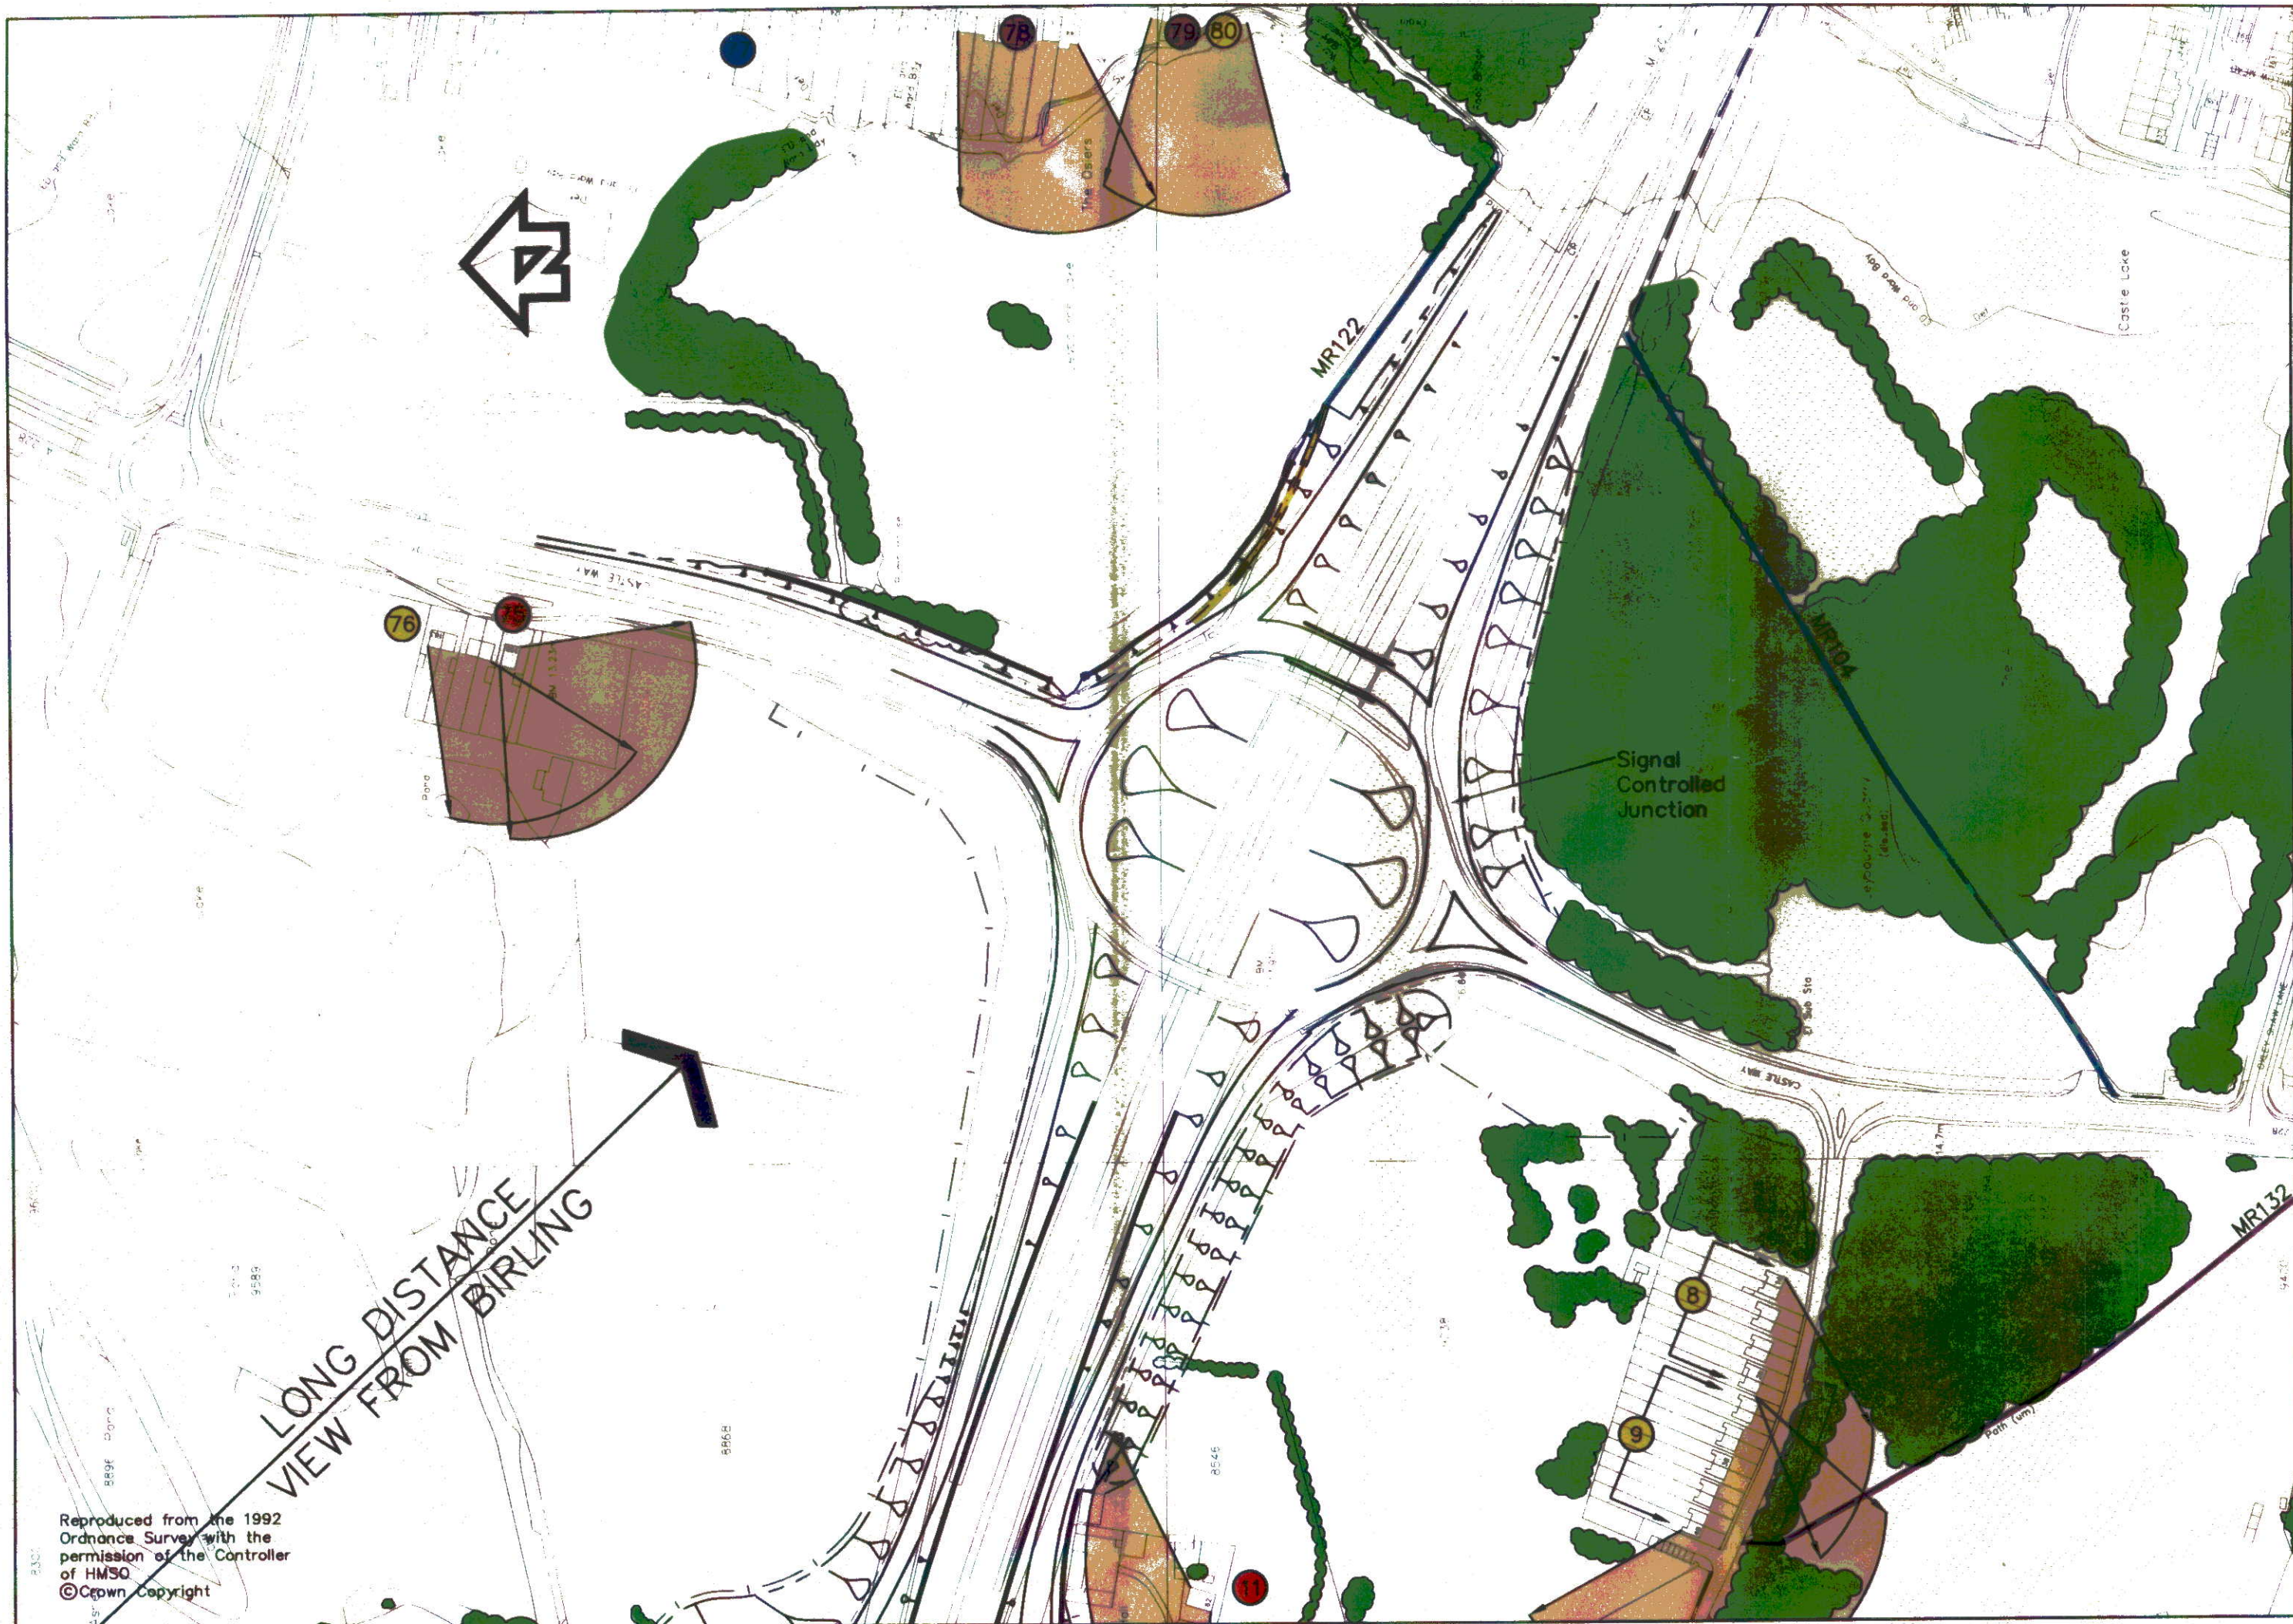
VISUAL INTRUSION PLANS WINTER 1998 **Figure 5**

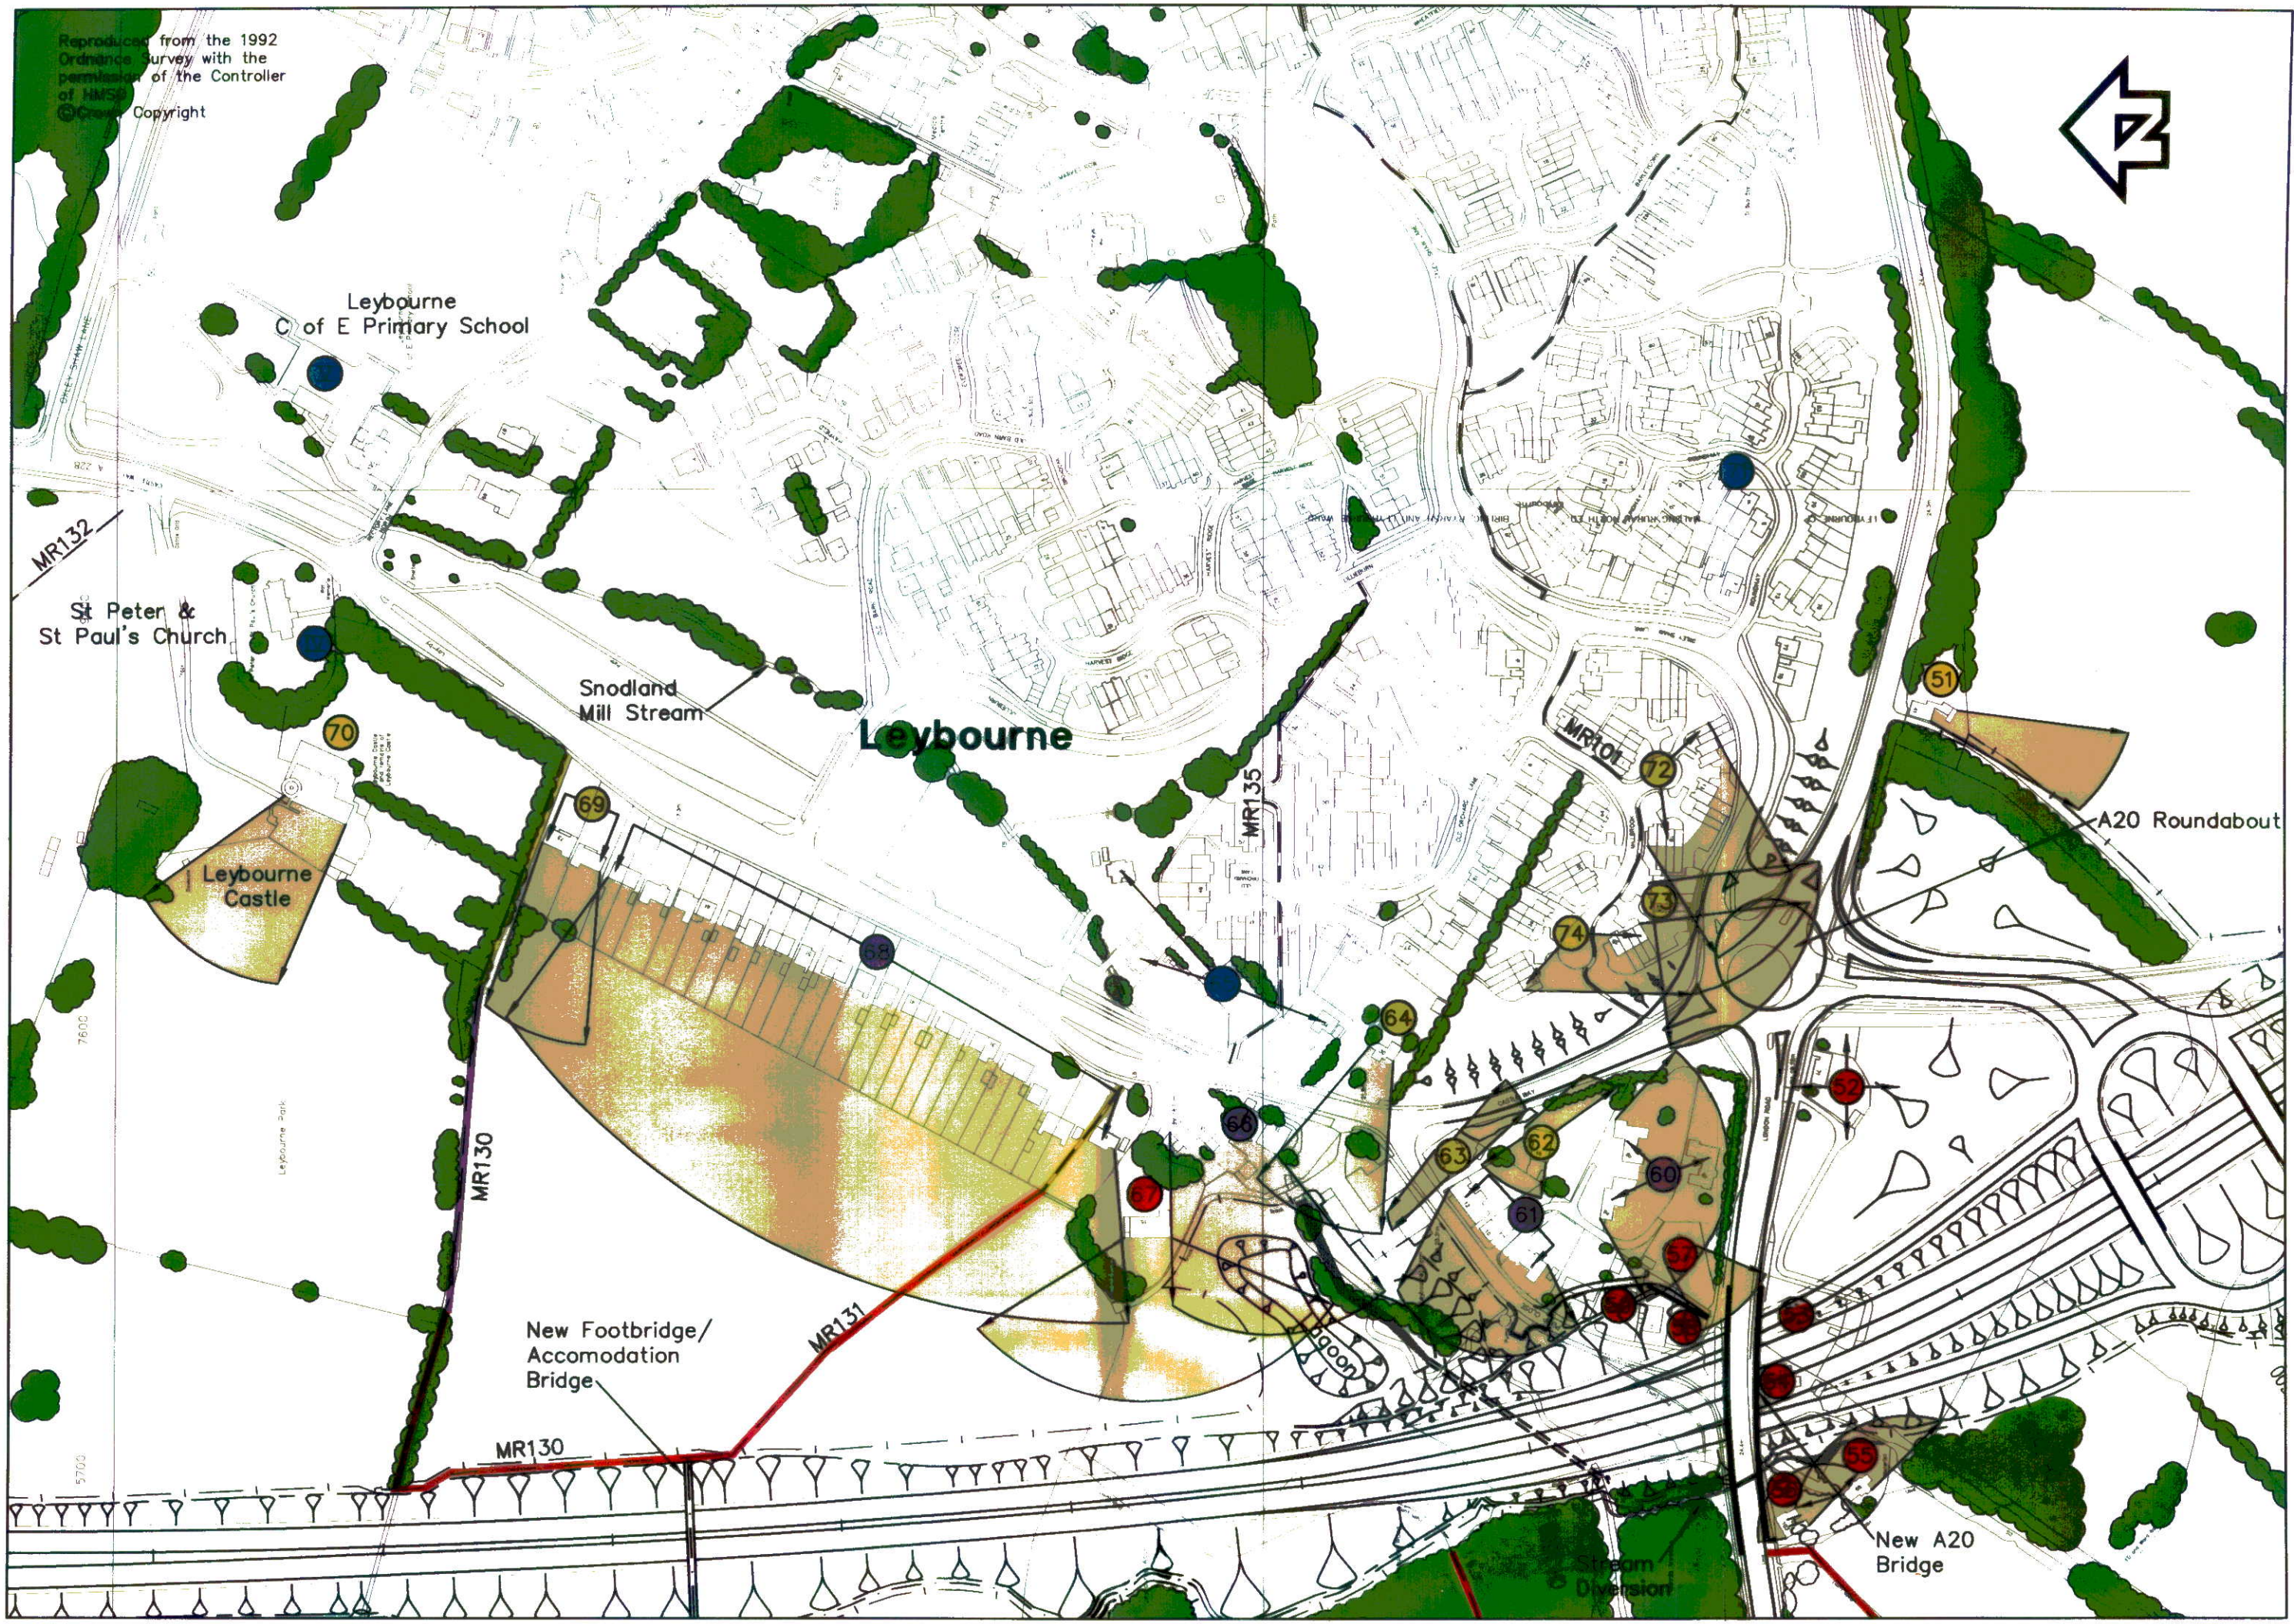
VISUAL INTRUSION PLANS WINTER 1998 **Figure 6**

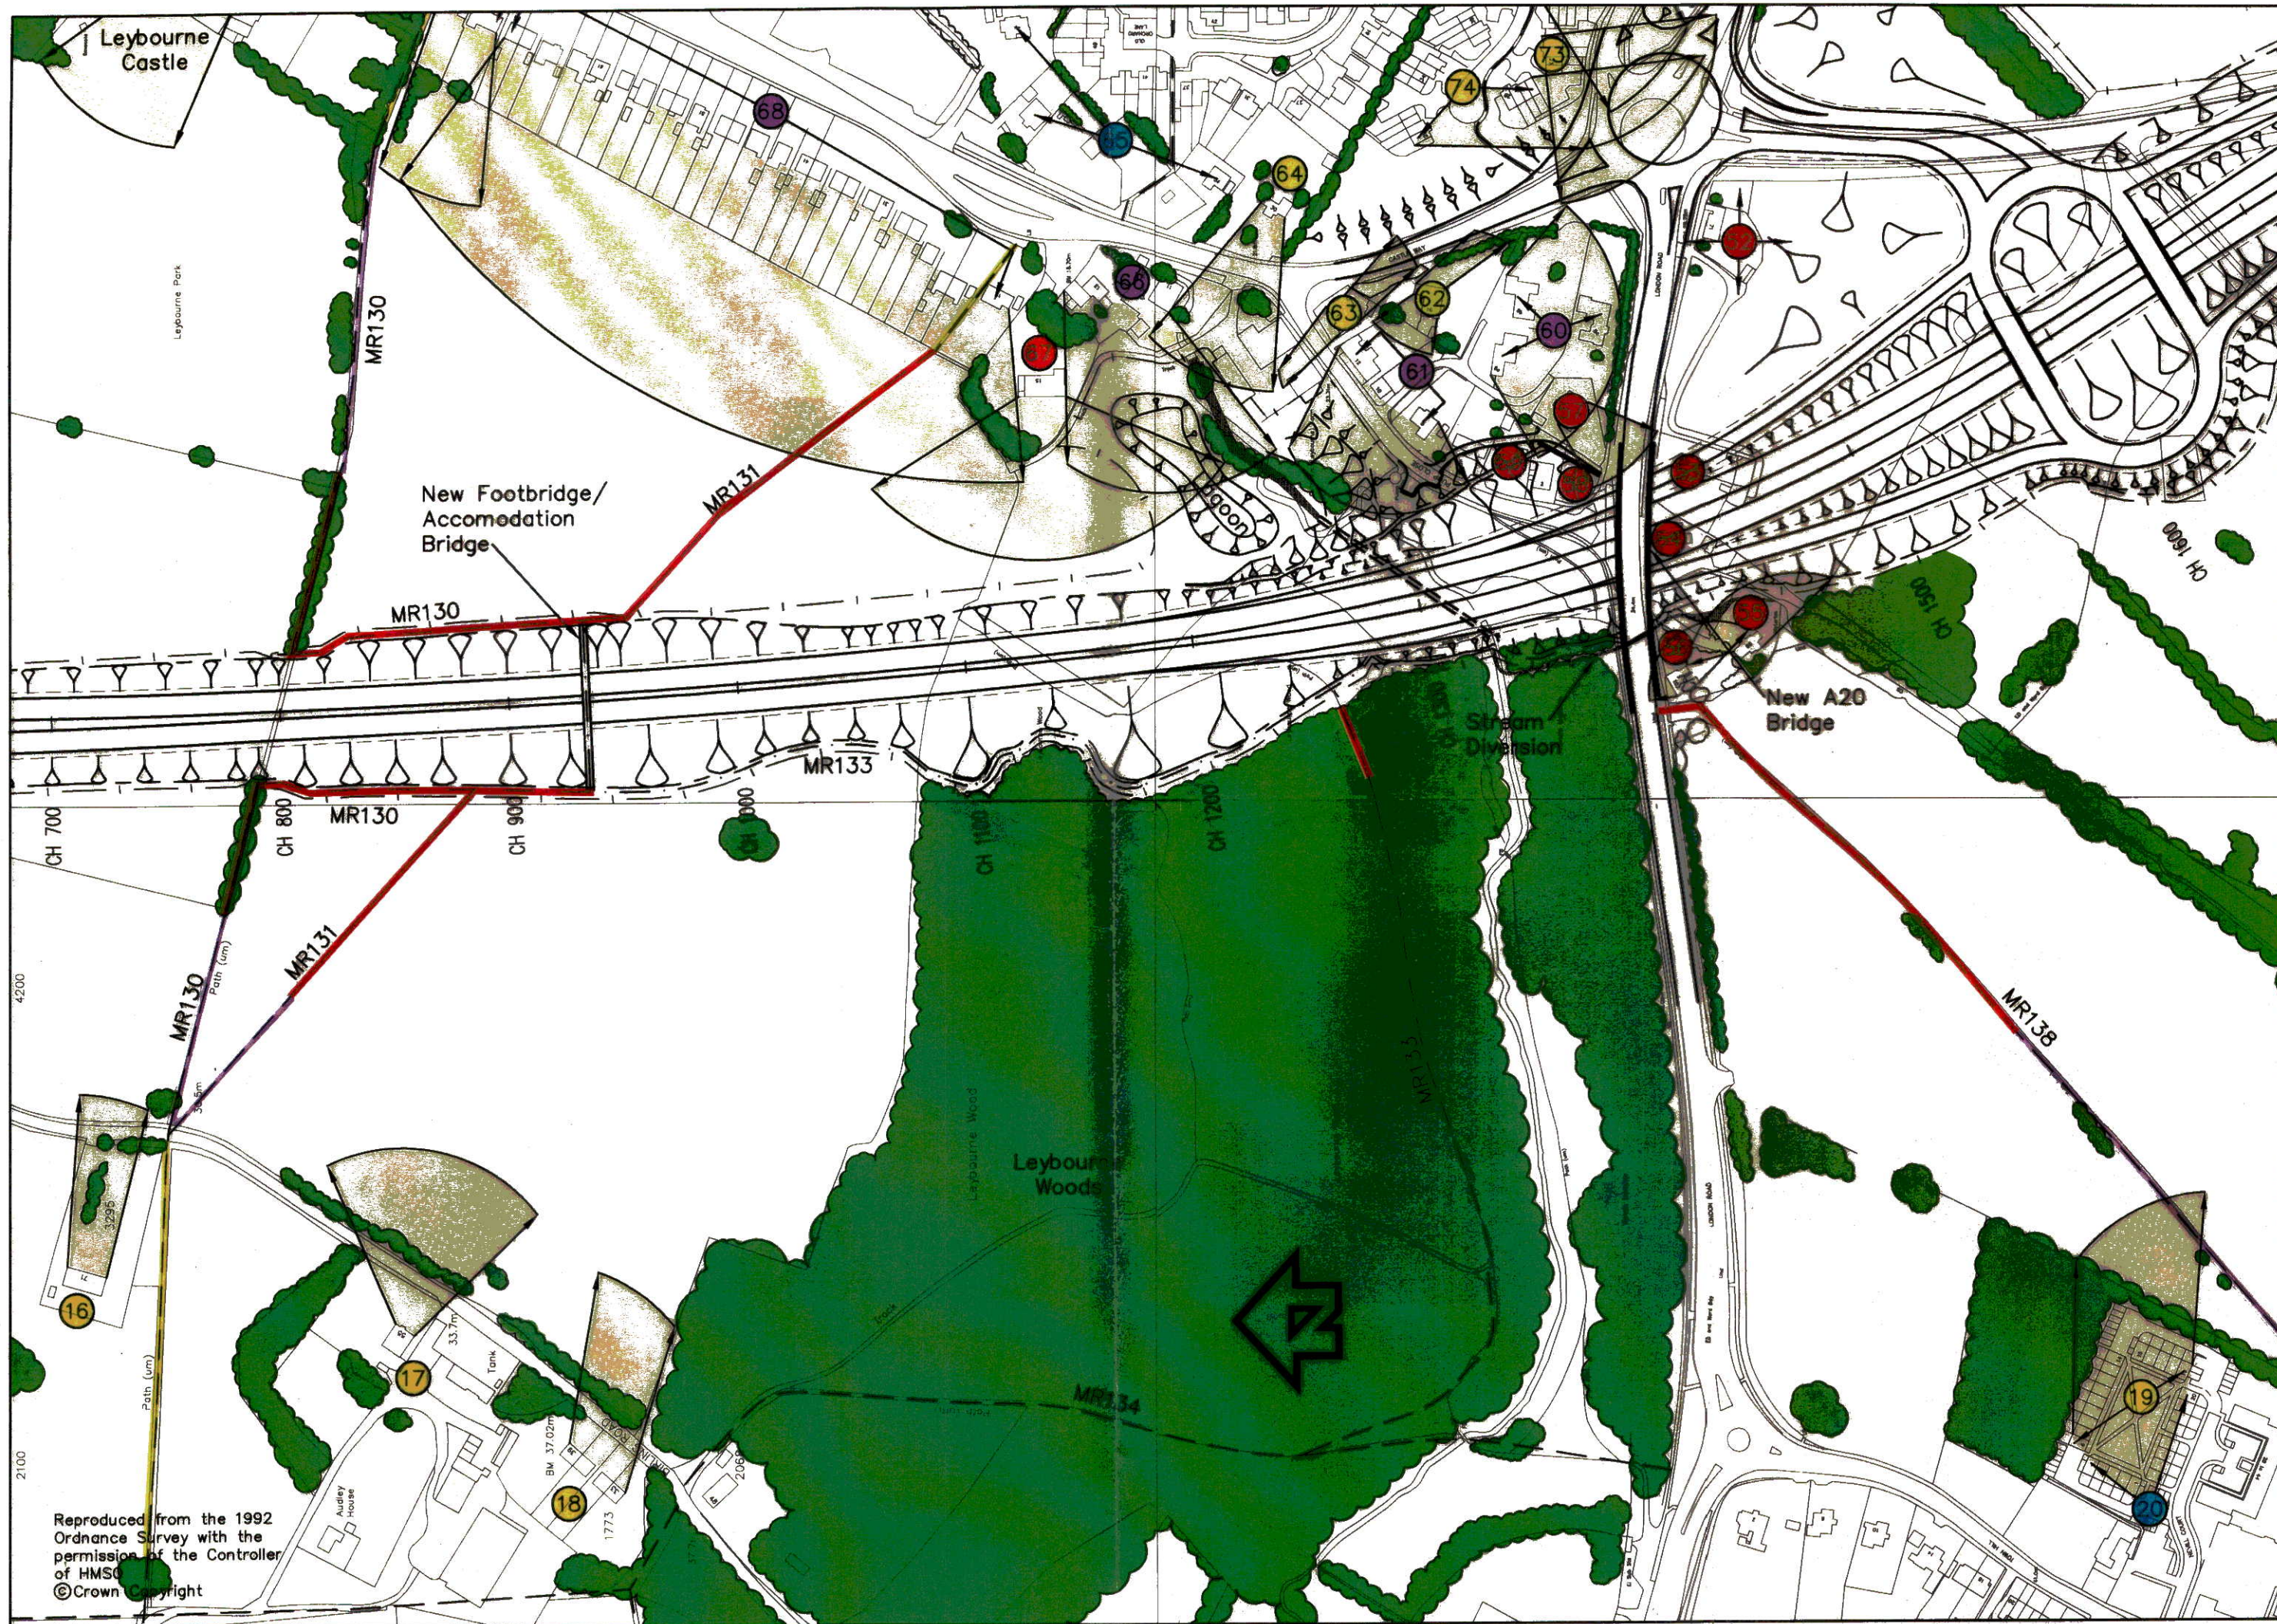
Figure 7

VISUAL INTRUSION PLANS WINTER 1998

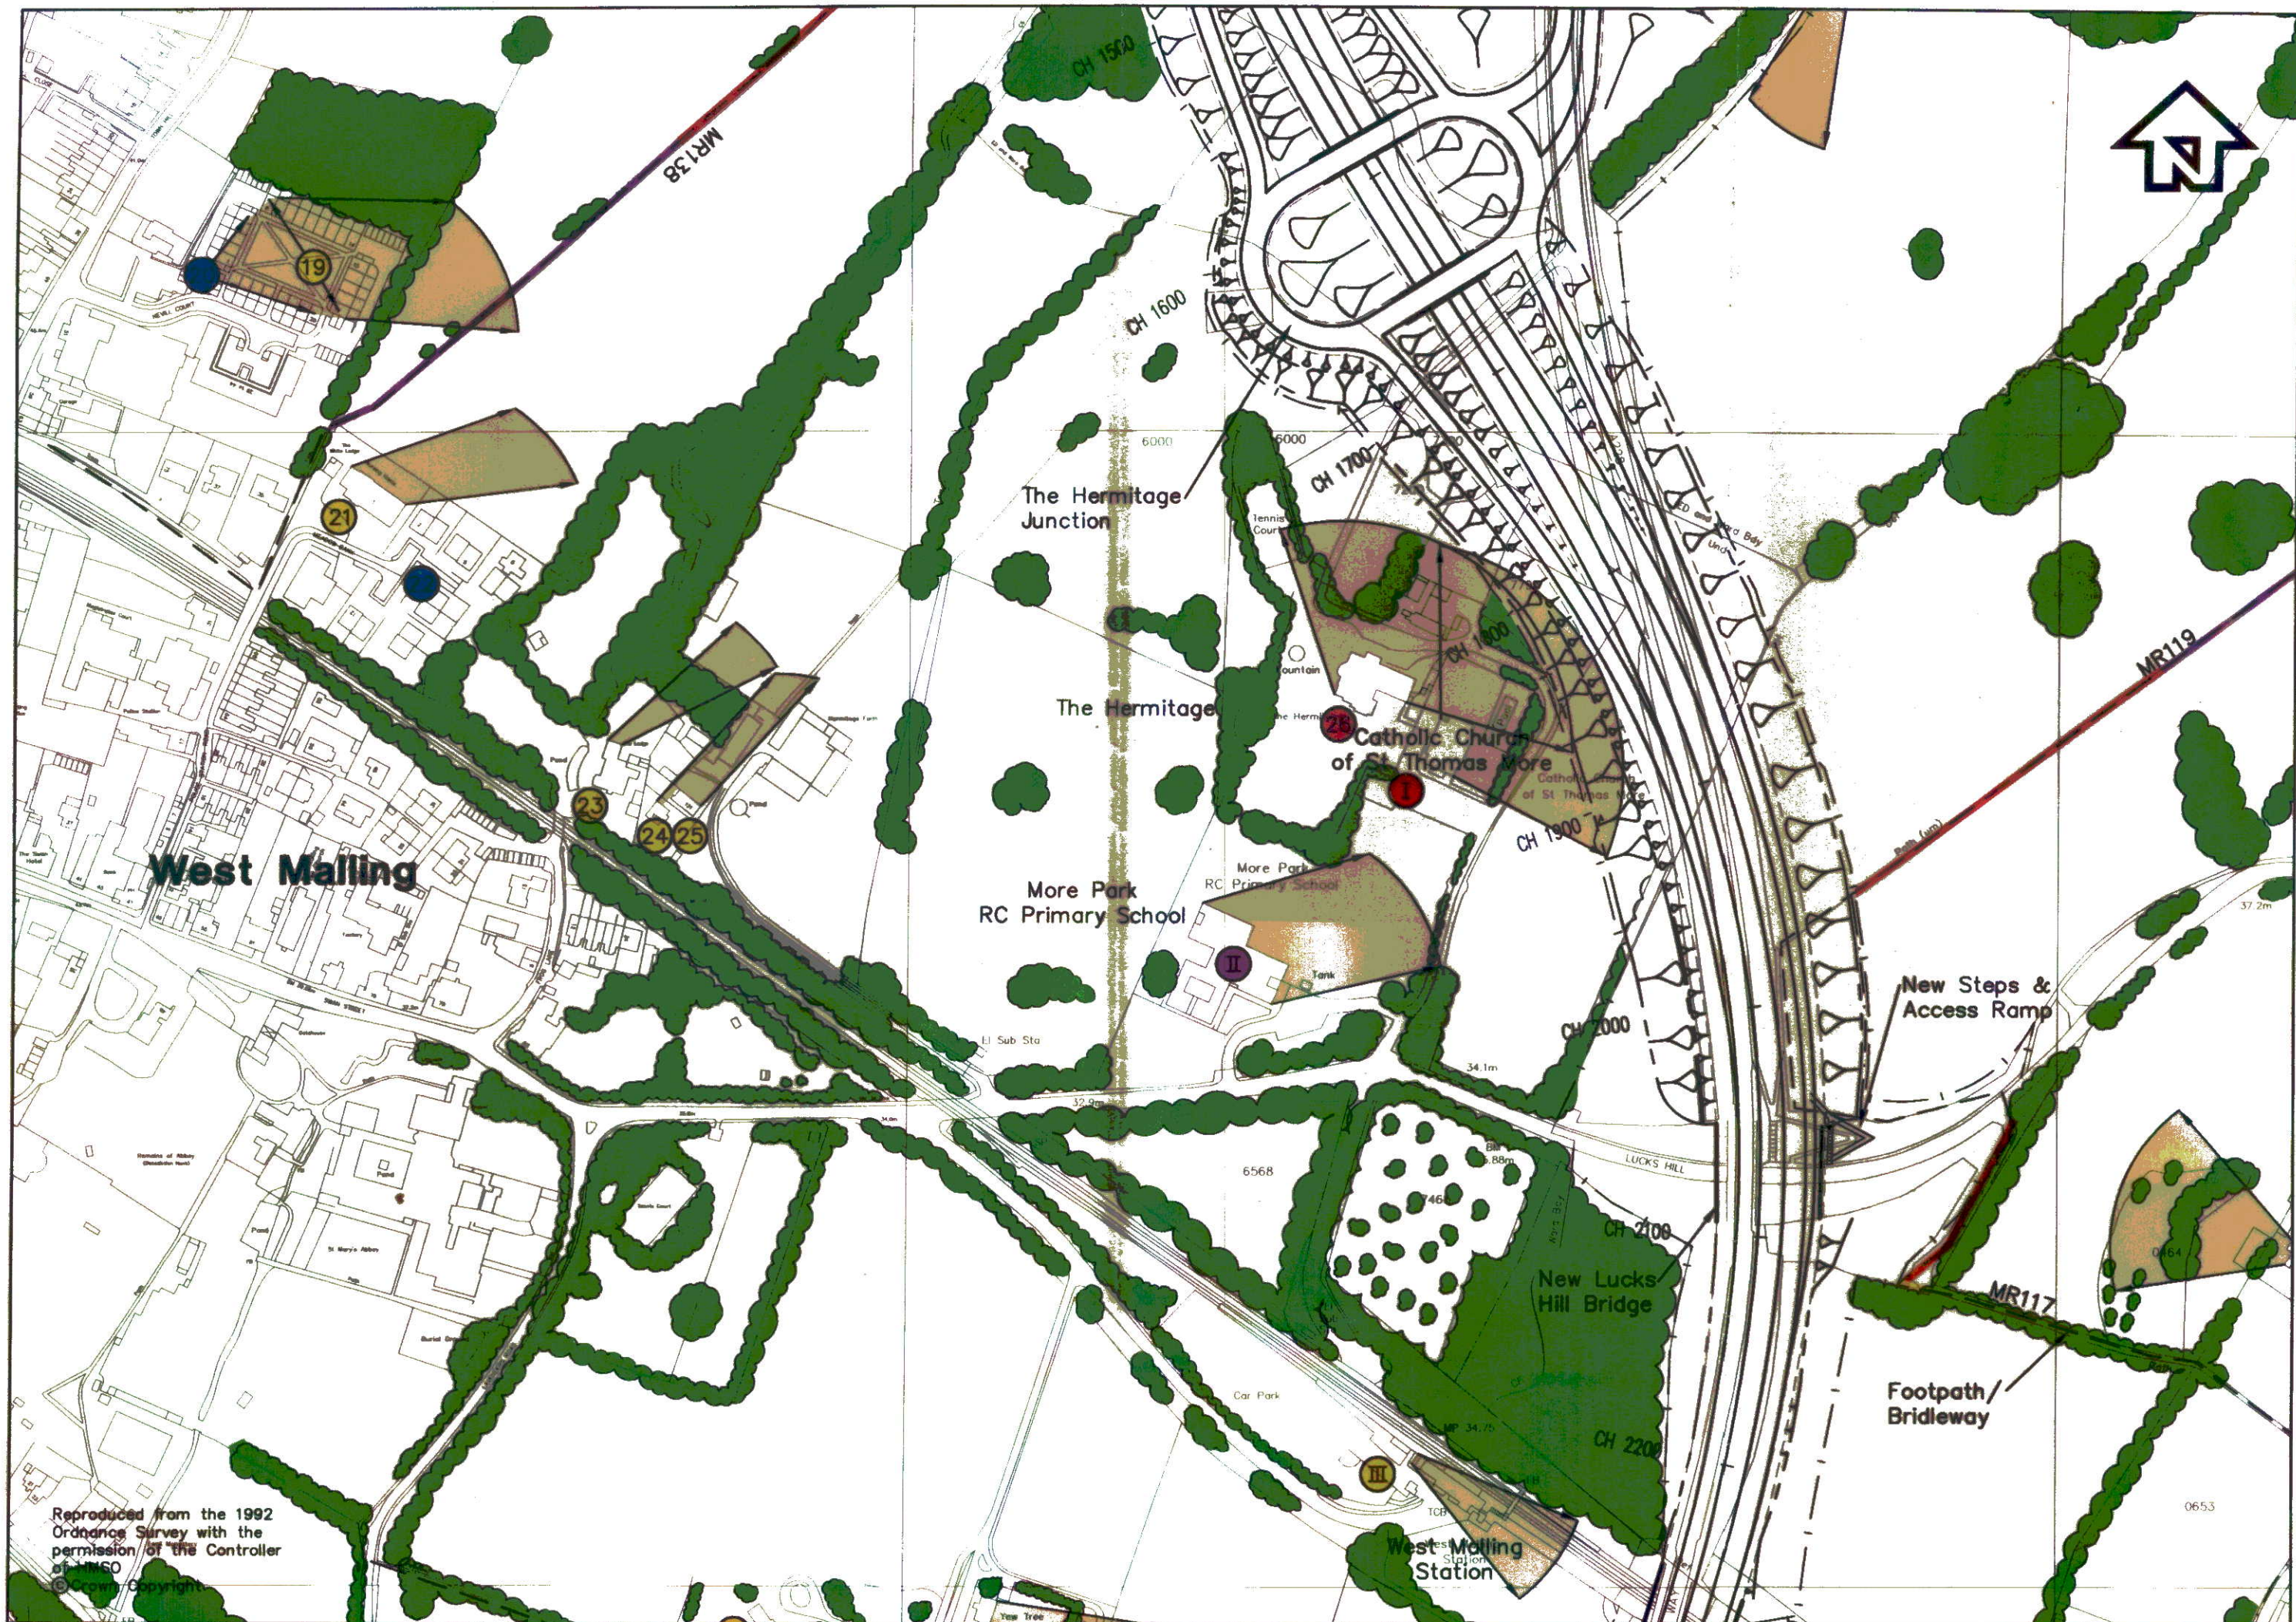
Figure 8

VISUAL INTRUSION PLANS WINTER 1998
