Landscape

*A228 Leybourne & West Malling Bypass
Environmental Statement
Volume 2 (part)*

Kent County Council

July 1995

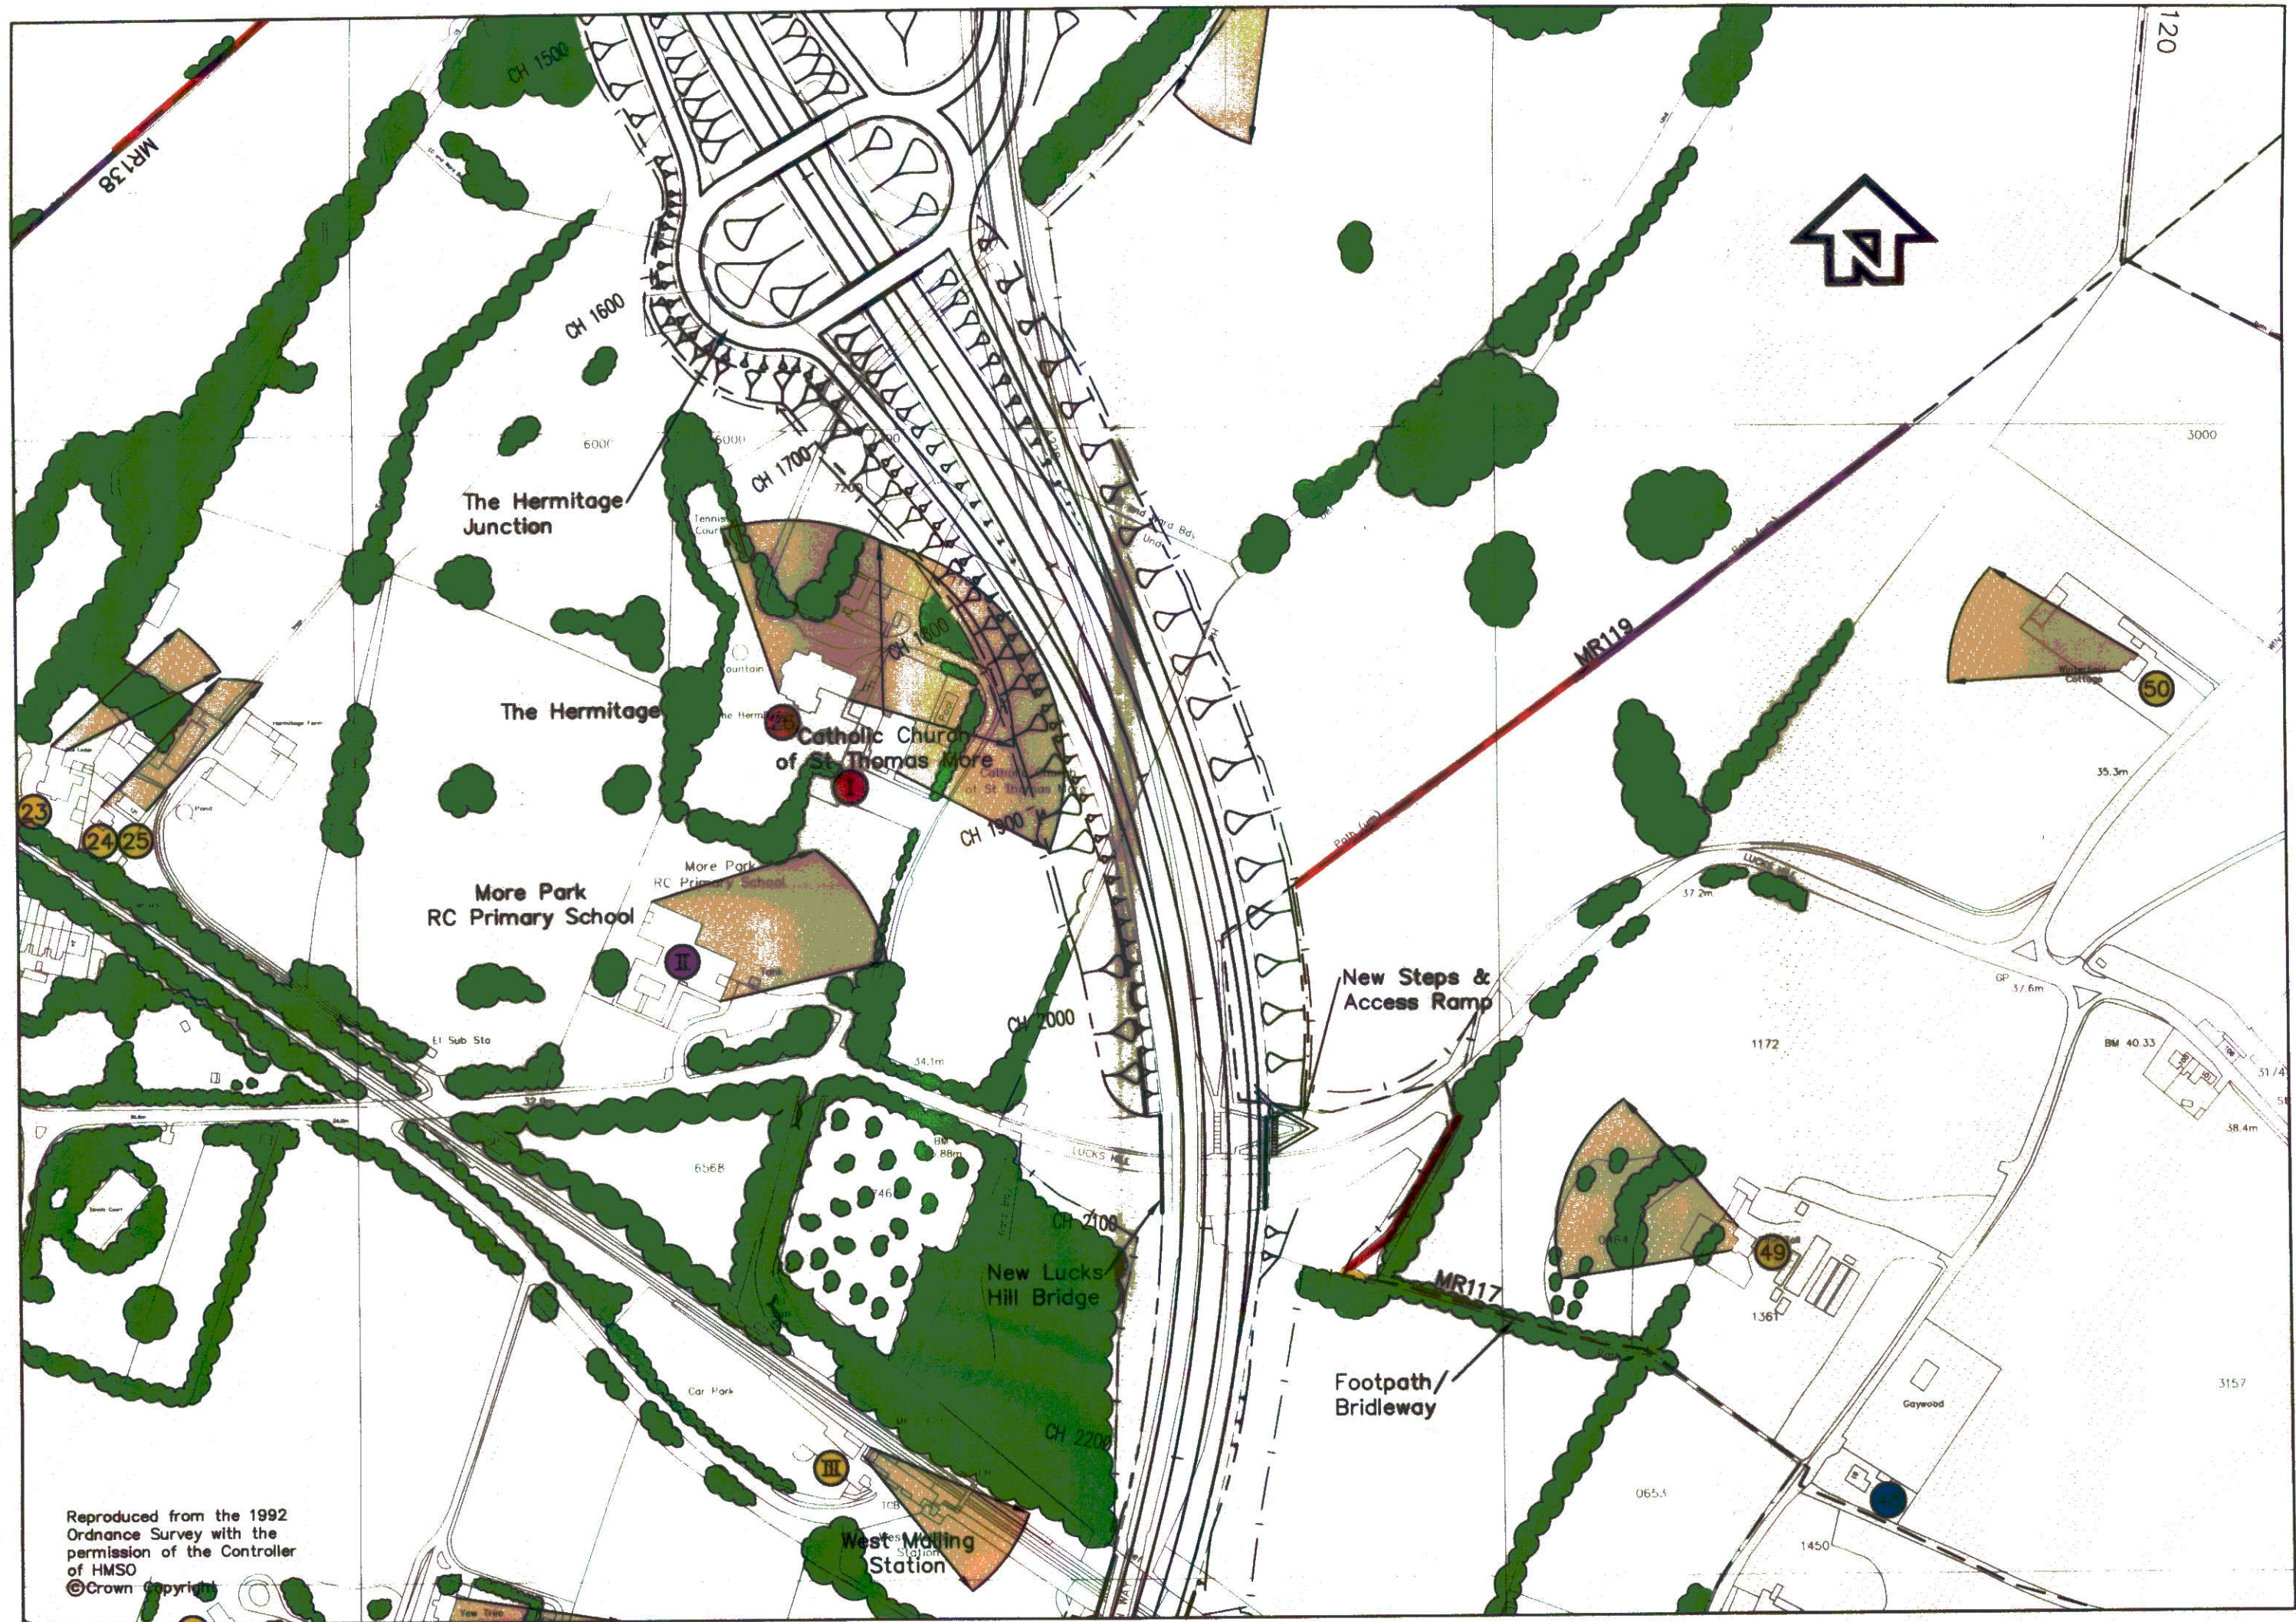
Figure 9

VISUAL INTRUSION PLANS WINTER 1998

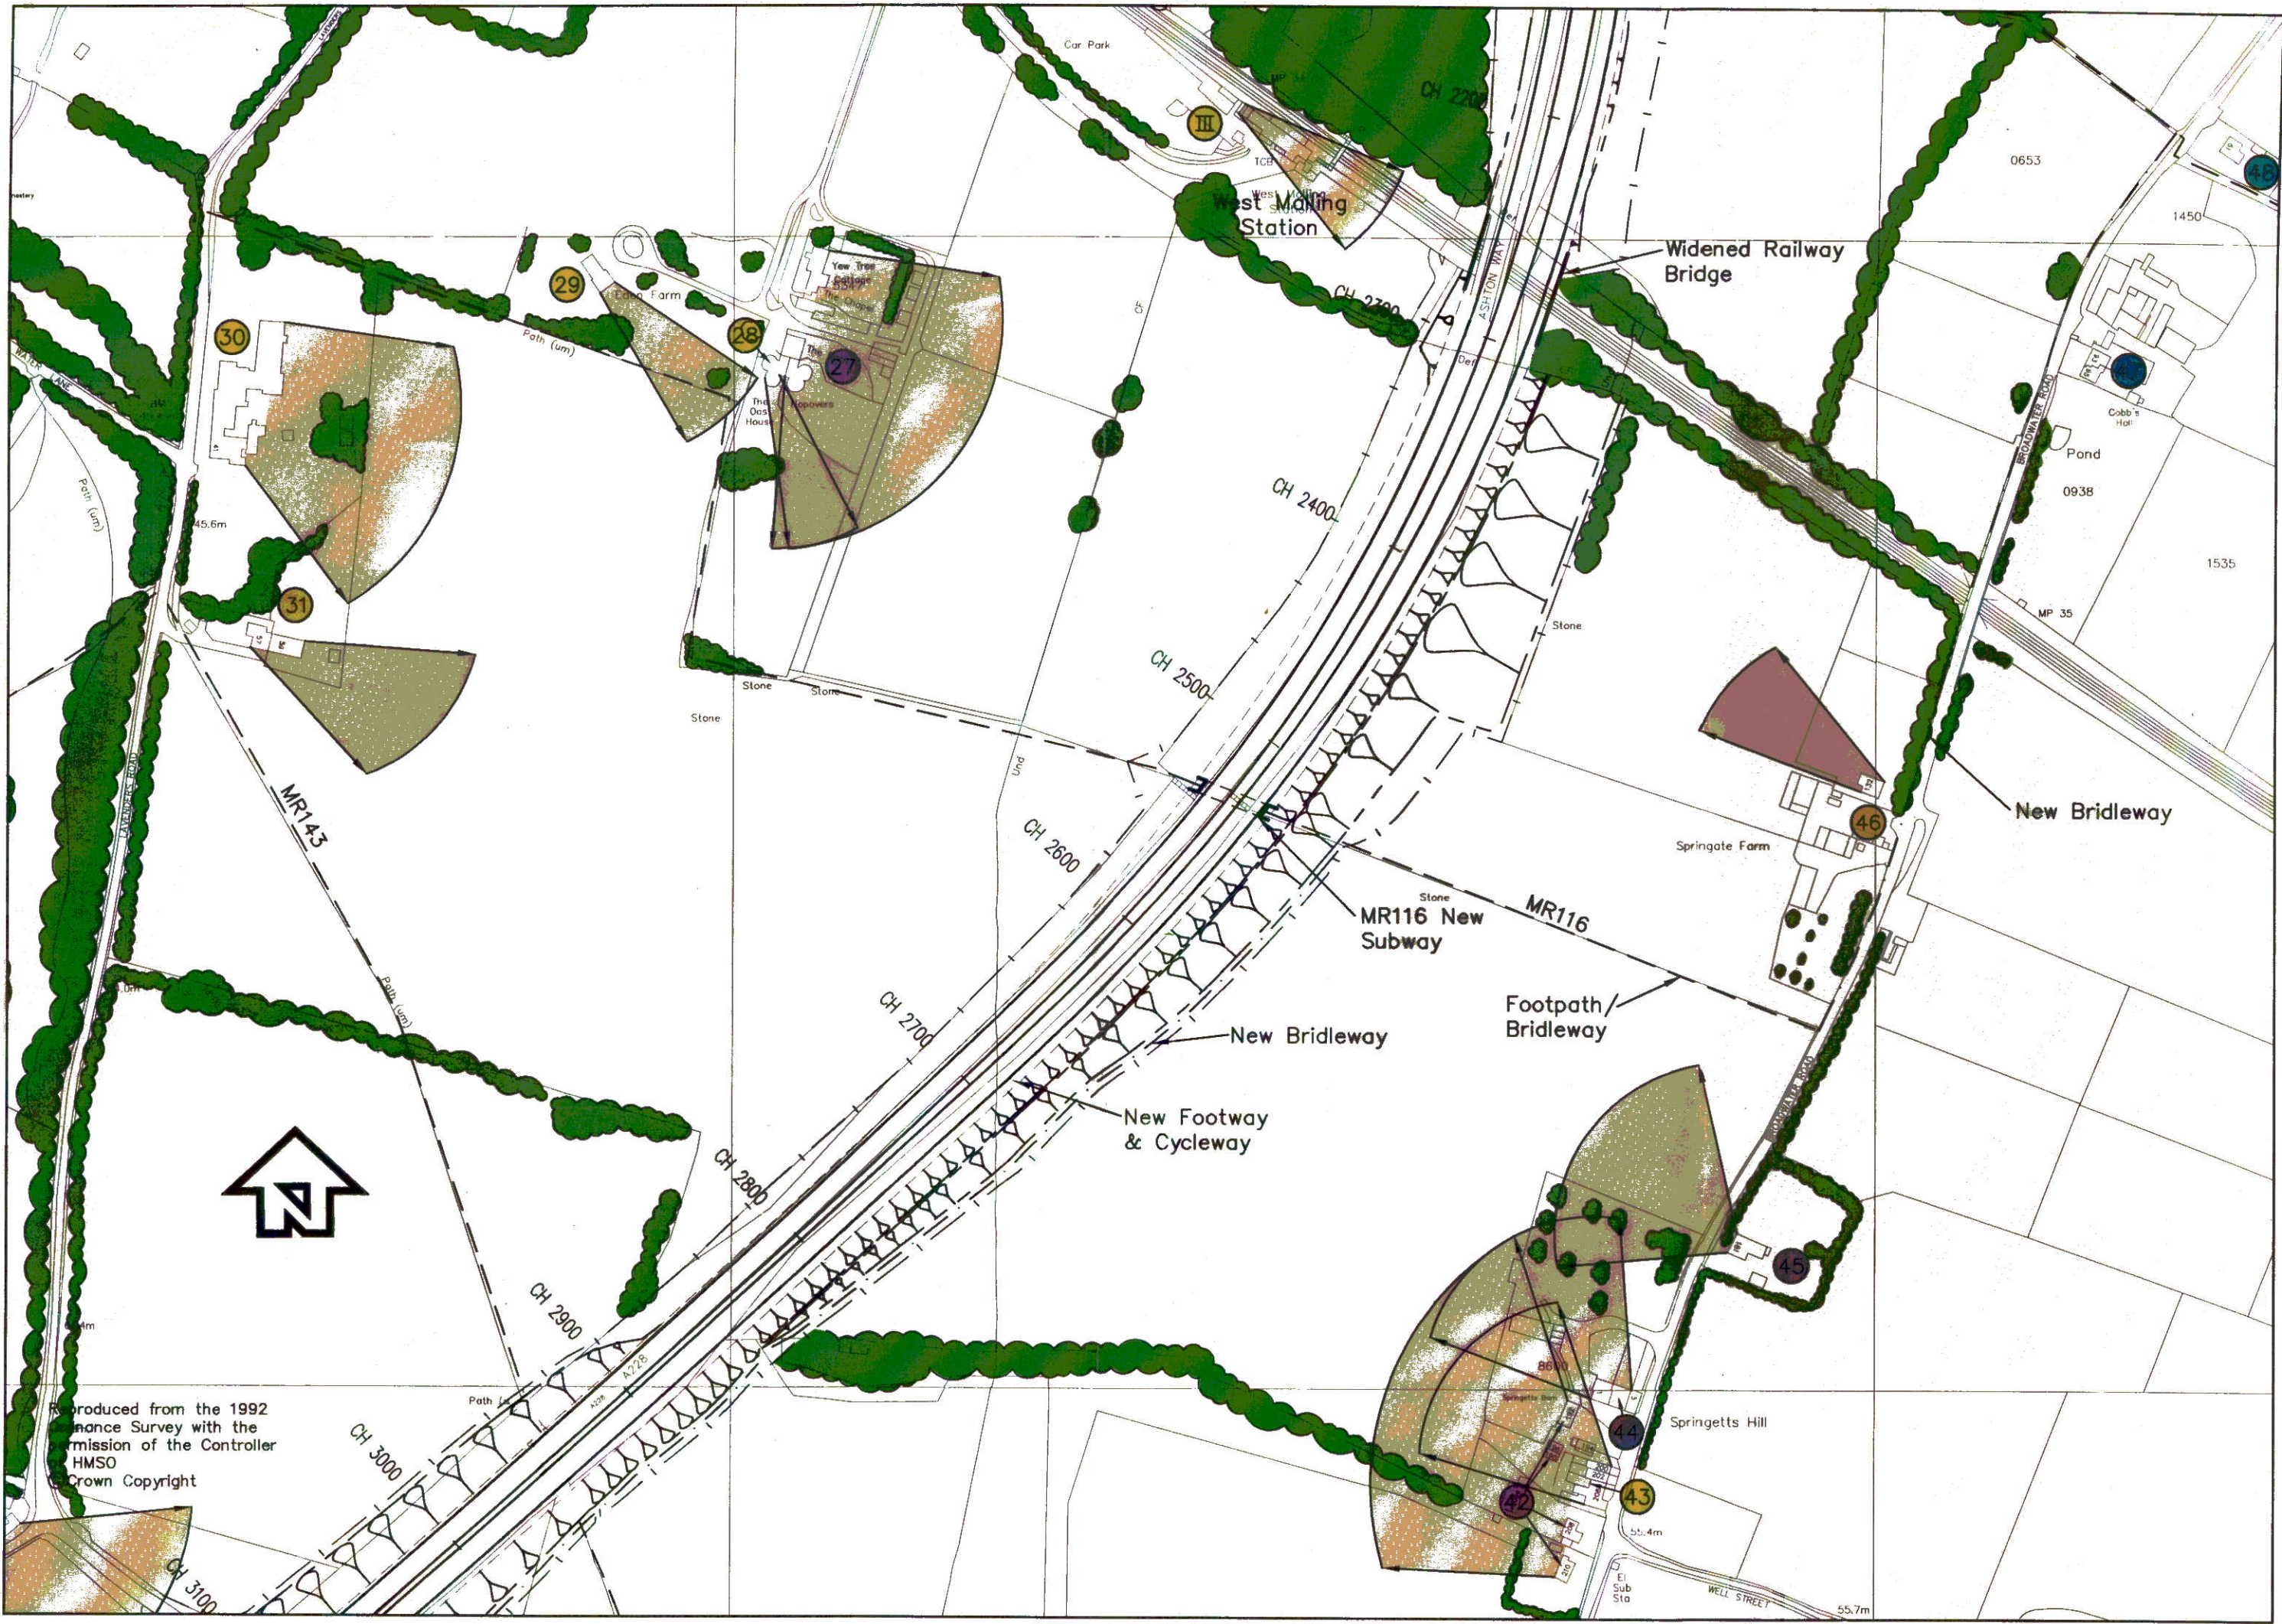
VISUAL INTRUSION PLANS WINTER 1998 **Figure 10**

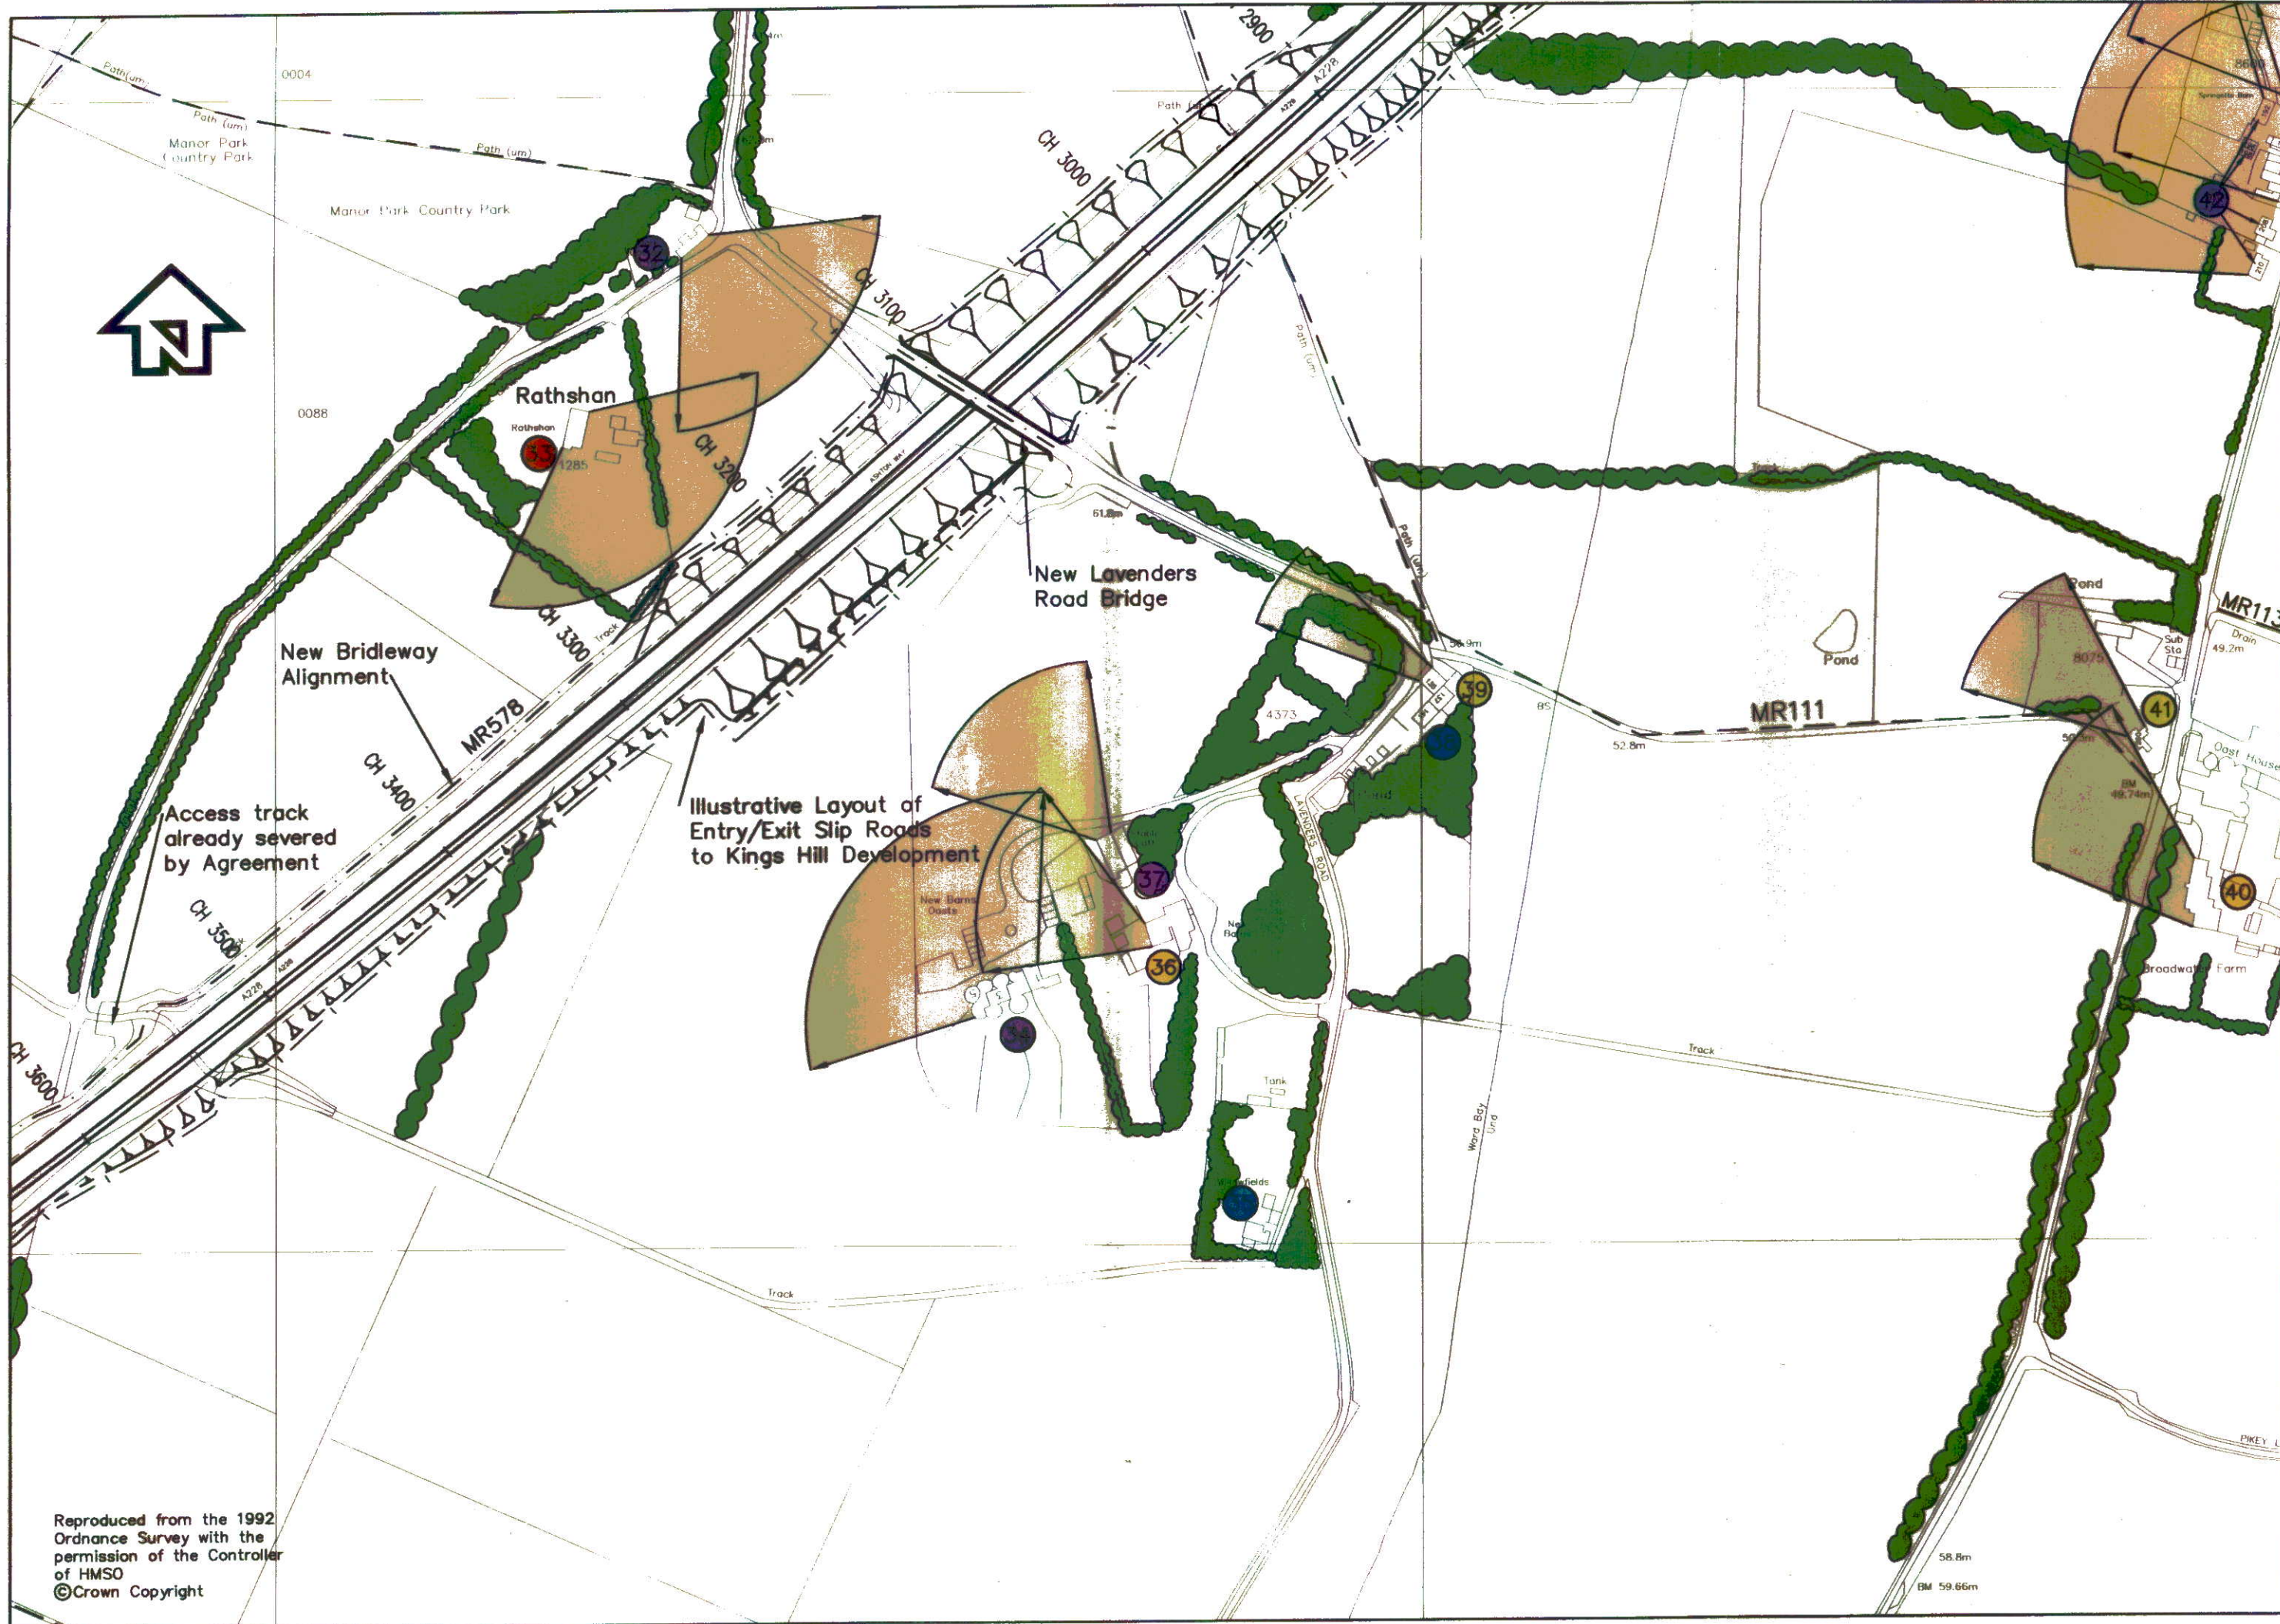
Figure 11

VISUAL INTRUSION PLANS WINTER 1998

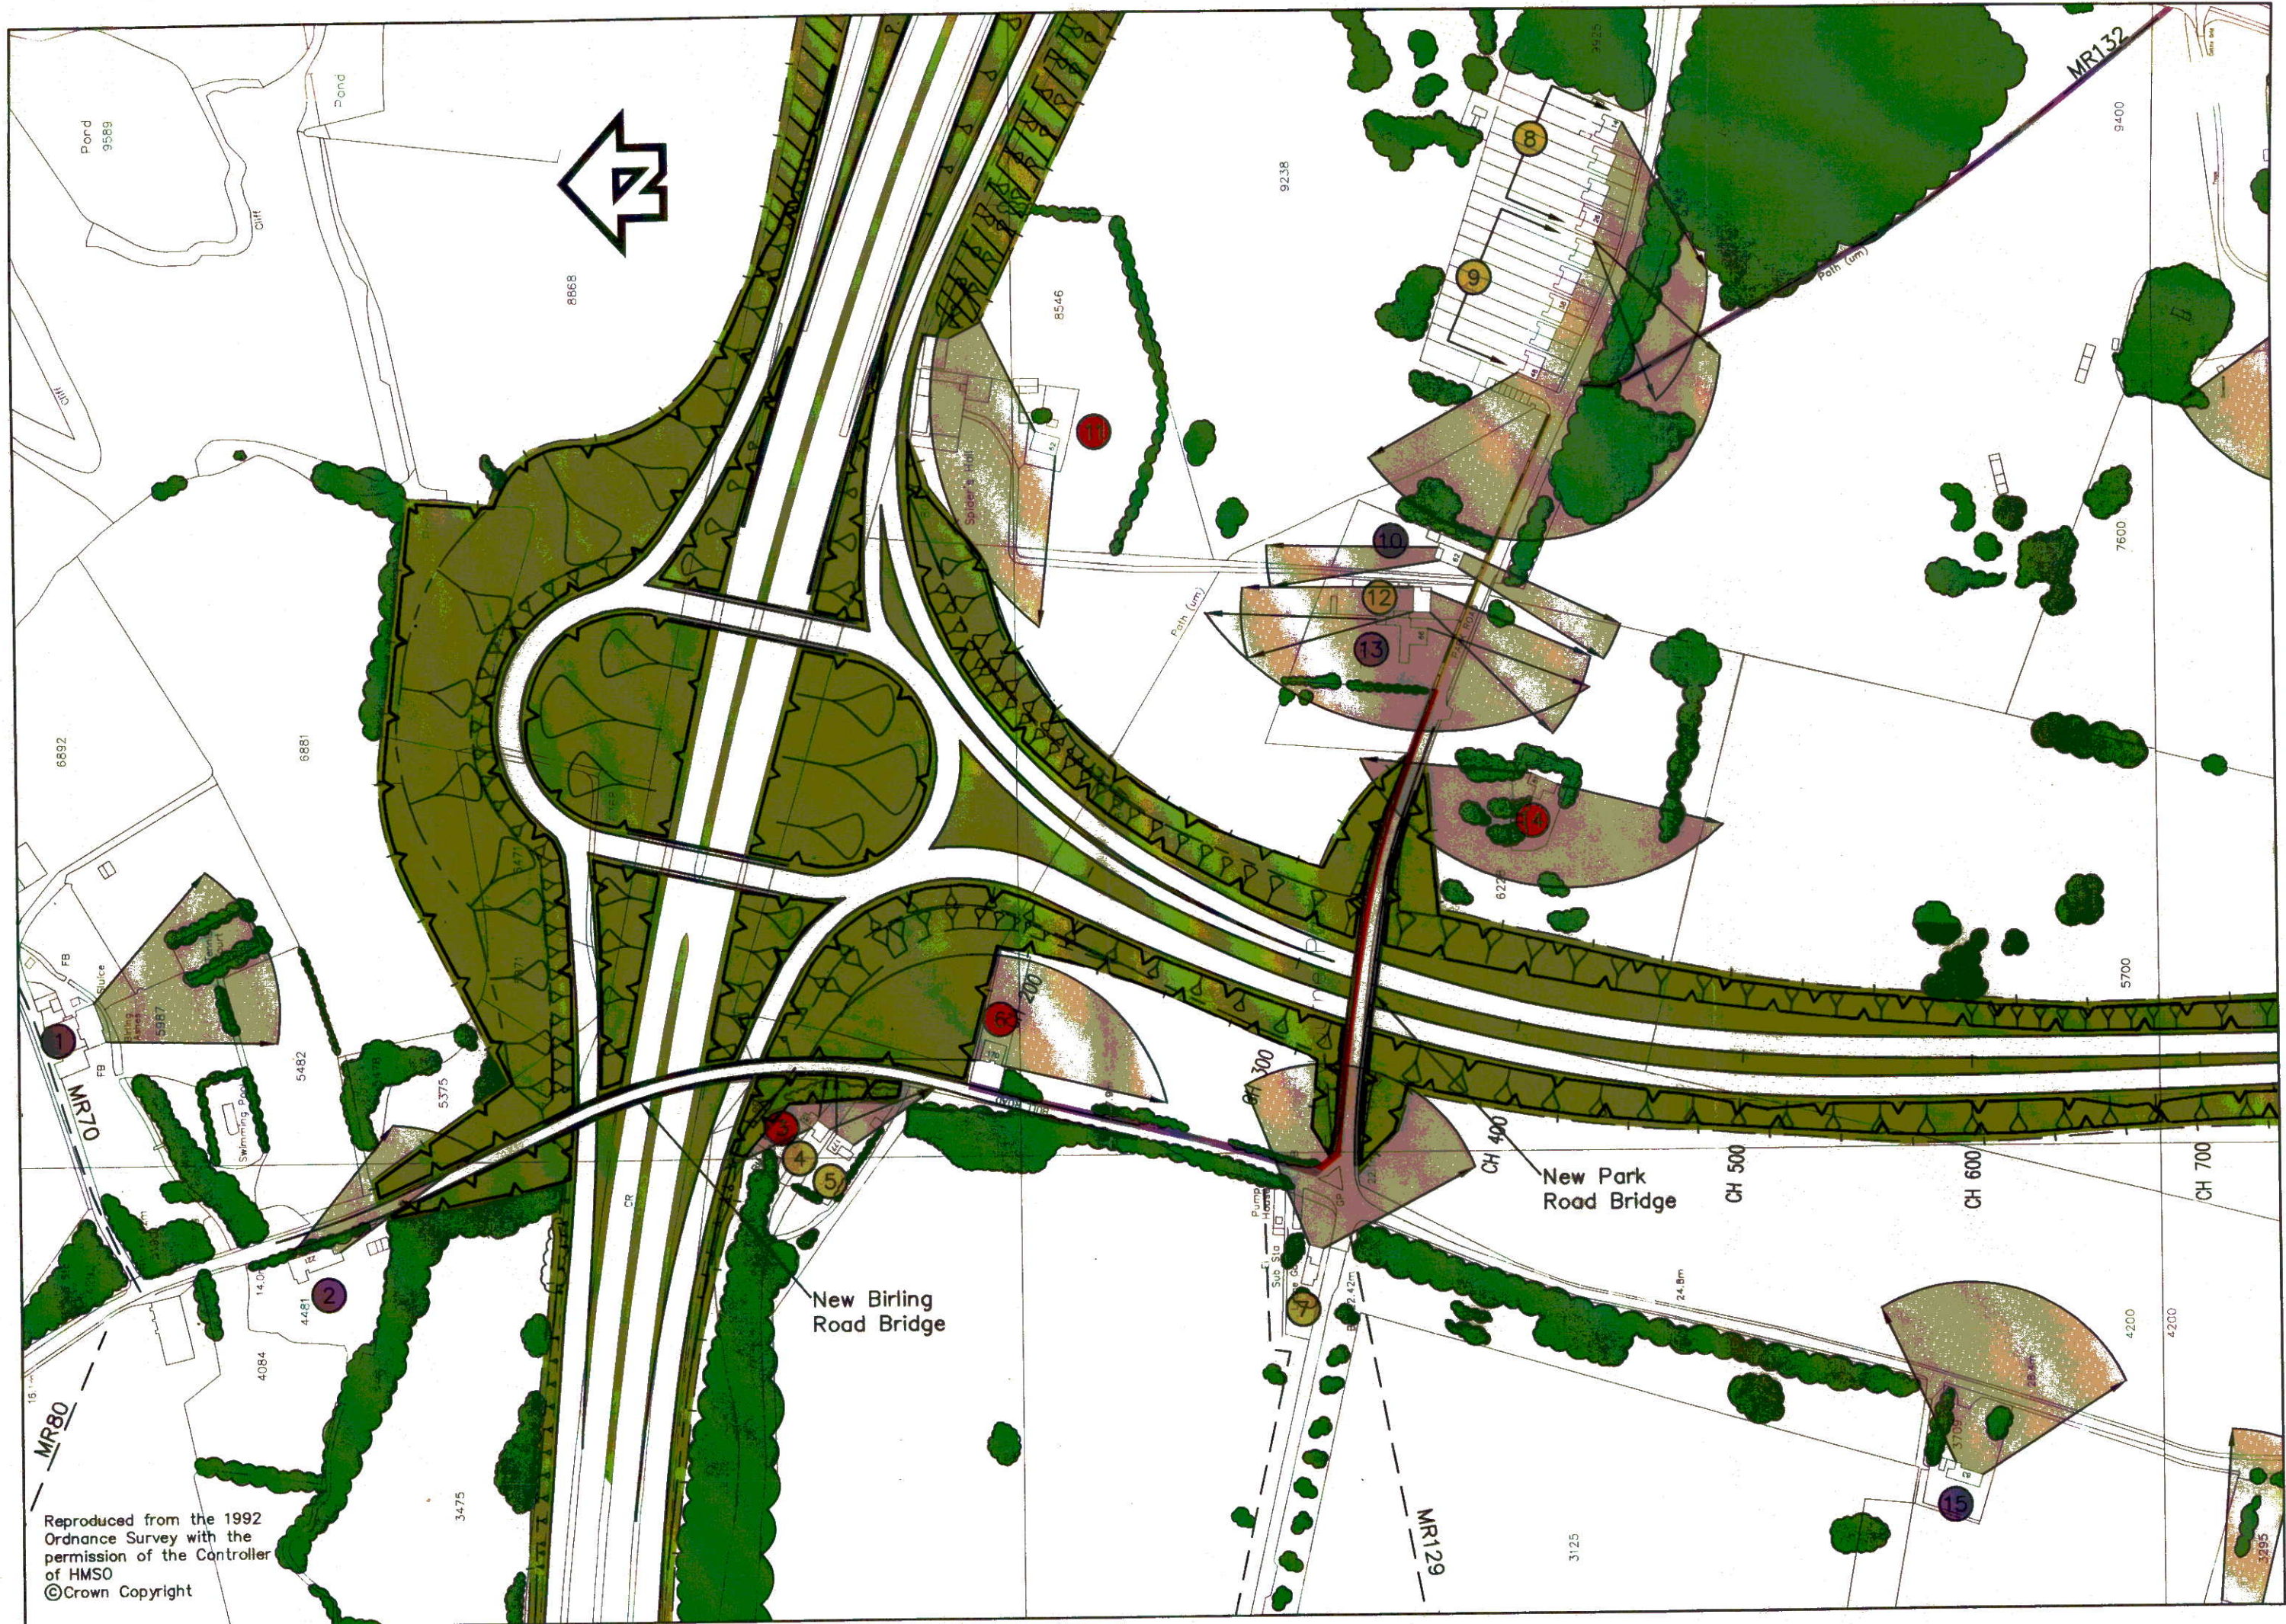
VISUAL INTRUSION PLANS SUMMER 2013 Figure 13

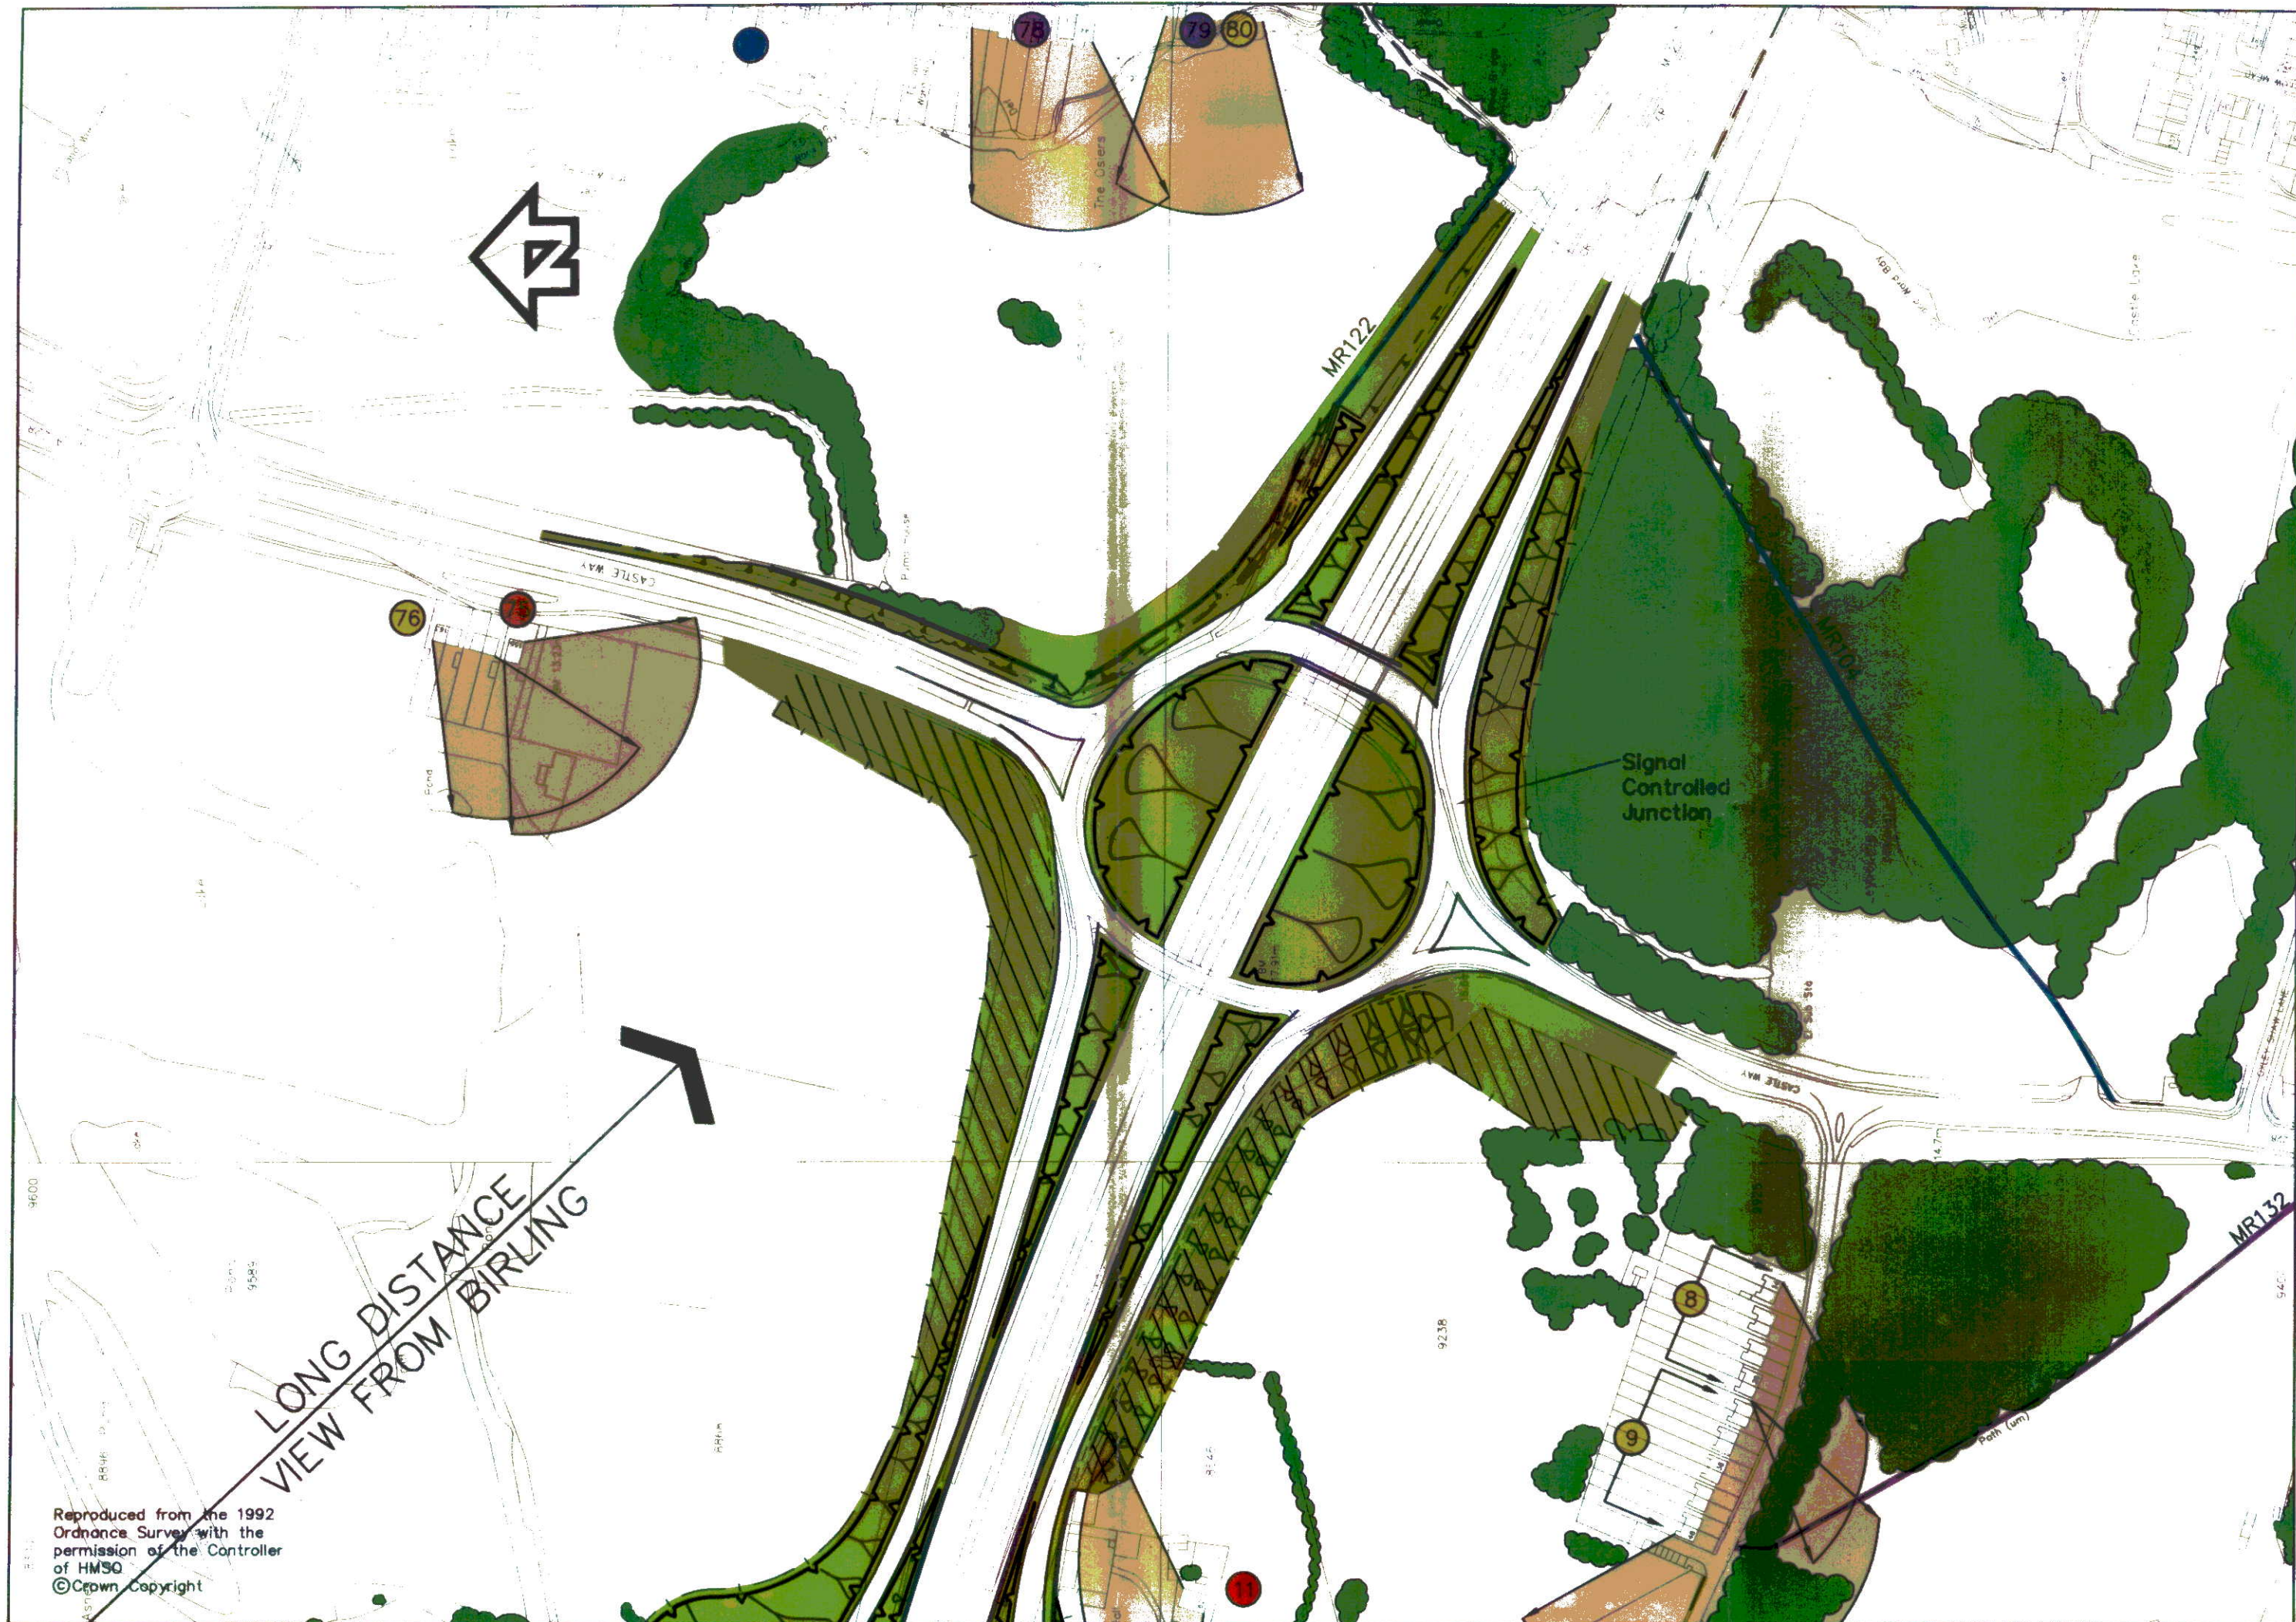
VISUAL INTRUSION PLANS SUMMER 2013 **Figure 14**

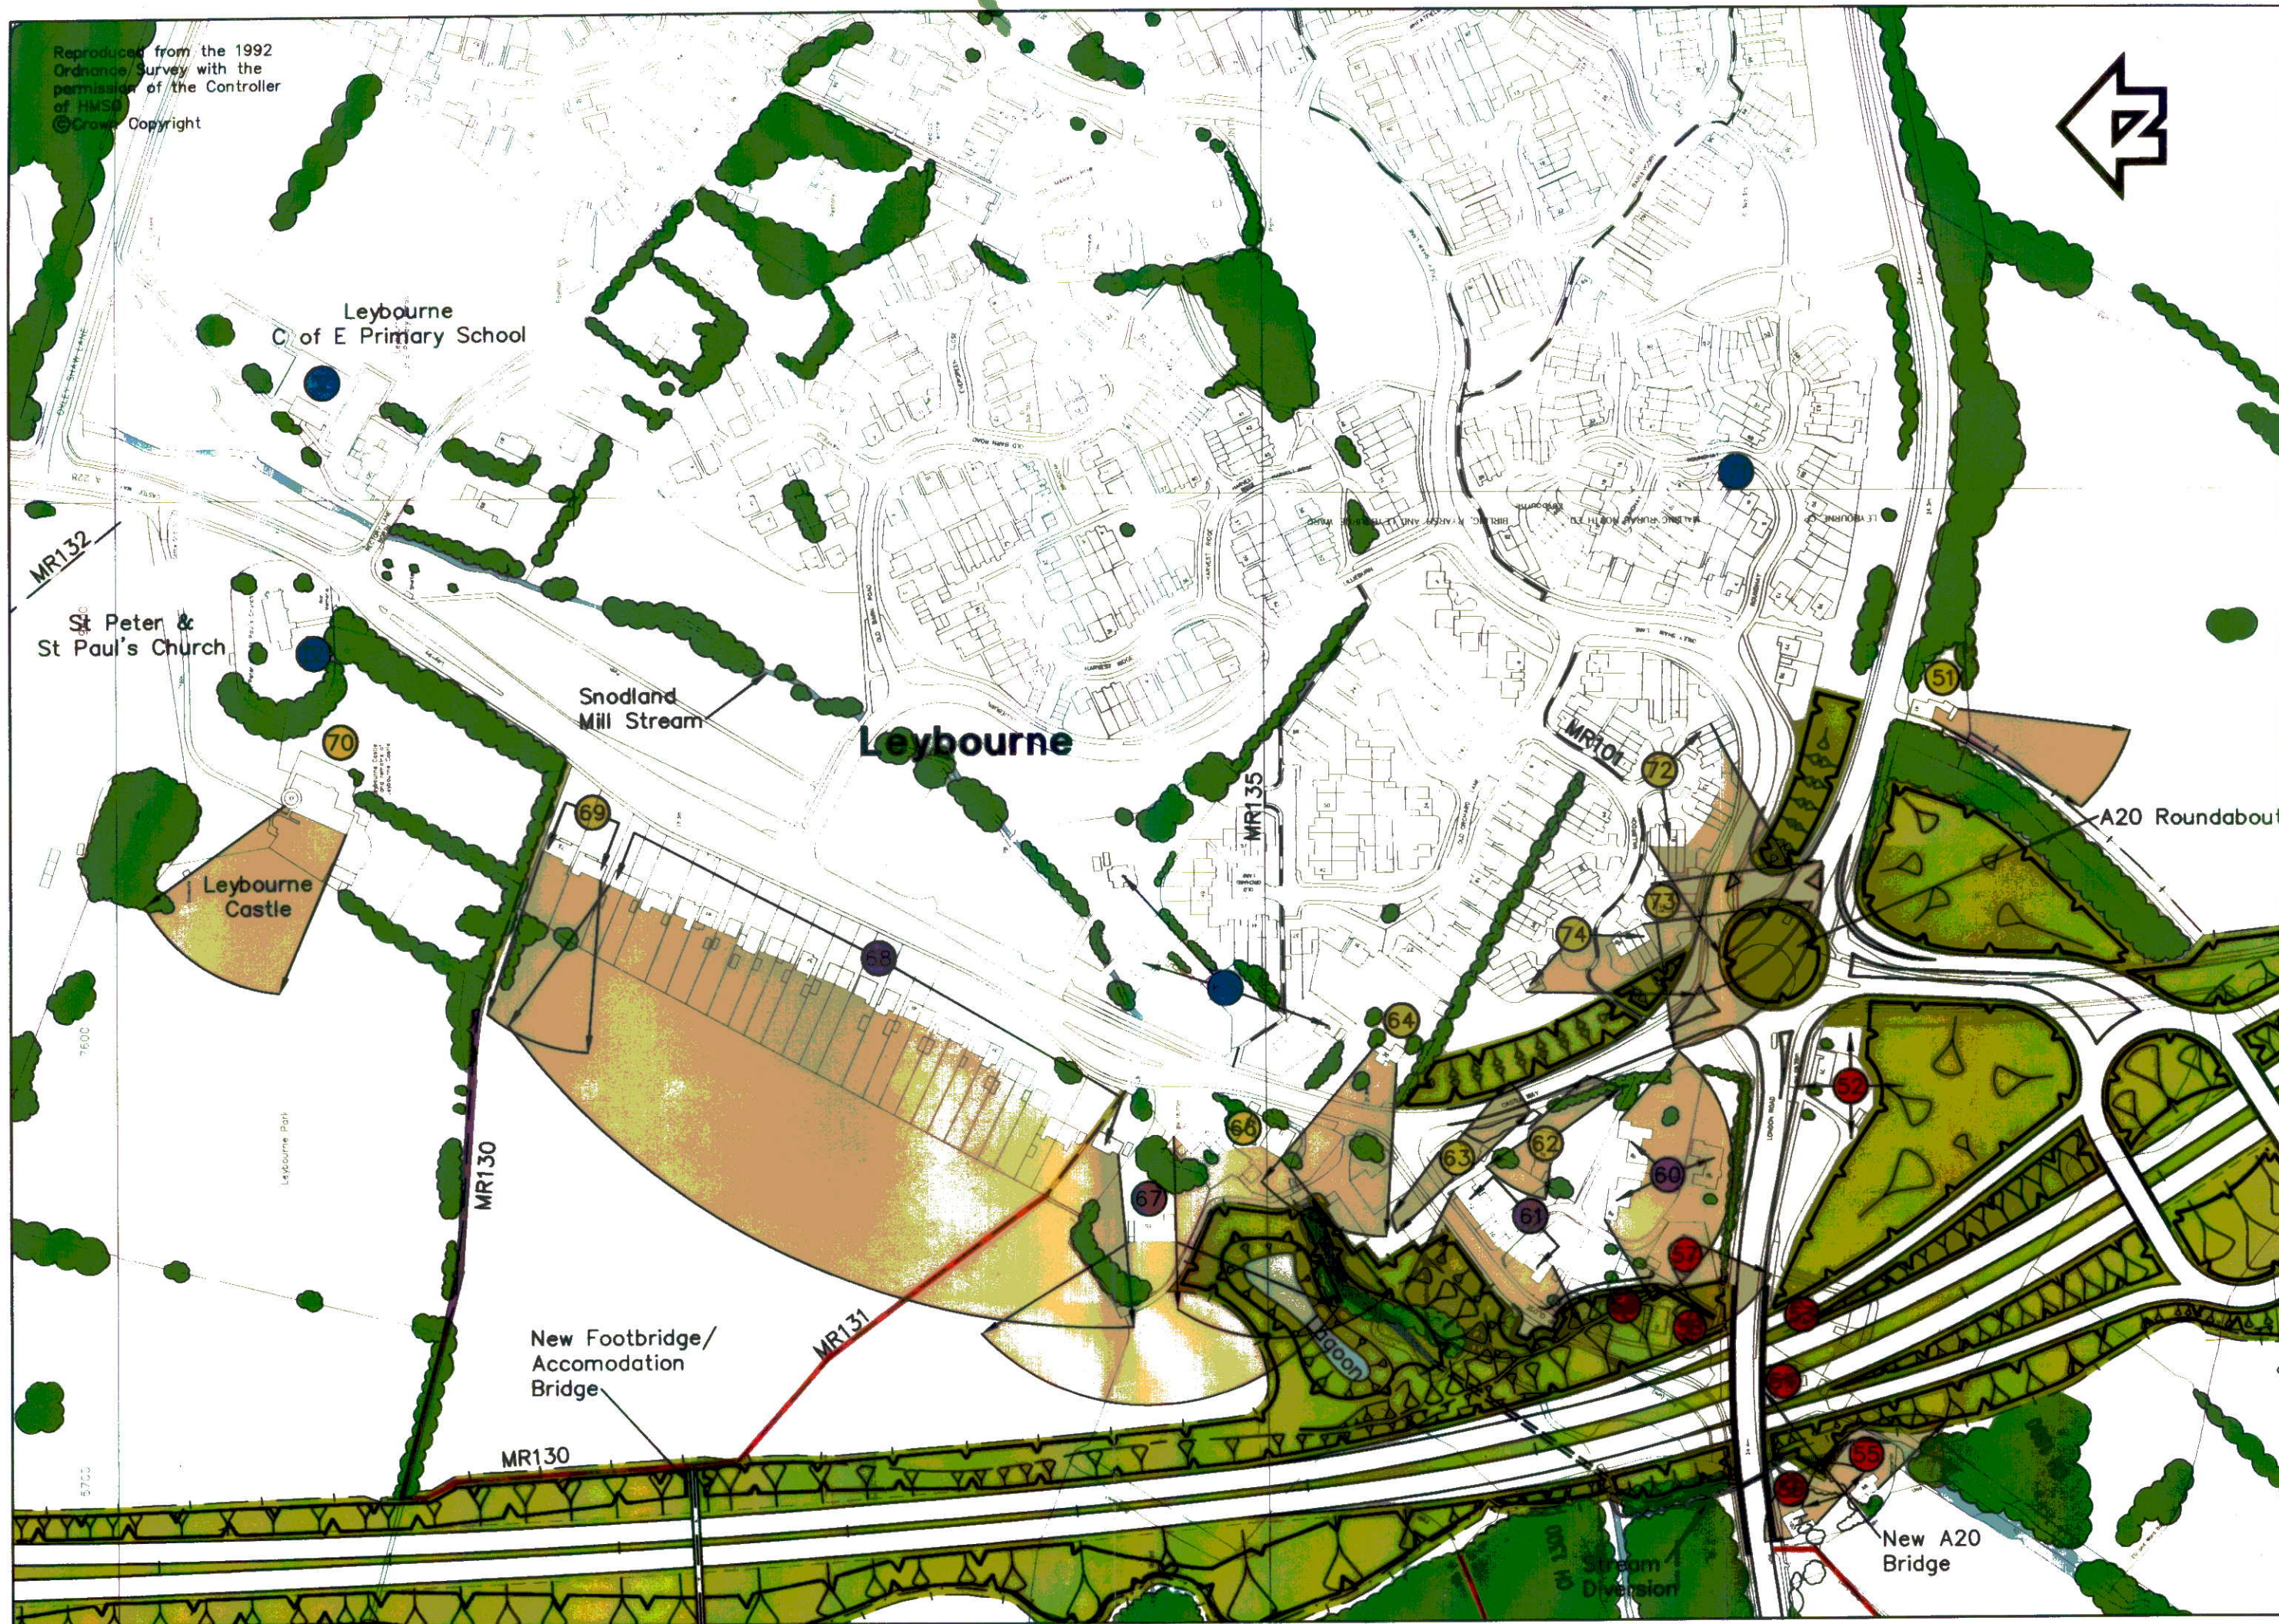
VISUAL INTRUSION PLANS SUMMER 2013 **Figure 15**
