Landscape

*A228 Leybourne & West Malling Bypass
Environmental Statement
Volume 2 (part)*

Kent County Council

July 1995

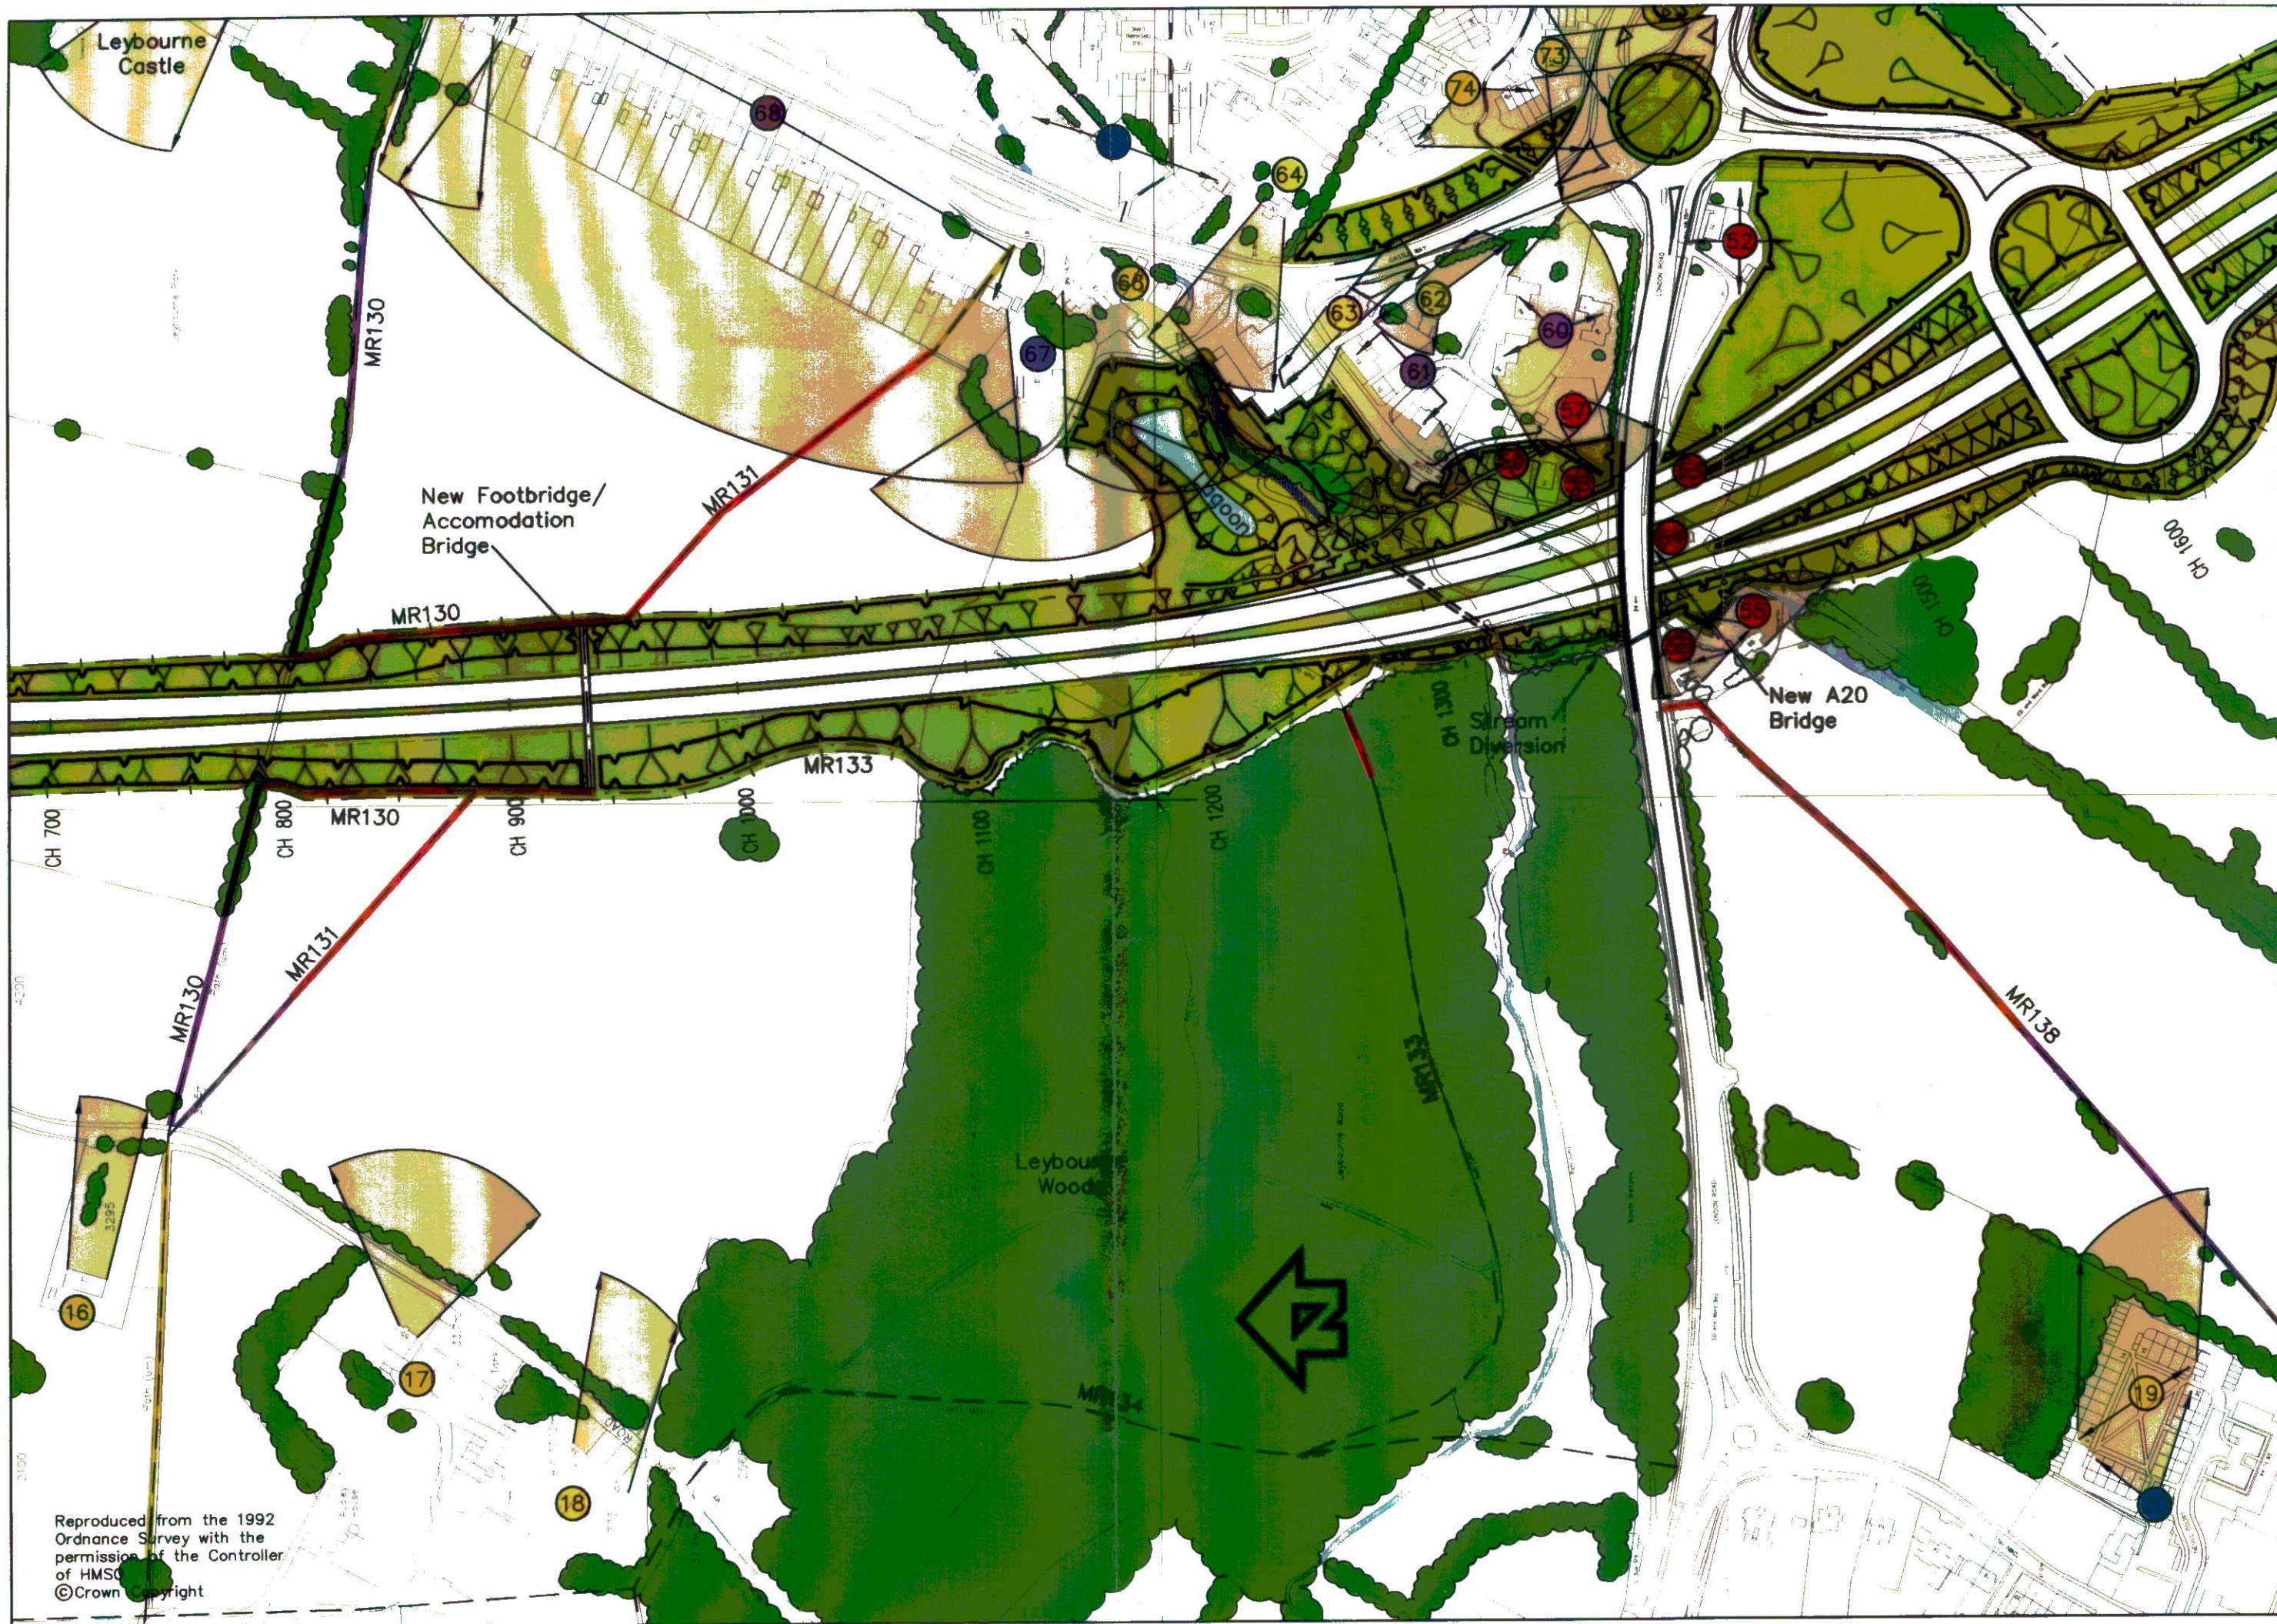
VISUAL INTRUSION PLANS SUMMER 2013 **Figure 16**

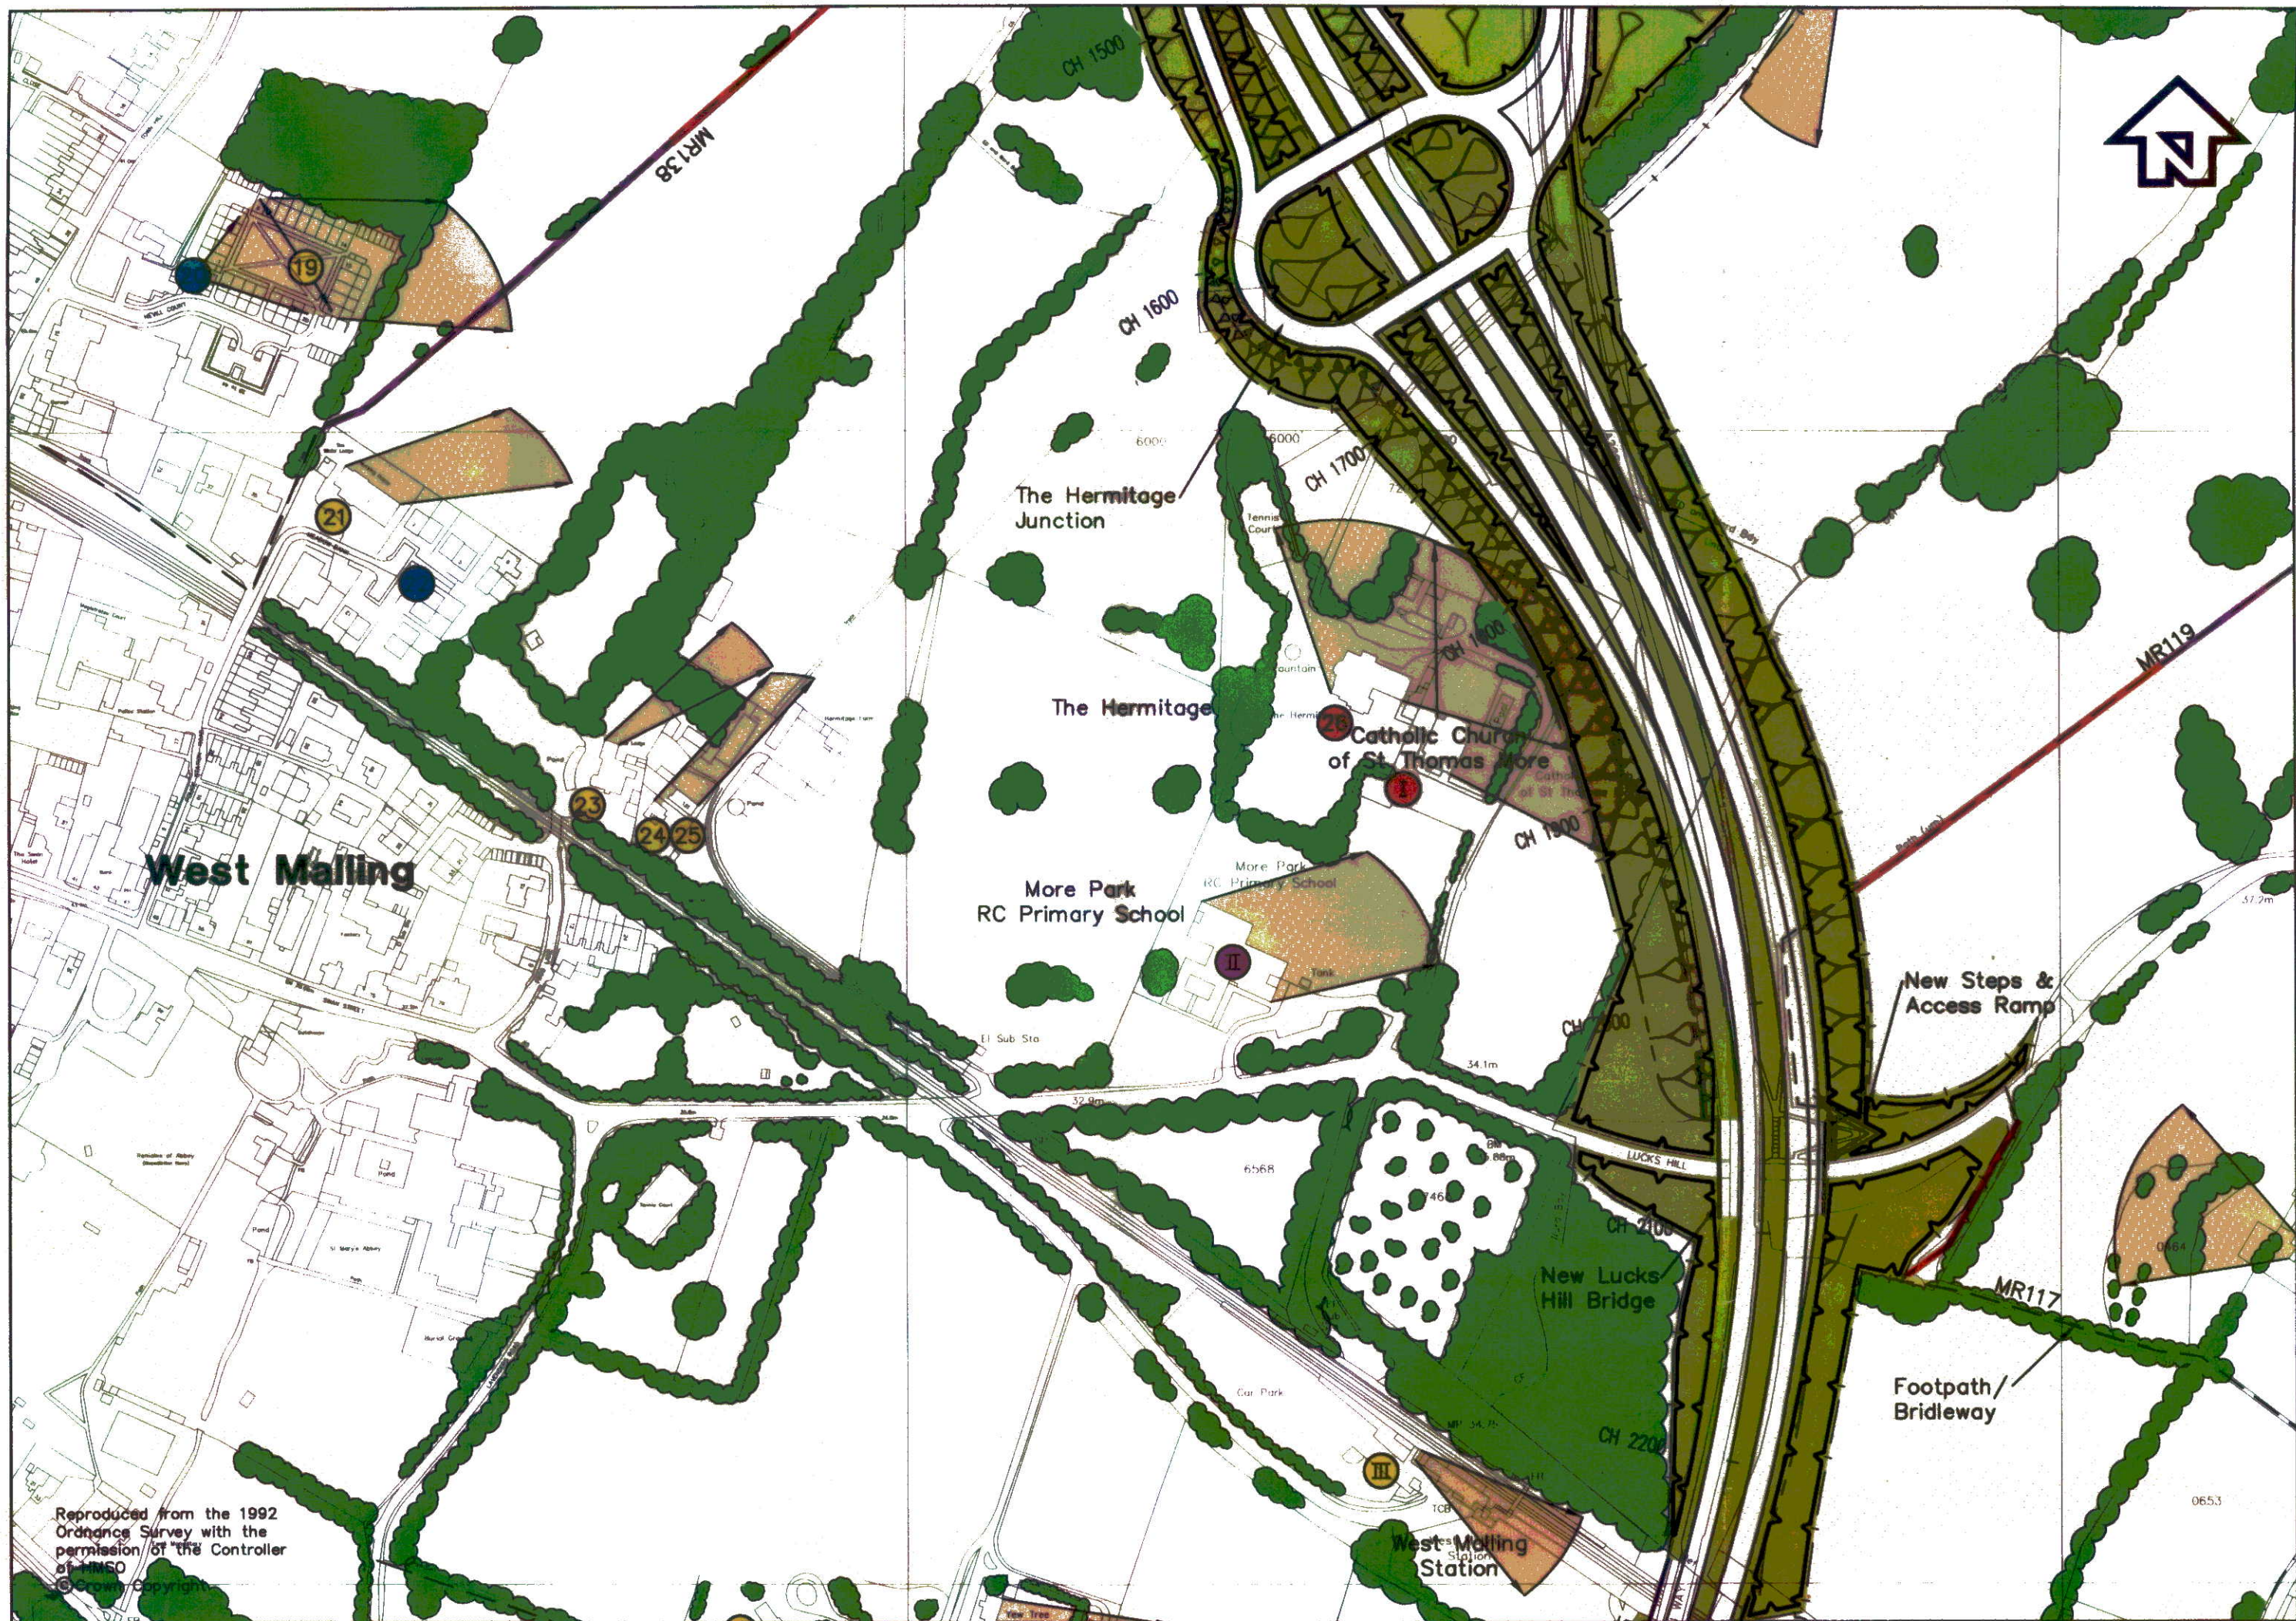
Figure 17

VISUAL INTRUSION PLANS SUMMER 2013

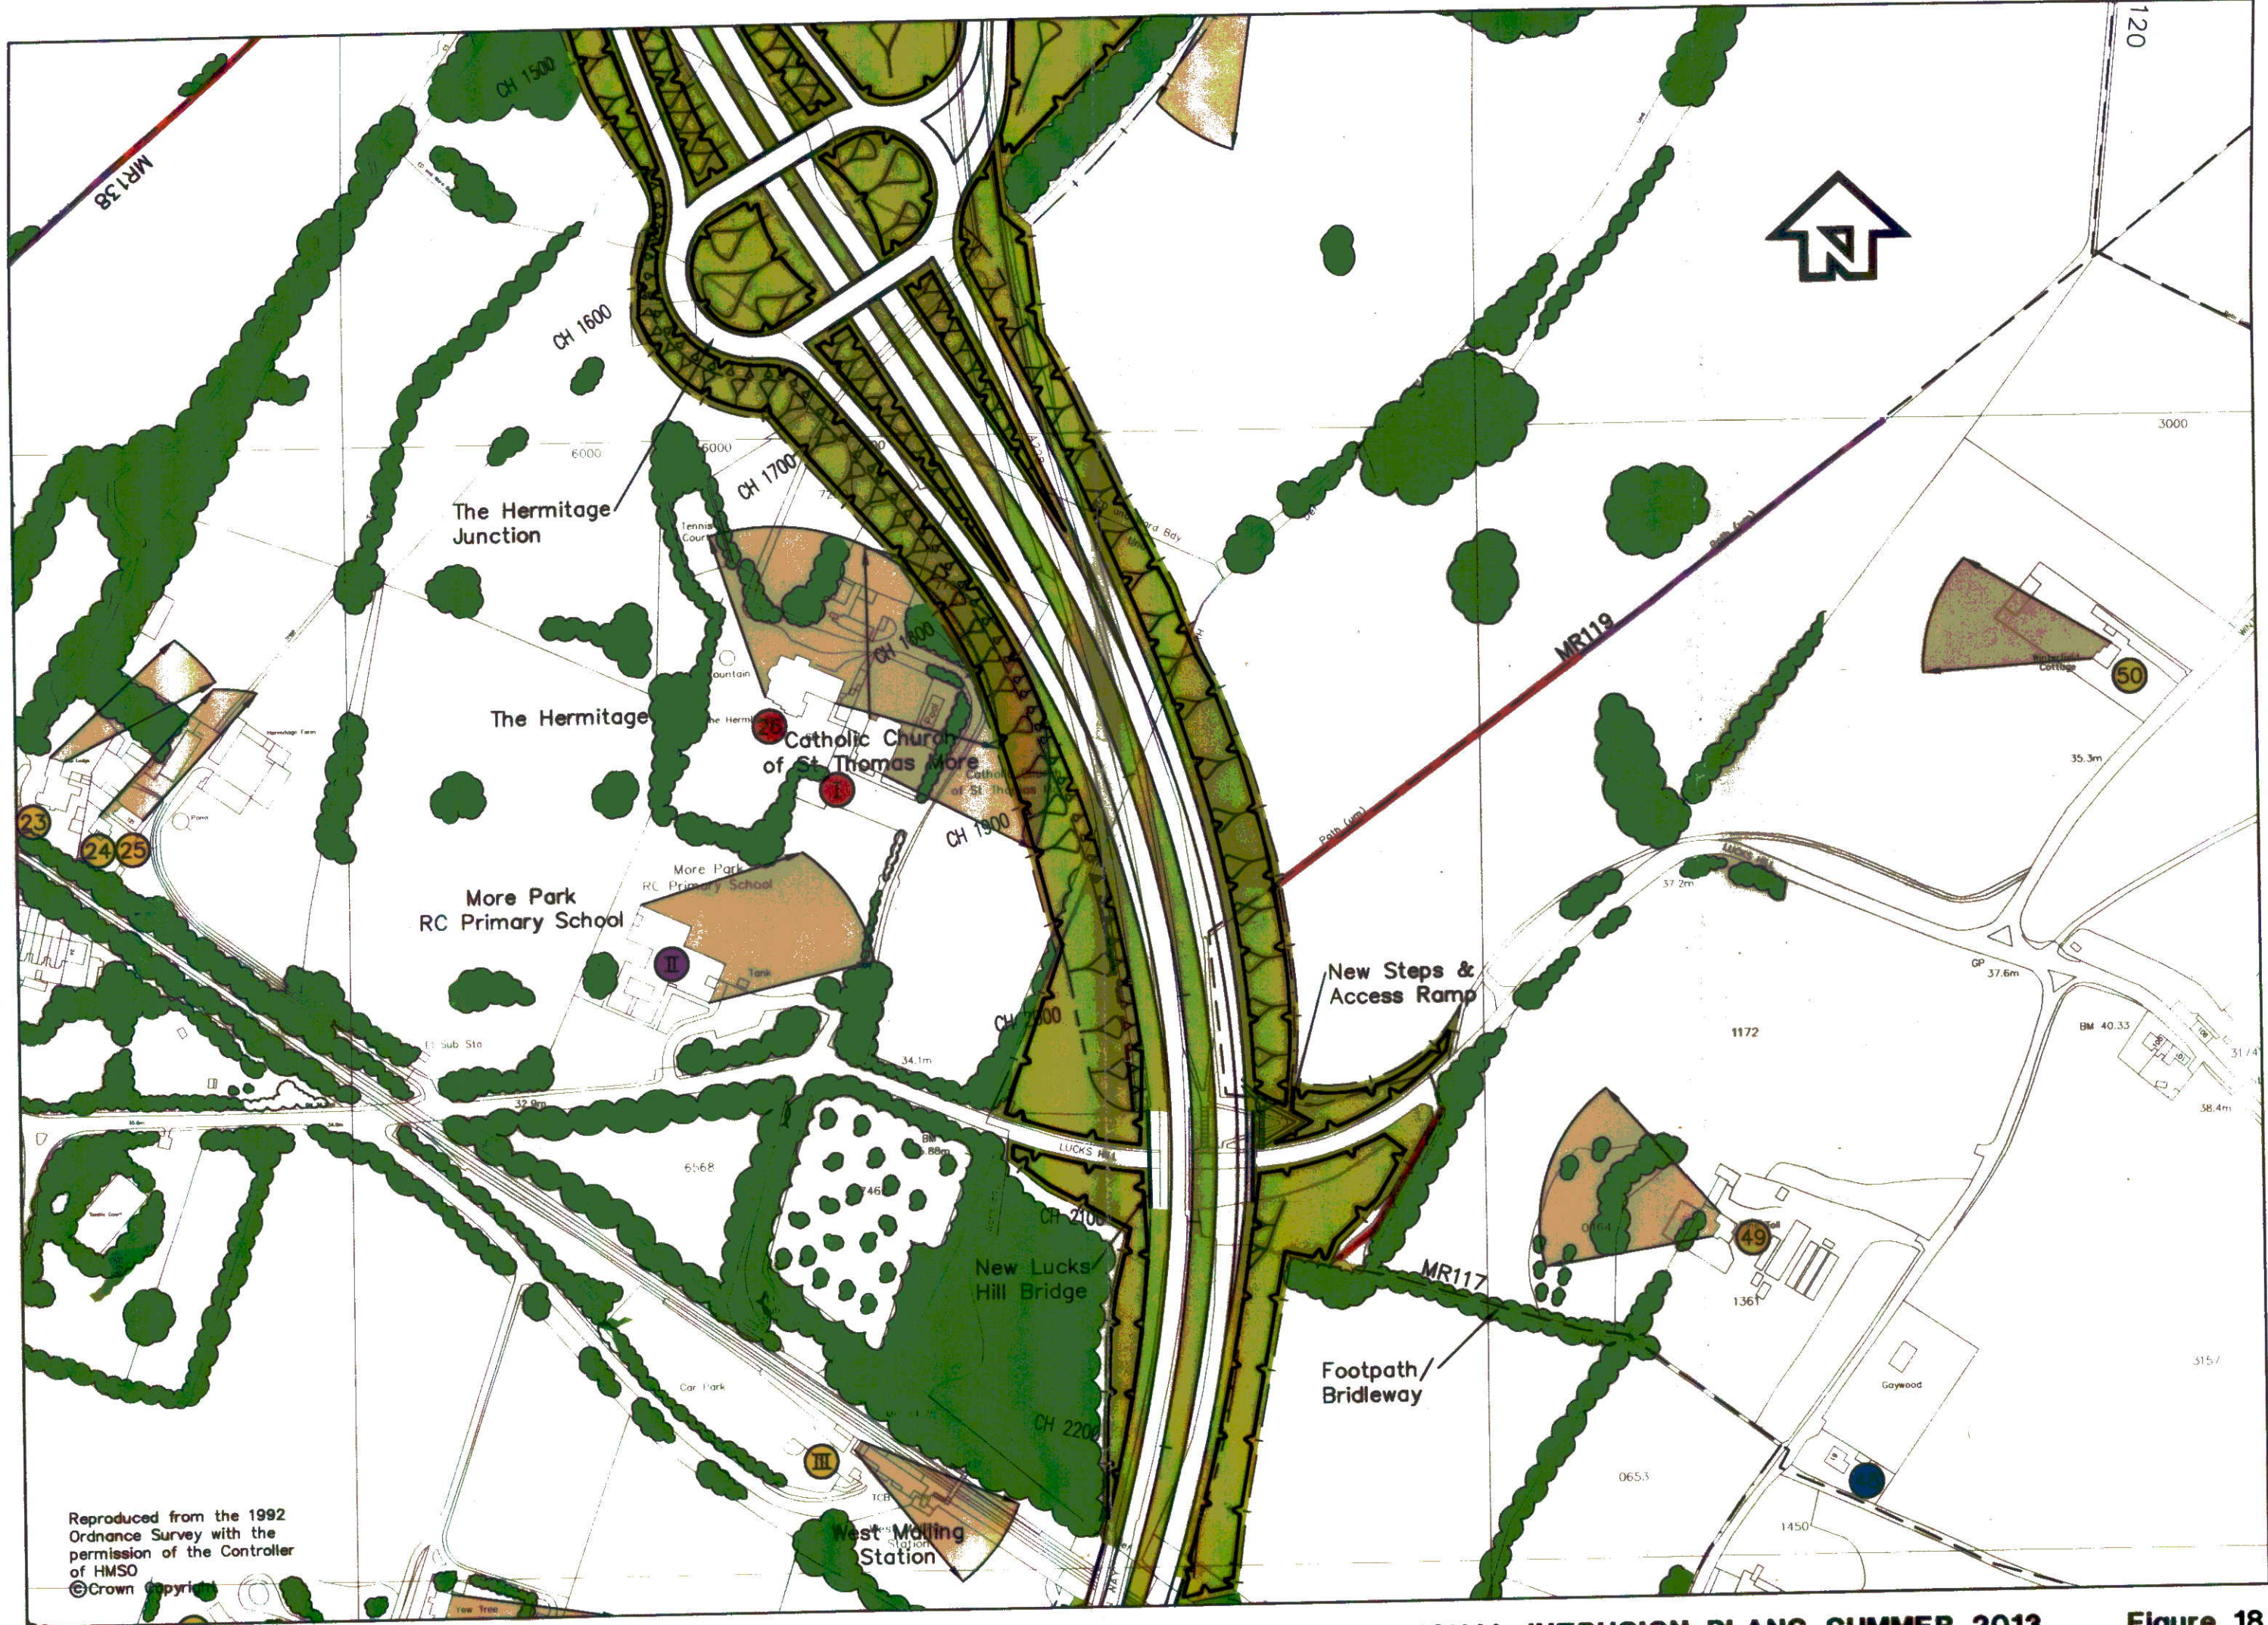
VISUAL INTRUSION PLANS SUMMER 2013 Figure 18

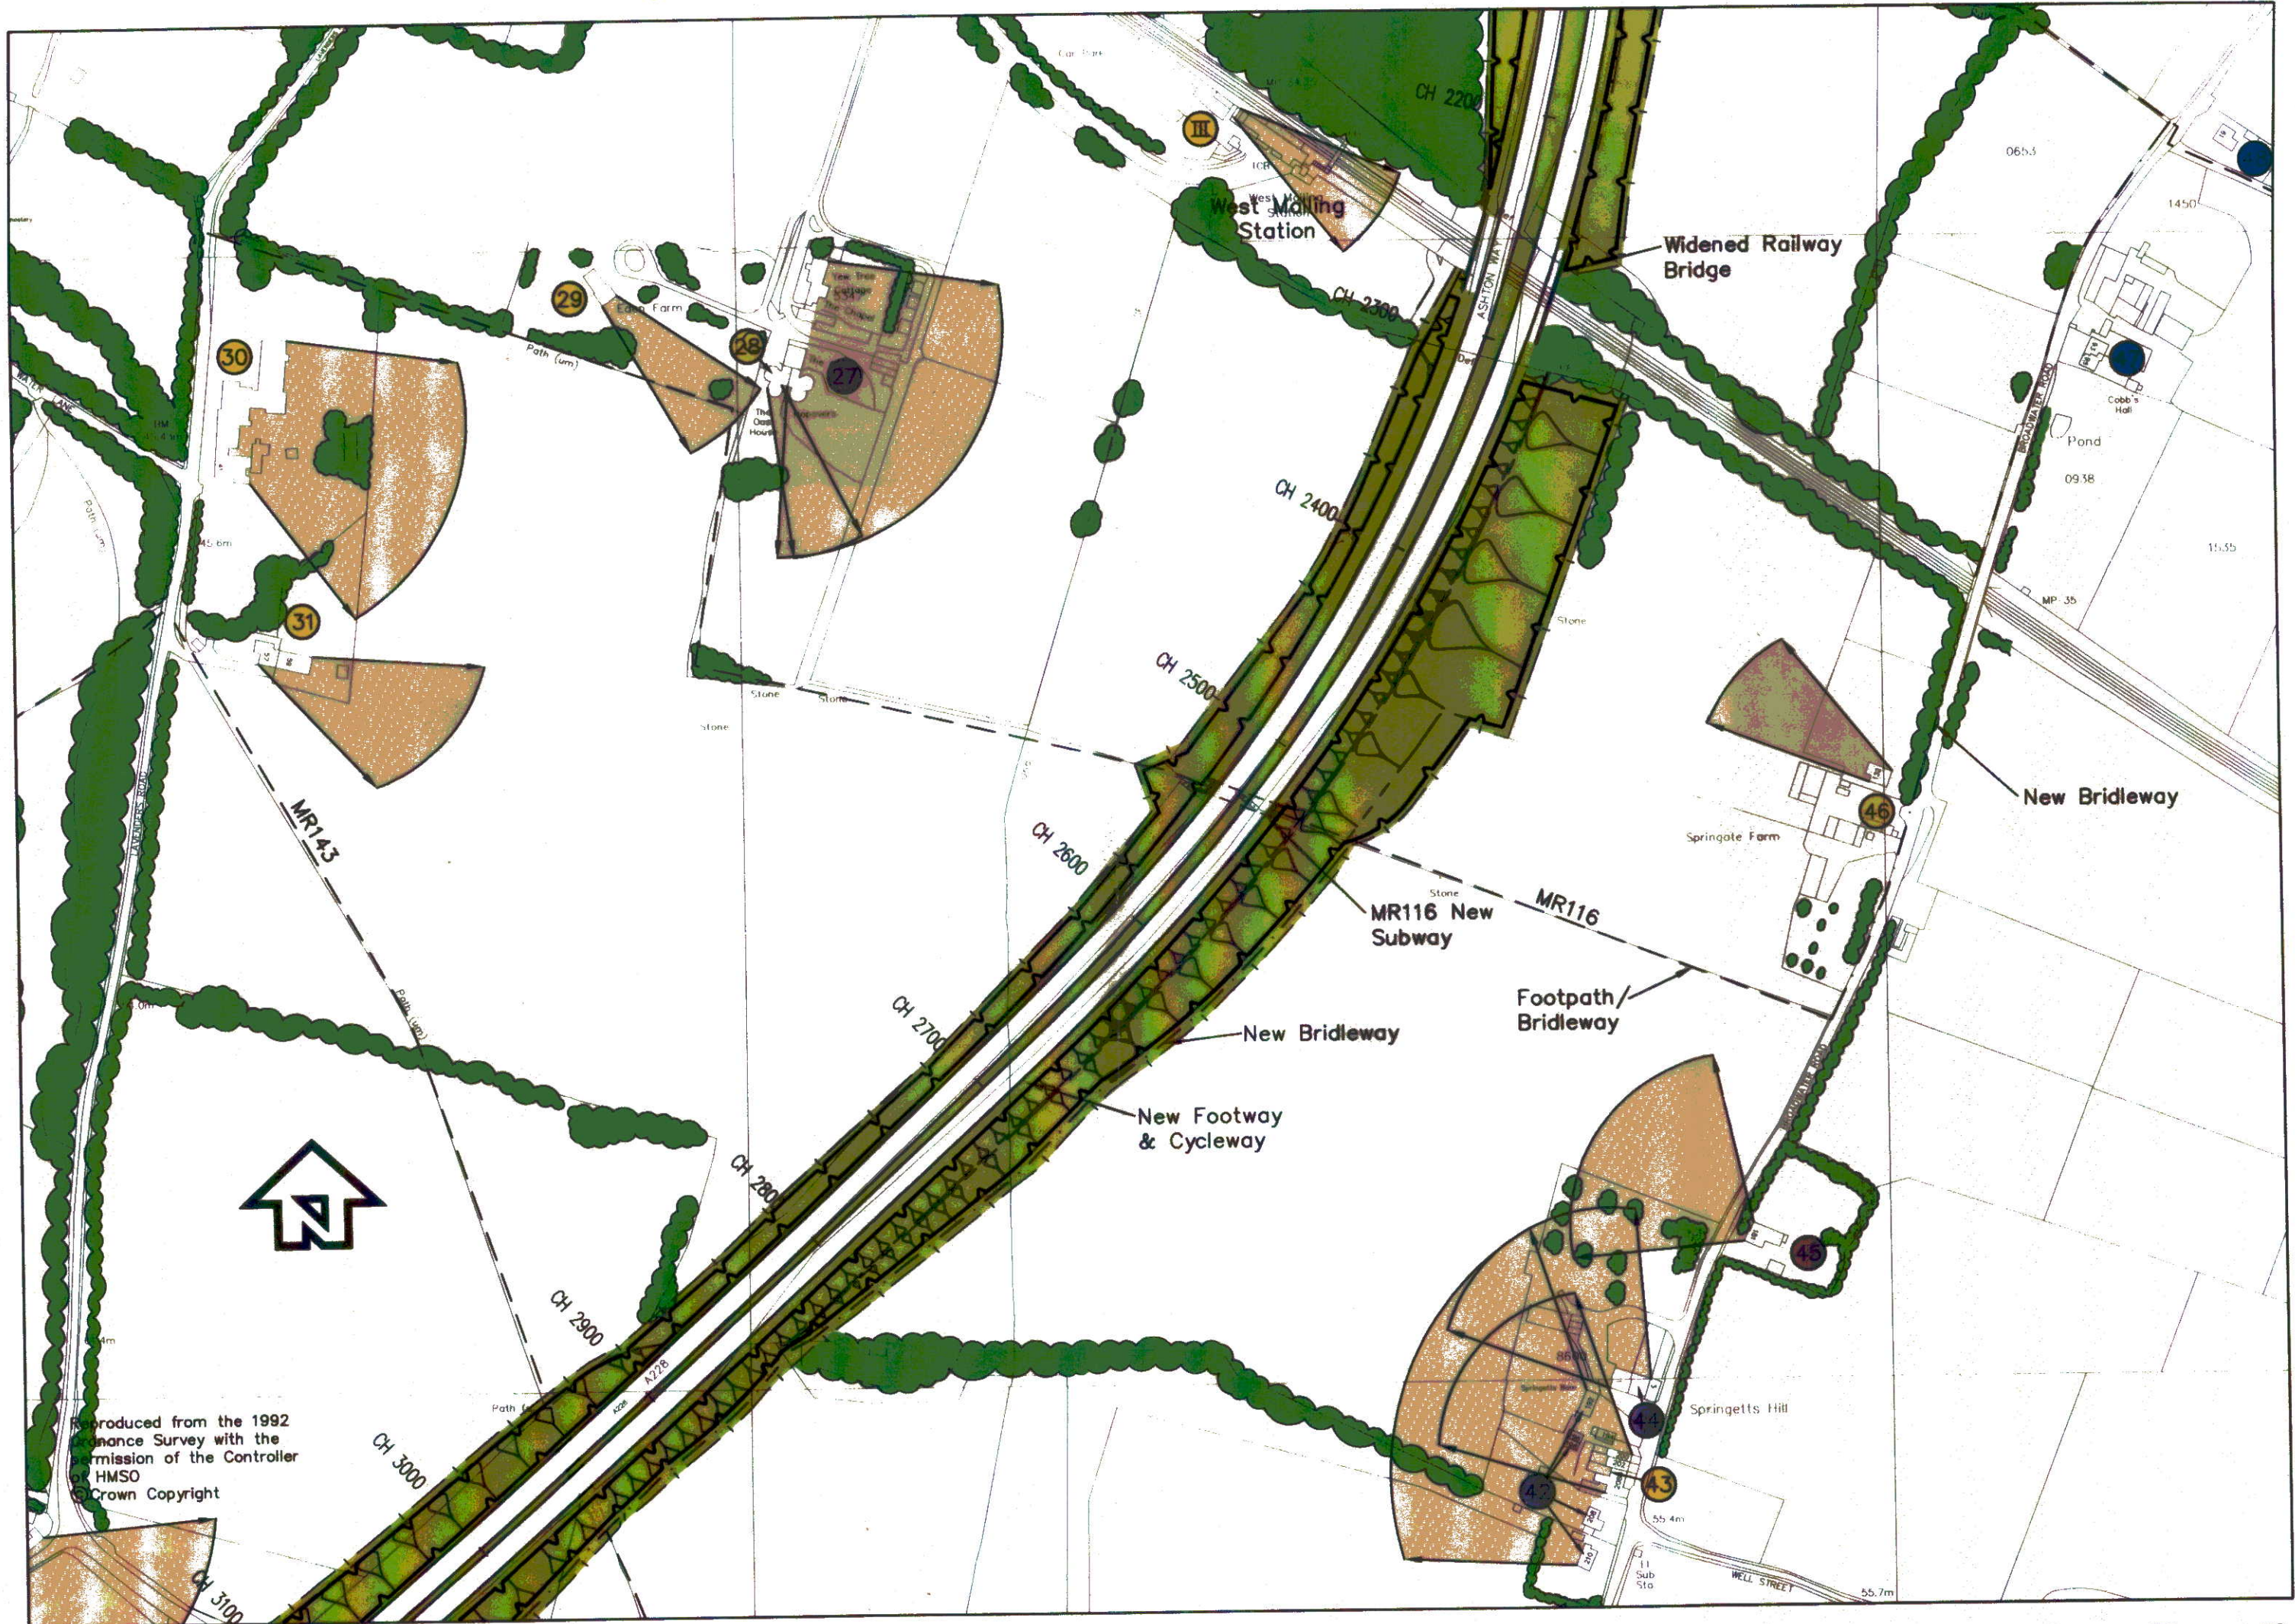
VISUAL INTRUSION PLANS SUMMER 2013 **Figure 19**

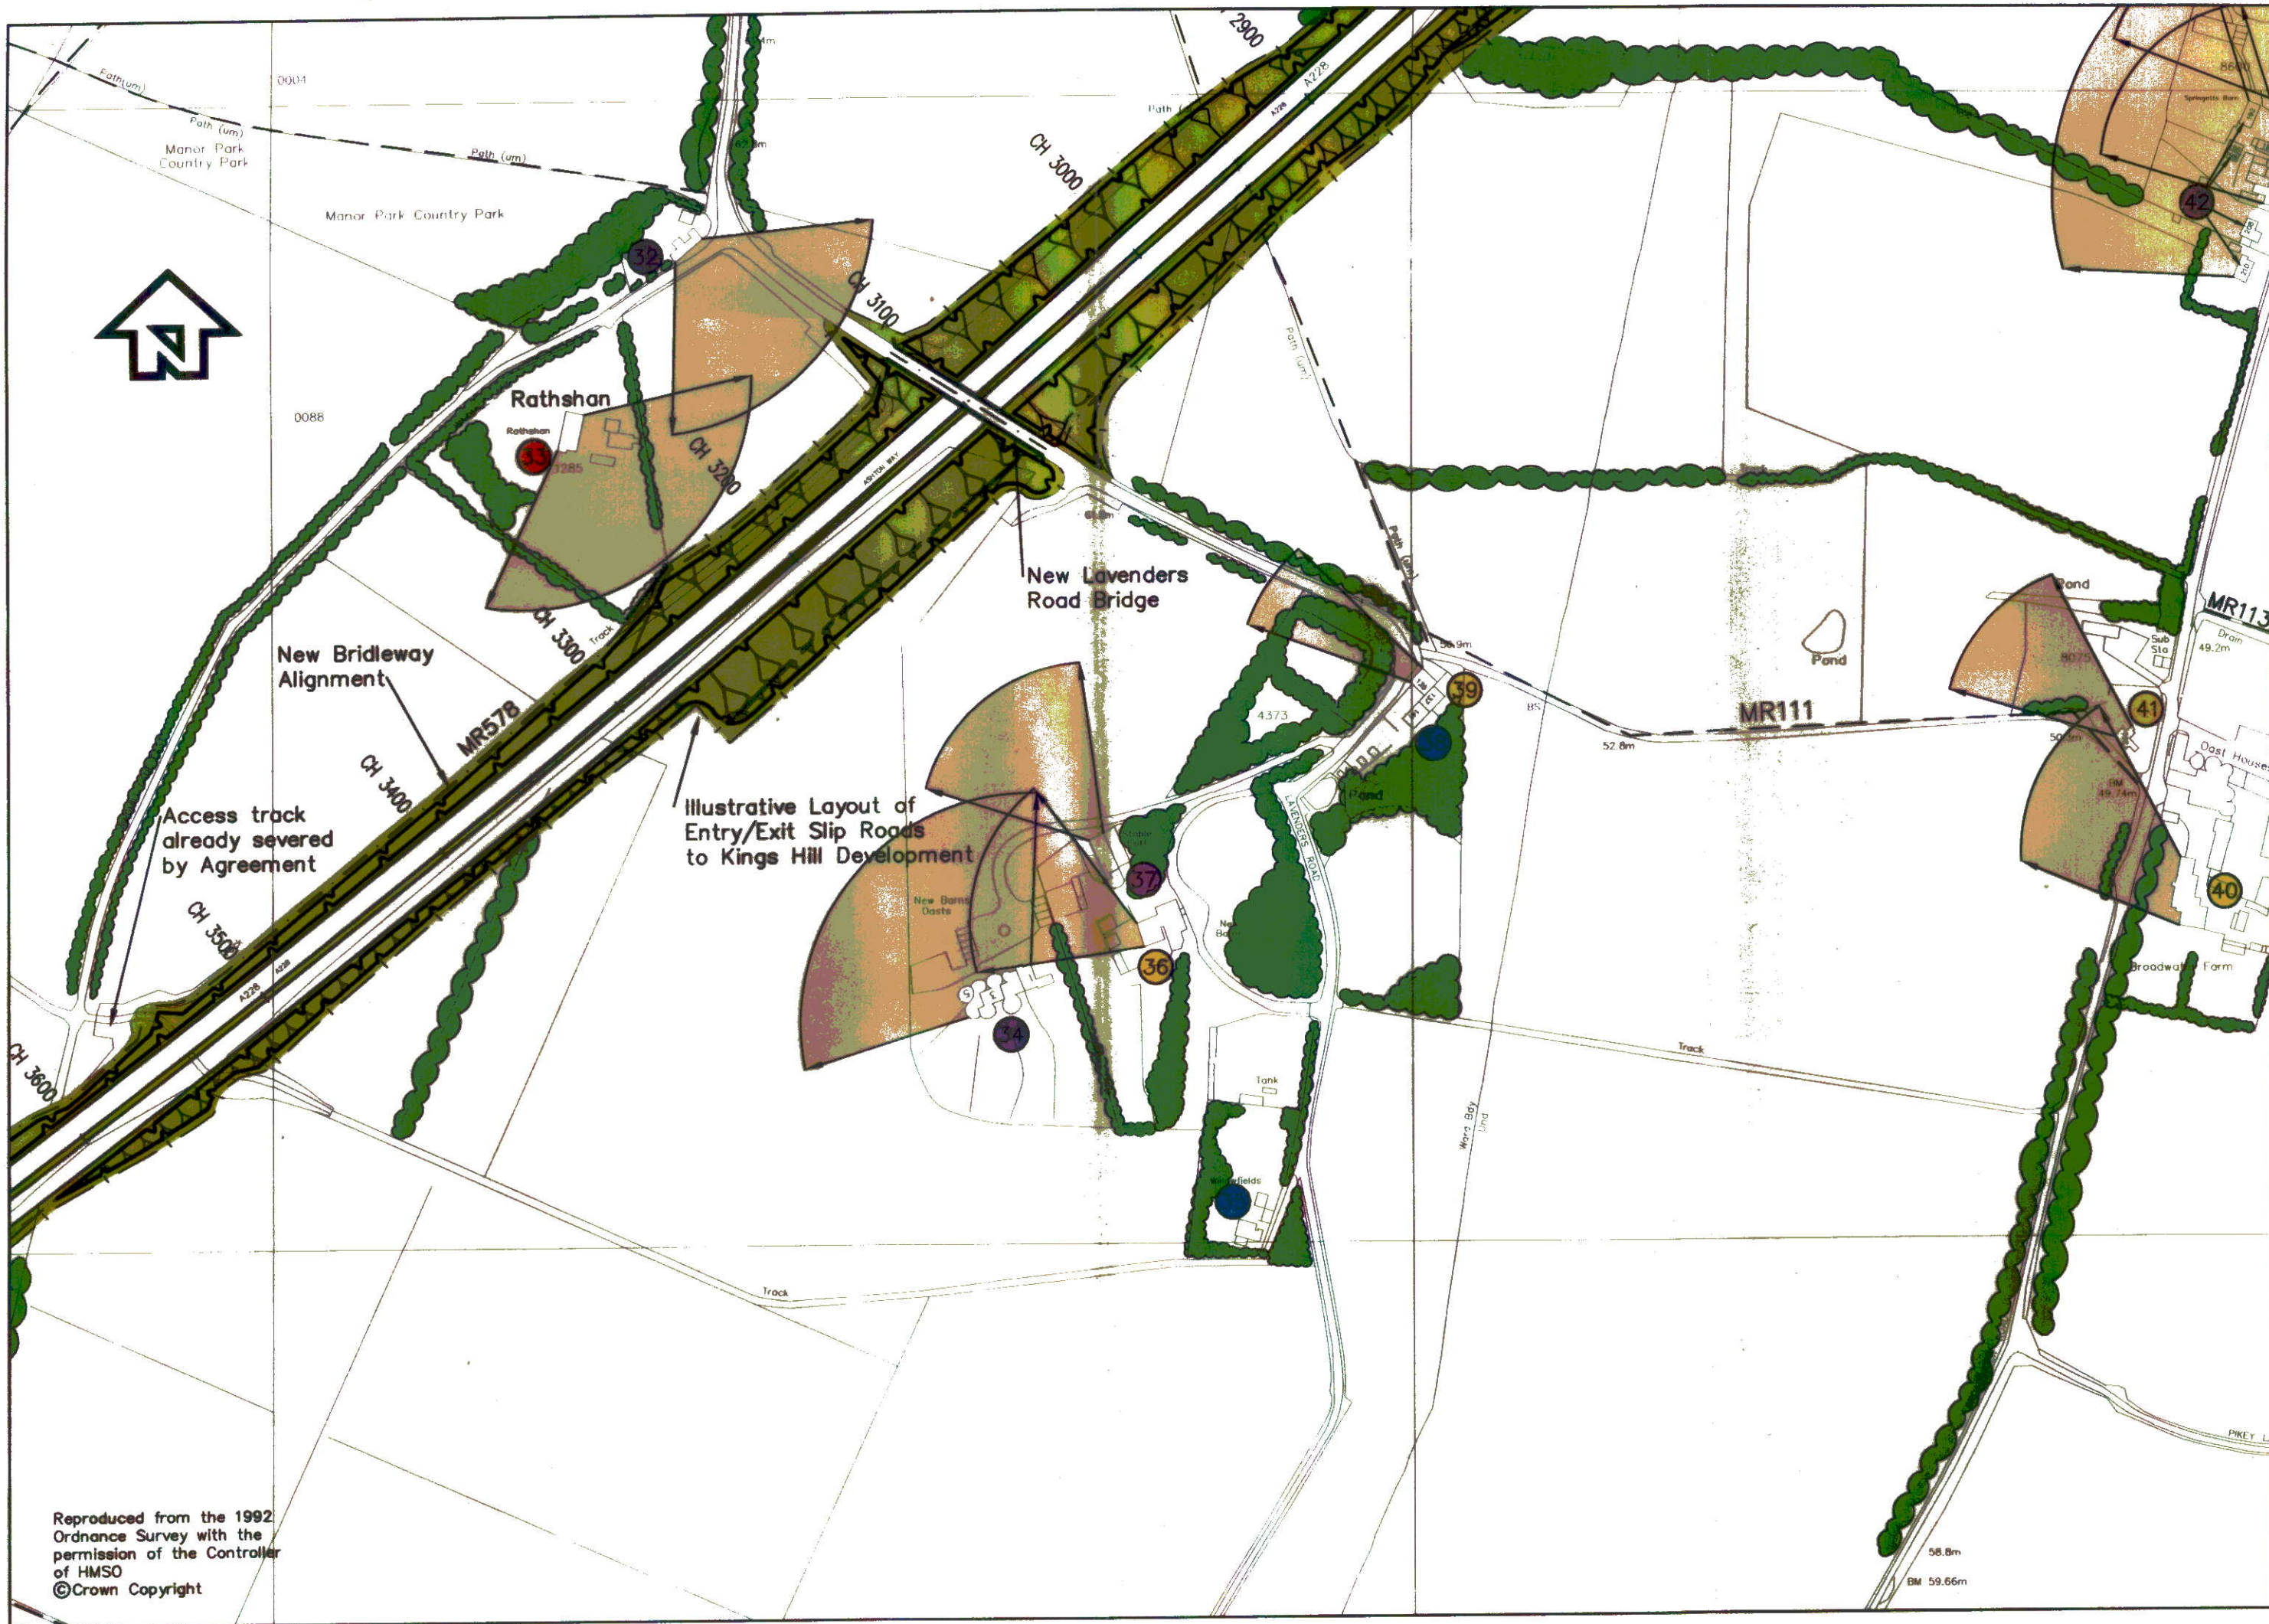
Figure 20

VISUAL INTRUSION PLANS SUMMER 2013
