A30 Bodmin to Indian Queens Improvement

Topographical Survey of Earthworks at Sites TS1 and TS3

Prepared on behalf of the Highways Agency by:
RPS Consultants in association with Parkman

July 2001

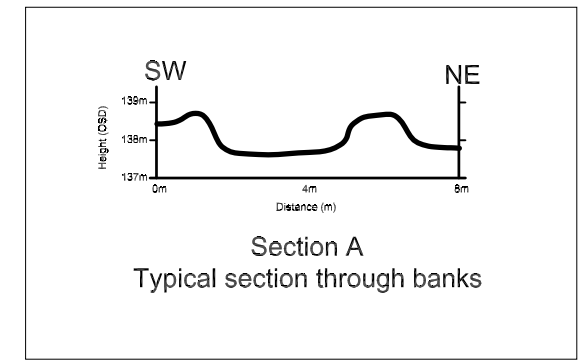
SCALE	DRAWN BY	
NTS	AMc	
DATE		
July 2001		
PROJECT NUMBER	FIGURE NUMBER	REVISION
R3834B	RPS 3

3.3 The track was located between the two fields on the survey site and ran for c.45m on a north-west to south-east alignment, see Photographs 1 and 3. The west and east sides were defined by stone walls with hedges respectively 1.2m and 1.0m in height above the bottom of the track and 1.1m and 1.6 in width, see Figure RPS 3, Section A. The wall and hedge on the west side continued to the south as the southern boundary of the western field. The wall and hedge on the east side terminated.

3.4 A low bank recorded 15m to the south of the track may have been a continuation of the east side of the track, see Photograph 1 (right foreground). This bank, c.0.3m in height, extended for 23m on a north-west to south-east alignment and consisted of uncoursed rubble and stone.

TITLE
Plan and Section of
Features at TS1

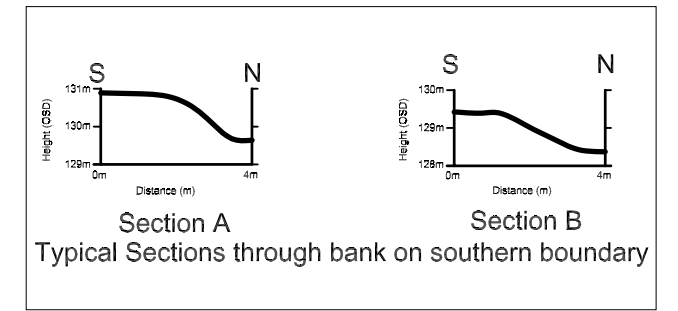
SCALE	NTS		DRAWN BY	AMc
DATE	July 2001			
PROJECT NUMBER	FIGURE NUMBER	REVISION		
R3834B	RPS 4

- 3.11 An area of relatively level ground, 50m in length, 36m in width and at a height of c.128m OD was recorded on the south part of the site. This possibly may have been the remains of a building platform associated with the farmstead of East Griglands.

- 3.13 The south-west boundary of the site was defined by a wall on the top of a bank, c.2m in height, with a scrubby hedge, see Figure RPS 4, Sections A and B, and Photograph 9. This bank was probably associated with the construction of the existing A30 (T). Hedges defined the northern part of the western boundary and the western part of the northern boundary and hedges on banks defined the boundaries of the field elsewhere.

PROJECT	A30 Bodmin to Indian Queens Improvement
TITLE	Plan and Section of Features at TS3

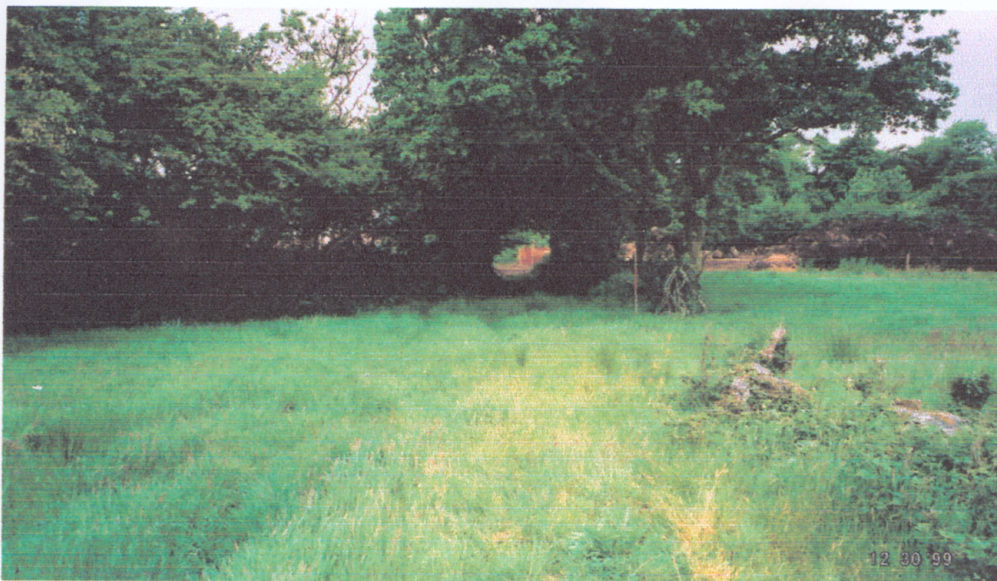
Photo 1: Track and Low Bank at Rosewin (TS1) looking North-West.

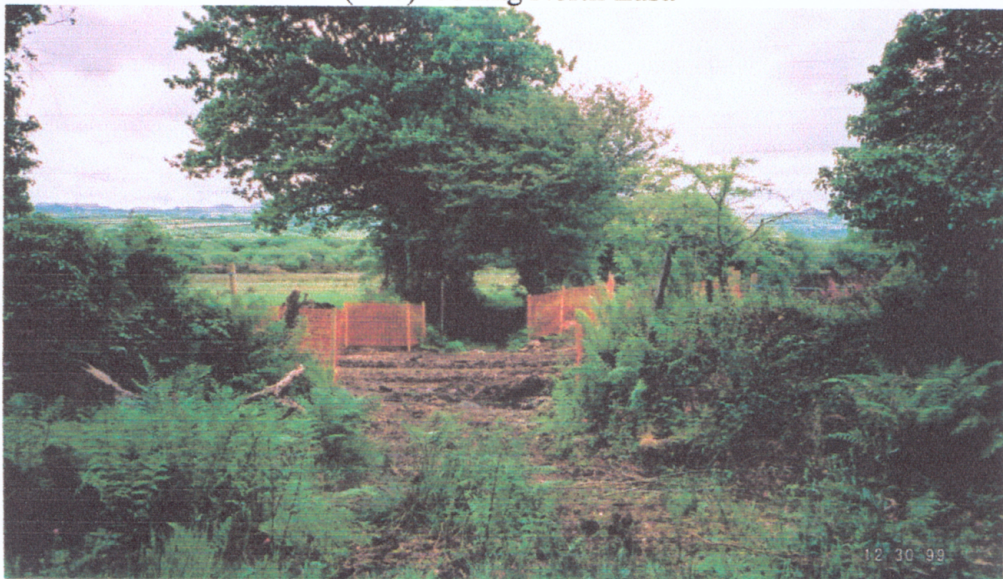
Photo 3: Track at Rosewin (TS1) with Pipeline Easement looking South-East.

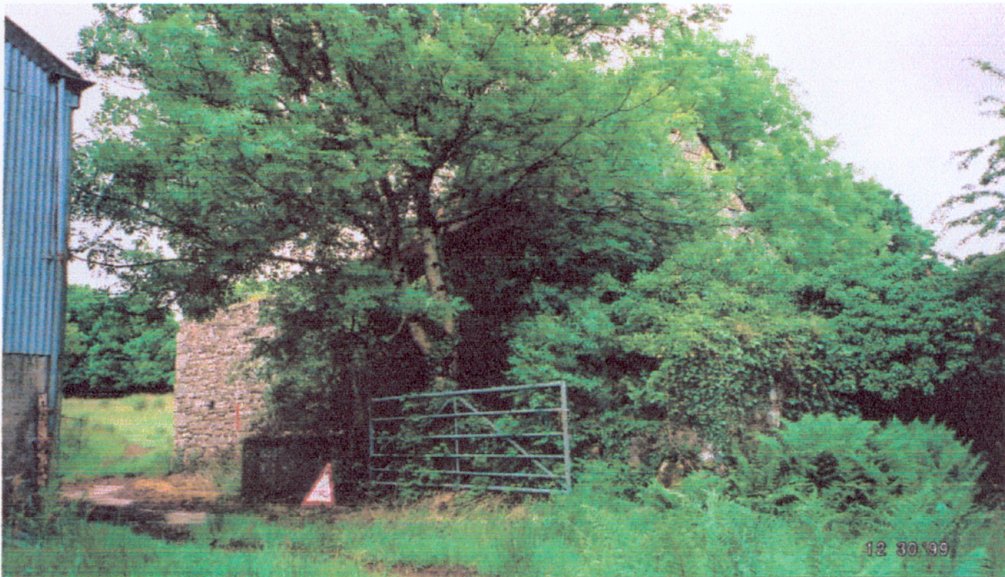
3.8 Although the farm buildings and house at Rosewin lay immediately to the north and outside the area of Site TS1 a general photographic record was made to provide a context for the associated track. The house on the north side of a central yard consisted of partially surviving granite and cob walls and a corrugated iron roof, a granite lean-to with a slate roof lay on the east side of the house, see Photographs 4 and 6. A two-storey cow house lay on the west side of the yard. This was constructed of granite walls and a slate roof with an outside

Photo 4: Farm House at Rosewin (TS1) looking North-West.

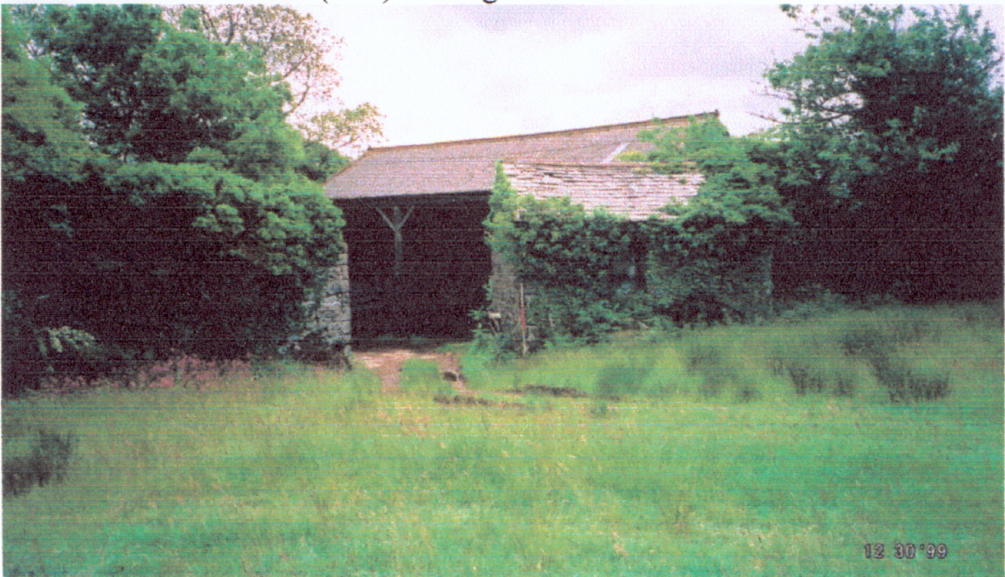
stairs leading to the first floor, see Photograph 5. A modern barn lay on the south side of the yard with remnants of other buildings on the east side.

Photo 5: Cow House and Barn at Rosewin (TS1) looking South-East.

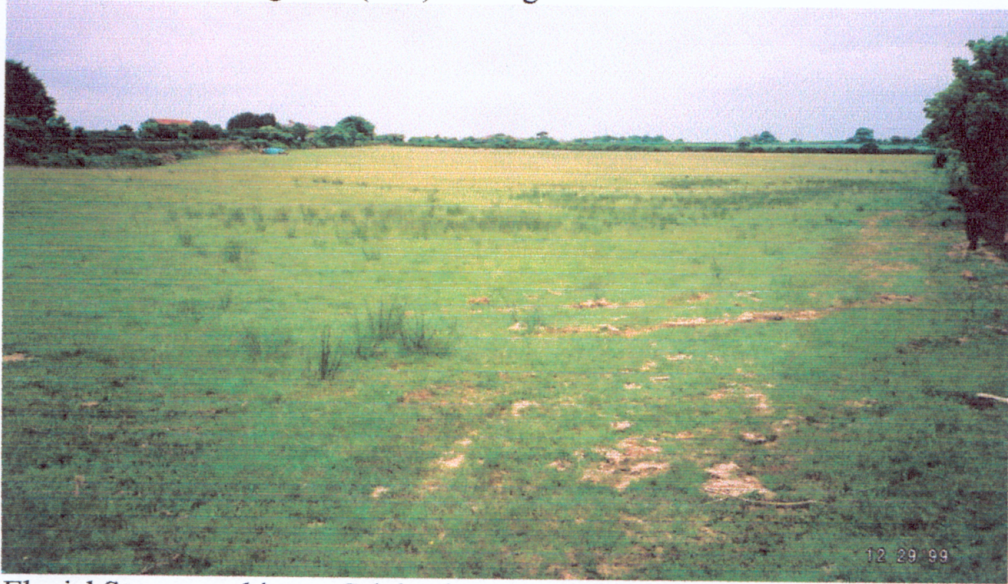
- 3.12 Other less pronounced irregularities in the general trend of the ground's slope recorded at the east of the site were probably associated with eluvial streamworking, see Photograph 8.

Photo 8: Eluvial Streamworking at Griglands (TS3) looking South-West.

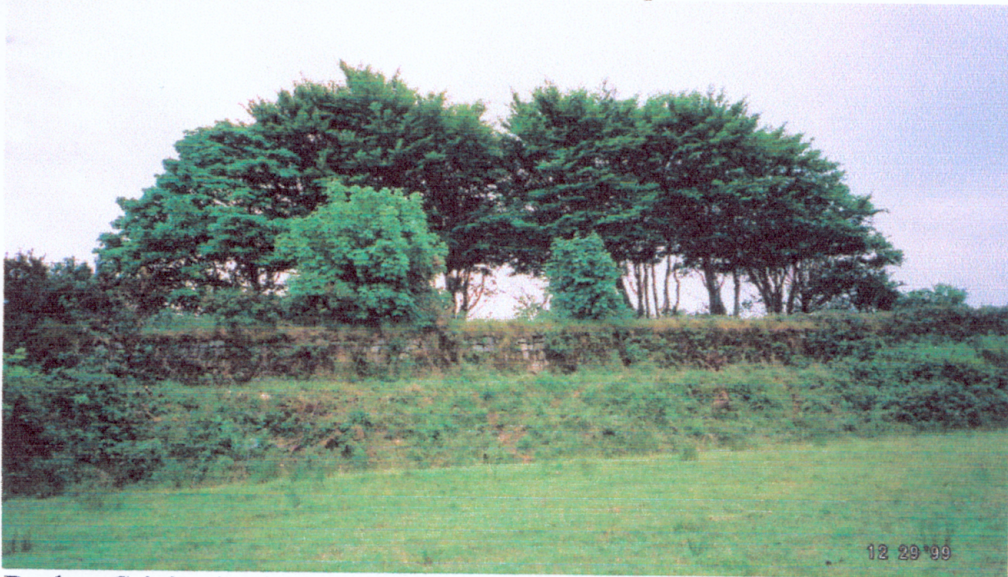
Photo 9: Bank at Griglands (TS3) looking South.
