A30 Bodmin to Indian Queens Improvements

Topographical Survey of Earthworks at Belowda

Site TS2

Prepared on behalf of the Highways Agency by:
RPS in association with Parkman

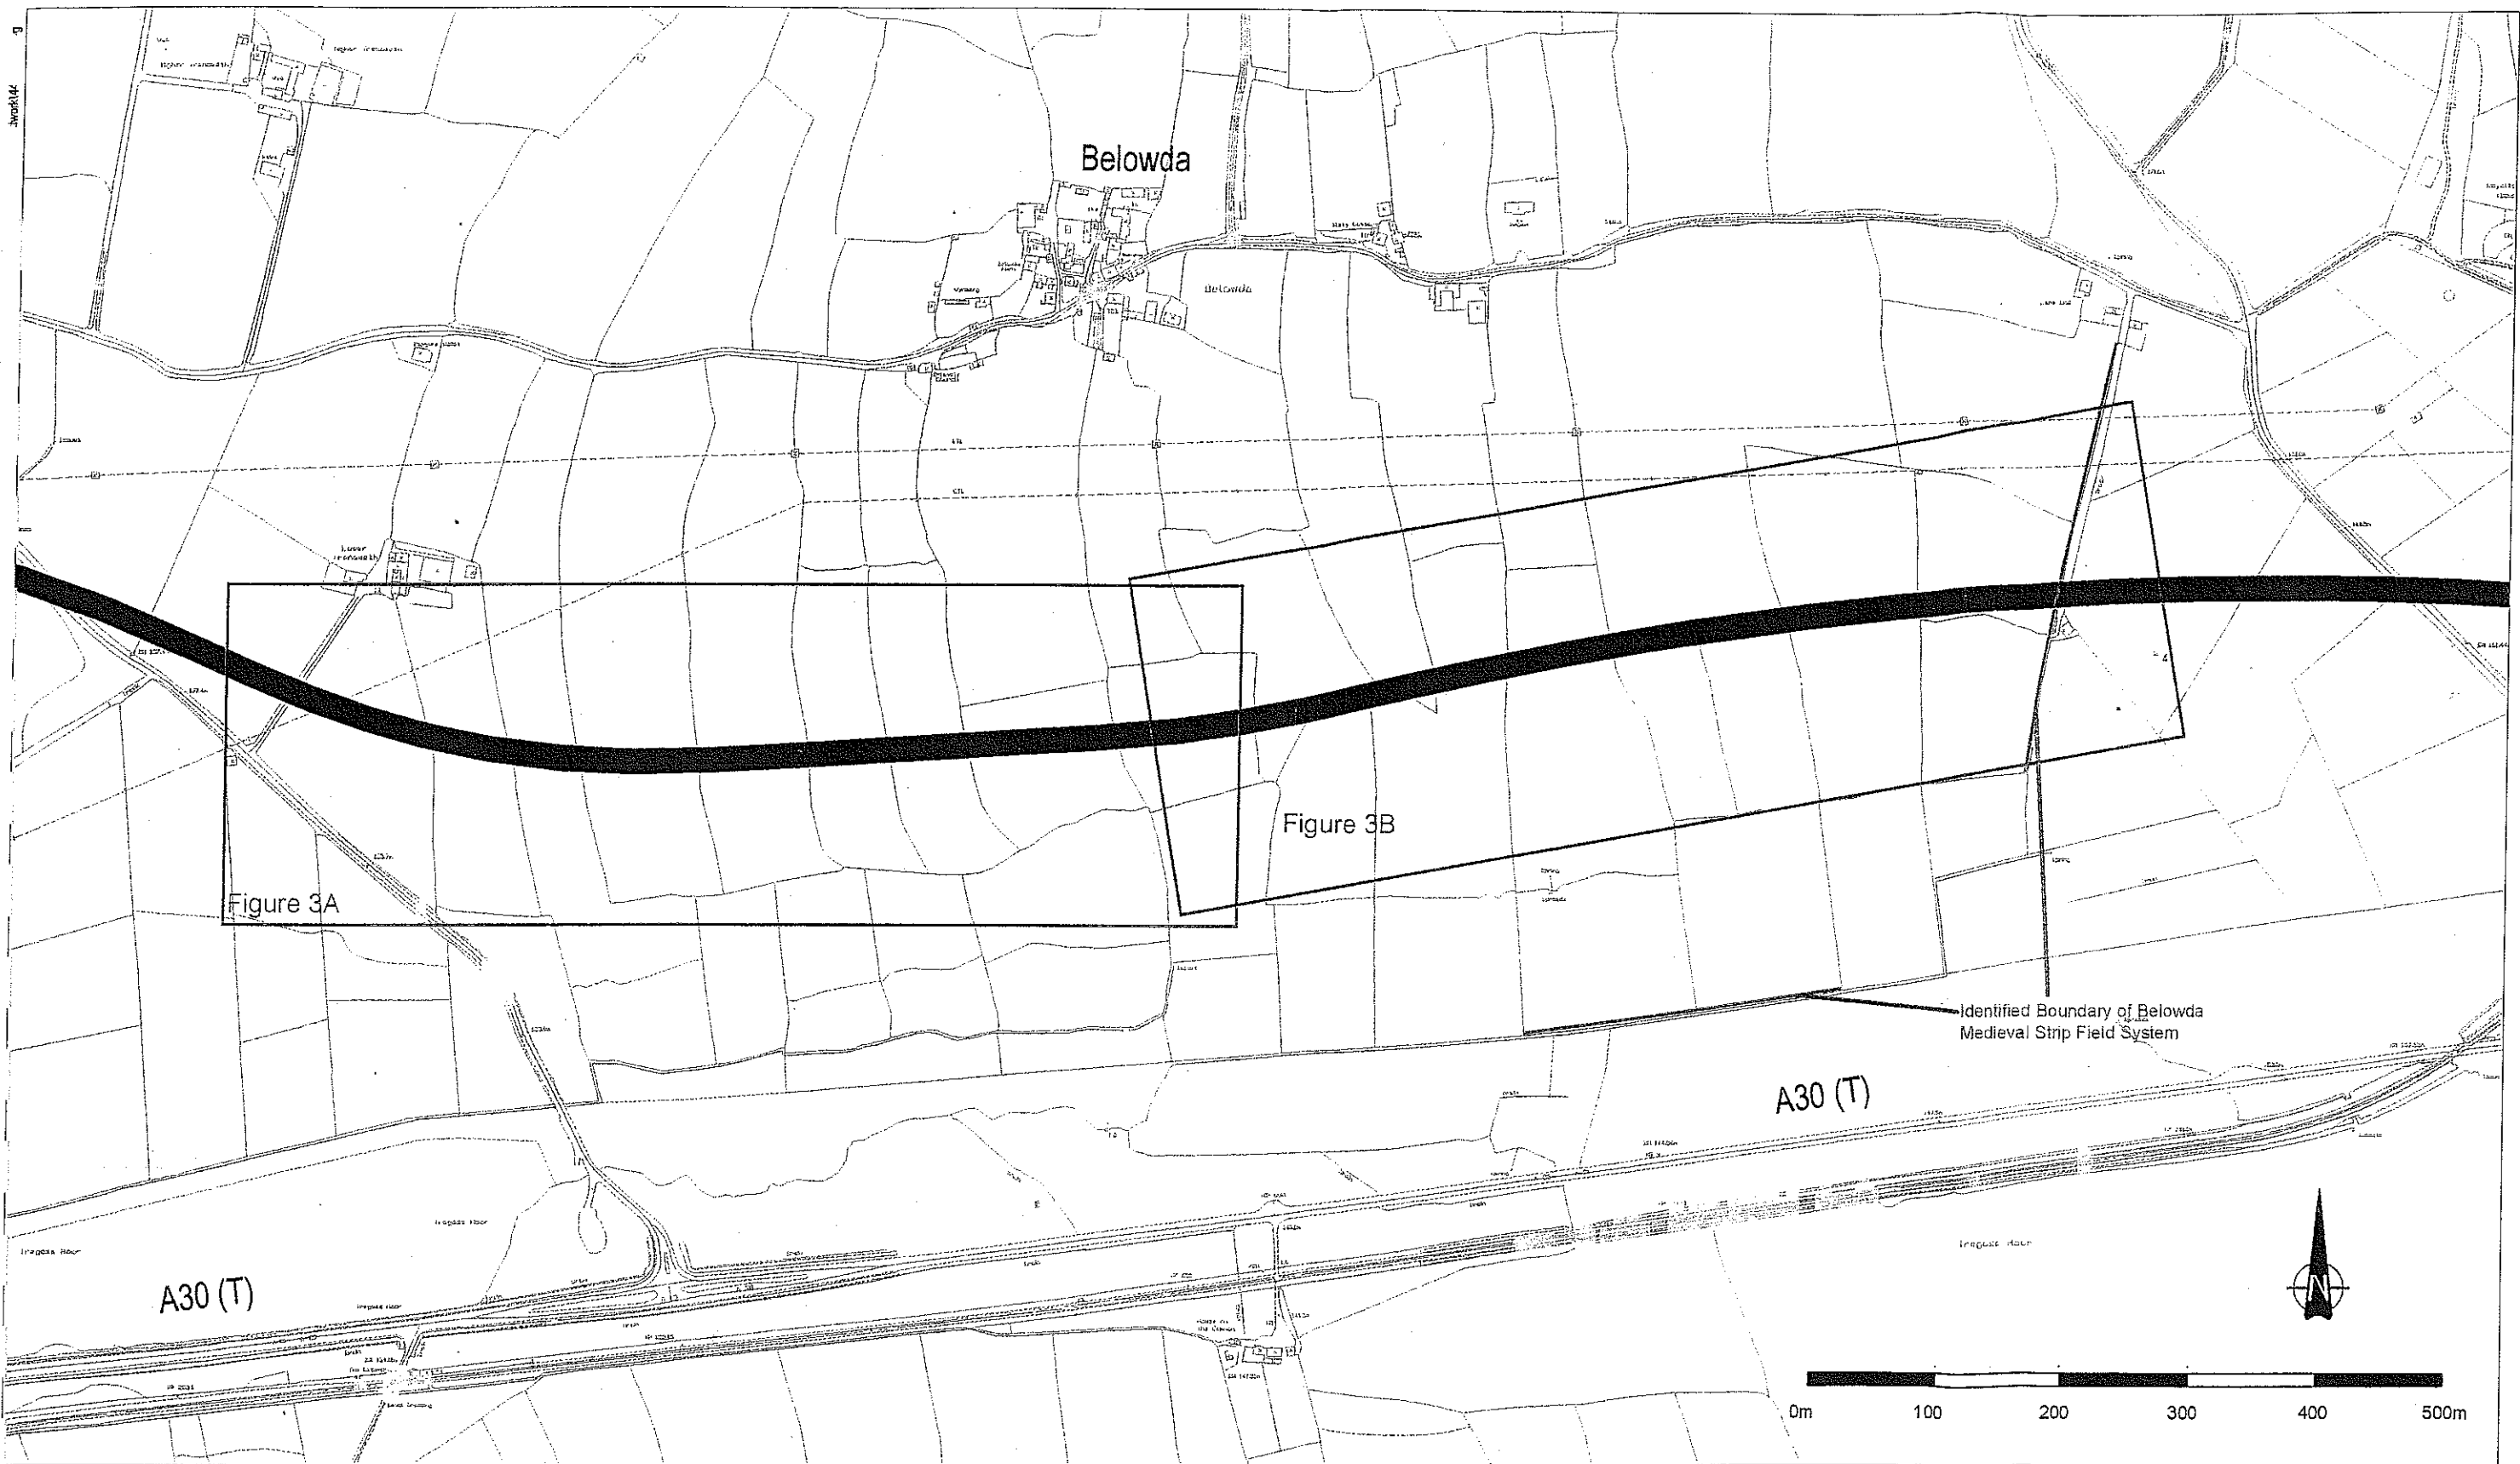
| Scale 1:5,000 | Drawn By AM | Checked By MC | Drawing No. RPS 1 |

| Title Topographical Survey at Belowda: Location of Survey Site (TS2) | | | |

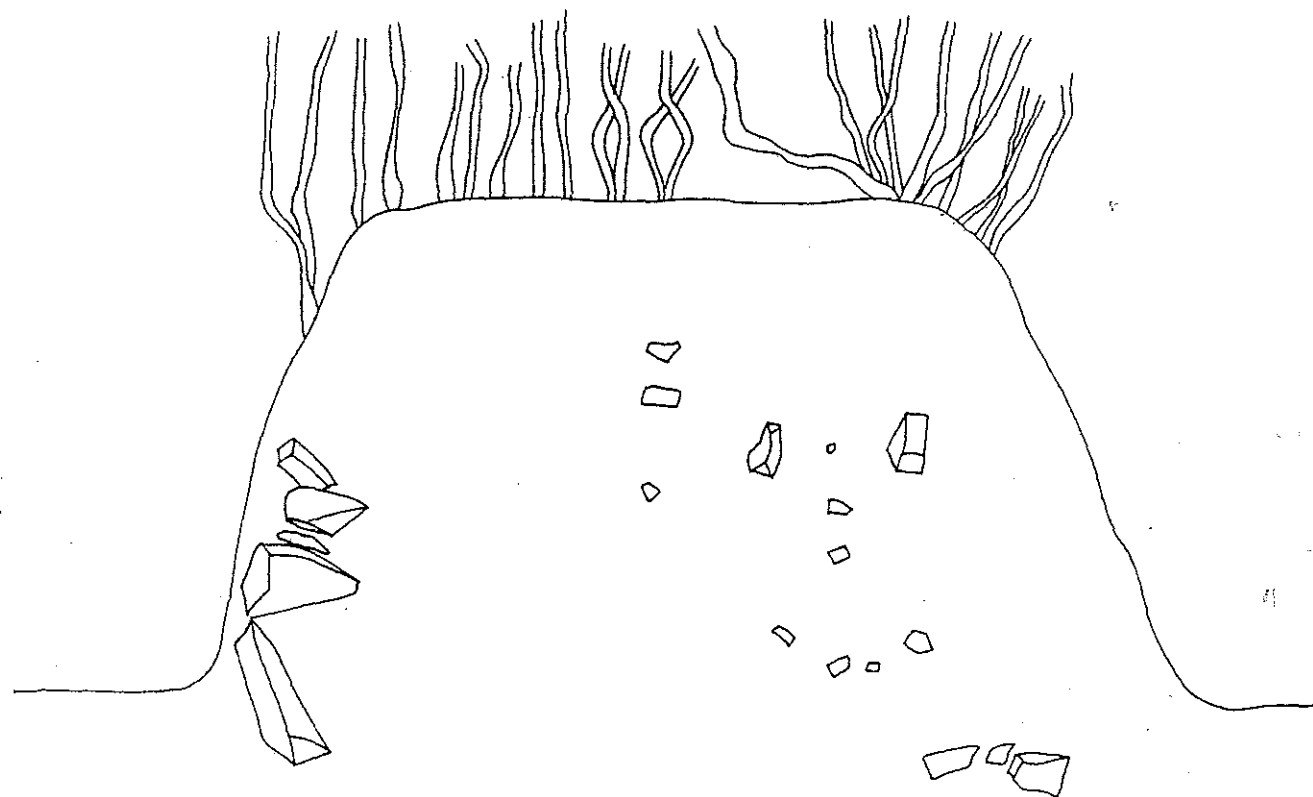
Title
South Facing Section Through Hedge on Bank

- 2.4 The character of the field boundaries was noted. A section of a field boundary exposed by the Transco pipeline, which ran through part of the northern edge of the survey area was drawn (see Figure RPS 4).

- 3.13 All the field boundaries within the survey area consist of earth banks (c. 1 to 1.5m in height and c. 2.5m in width) with hedges on top (P3, P13 and P17). Where visible, the bases of the banks appear to be stone faced with granite (see Figure RPS 4, P3, P6, P7, P9 and P14).

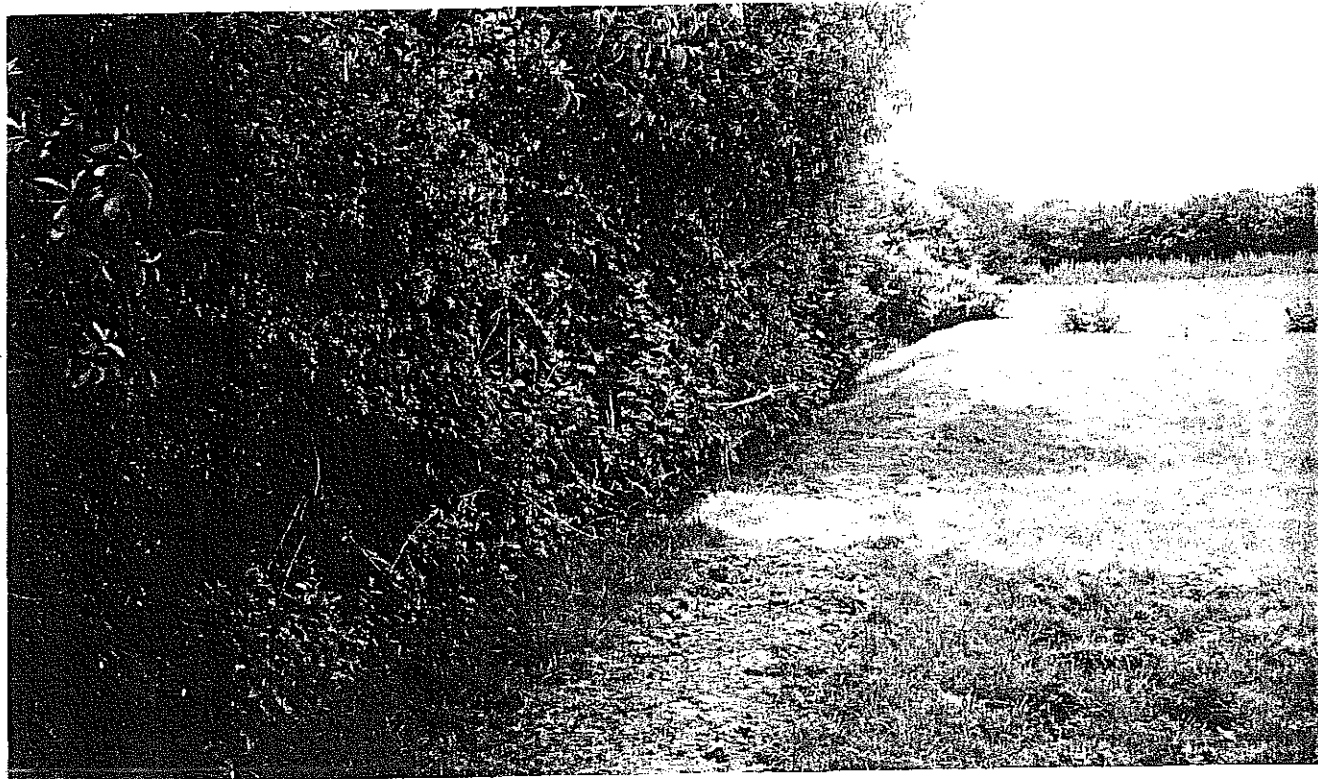
P11

- 3.12 The north-south aligned field boundaries are longer and slightly sinuous, whilst the east-west boundaries are generally shorter and straight. In places, there are shallow ditches running adjacent to the east-west aligned boundaries (P11).
