**A30 TRUNK ROAD
HONITON TO EXETER IMPROVEMENT
ARCHAEOLOGICAL EVALUATION
PART 1: BLACKHORSE, SOWTON**

Exeter Museums Archaeological Field Unit

Report No. 94.101

December 1994

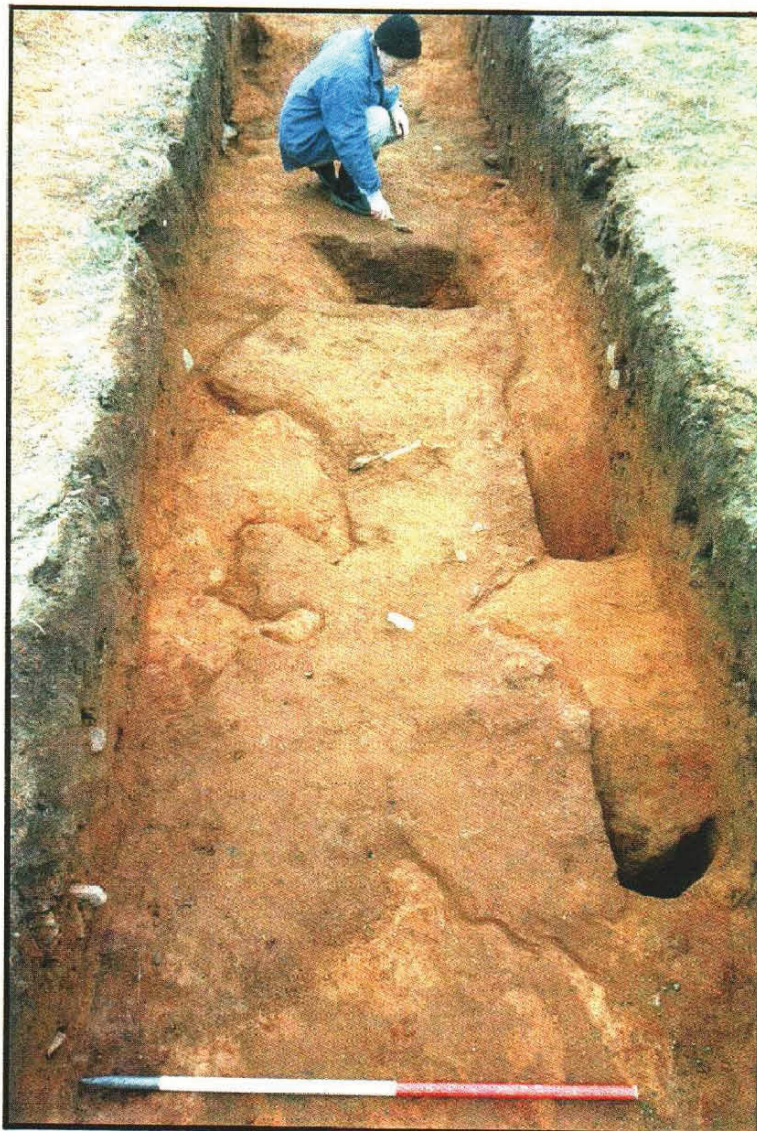
Plate 3 Linear feature 769 exposed in plan in Trench 1. Looking south.
(Scale: 1m).

To the south of the enclosure ditch in Trench 1, a linear feature (769) orientated north-south, was recorded for a distance of 6.5m. At its northern end (5m from the ditch) the feature bifurcated at right angles to the main alignment of the trench, and another westward extension was recorded 1.5m south of this.

Although not fully excavated, the varying profiles (V-shaped and U-shaped) of the feature suggest that it was not of natural origin, and it may have been a post-trench. It was between 0.3 and 0.5m deep. It was filled with concreted red sand (768). No finds or charcoal were recovered. At its southern end this feature was cut by a ditch (770).

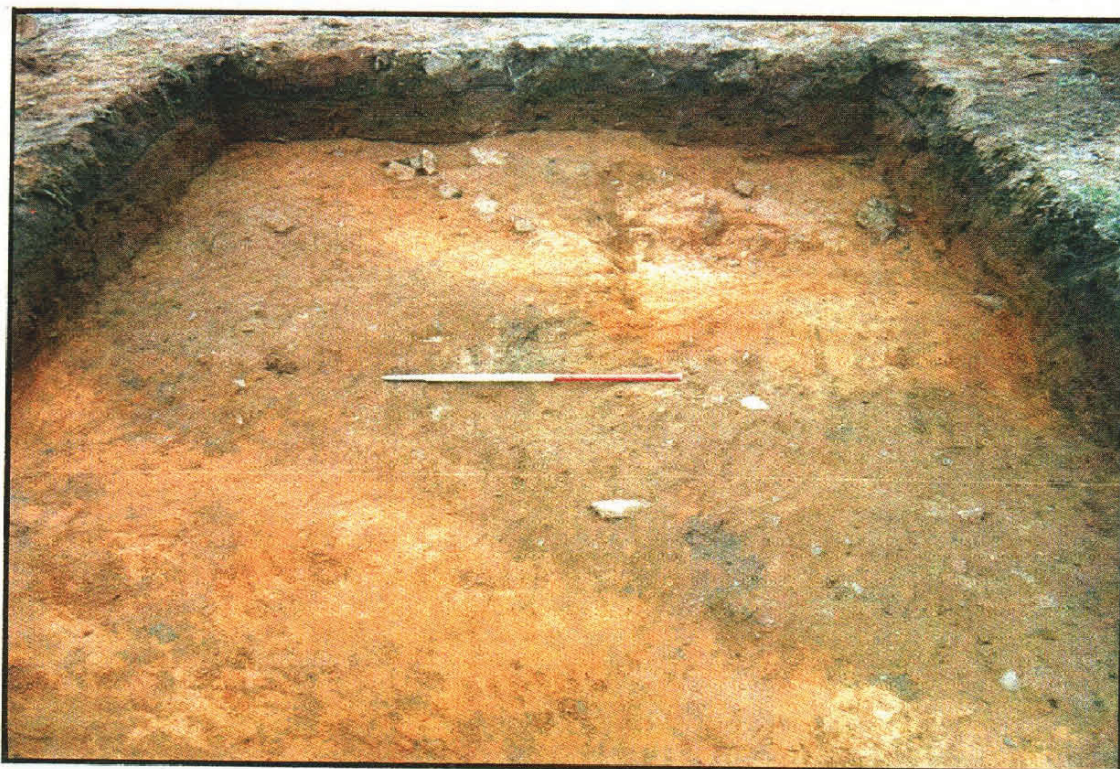
Plate 4 Curvilinear feature 772 exposed in plan in Trench 3. Looking east. (Scale: 1m).

An asymmetrical ditch (772) was located in Trench 4, 8m east of the enclosure ditch. This feature continued northward and was seen to turn in a north-easterly direction in Trench 3, where it cut two earlier features, a pit (776) and the linear feature (774; see 3.2). The ditch was between 1.1m and 1.4m wide. Its western side was 0.1m deeper than the eastern side. It may represent a post-trench or palisade slot for an earlier enclosure, or a sub-division of the main enclosed area. No finds were recovered from this feature, but charcoal was extracted for future radiocarbon dating if required.

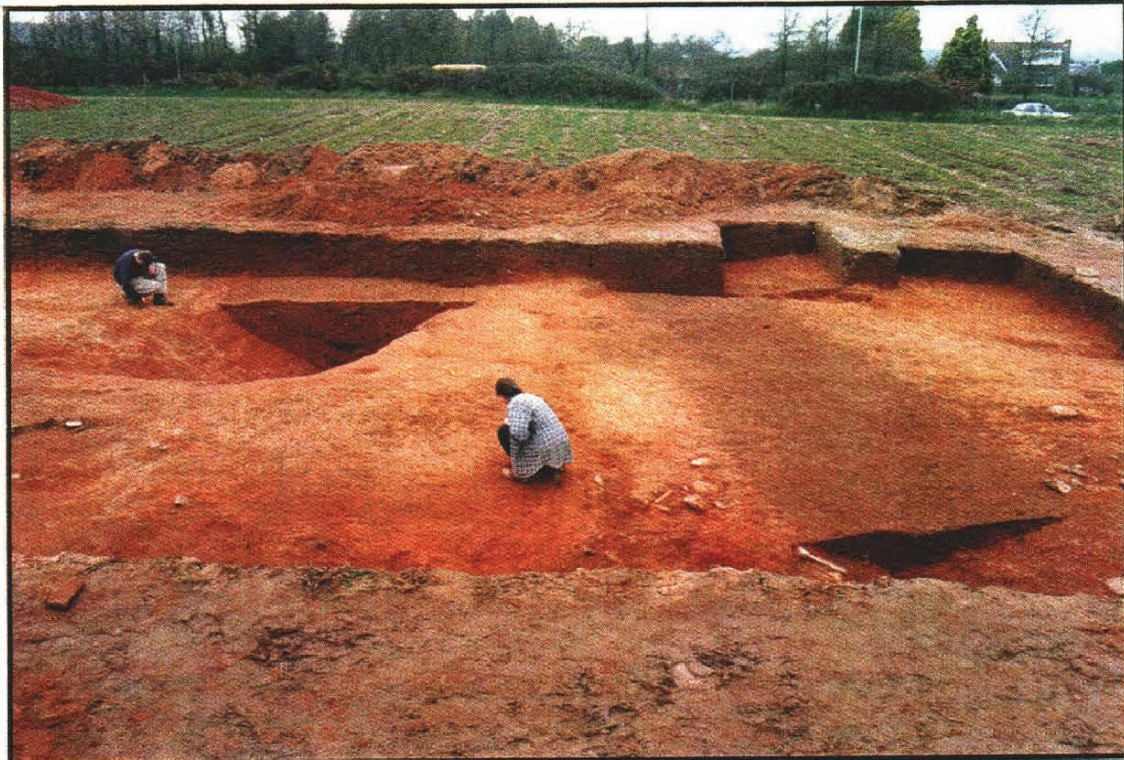
Plate 5 View of eastern half of Trench 6, showing ditch terminus and post-medieval ditch 702 on the right. Looking north.

Trench 6 was excavated across the eastern entrance to the enclosure. The ditch terminus to the north was exposed for a distance of 5.5m. Only *c.* 0.5m of the tip of the ditch terminus to the south (780) was exposed at the southern edge of the trench.
