**A35 STINSFORD TO CUCKOO LANE
ROAD IMPROVEMENT, DORSET**

**ARCHAEOLOGICAL FIELD EVALUATION
AND HISTORIC LANDSCAPE ASSESSMENT**

November 1993

CAT Job 0341
CAT Report 93140

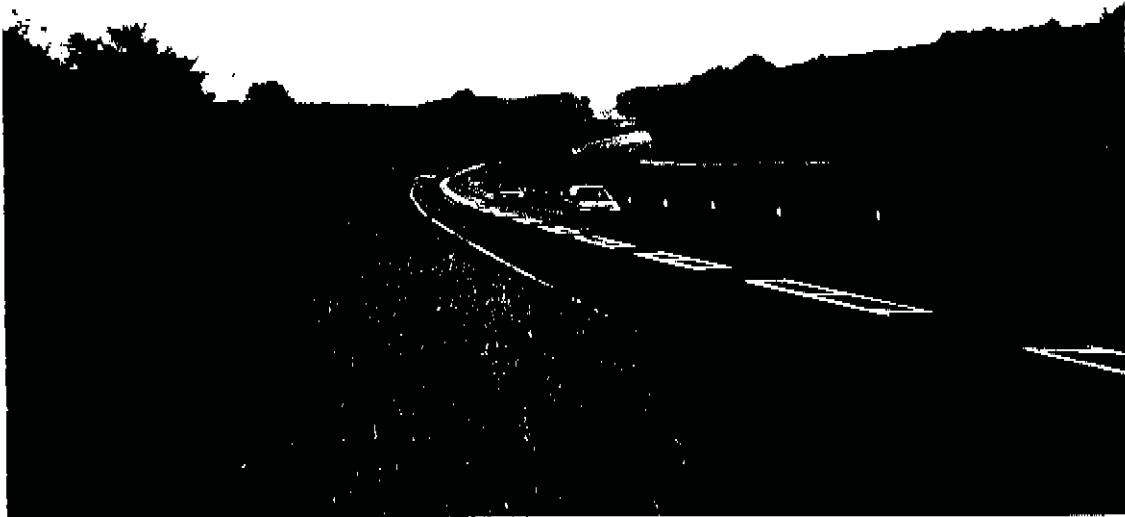
1

A. The north-north-west margin of the road from chainage 2200 to Cuckoo Lane.

Sycamore, Beech and Hazel, with a few evergreens, approximately 15m thick and important visually.

[Photo 1].

- 11.3 The HEDGES themselves are not species rich, or are sufficiently well marked with earthworks to be of any unusual or special value.
- 11.4 The TREE plantations are long established. The north-north-west road margin from chainage 1920 to Cuckoo Lane is visually important, and should be retained and protected from damage during the works.
